Inspection Photos

11/06/2019

Operator: MARALEX RESOURCES INC - 53255

Location ID: 312599

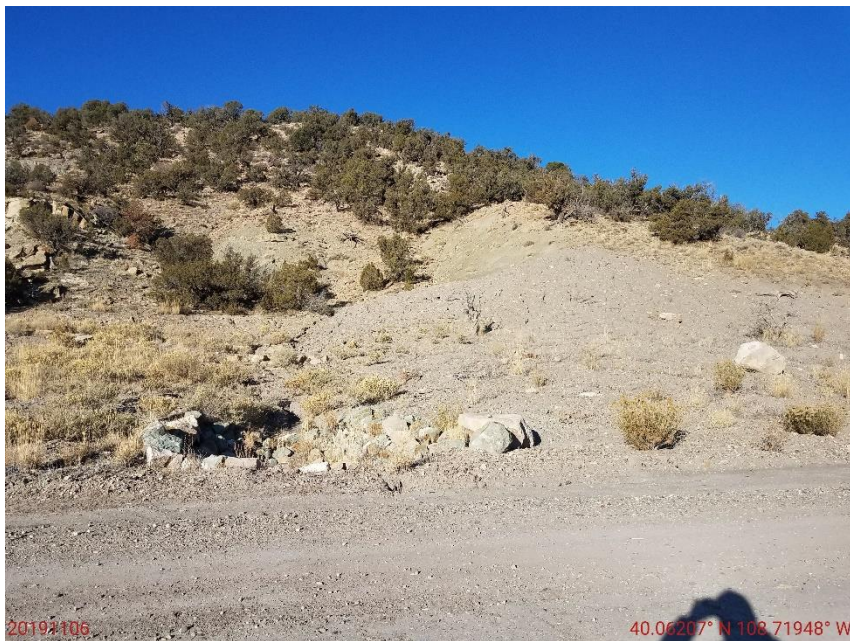
Photo 1: Photo taken from the access road, facing west. Photo provides overview of the location.

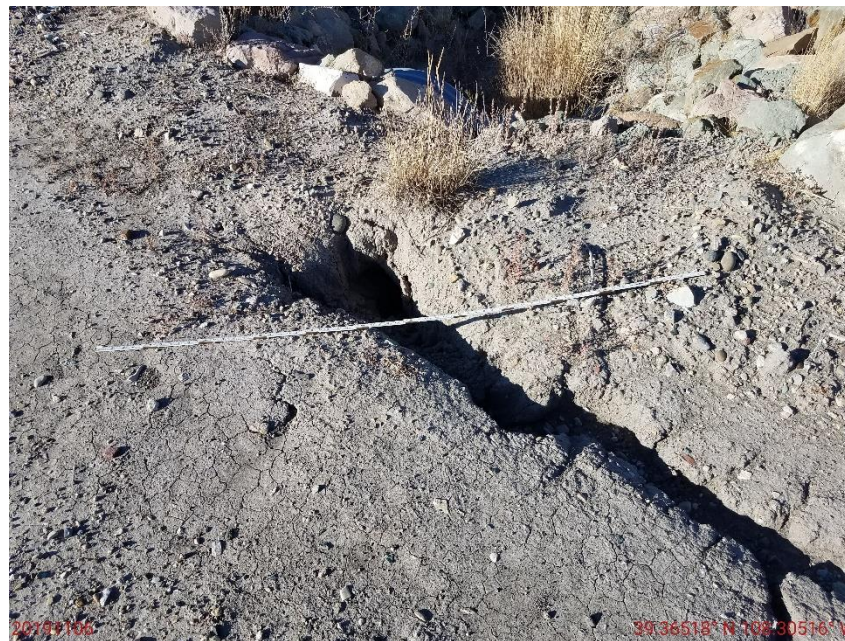
Photo 2: Photo taken from the culvert adjacent to the access road. Photo shows stormwater erosion degradation. 6 foot measuring stick for reference area.

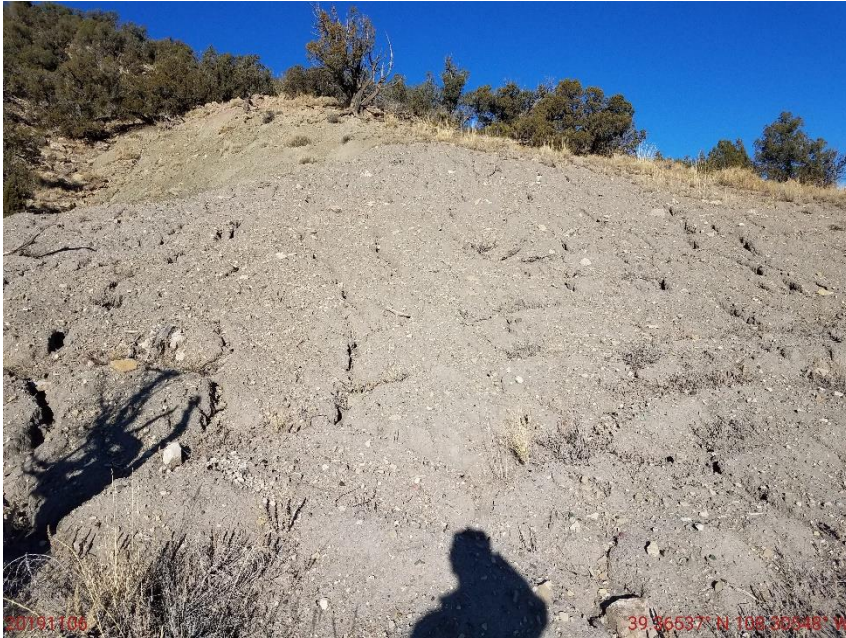
Photo 3: Photo taken from the location, facing west. Photo shows stormwater erosion degradation occurring throughout location. Operator has failed to conduct ongoing stormwater monitoring and management, resulting in reclamation failure of the location.

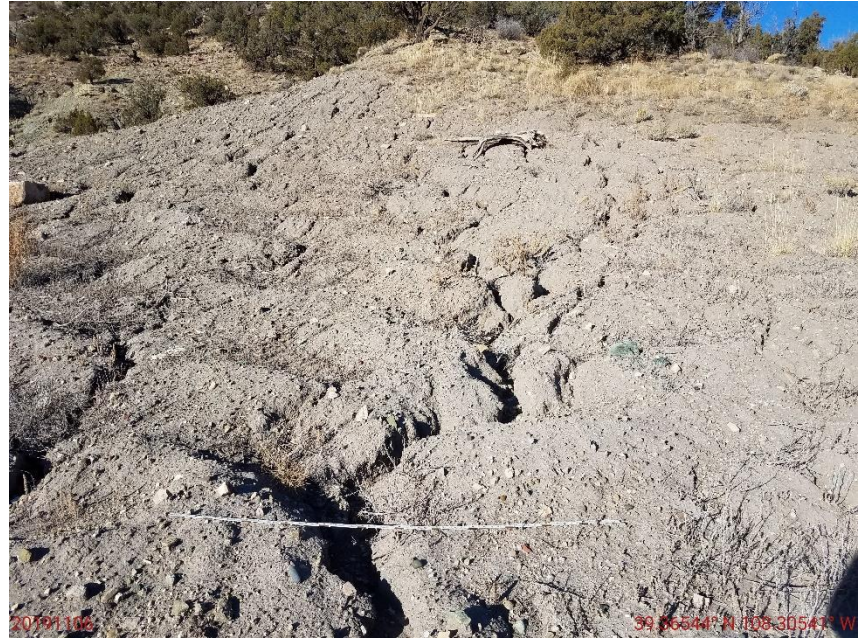
Photo 4: Continued from photo 3. 6 foot measuring stick for reference.

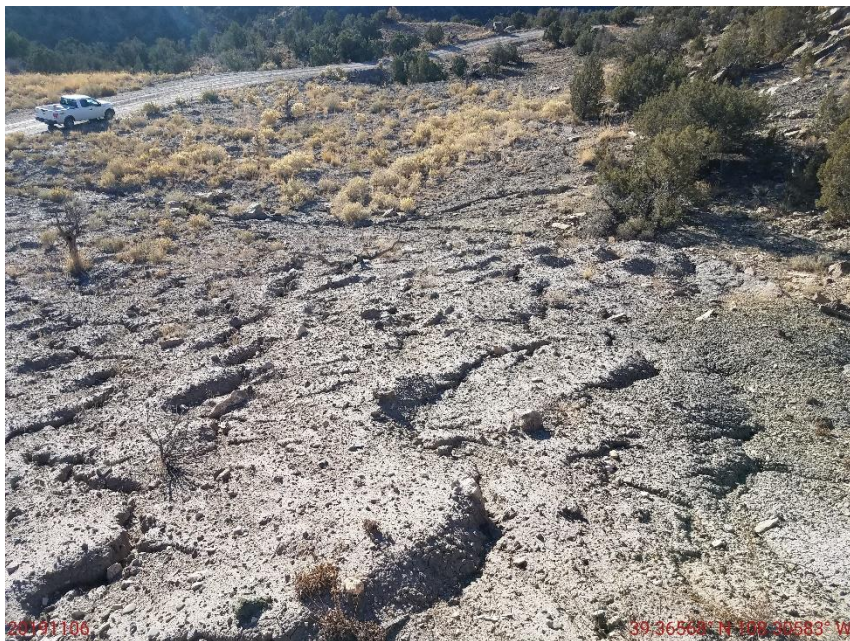
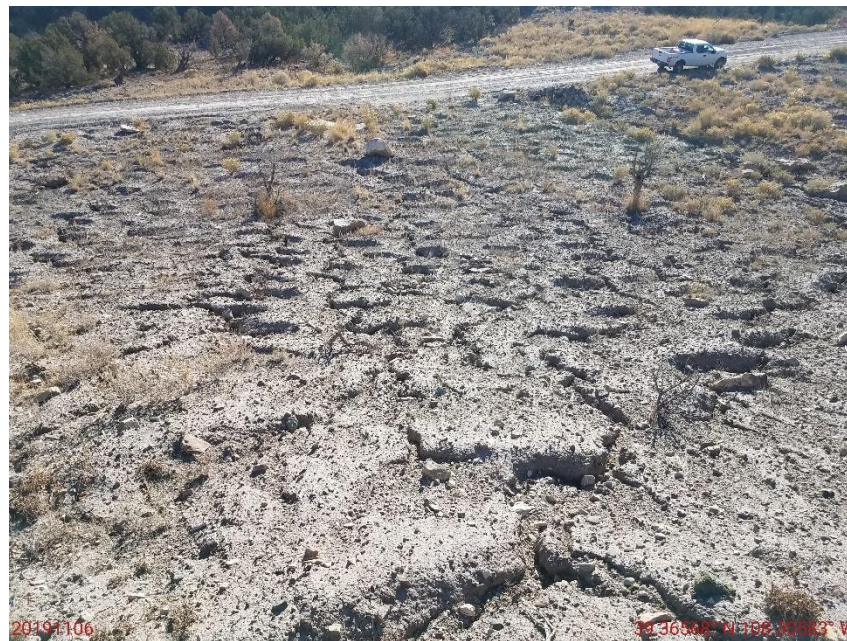
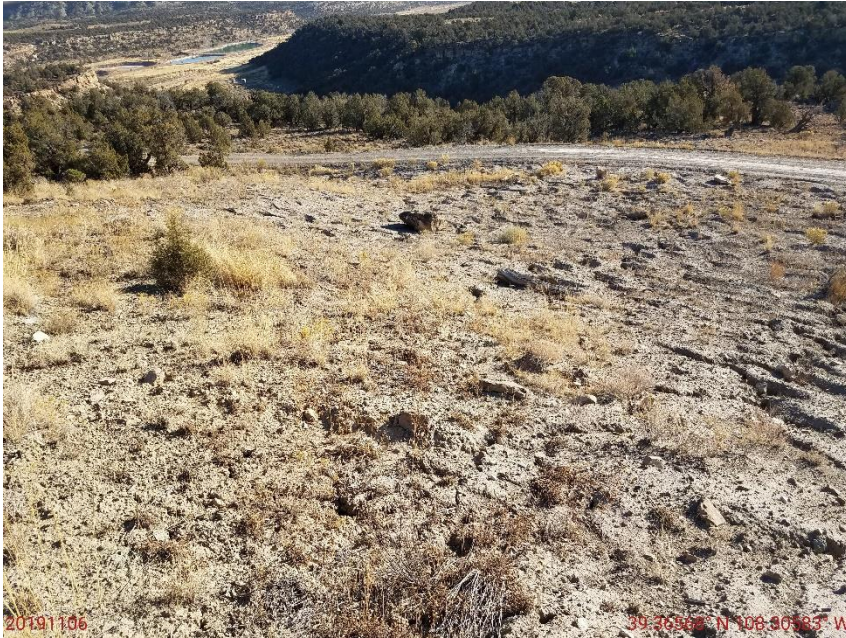
Photo 5: Photo taken from the west end of the location, facing south. Photos 5-7 provide an overview of the location from south, east, to northeast. Photo shows erosion degradation on location.

Photo 6: See comments under photo 5.

Photo 7: See comments under photo 5.

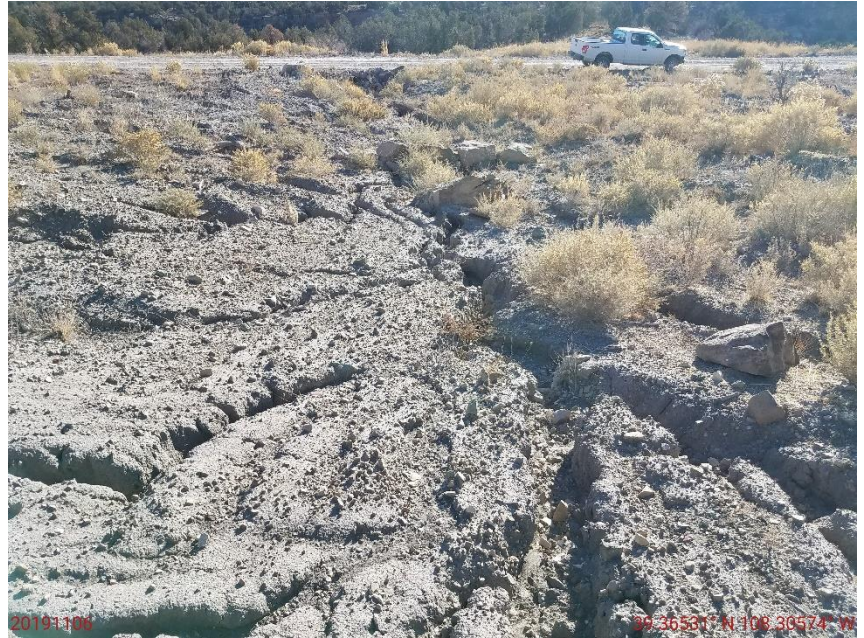
Photo 8: Photo taken from the location, facing east. Photo shows erosion degradation on location.

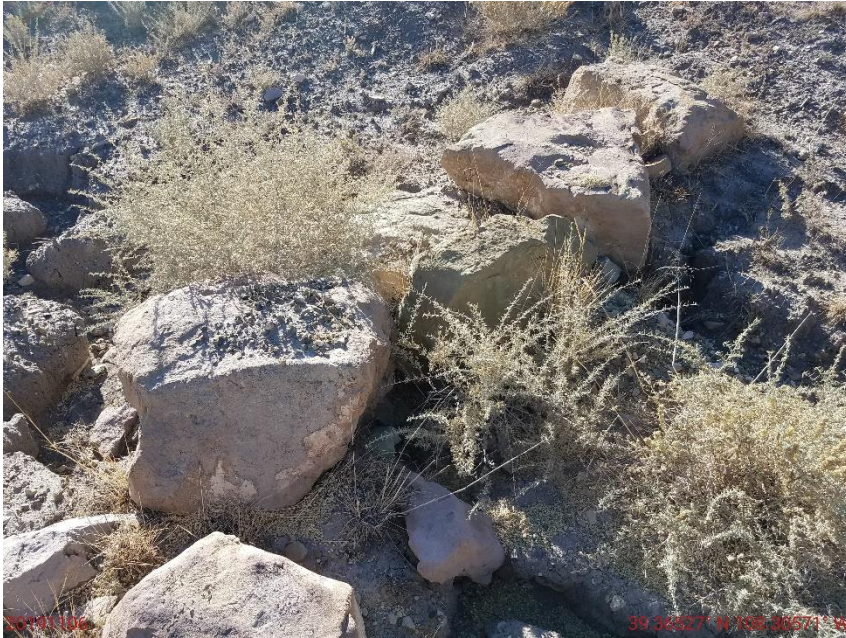
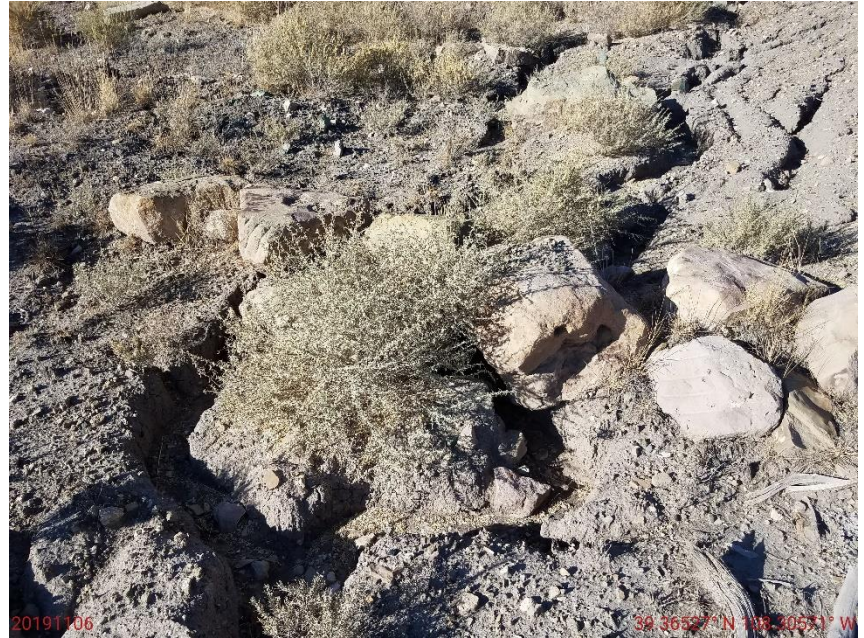
Photo 9: Photo taken from the location. Photo shows what appears to be a rock-check installed in the low areas of the location. BMP does not appear to have been constructed in accordance with good engineering practices and is not in proper functioning condition.

Photo 10: Continued from photo 9.

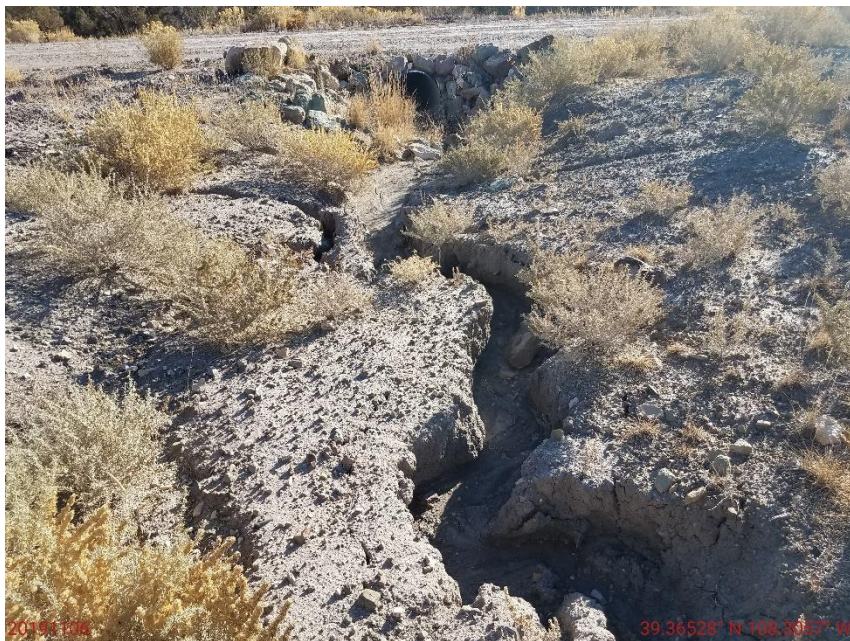
Photo 11: Photo of culvert under access road and erosion degradation.

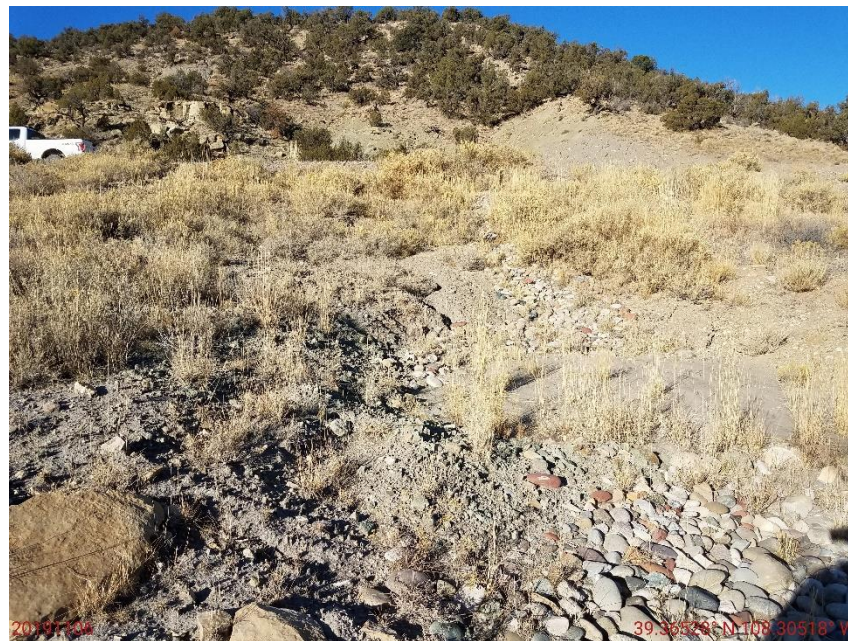
Photo 12: Photo taken down-slope of the culvert. Photo shows erosion degradation due to stormwater runoff from the location.
