Inspection Photos  
Location Name: A27  
Spill/Release ID: 468839  
Inspection Date: October 21, 31, 2019

**COLORADO**  
Oil & Gas Conservation  
Commission  
Department of Natural Resources

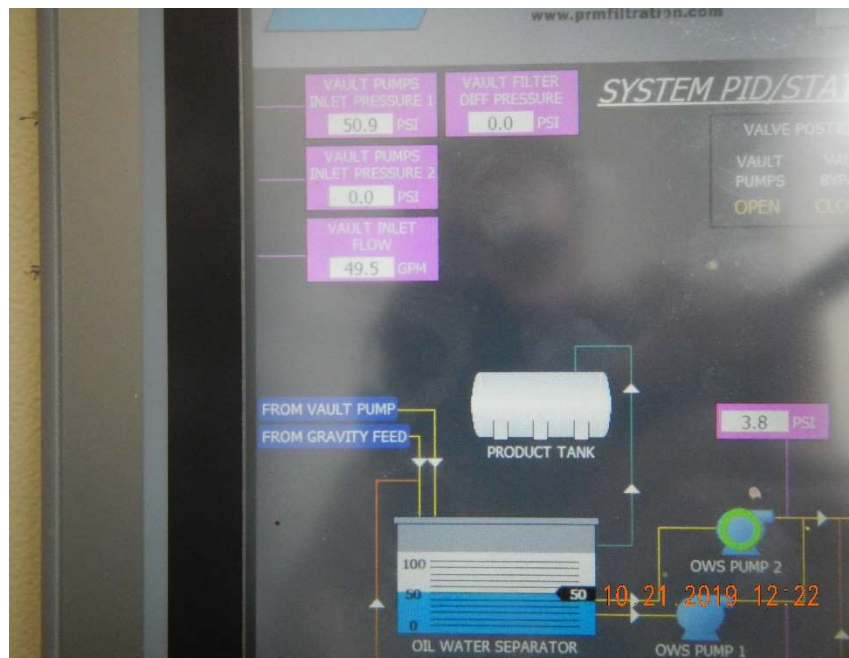
Photo #1 – View of the Water Collection / Treatment and Condensate Recovery System display. The vault inlet and outlet were flowing at approximately 49 GPM.

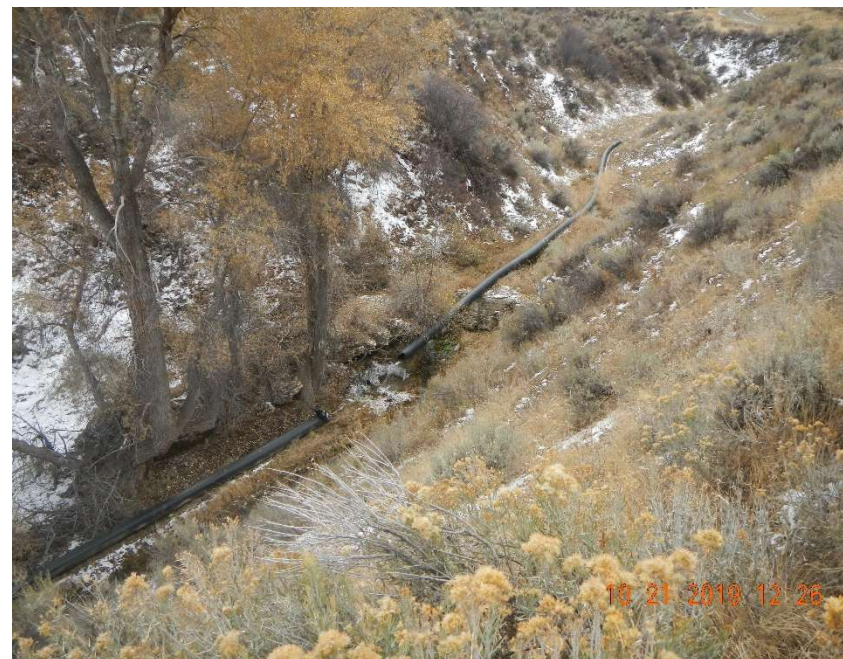
Photo #2 – View of the ruptured poly pipe looking south.

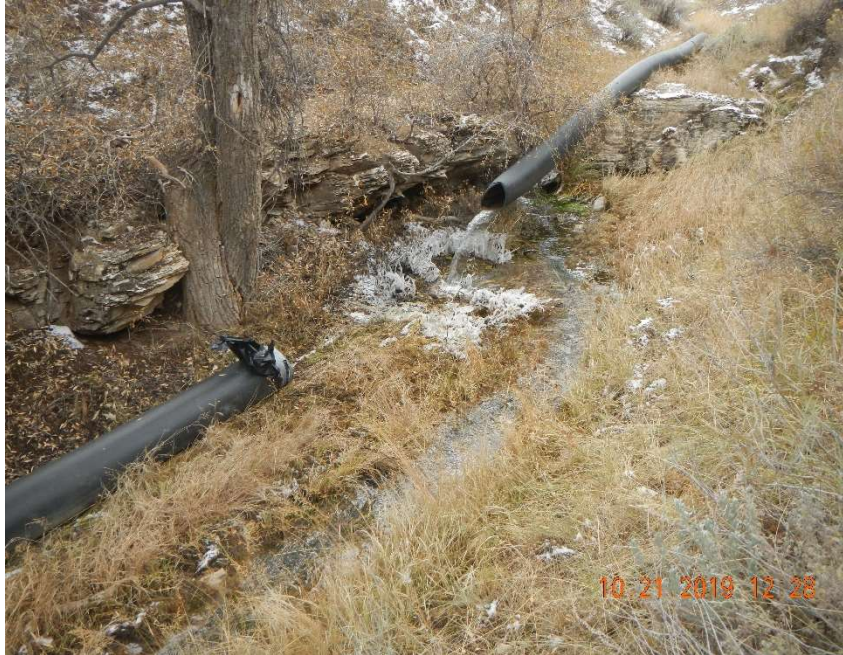
**Photo #3 - View of the ruptured poly pipe looking south.**

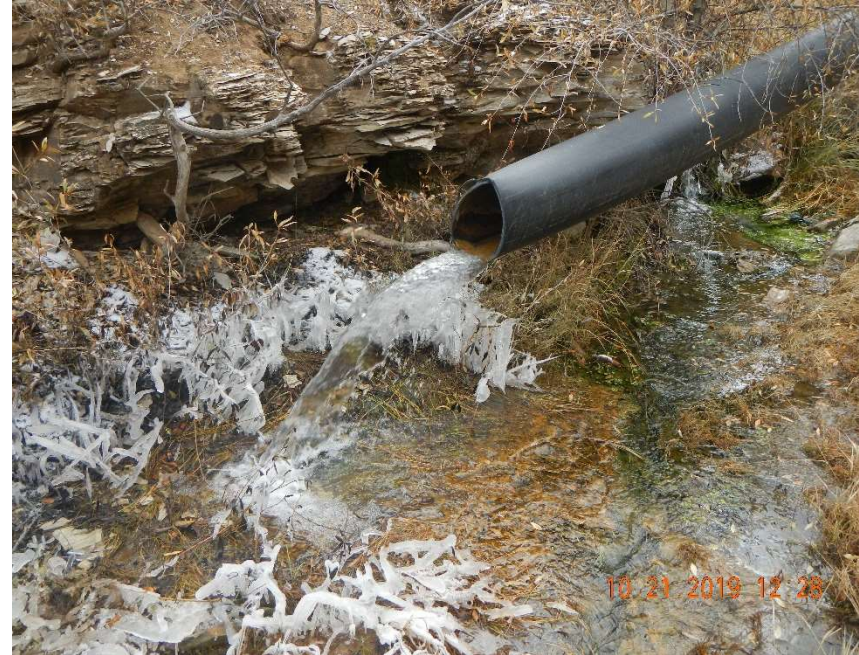
**Photo #4 – View of the ruptured poly pipe.**

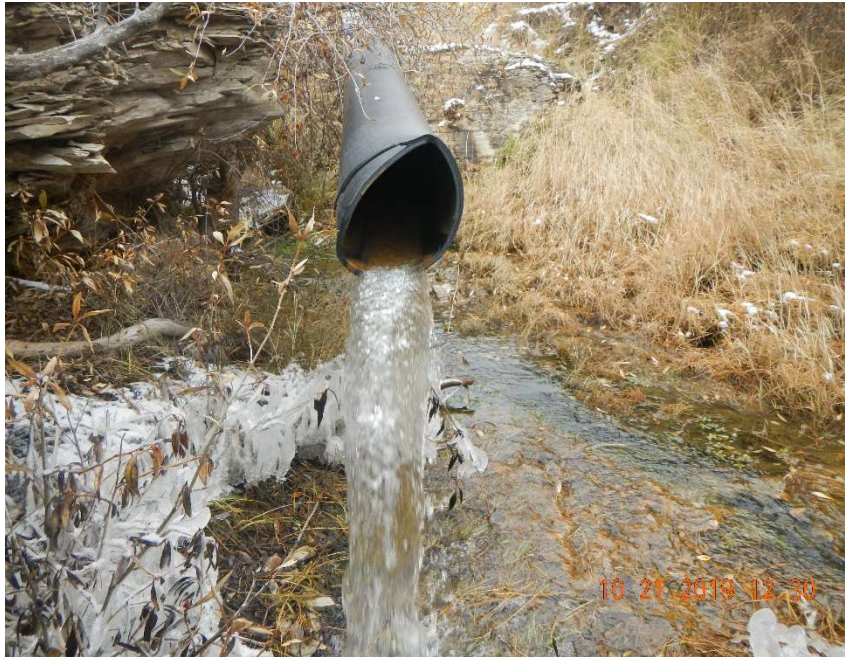
**Photo #5 – View of the ruptured poly pipe.**

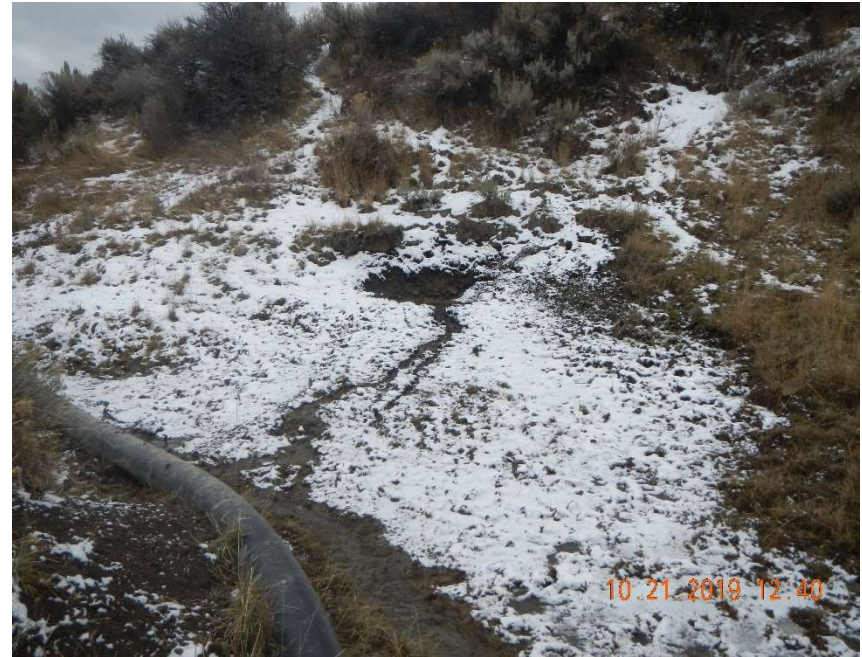
**Photo #6 – Hydrocarbon seep north of the weir and south of the Water Collection Vault.**

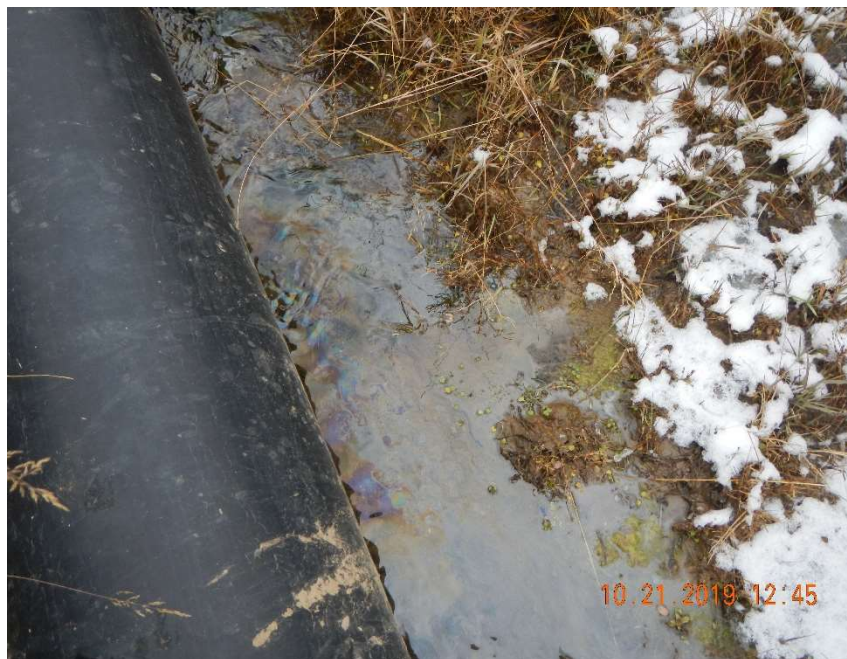
**Photo # – Hydrocarbon sheen noted on surface water north of the weir and south of the Water Collection Vault.**

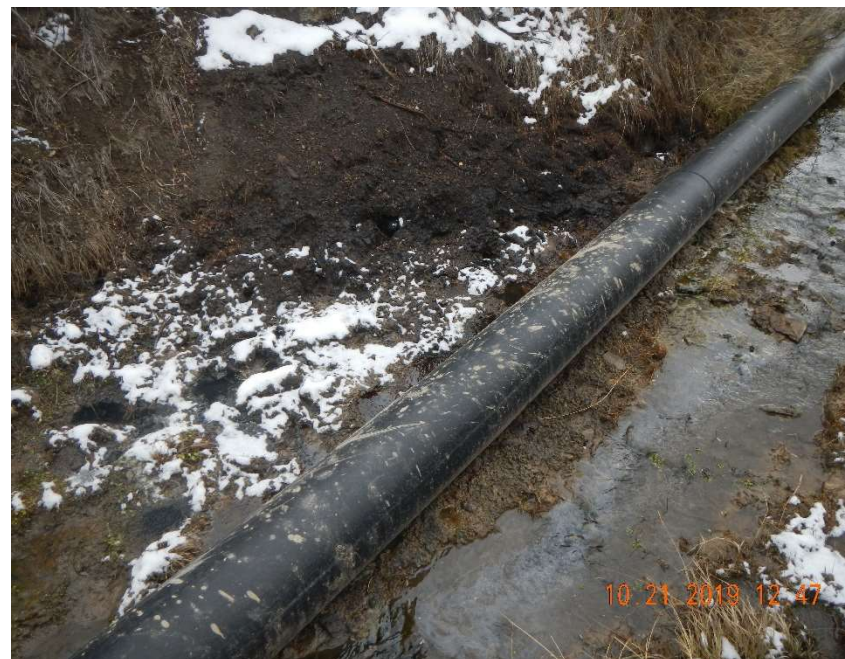
**Photo # – Hydrocarbon Seep north of the weir and south of the Water Collection Vault.**

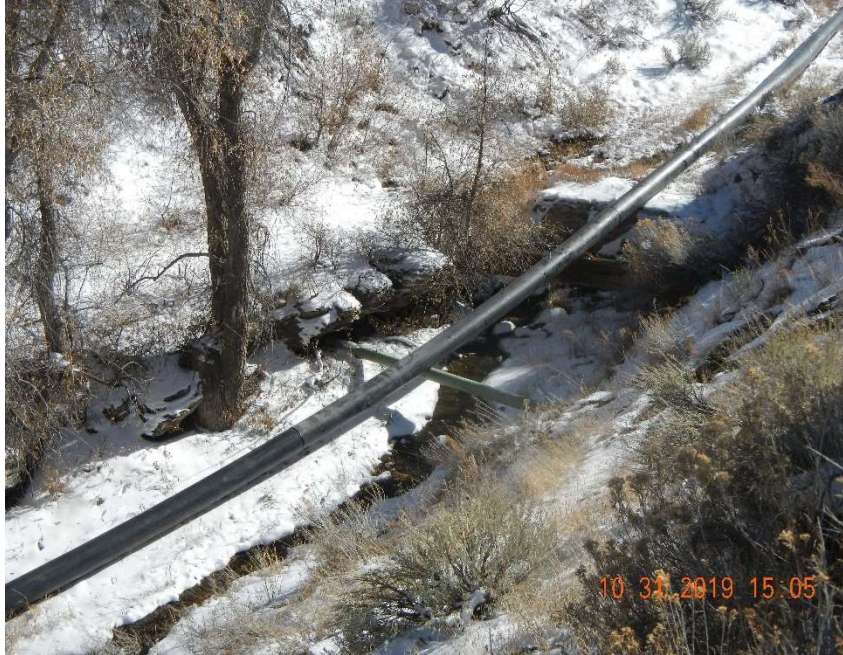
**Photo #7 - View of the repaired poly pipe with additional support.**

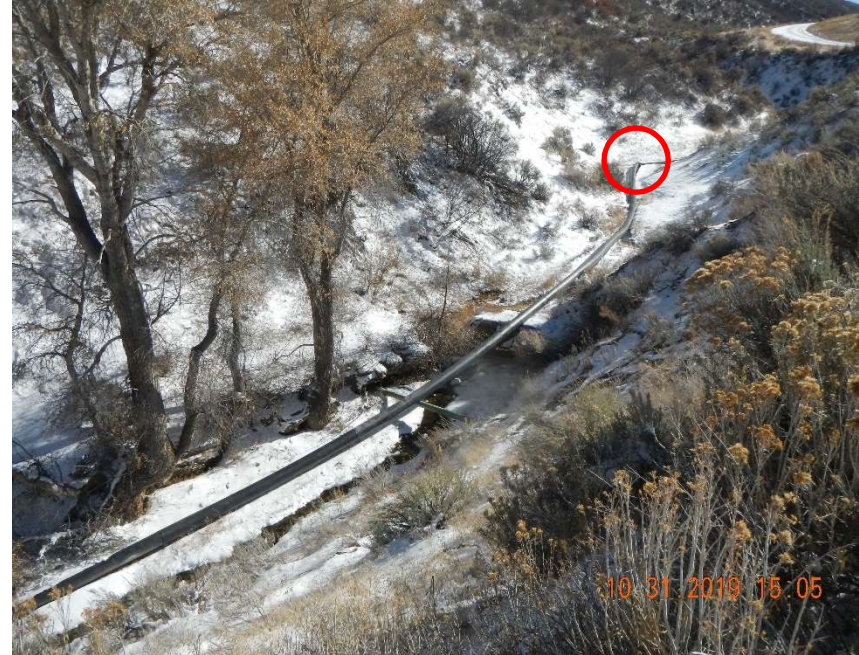
**Photo #8 – View of the repaired section and the kink in the poly pipe (Red circle).**

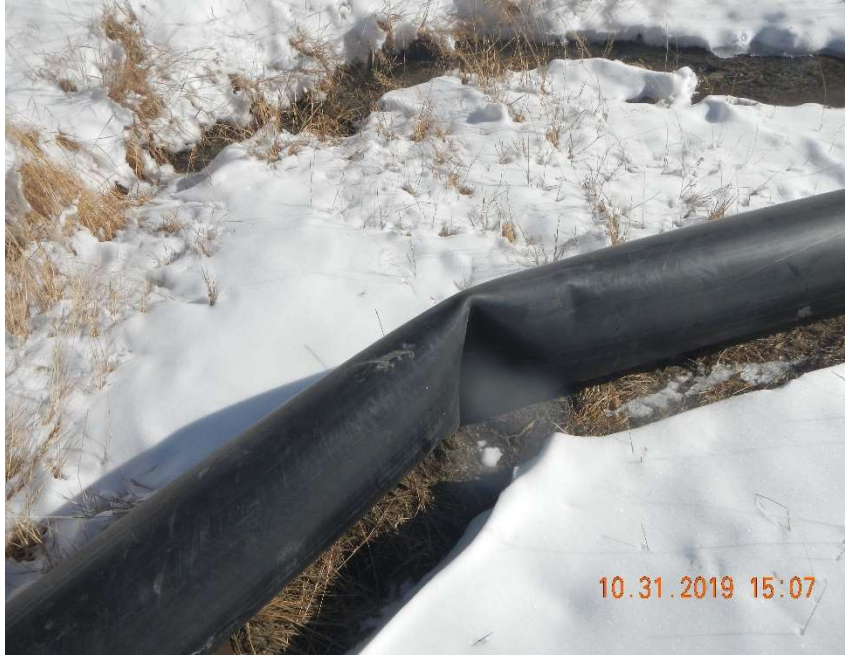
**Photo #9 – View of the kink in the poly pipe.**

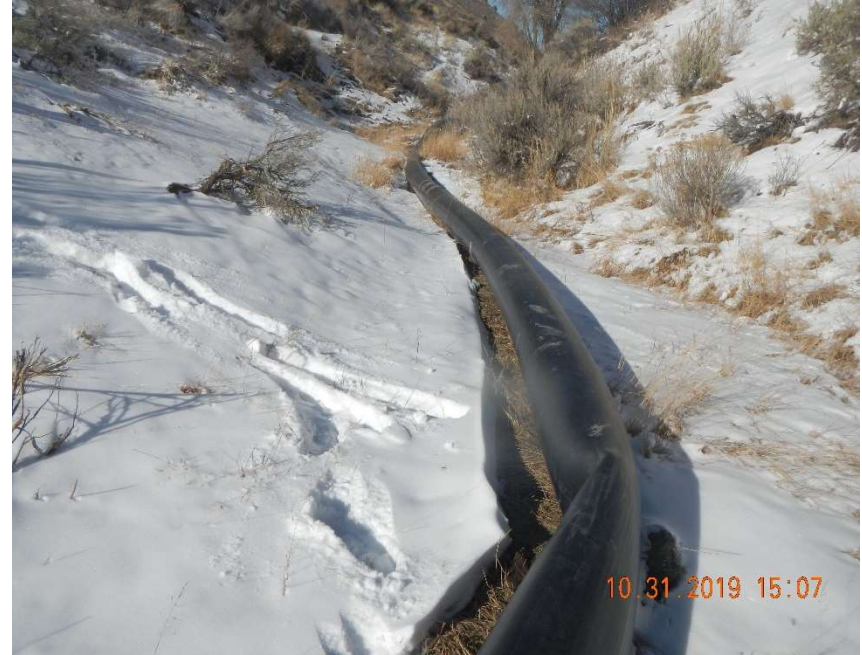
**Photo #10 – View of the kink in the poly pipe looking north.**

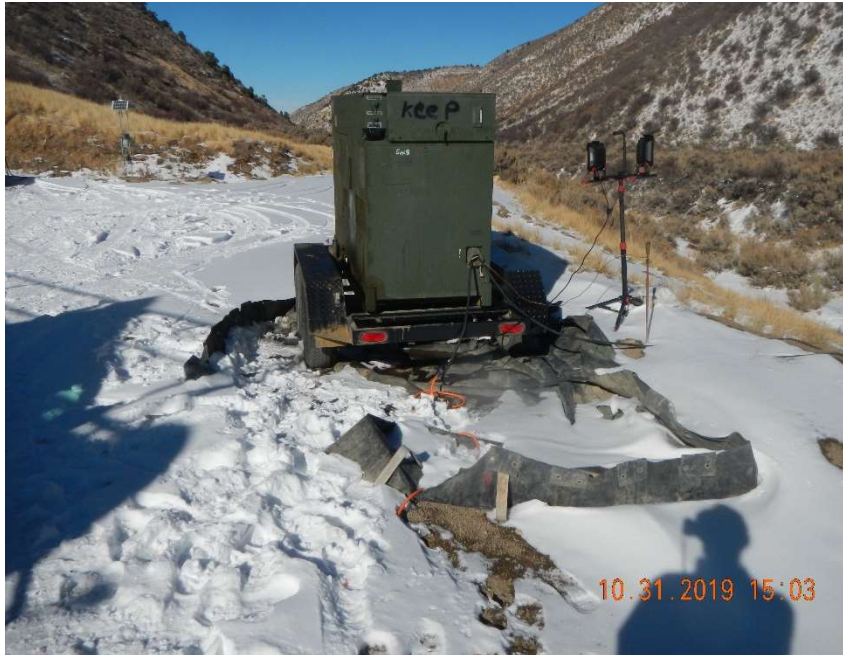
**Photo #11 – View of the pump generator secondary containment in disrepair.**

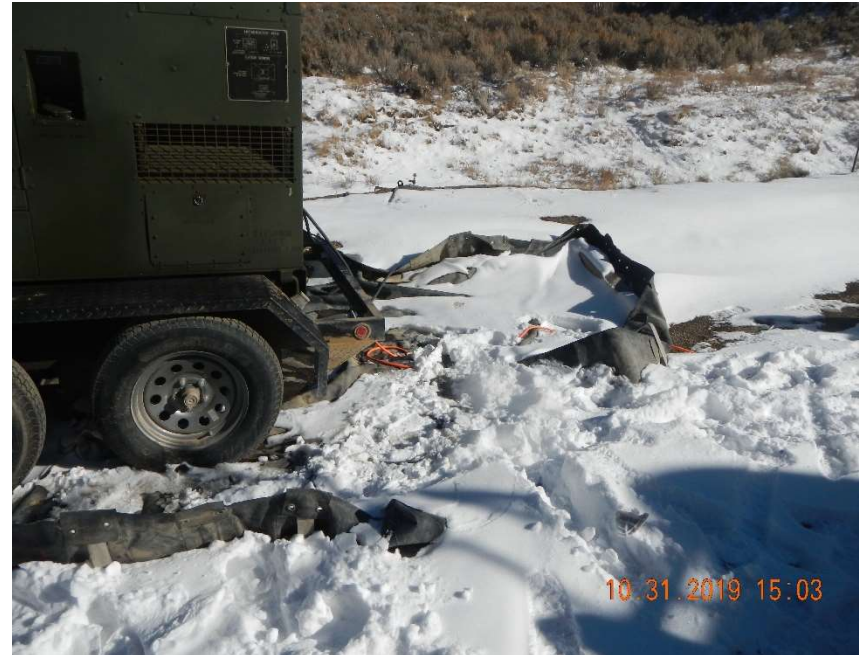
**Photo # - View of the pump generator secondary containment in disrepair.**

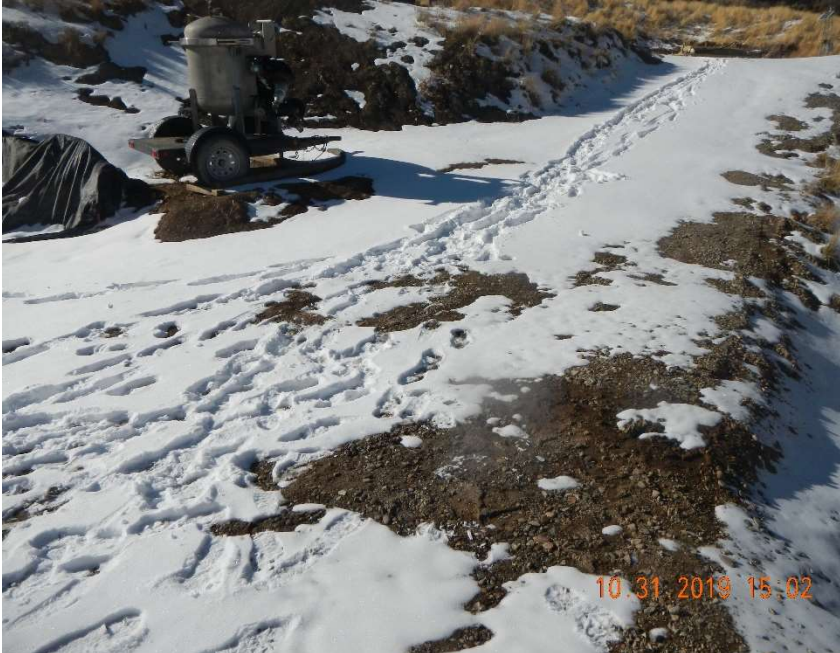
**Photo #13 – View of the stained soil with a detectable hydrocarbon odor located north of the Water Collection Vault.**

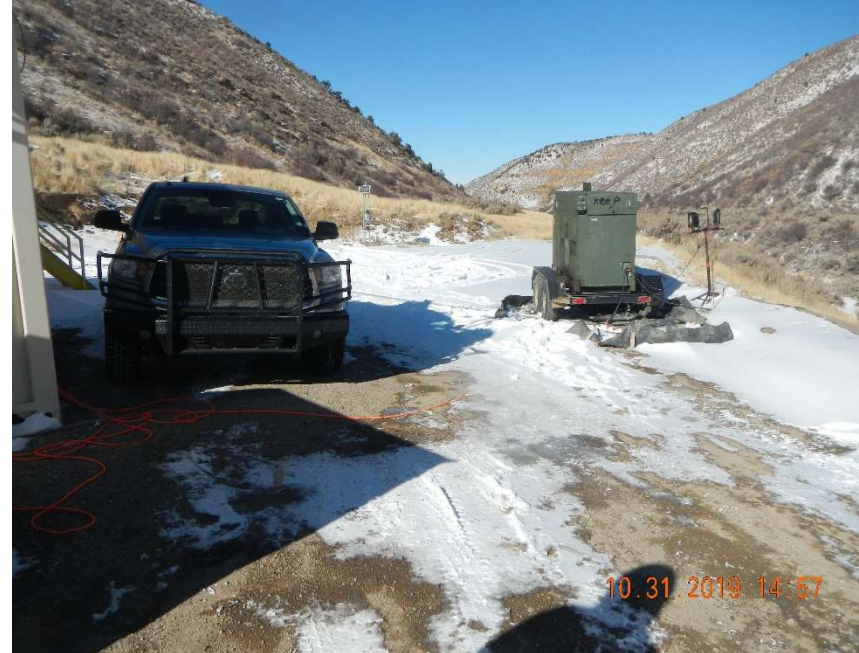
**Photo #14 – View of the Operator's truck blocking access to the northern section of the location.**
