Location Name: Tindall Operating – Dorothy 1 – Rem #11611
Inspection Date: 11/19/2019

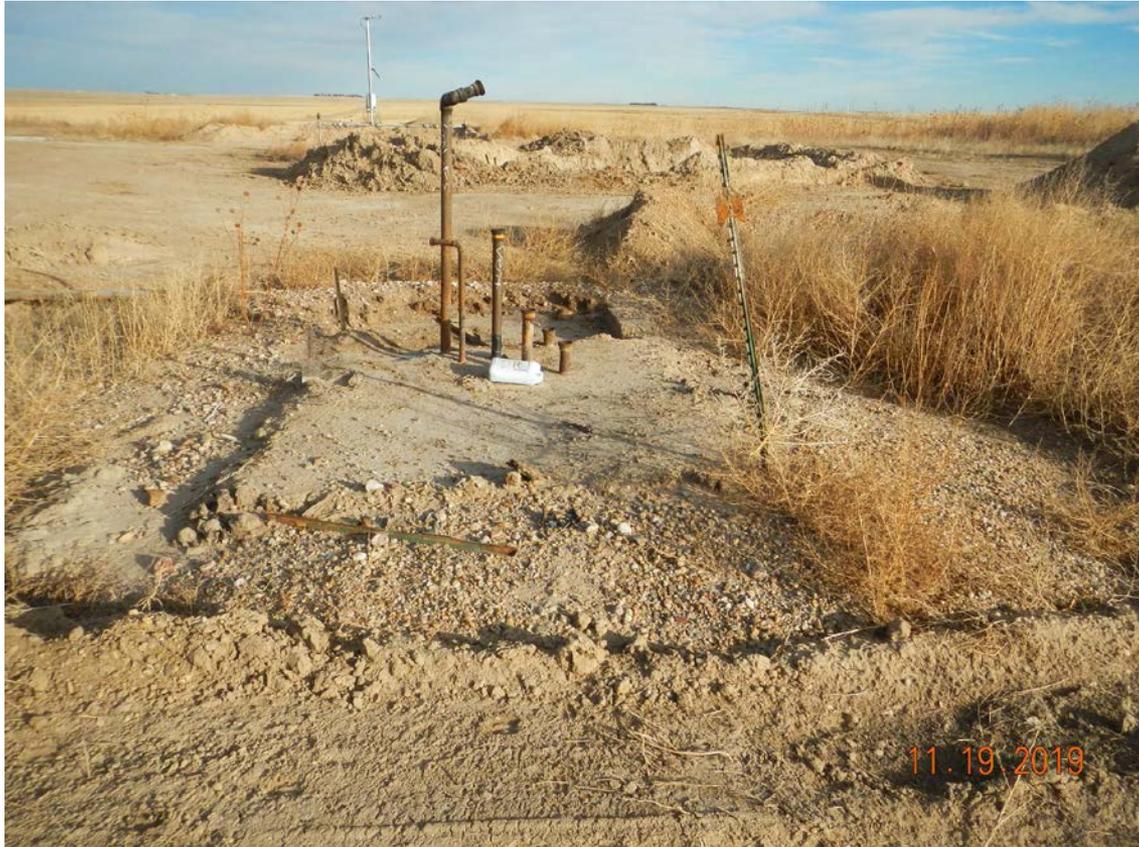
Photo # 1 – View east across location from west side of former vertical separator berm

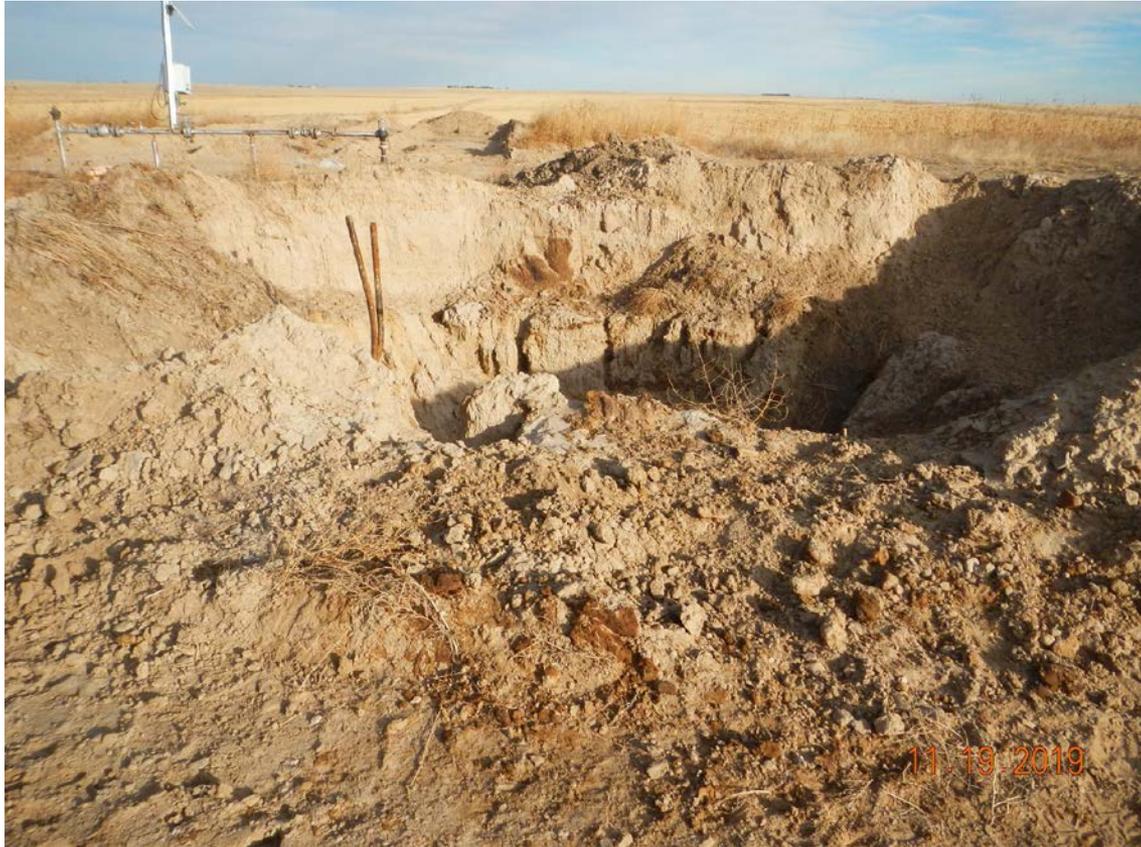
Photo # 2 – View east across former pit excavation

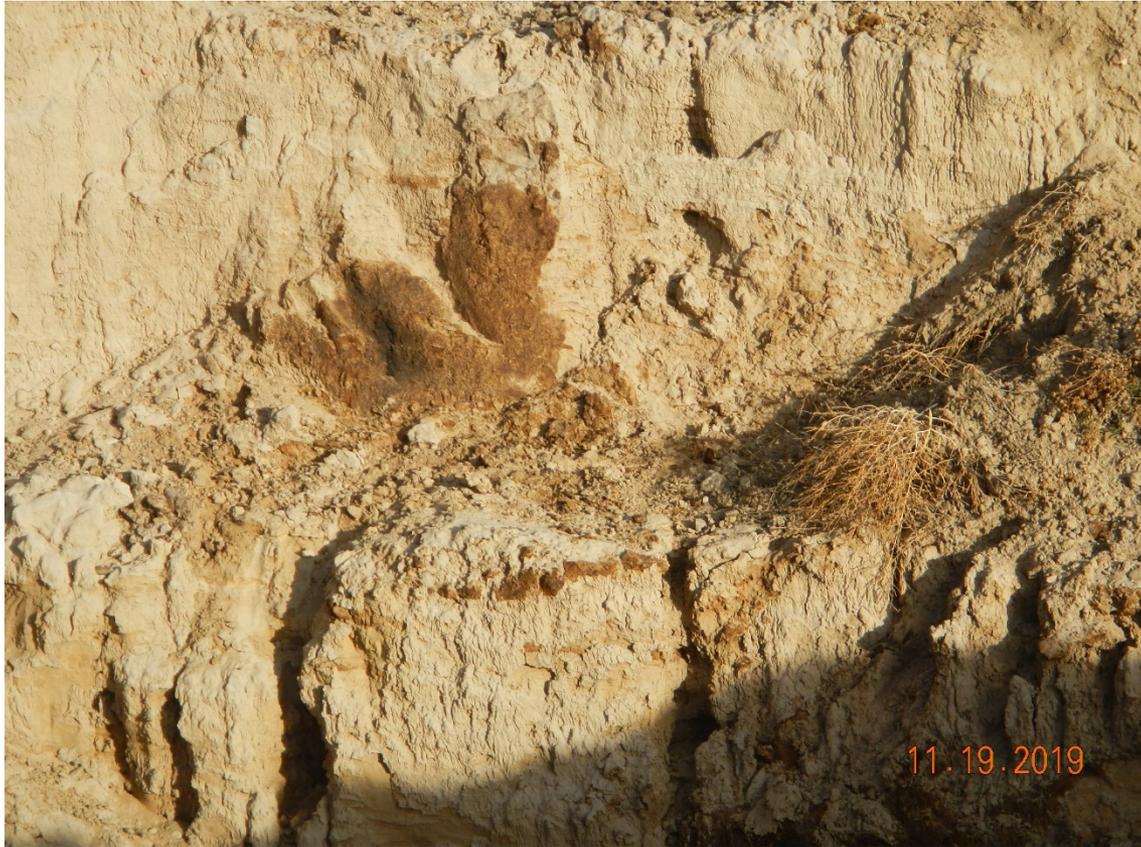
Photo # 3 – View east at east wall of pit excavation, oily soil requires removal

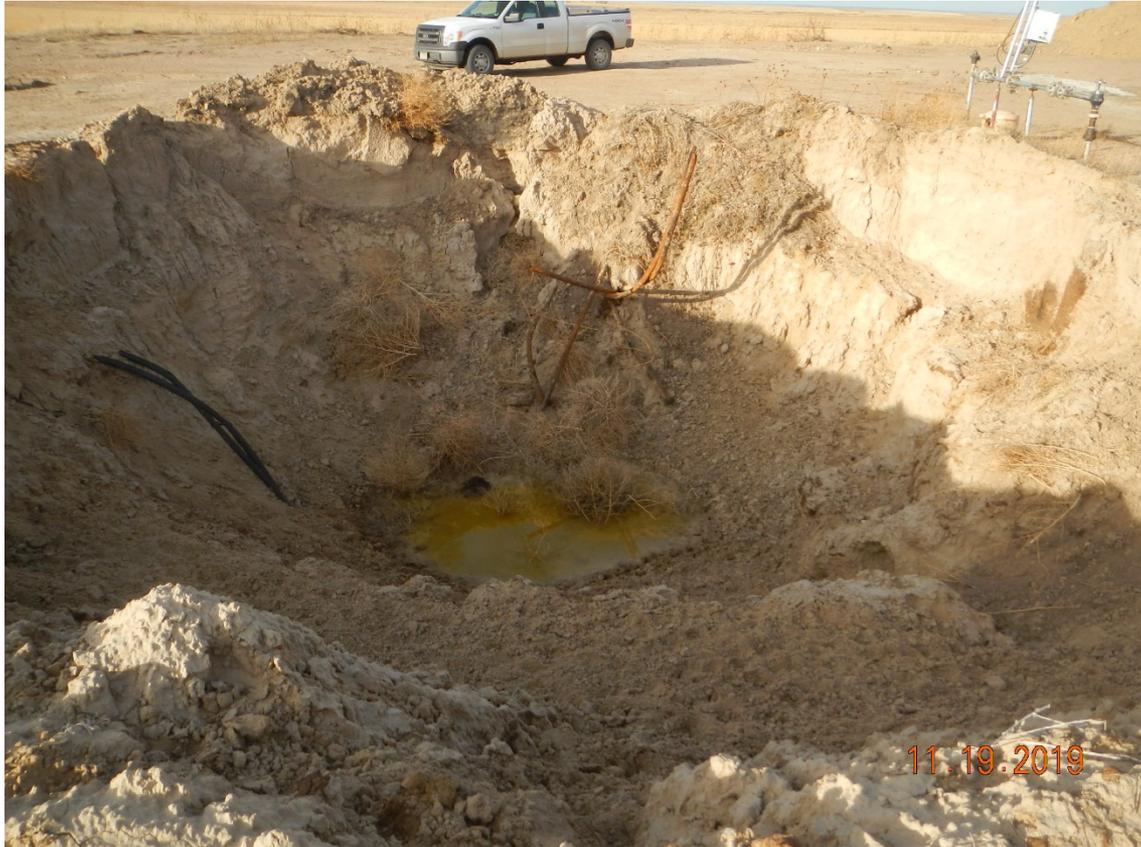
Photo # 4 – View north at pit excavation

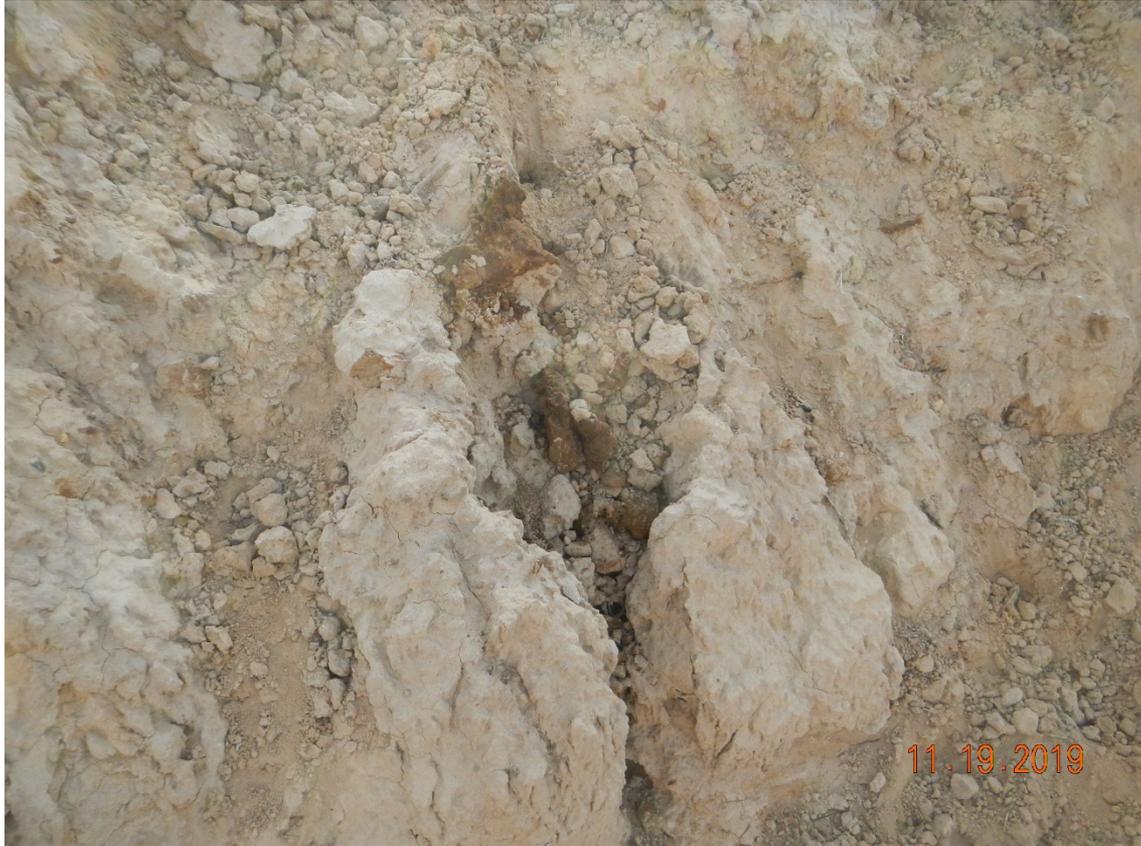
Photo # 5 – Petroleum impacted soil remains in the southwest wall of the pit excavation

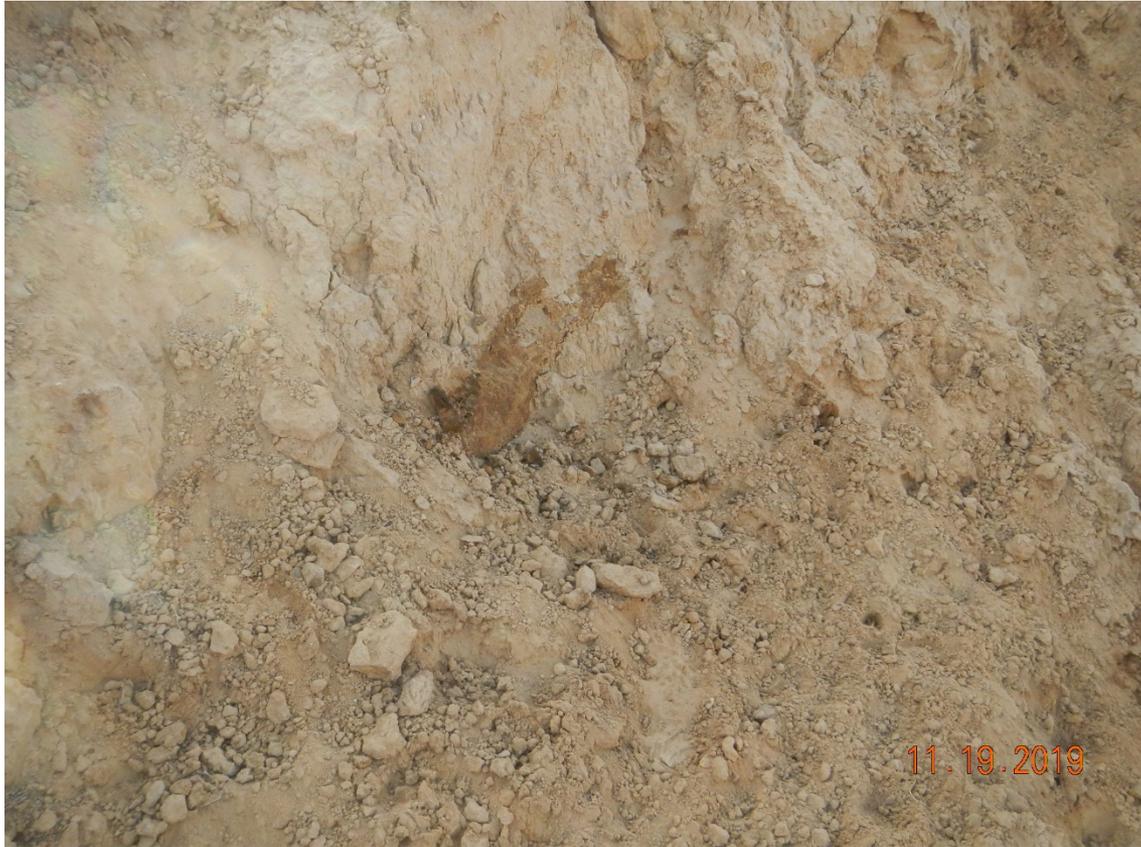
Photo # 6 – Petroleum impacted soil remains in the southwest wall of the pit excavation

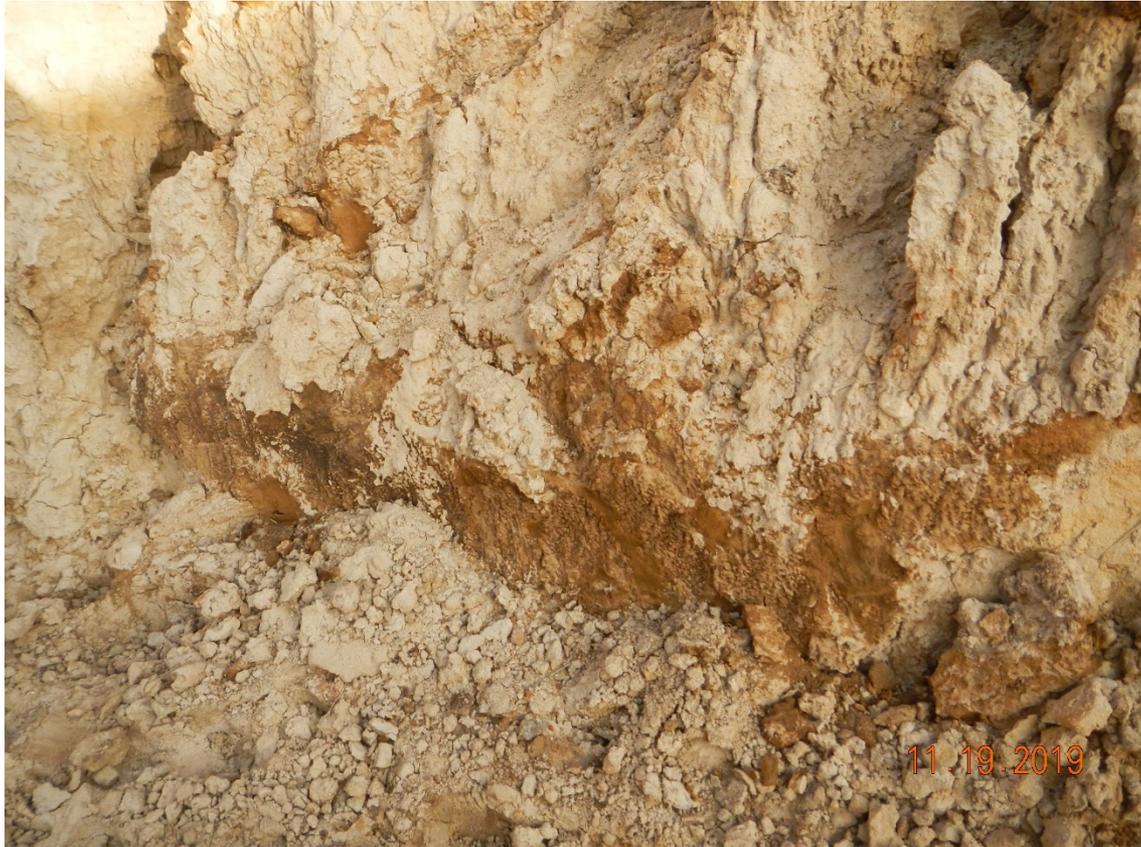
Photo # 7 – Petroleum impacted soil remains in the east wall of the pit excavation

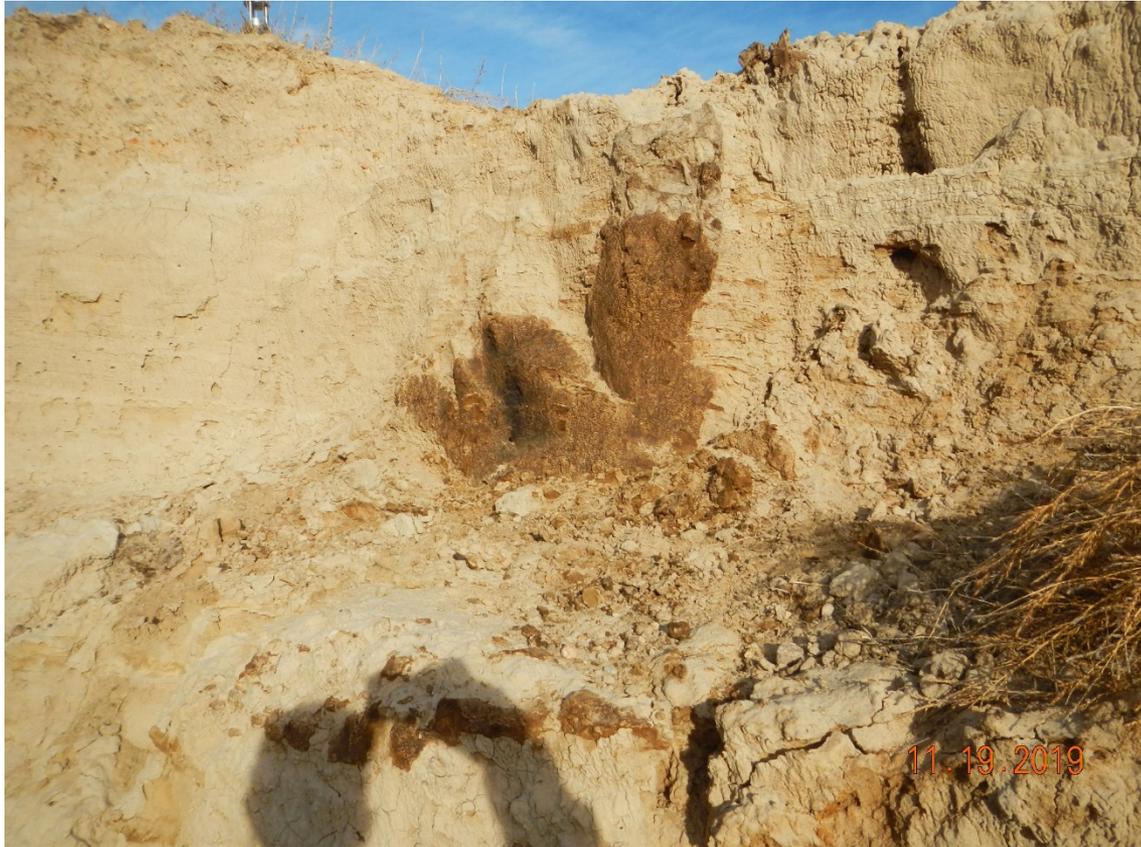
Photo # 8 – Petroleum impacted soil remains in the east wall of the pit excavation

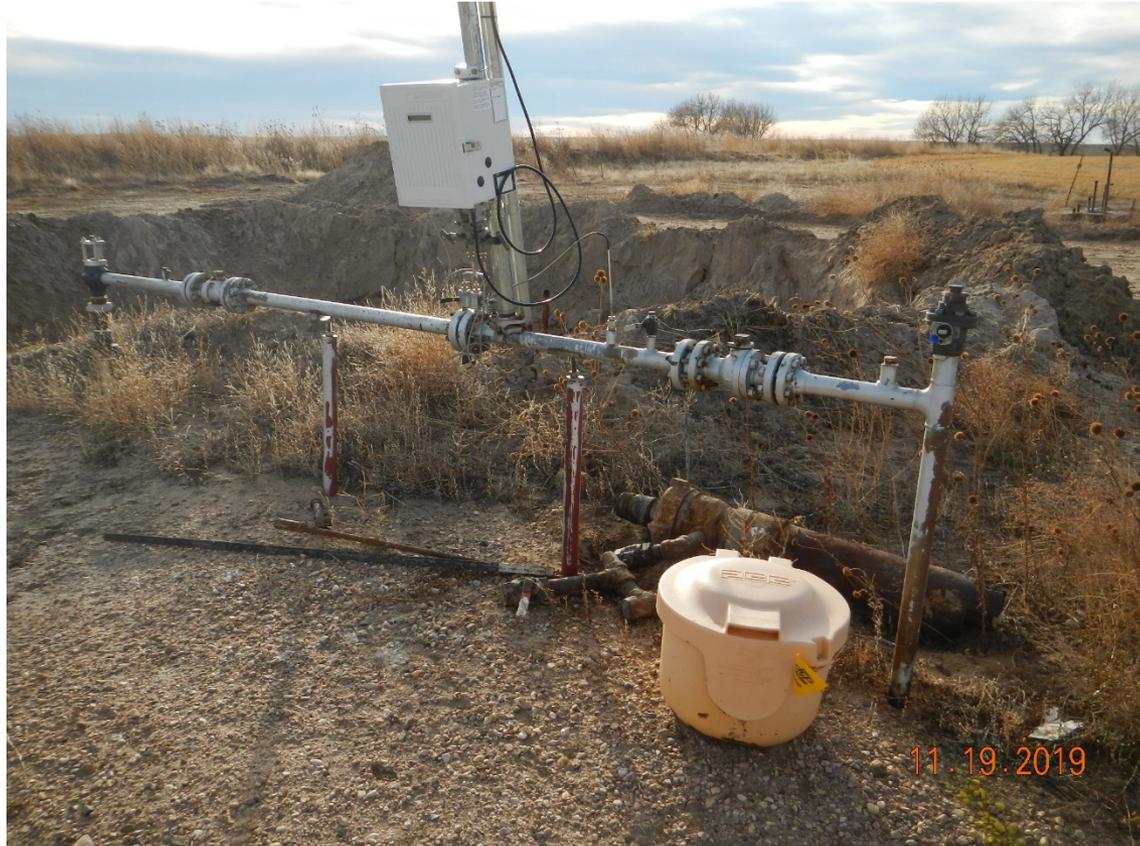
Photo # 9 – Unused equipment and flowline risers need to be removed

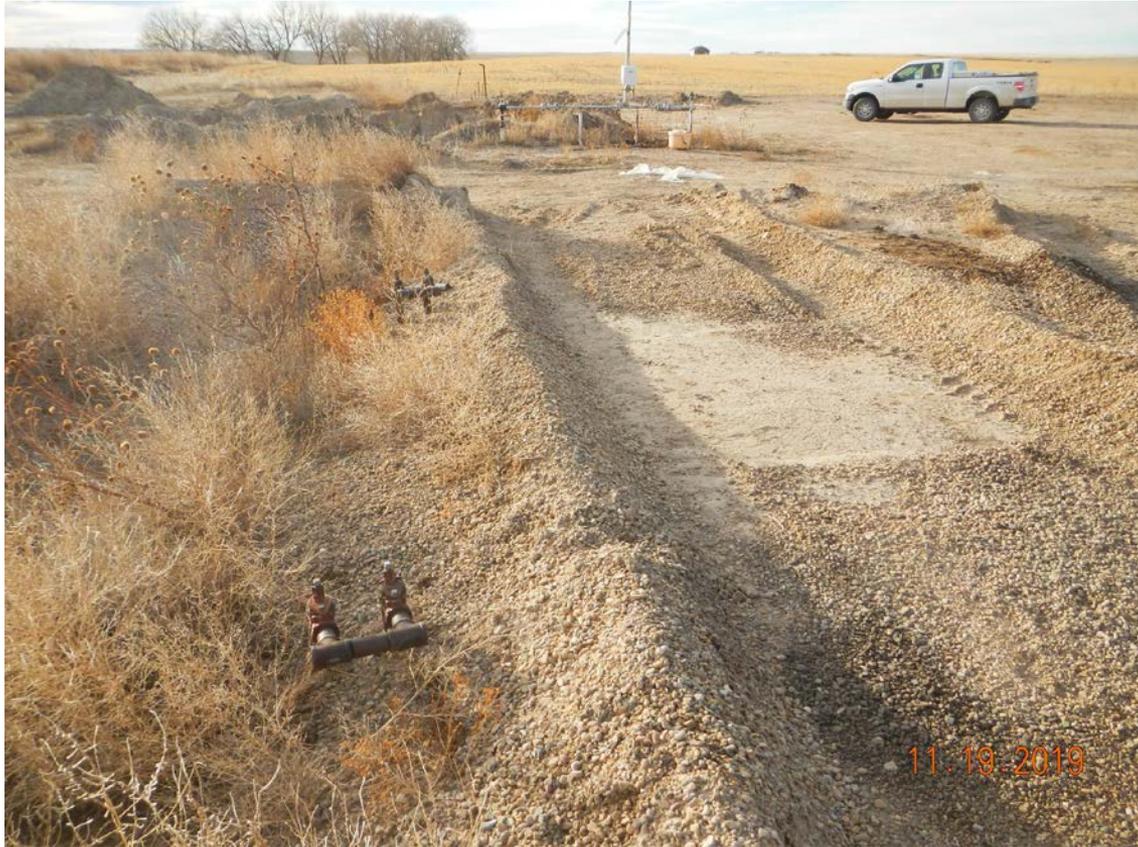
Photo # 10 – View west from former tank battery area, flowline risers, gravel require removal

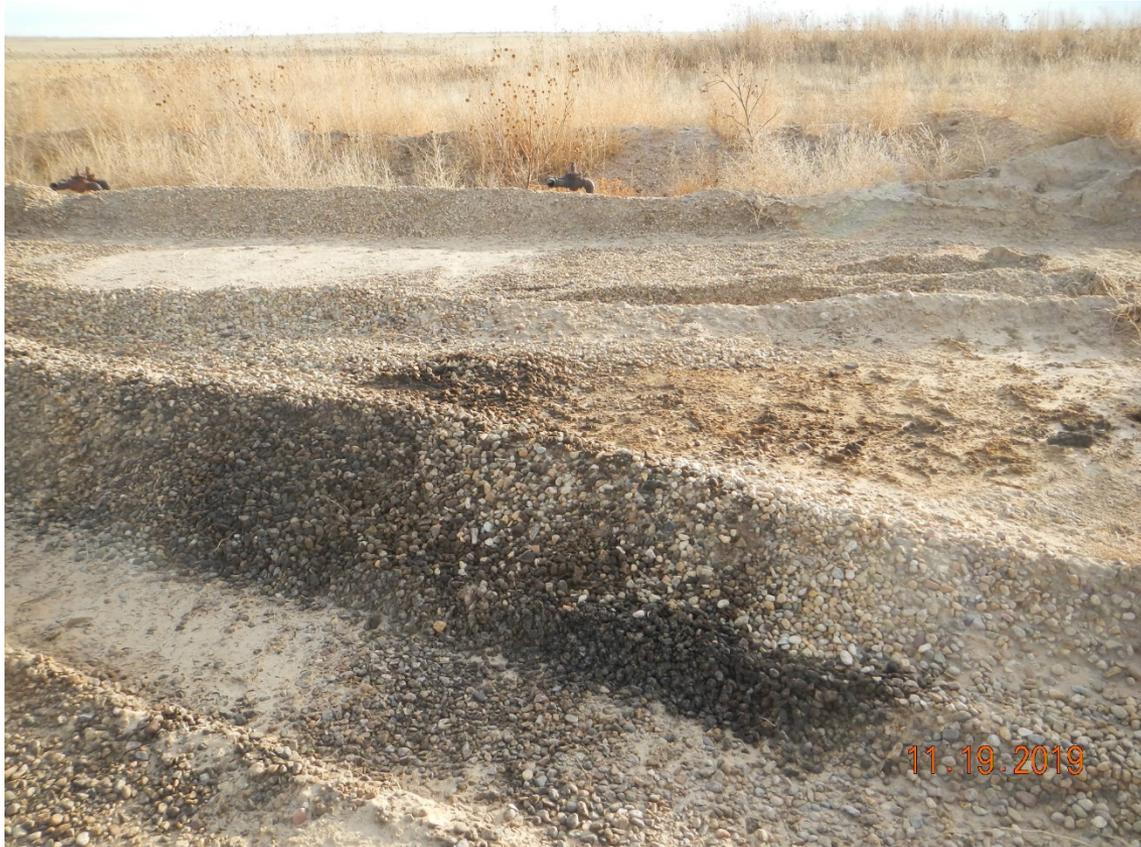
Photo # 11 – View south at former tank battery area, flowline risers, oily gravel require removal

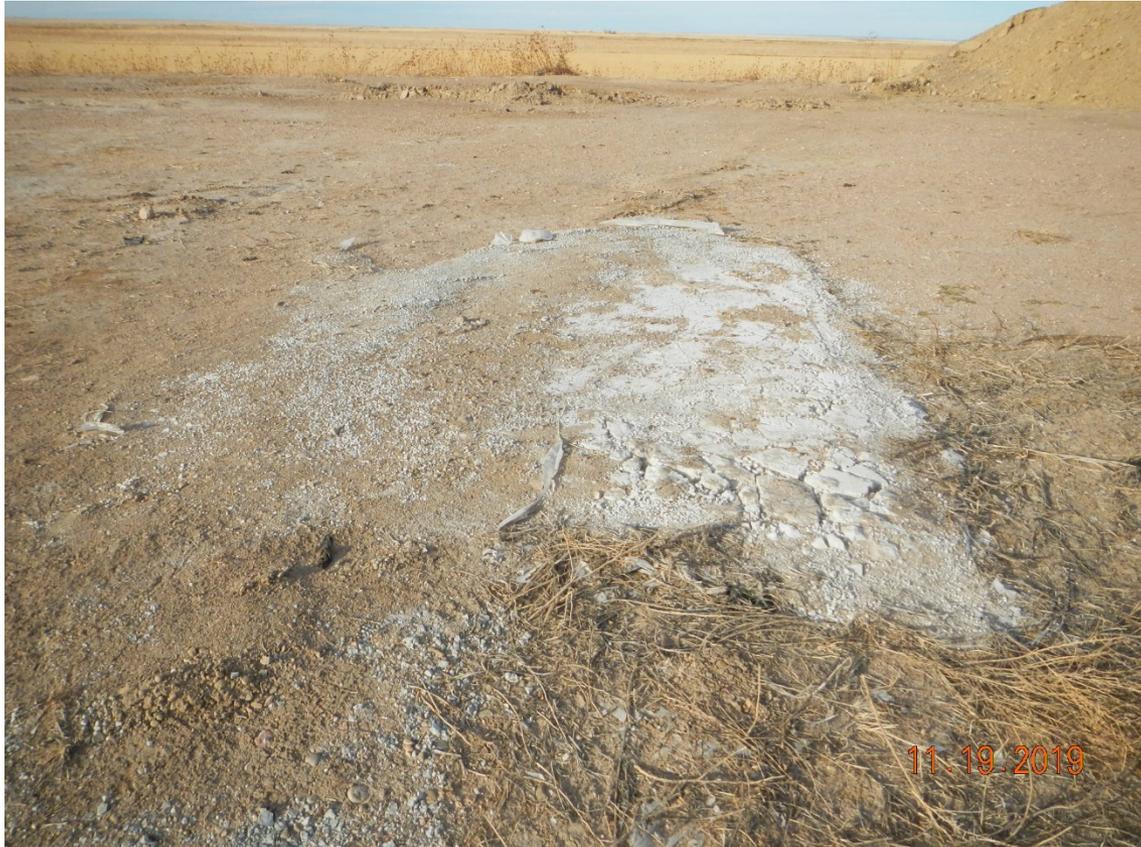
Photo # 12 – View north at cement on plastic

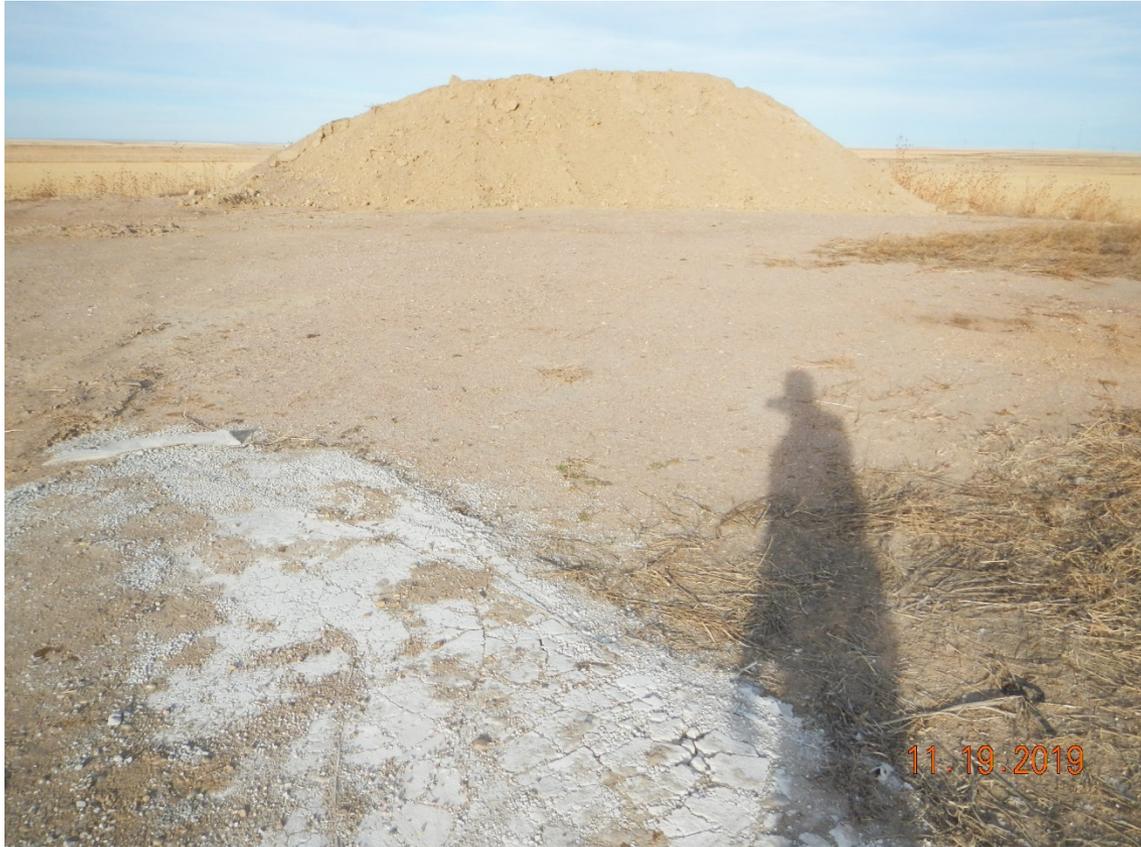
Photo # 13 – View north at cement on plastic and soil stockpile

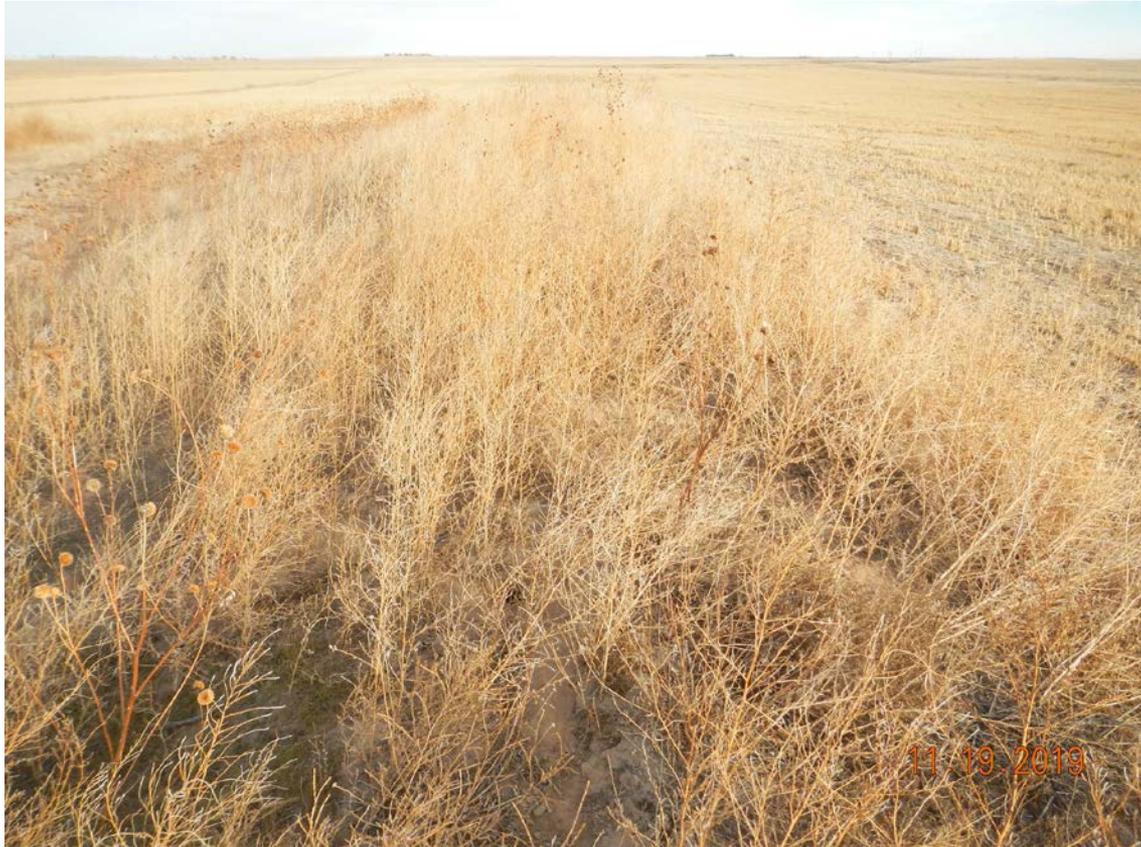
Photo # 14 – View east along soil berm south of the location

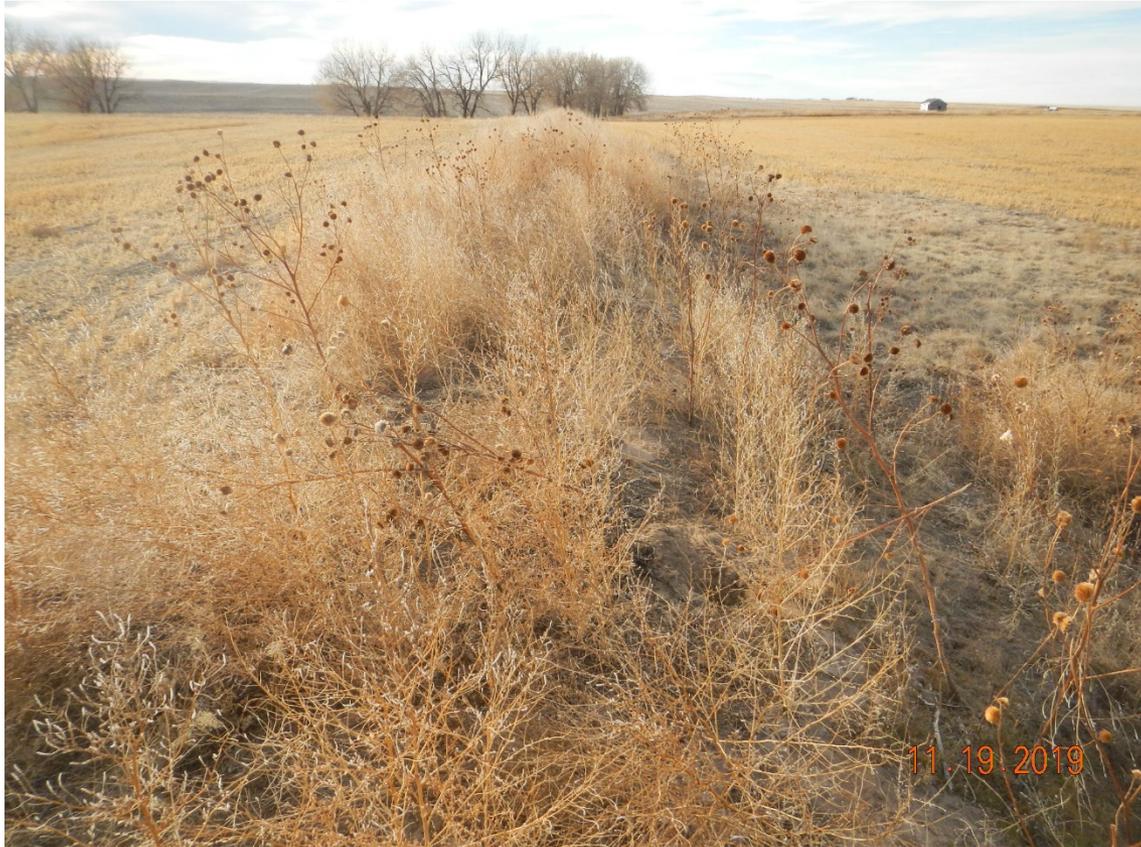
Photo # 15 – View west along soil berm on south side of the location
