Inspection Photos
Operator: BP America
Location/API #: 067-05796
Date: 11-12-2019

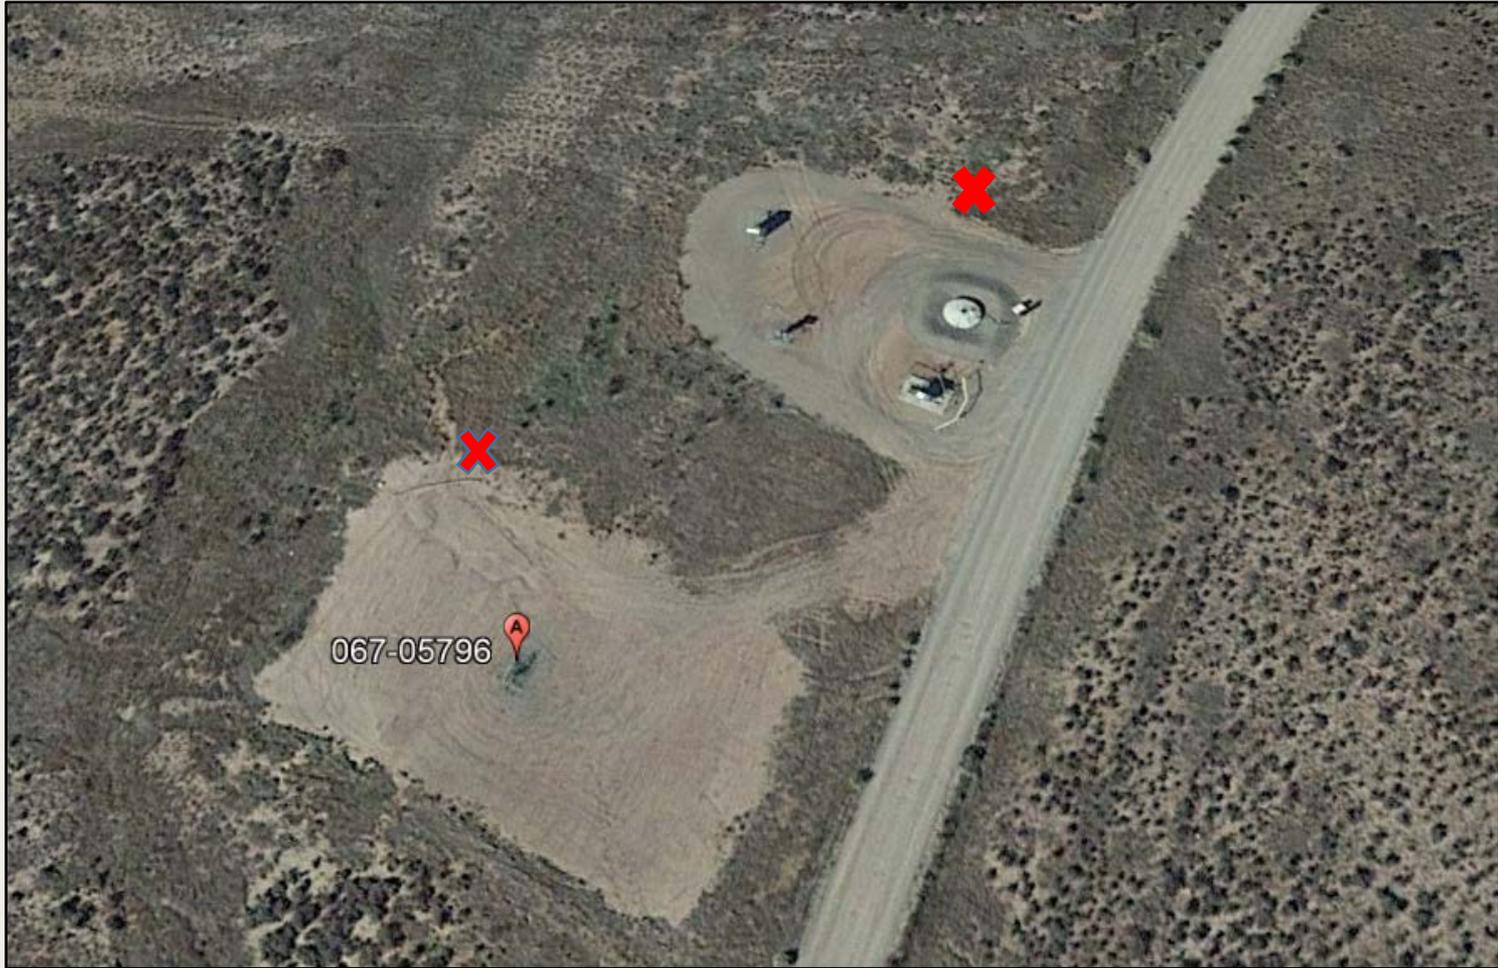
Photo 1. Aerial view of project area (2016 Google Earth). Red “X’s” indicate areas within the project area where erosion and sedimentation is occurring.

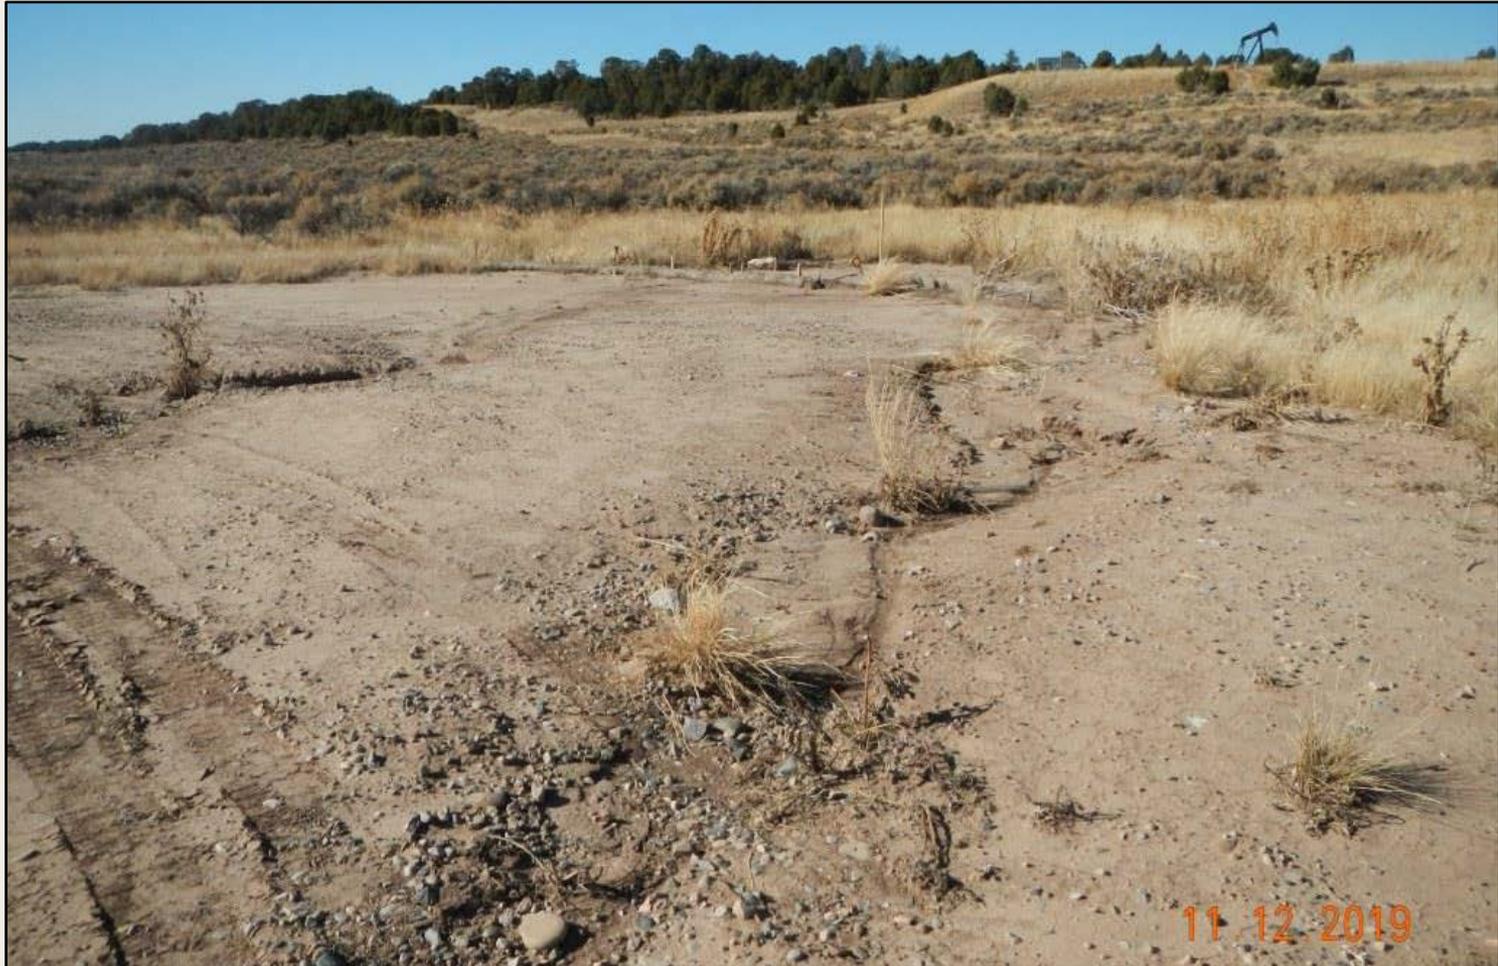
Photo 2. View of erosional channels within the western project area (northwestern corner of southern working surface). Channels are approximately 2-3 feet wide, and 6 to 10 inches deep.

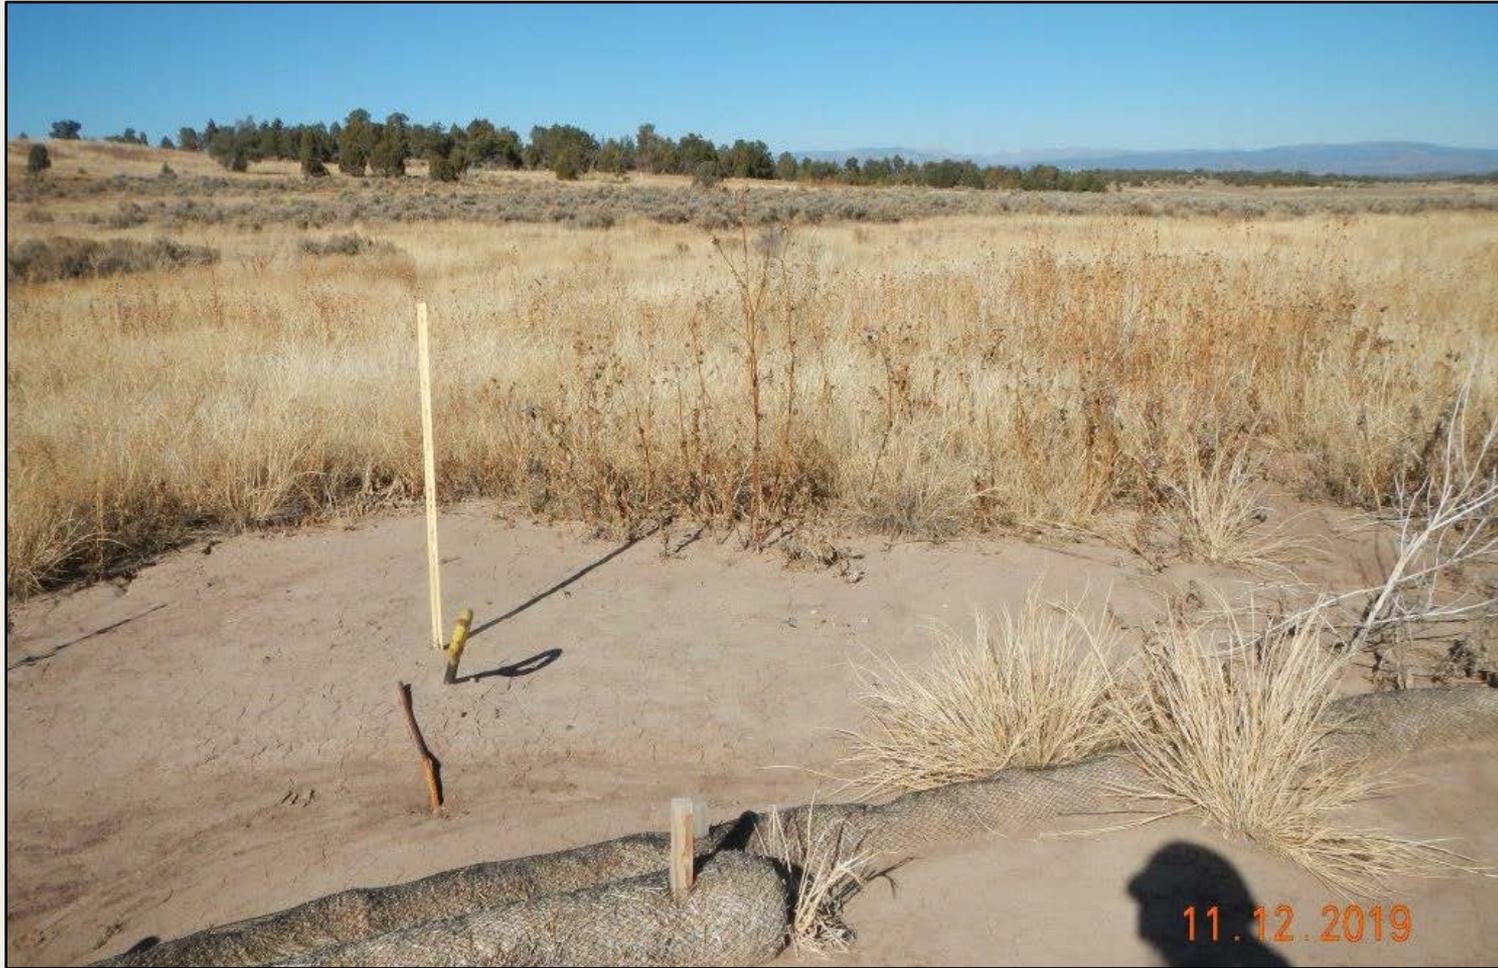
Photo 3. View of sediment deposition and wattles filling with sediment, downslope of erosional channels in Photo 2. Sediment flows off of the working area in this corner.

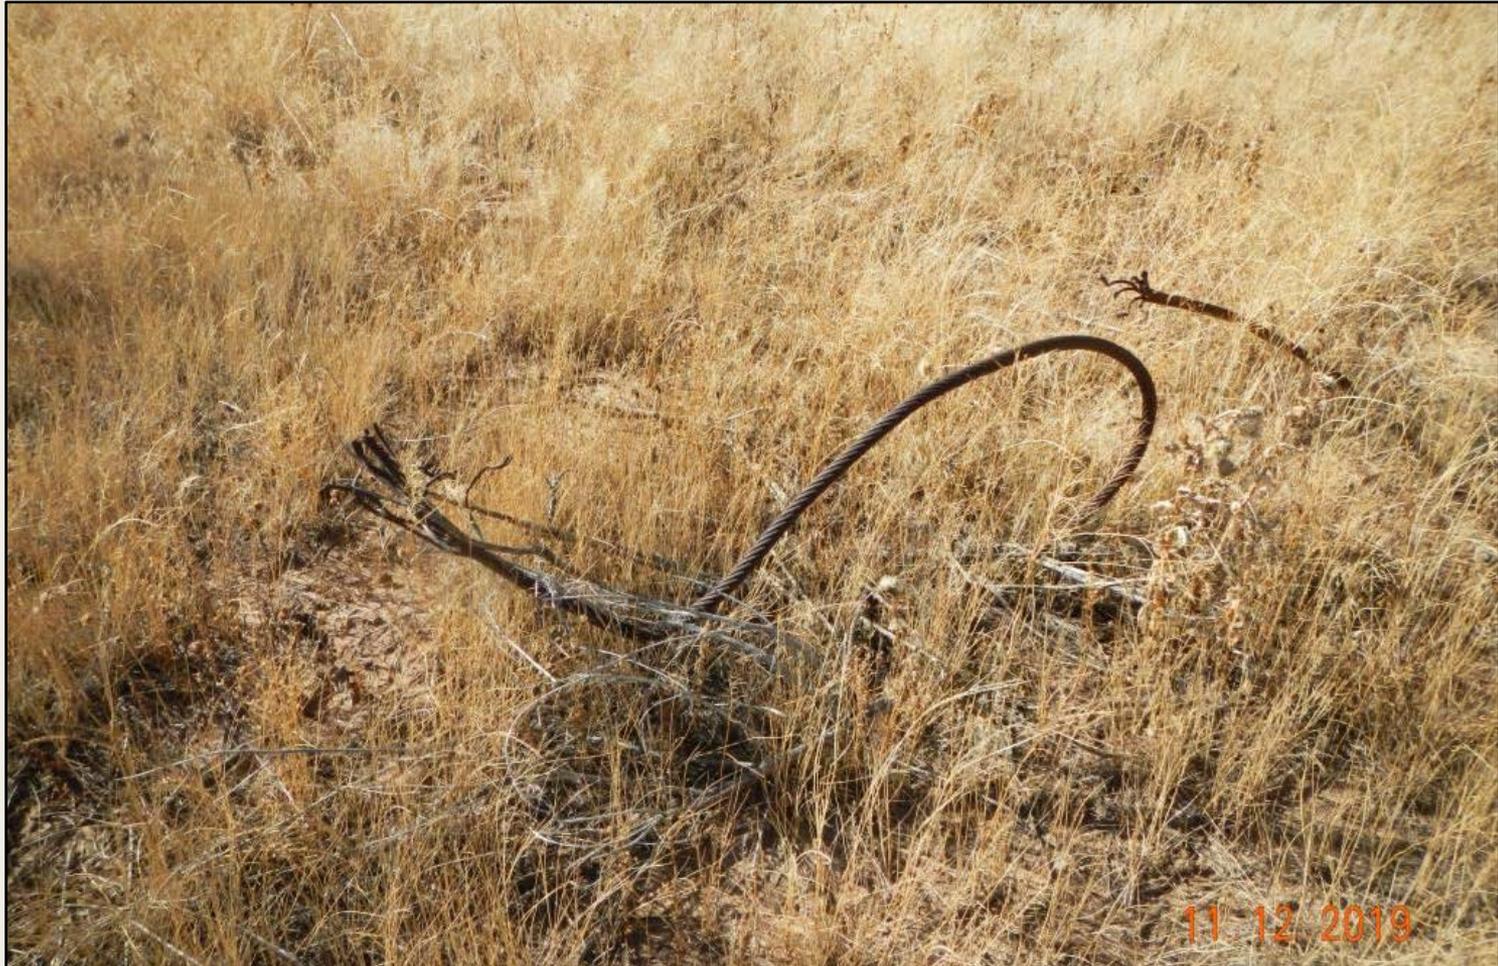
Photo 4. View of cable that remains within the interim reclamation area.

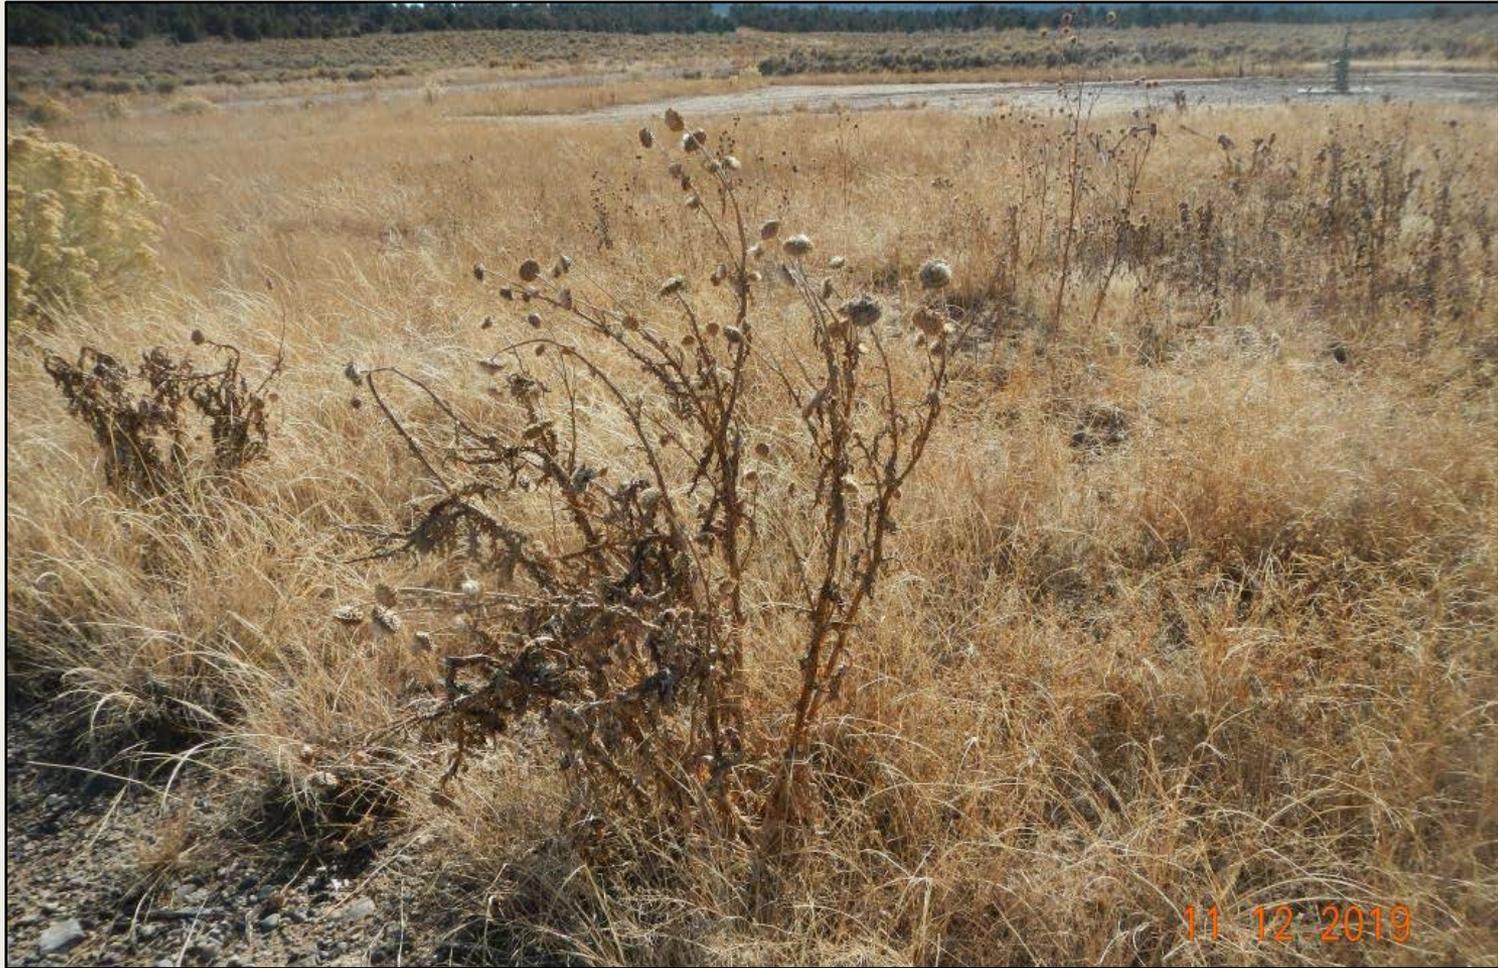
Photo 5. View of musk thistles (approximately 50) individuals observed.

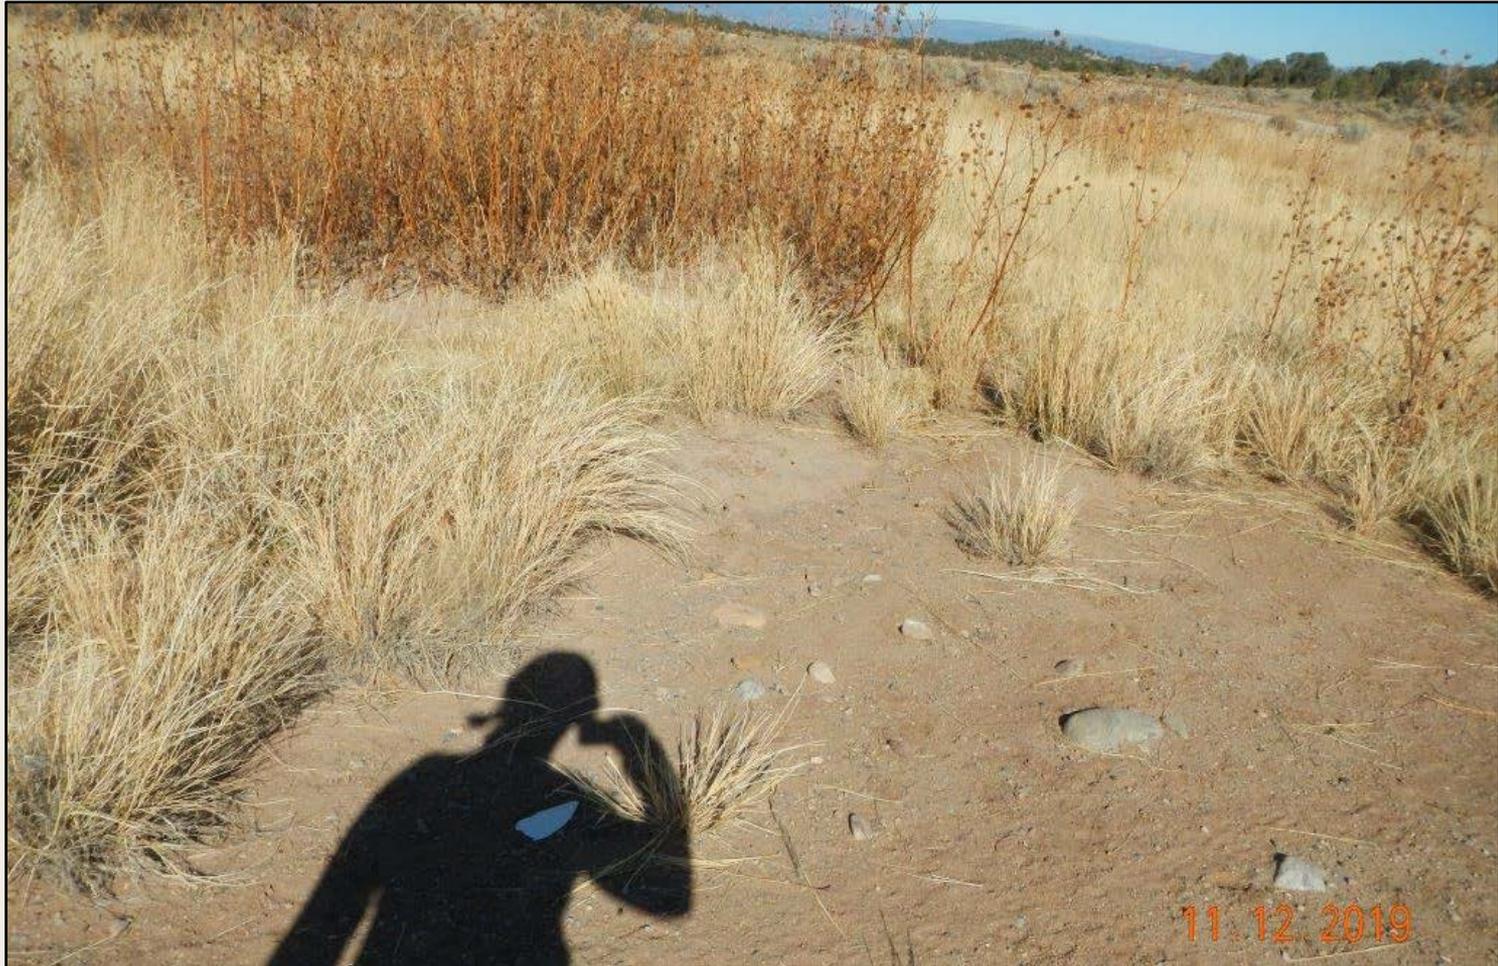
Photo 6. View of area in the northern project area where sediment flows off of the well pad.
