Inspection Photos
Operator: Western Gas Resources
Location/API #: 067-06178
Date: 11-19-2019

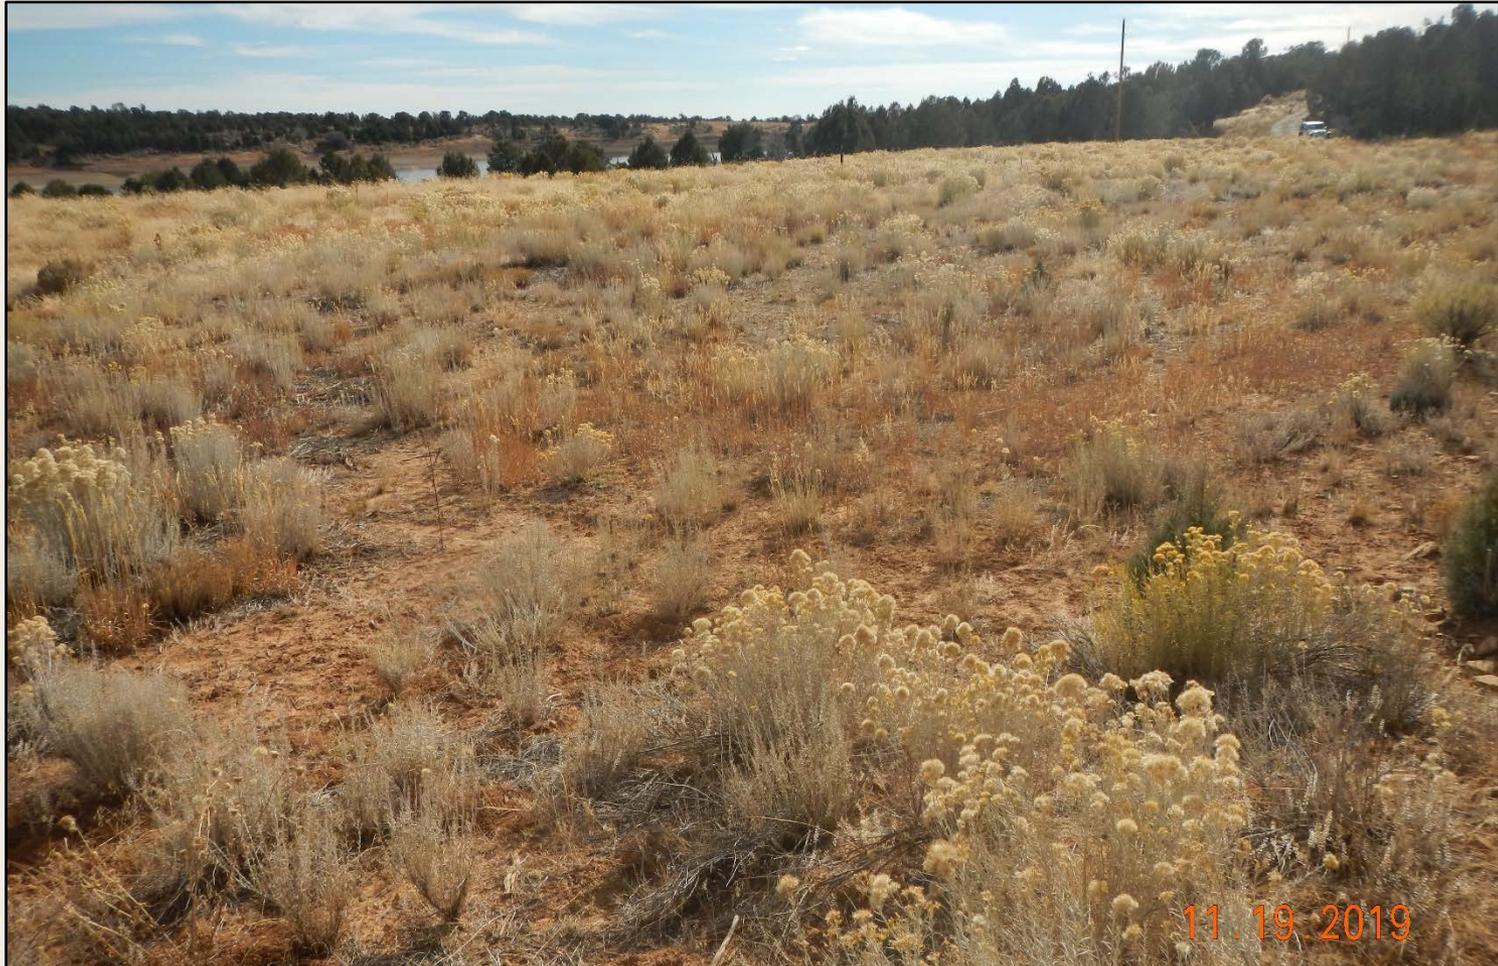
Photo 1. View of the project area from the northwestern corner facing center.

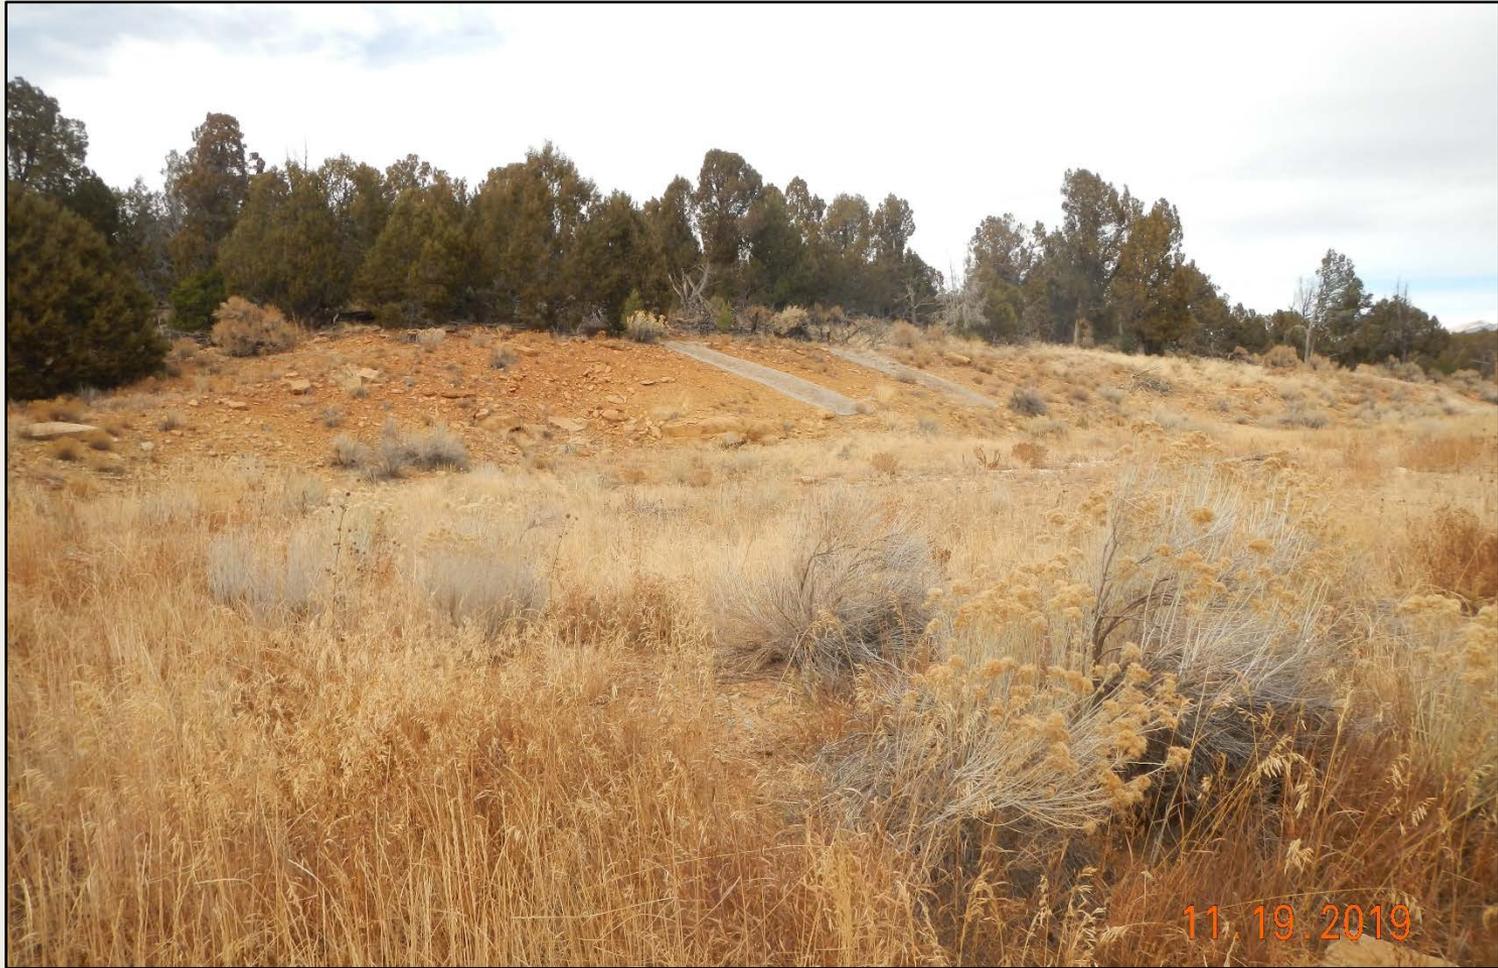
Photo 2. View of the southwestern cut-slope from the well pad entrance. Bare soils on well pad cut-slope remain unstabilized. Erosion blankets and seeding should be conducted across the southwestern slope, not just in the 2 small areas shown.

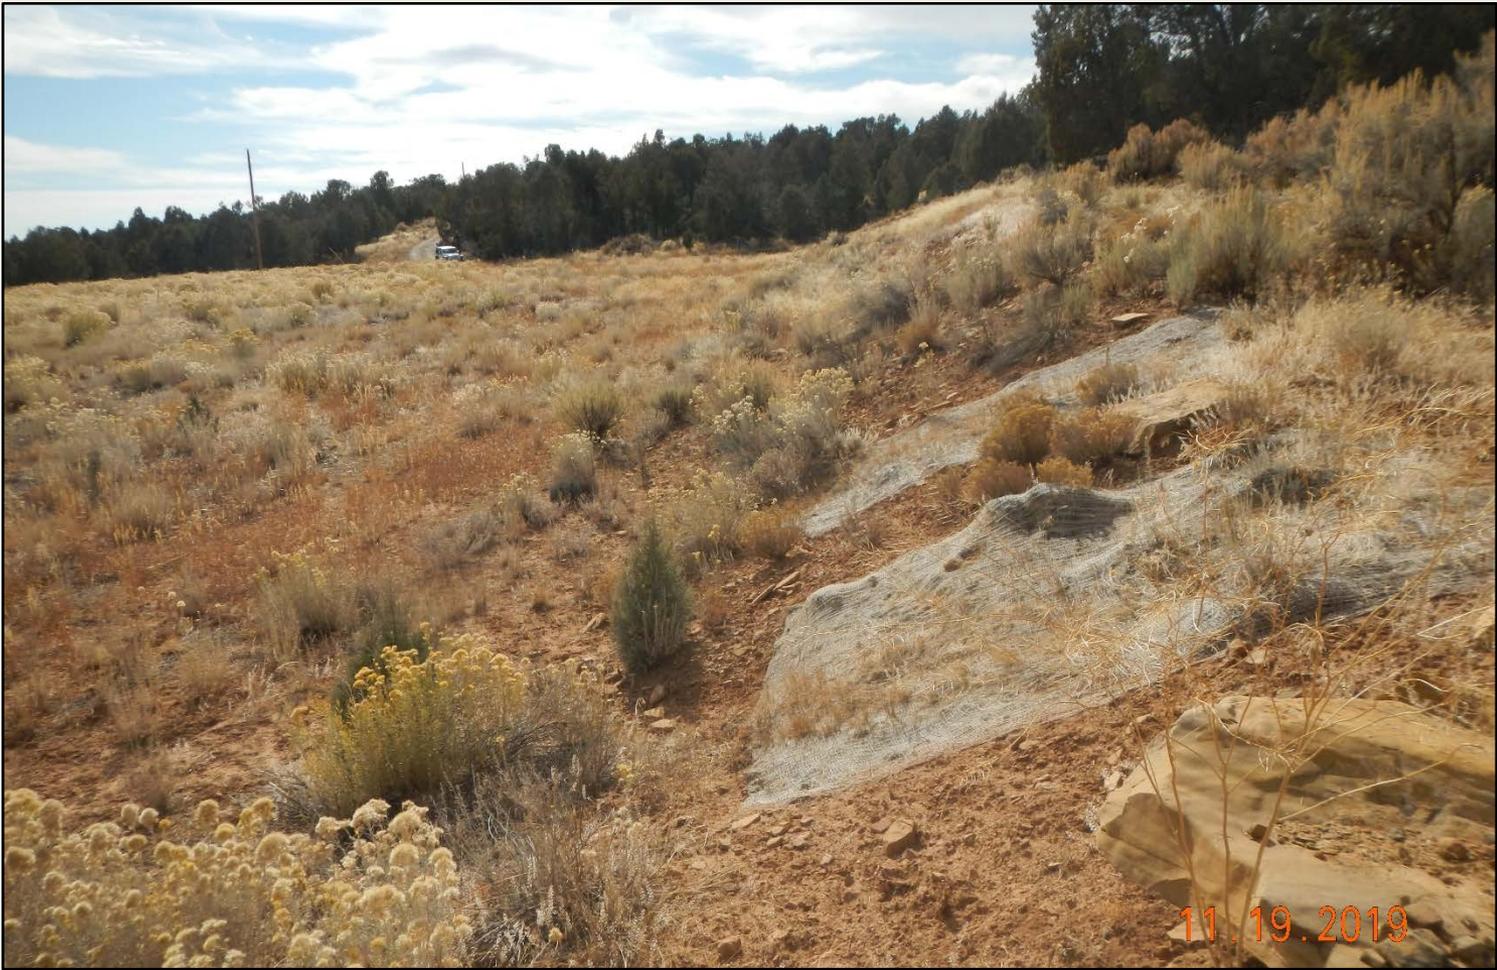
Photo 3. View of the western project from northwestern corner facing southward. Erosion blankets are in place on portions of the cut-slope, but portions of the cut-slope remain bare.

Vegetation at top of slope is under-cut from stormwater erosion

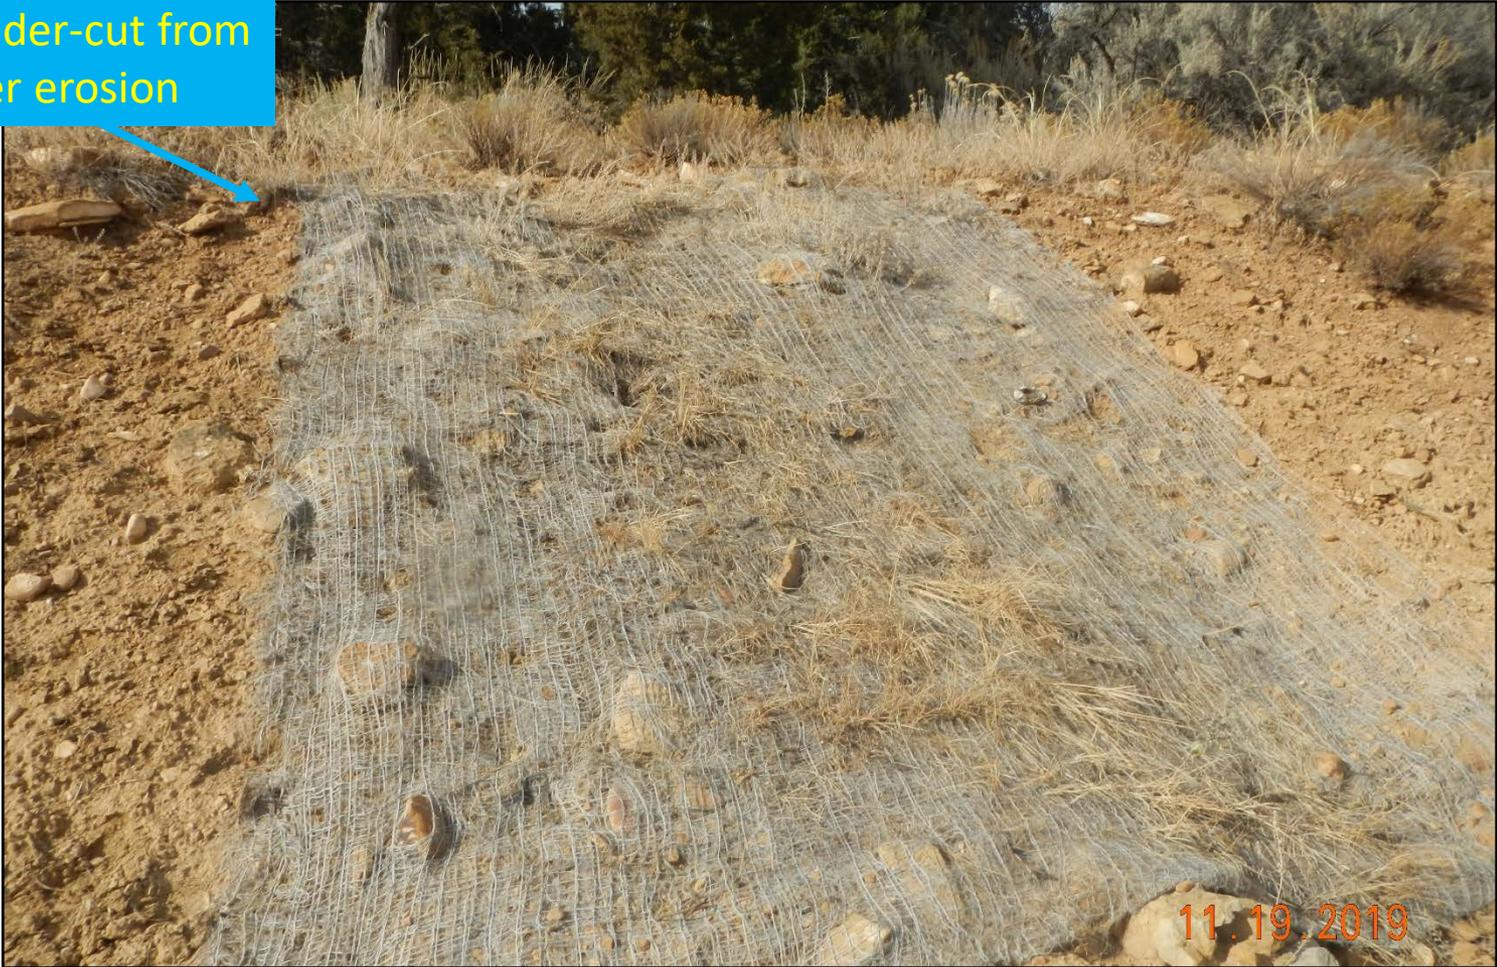
Photo 4. Closeup view of erosion blanket on the western cut-slope. Perennial vegetation is becoming established in the center of the blanket, but not on outer edges or on bare soils that remain on the cut-slope. Vegetation at top of slope is under-cut by erosional processes. Vegetation at top of slope is under-cut from stormwater erosion.

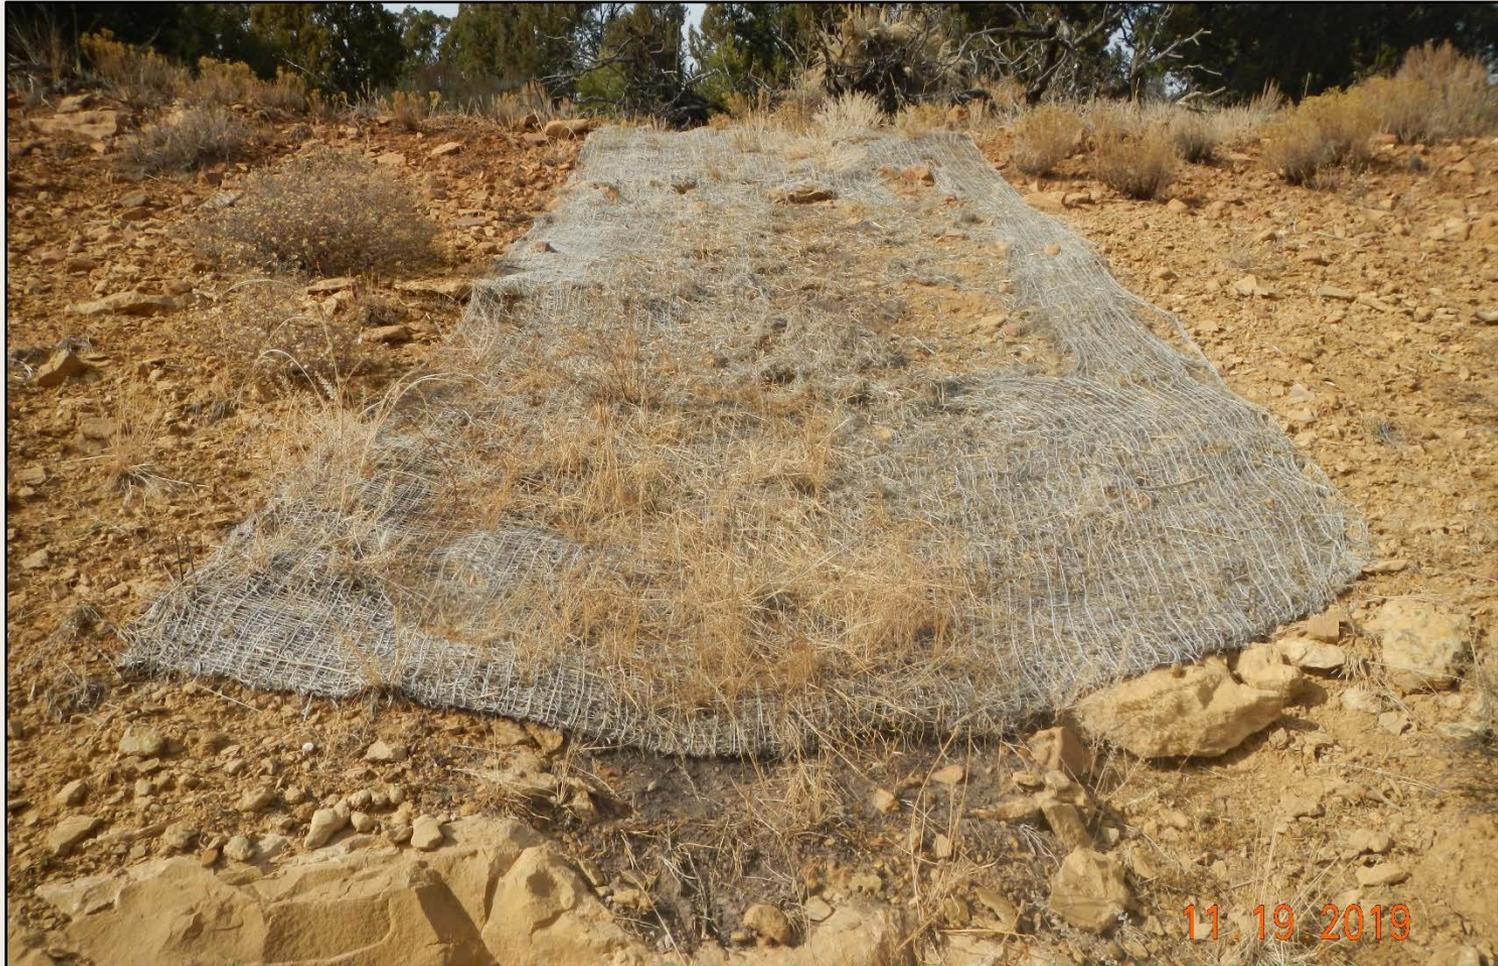
Photo 5. View of another erosion blanket on the cut-slope. A portion of the blanket is torn and needs repair.

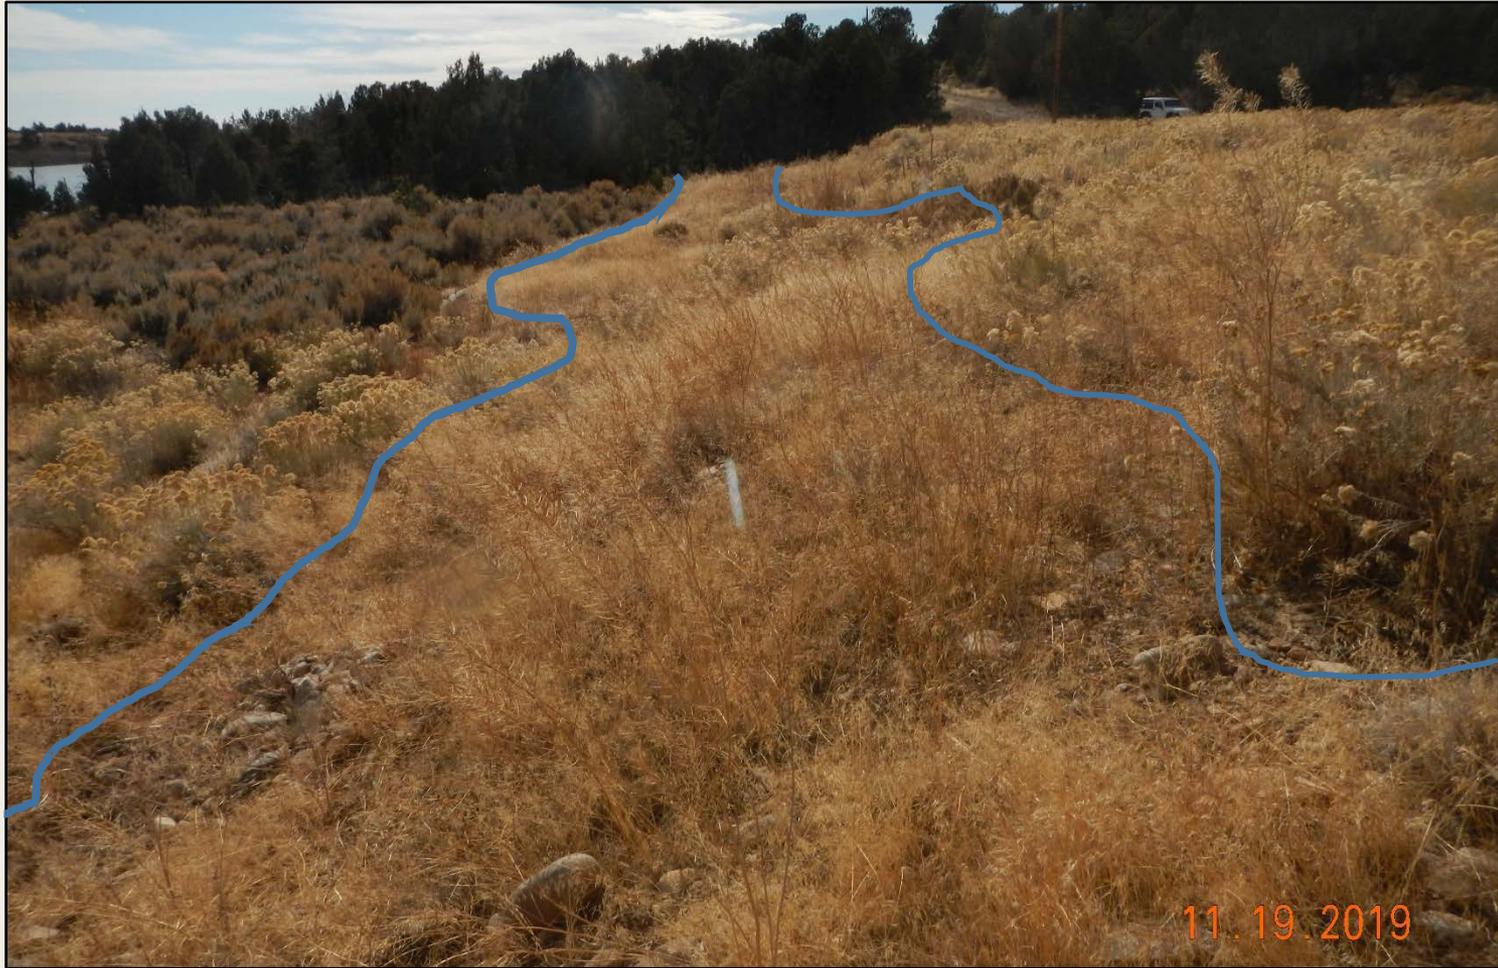
Photo 6. View of the eastern fill-slope facing southward. Vegetation between the two blue lines is largely annual species and not stabilized with desirable perennial vegetation.

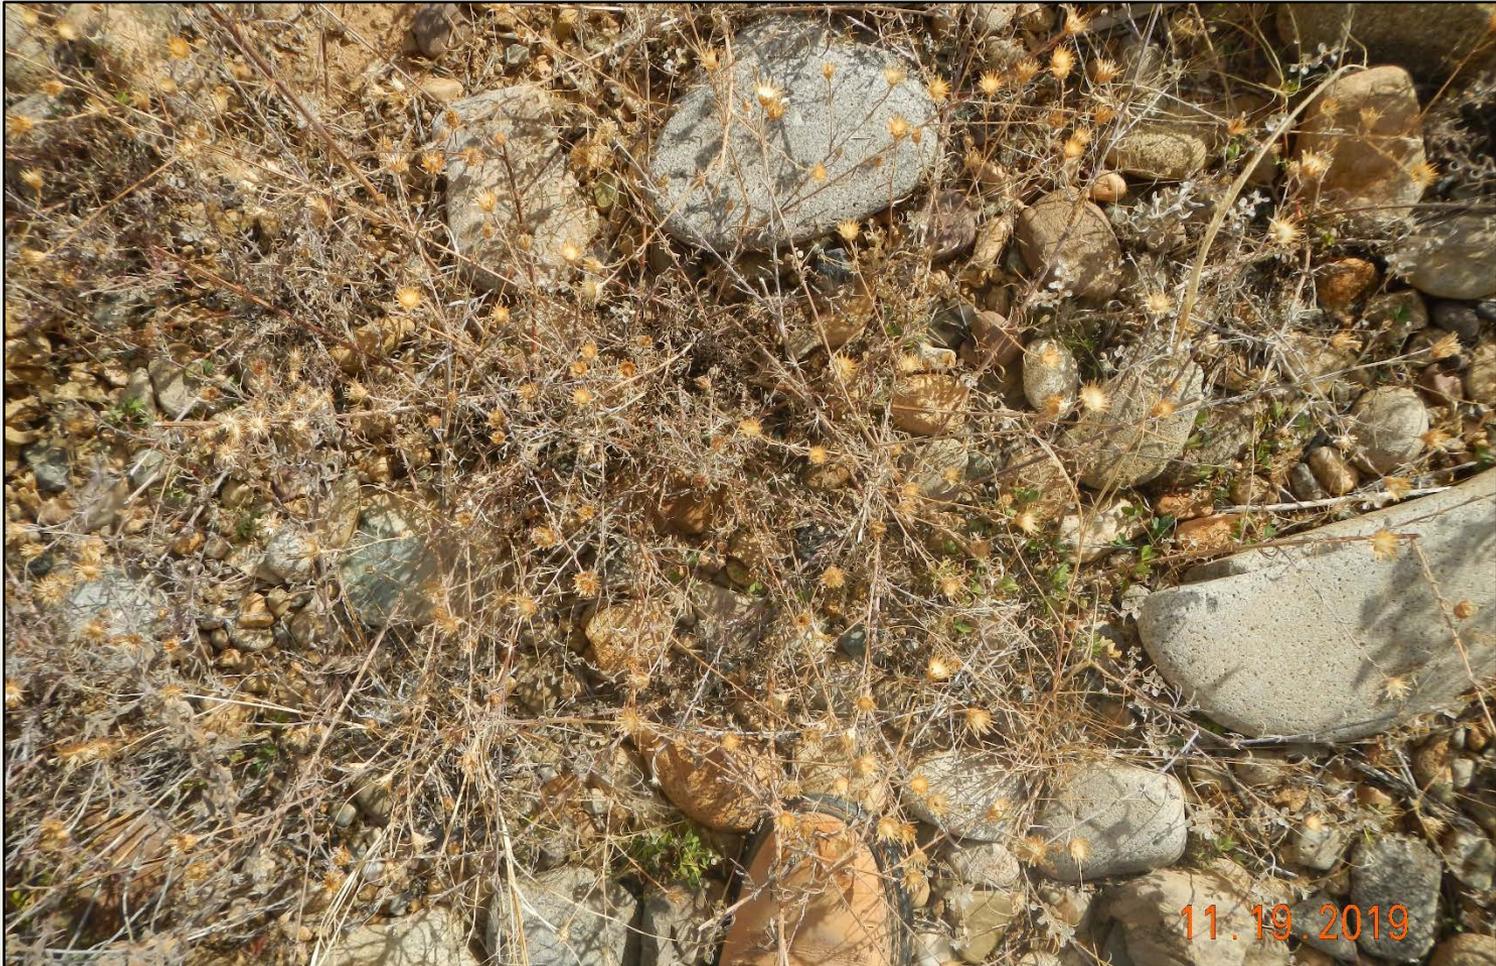
Photo 7. View of dense spotted knapweeds on the well pad, in dormant vegetative condition.

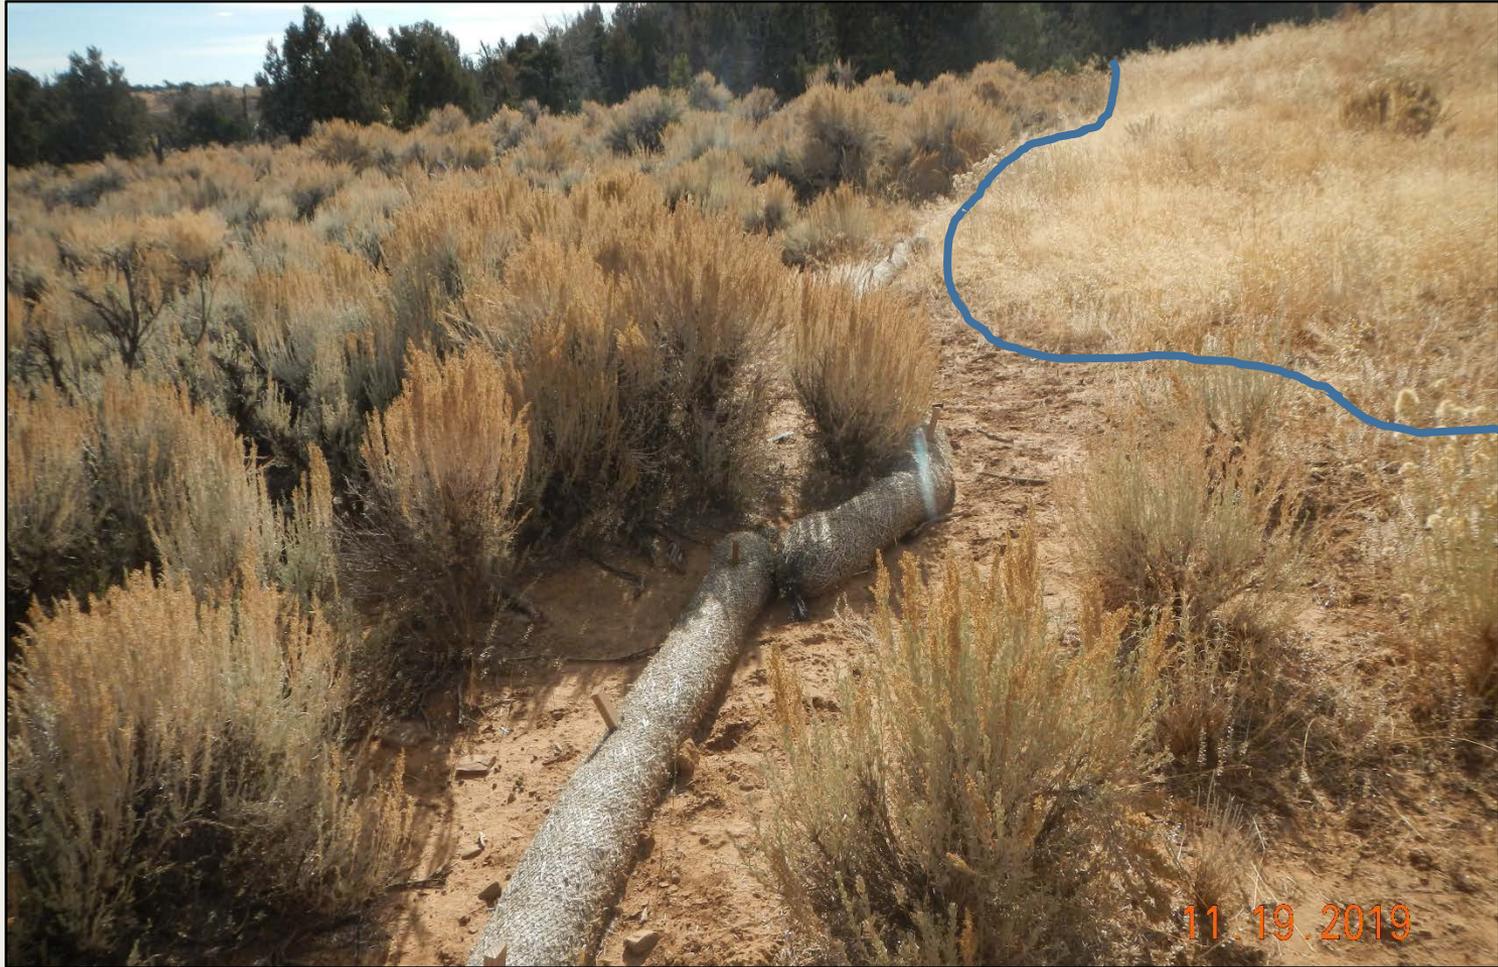
Photo 8. View of the southeastern edge of the project area. Dense annual vegetation (largely cheatgrass) right of the blue line. Area needs to be stabilized with desirable perennial vegetation.

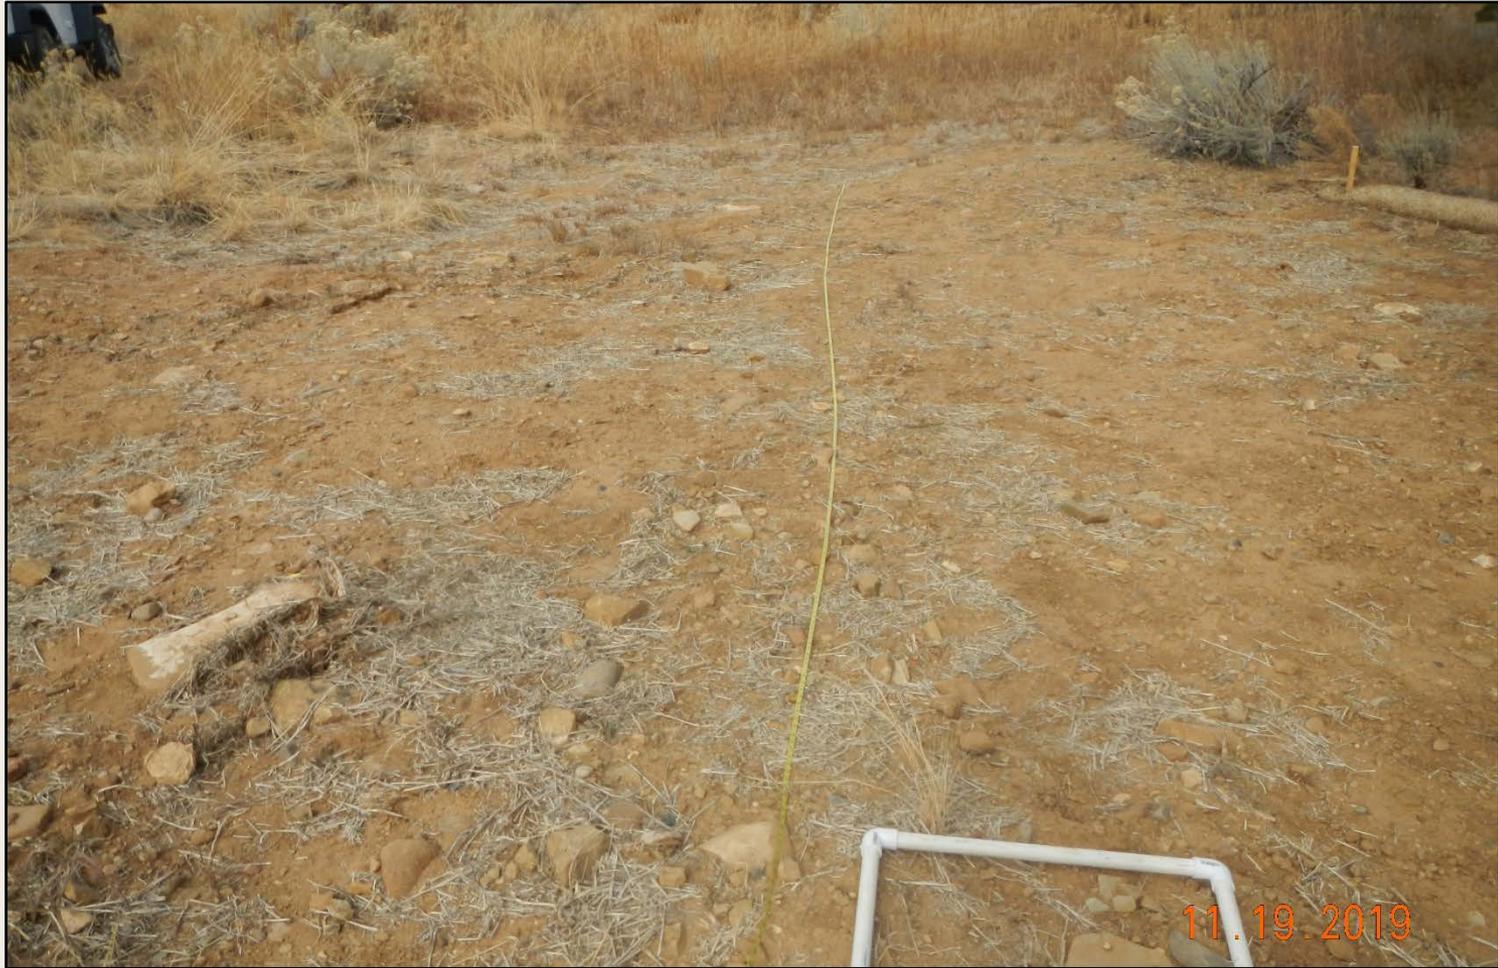
Photo 9. View of area where pipeline riser was removed. Area is seeded.

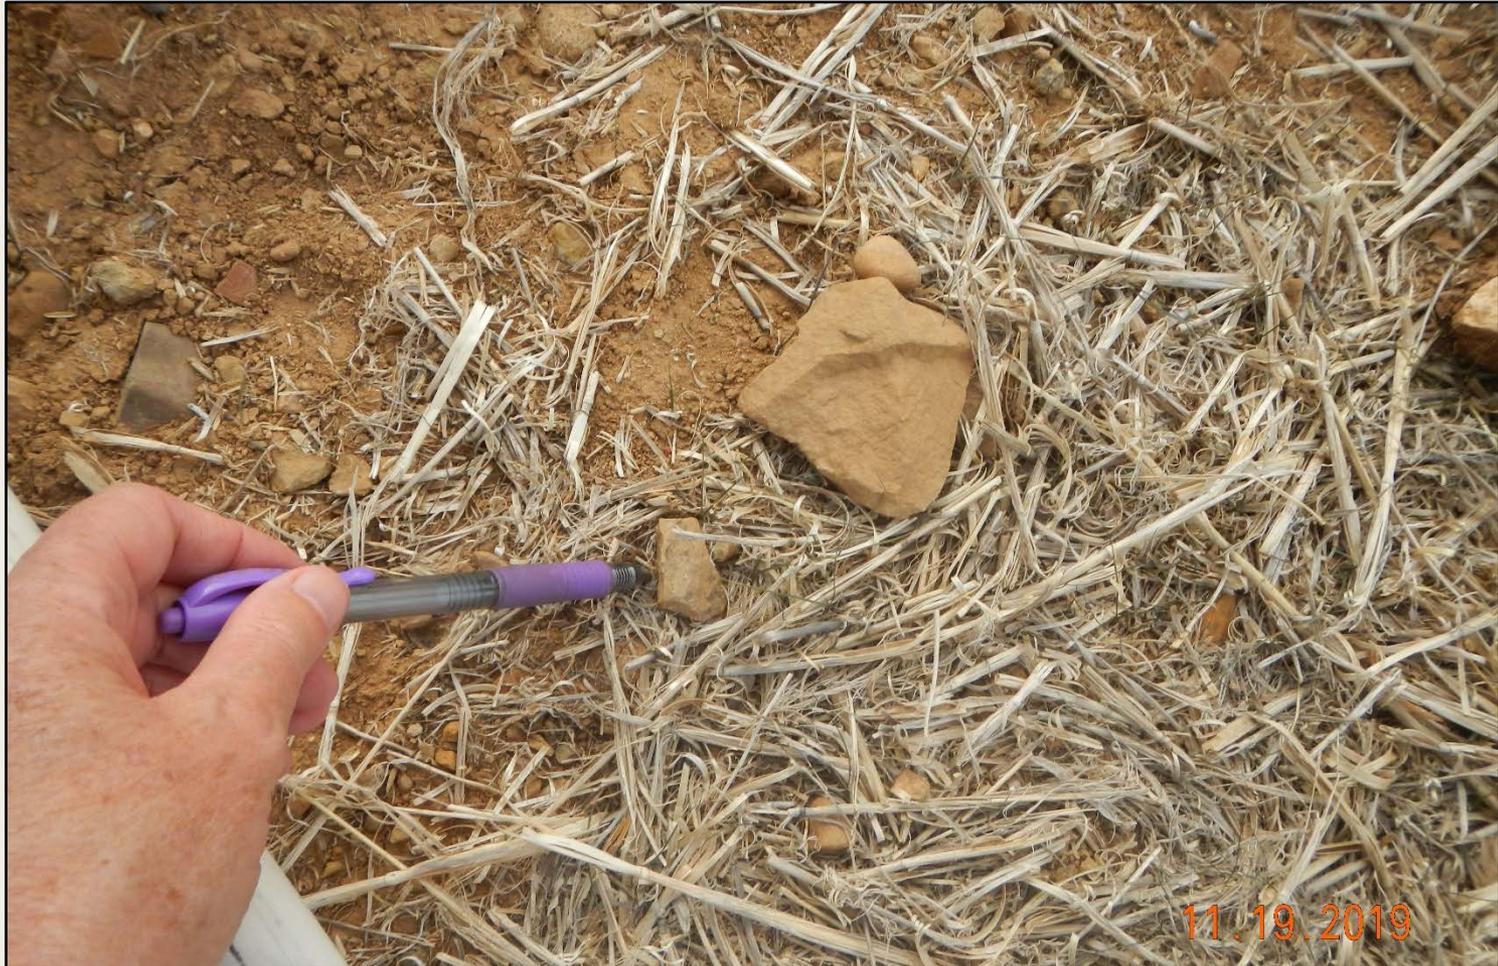
Photo 10. Closeup view of seedlings within the re-seed area, approximately 1-1.5 inches tall.

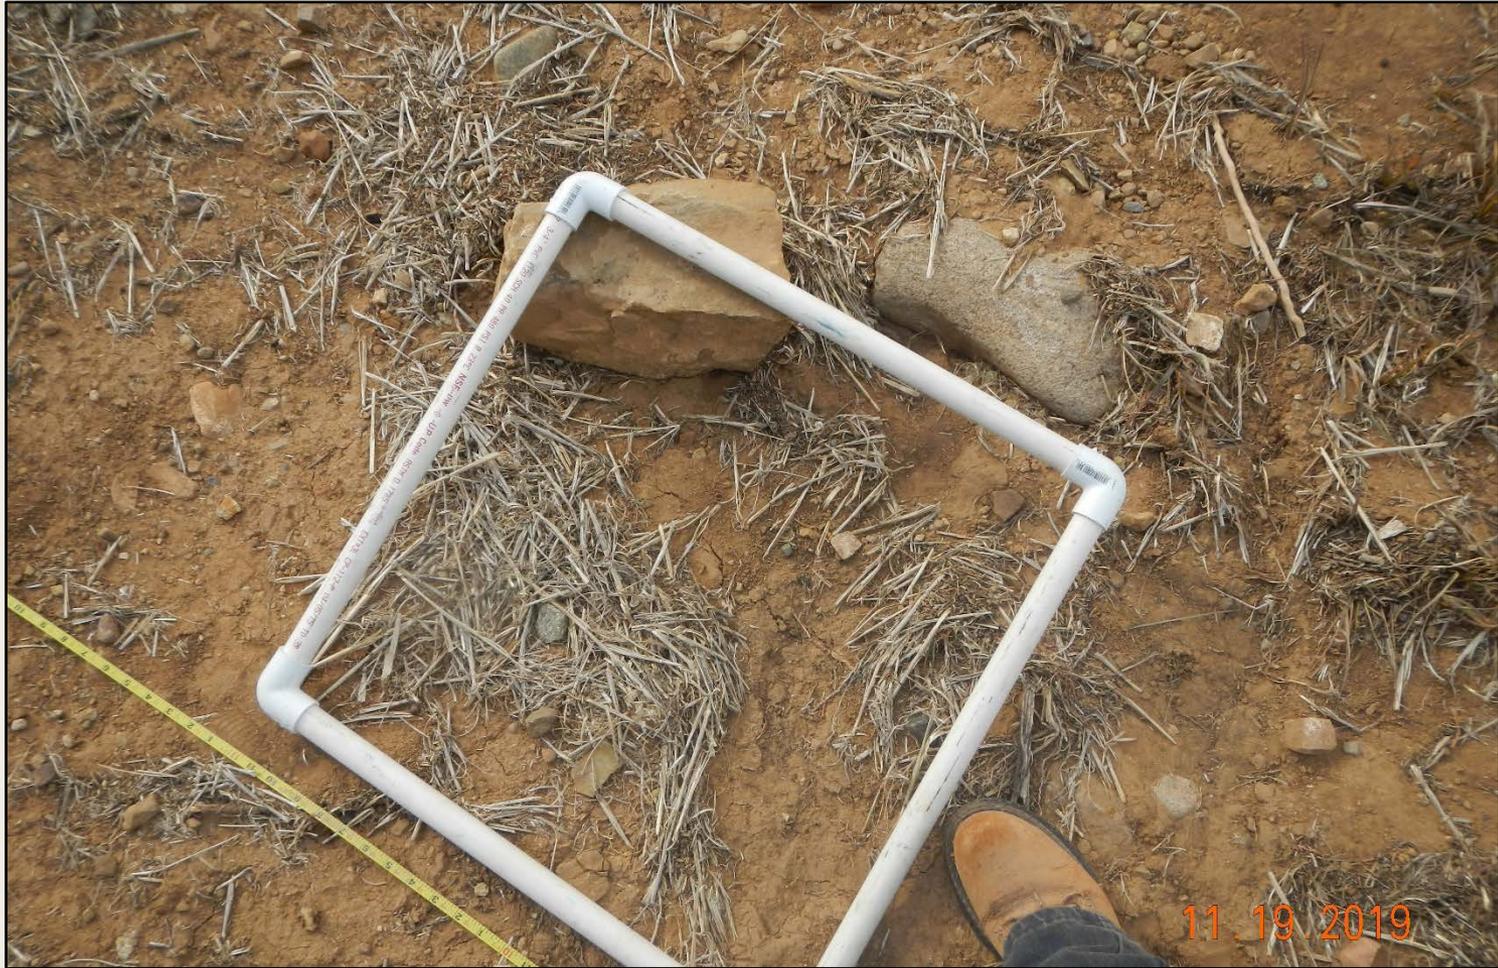
Photo 11. Birdseye view germination quadrat.

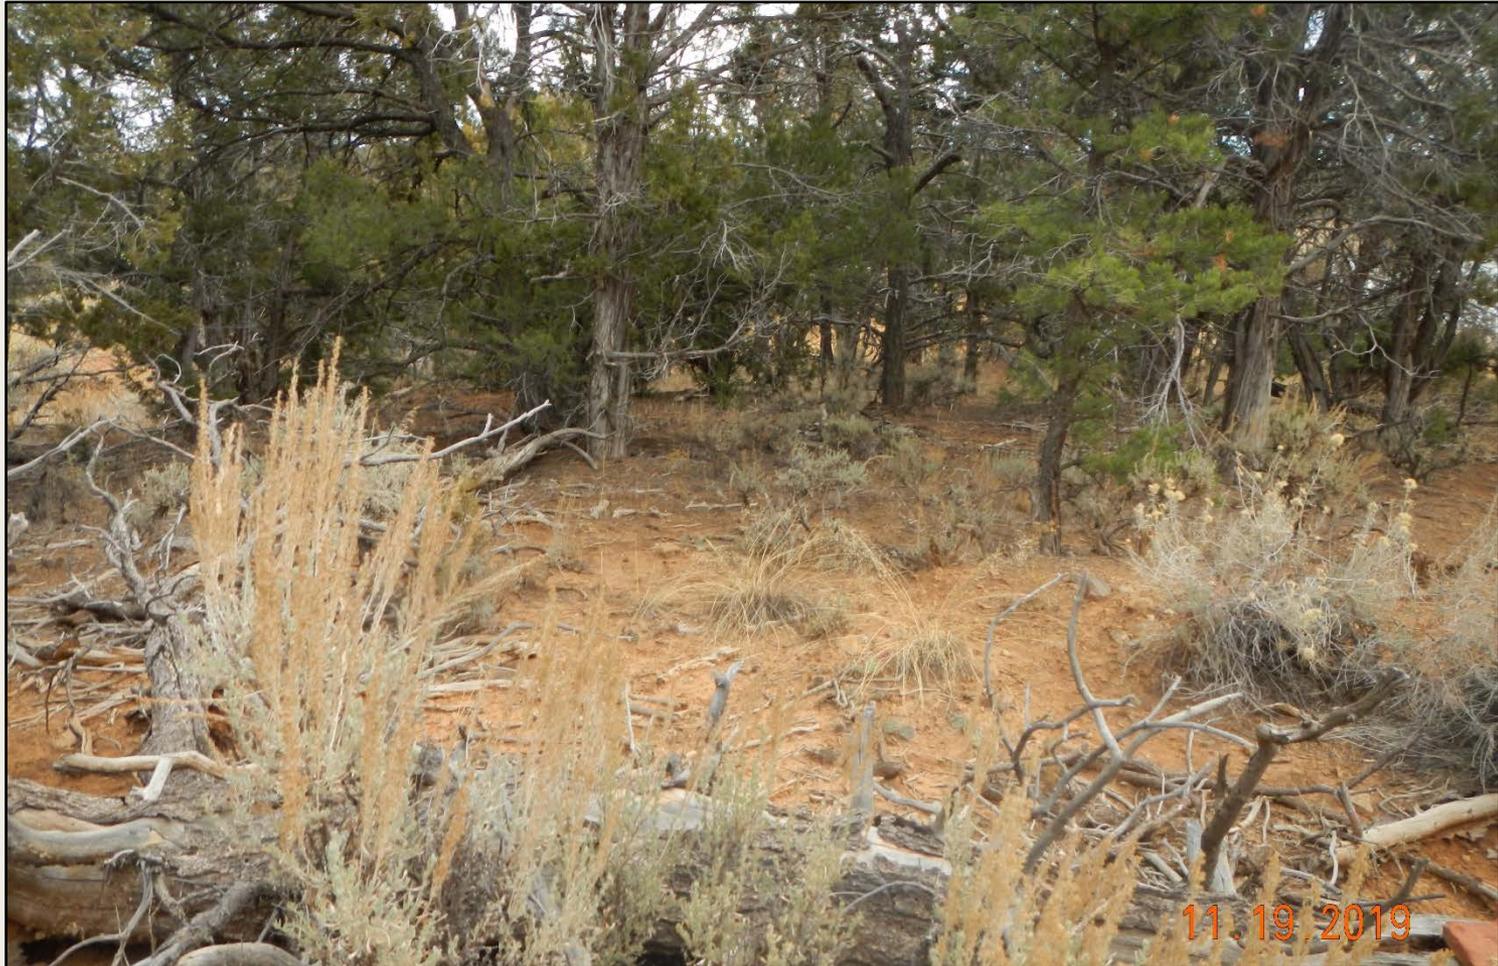
Photo 12. View of reference area vegetation, comprised of pinyon and juniper woodland with an open sagebrush and herbaceous understory.
