# Inspection Photos

API: 05-073-06369

Operator: NIGHTHAWK PRODUCTION

Inspection Date: 11/25/2019

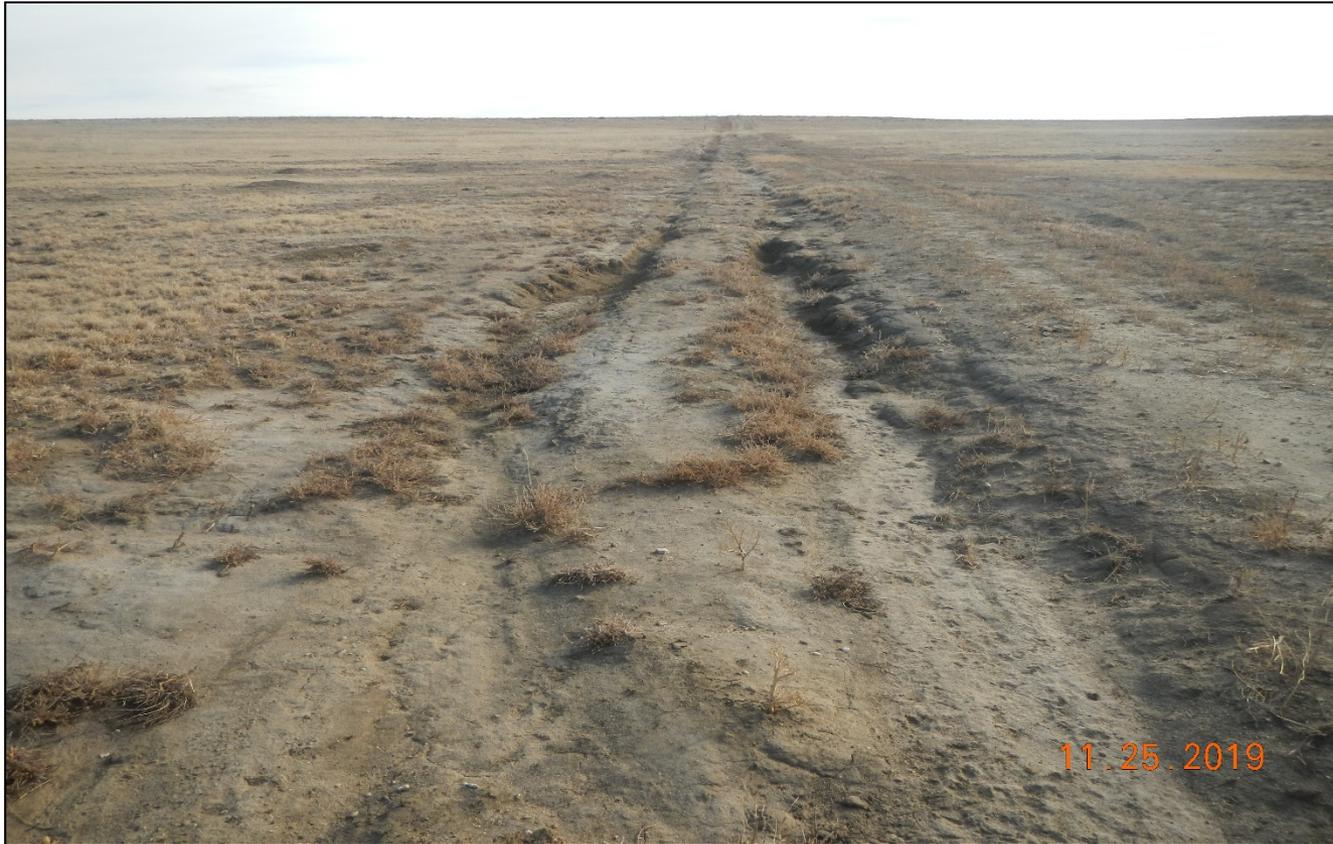
**Photo 1.** Facing east along the access road which was requested to remain. There are erosion issues along the road that need to be repaired and stabilized. Previous corrective action was not performed.

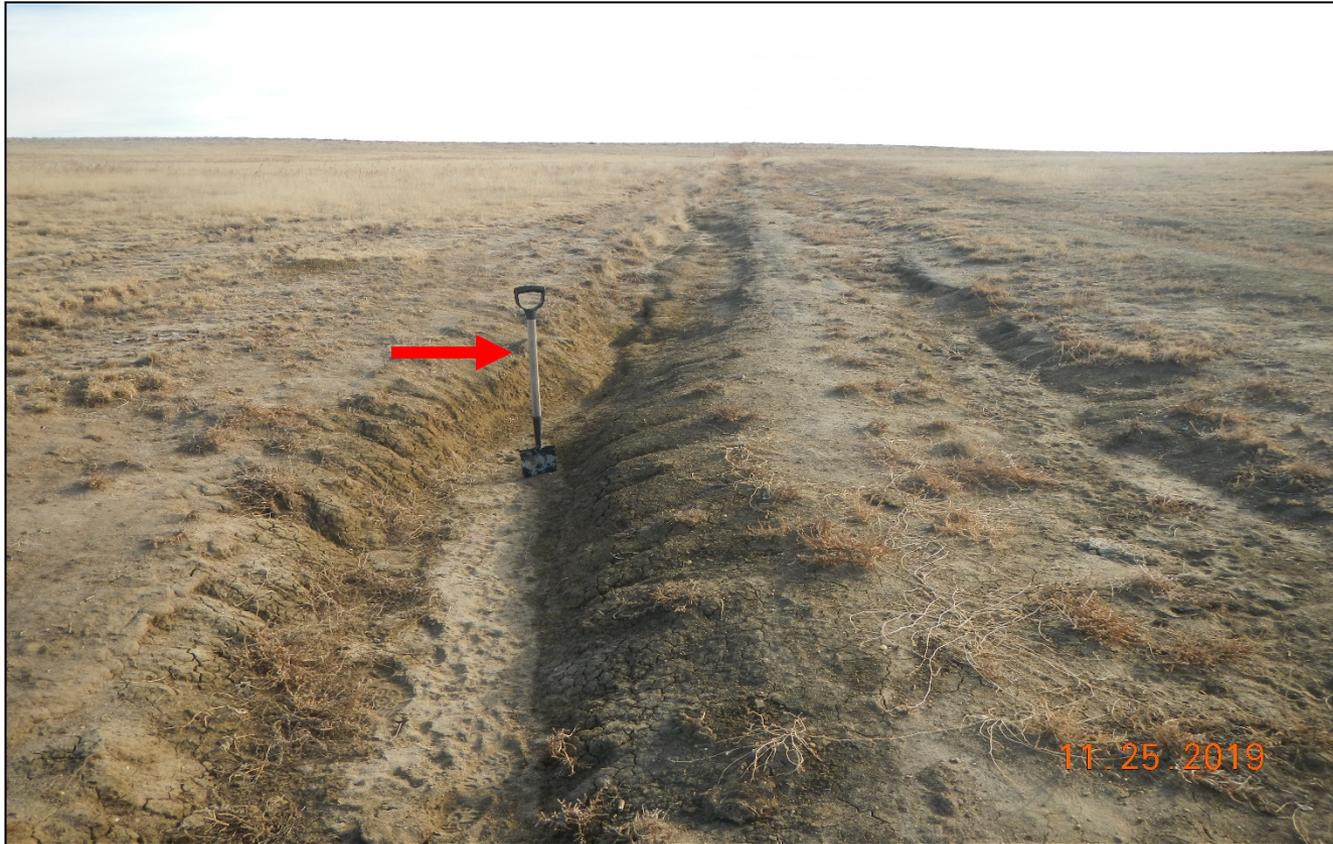
**Photo 2.** Facing east along the access road which was requested to remain. There are erosion issues along the road that need to be repaired and stabilized. Arrow points to 3.5 ft. shovel to show depth of erosion. Previous corrective action was not performed.

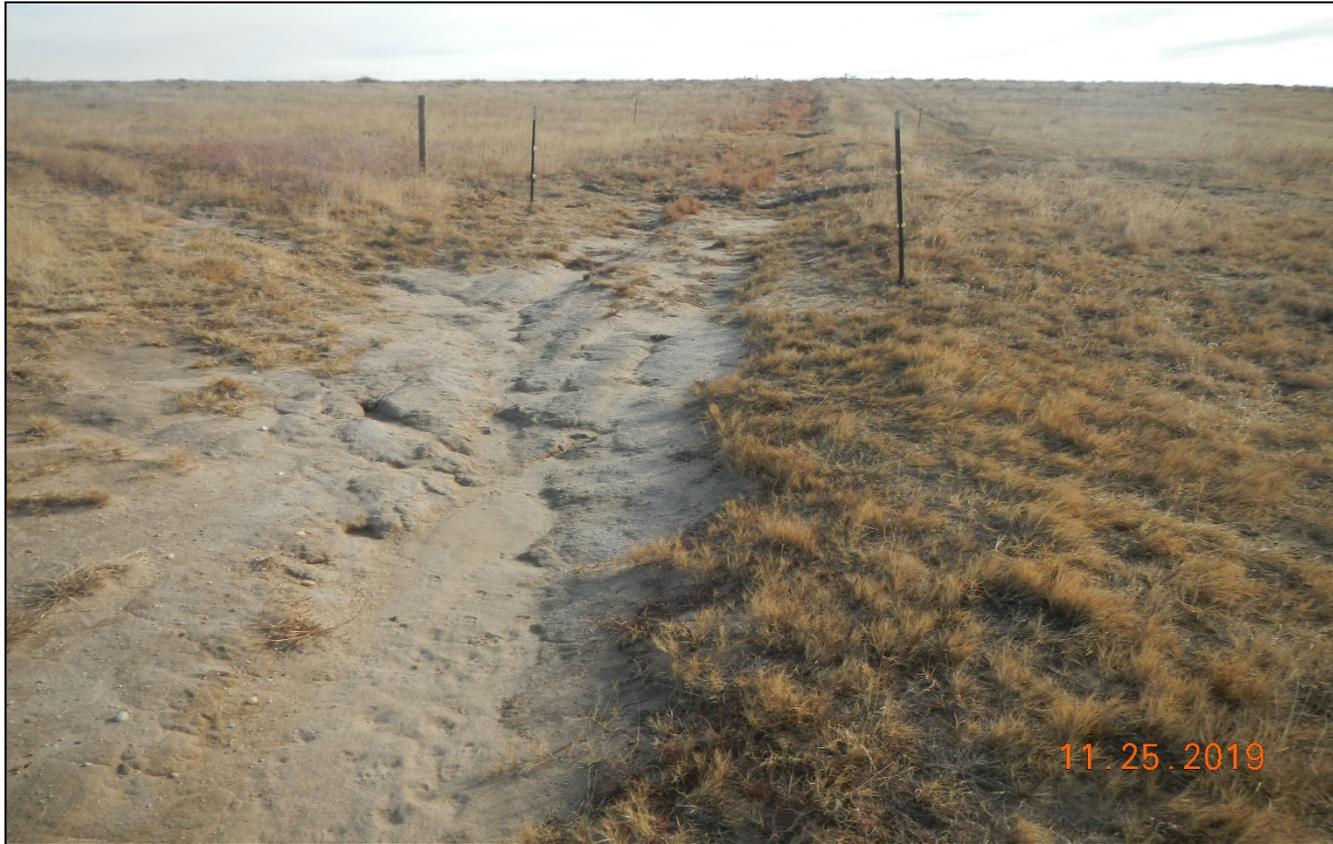
**Photo 3.** Facing east along the access road closer to the location which was reclaimed and fenced. The fence is degraded and has not been repaired. The photo depicts noncompliance of the corrective action.

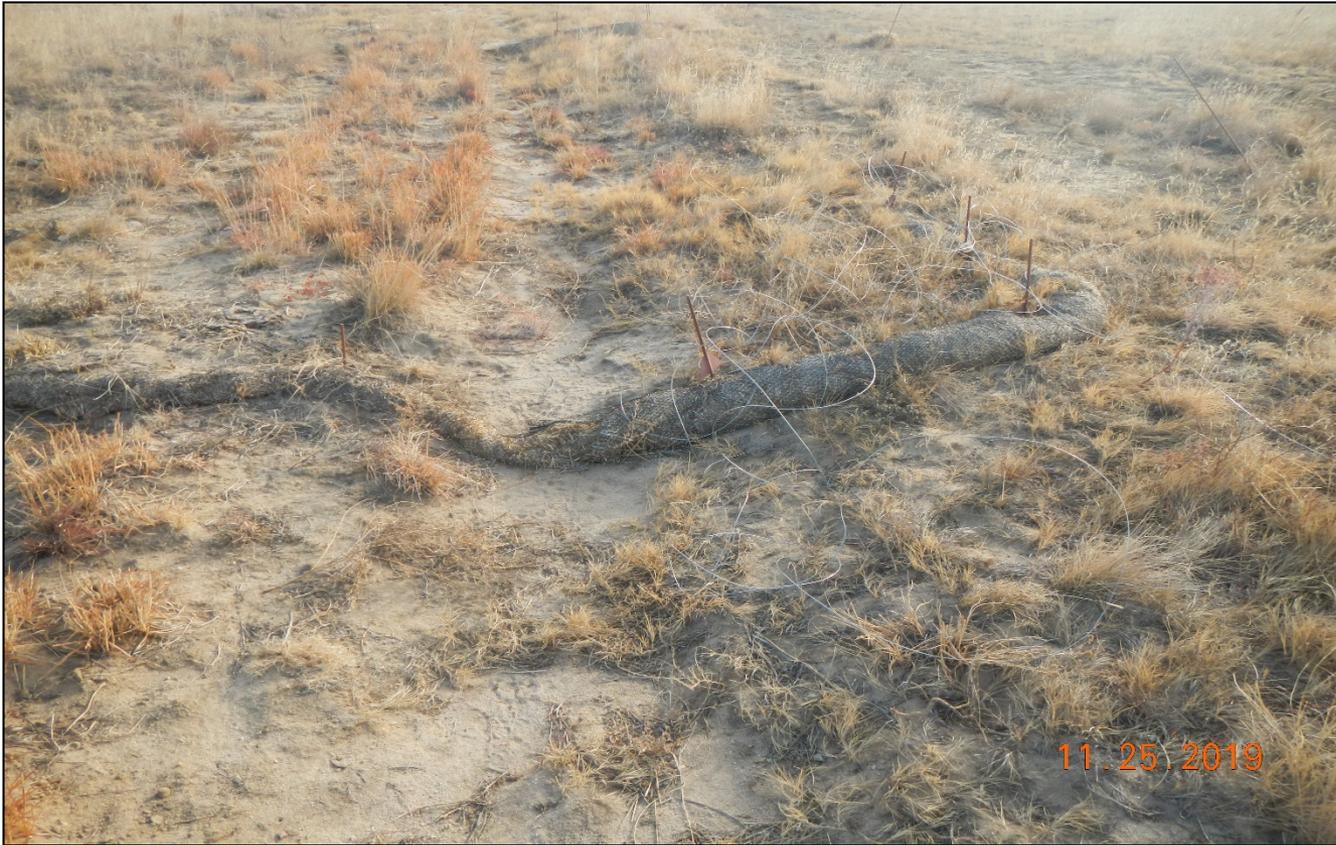
**Photo 4.** Wattles are degraded along the reclaimed portion of the access road. Wire from the electric fence is strung along the ground. The photo depicts noncompliance of the corrective action.

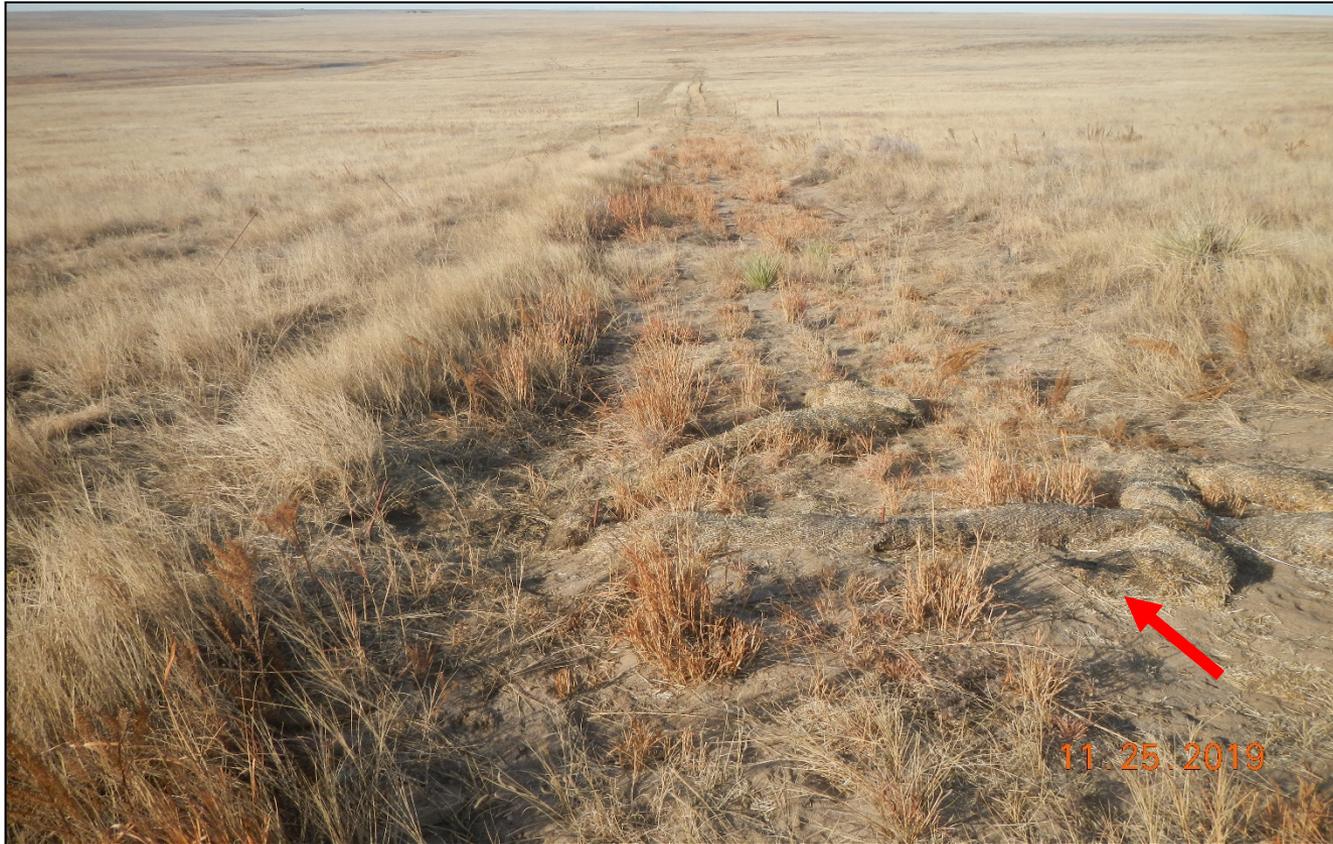
**Photo 5.** Facing back to the west at the reclaimed portion of the access road. Arrow points to wattles that are not maintained. The photo depicts noncompliance of the corrective action.

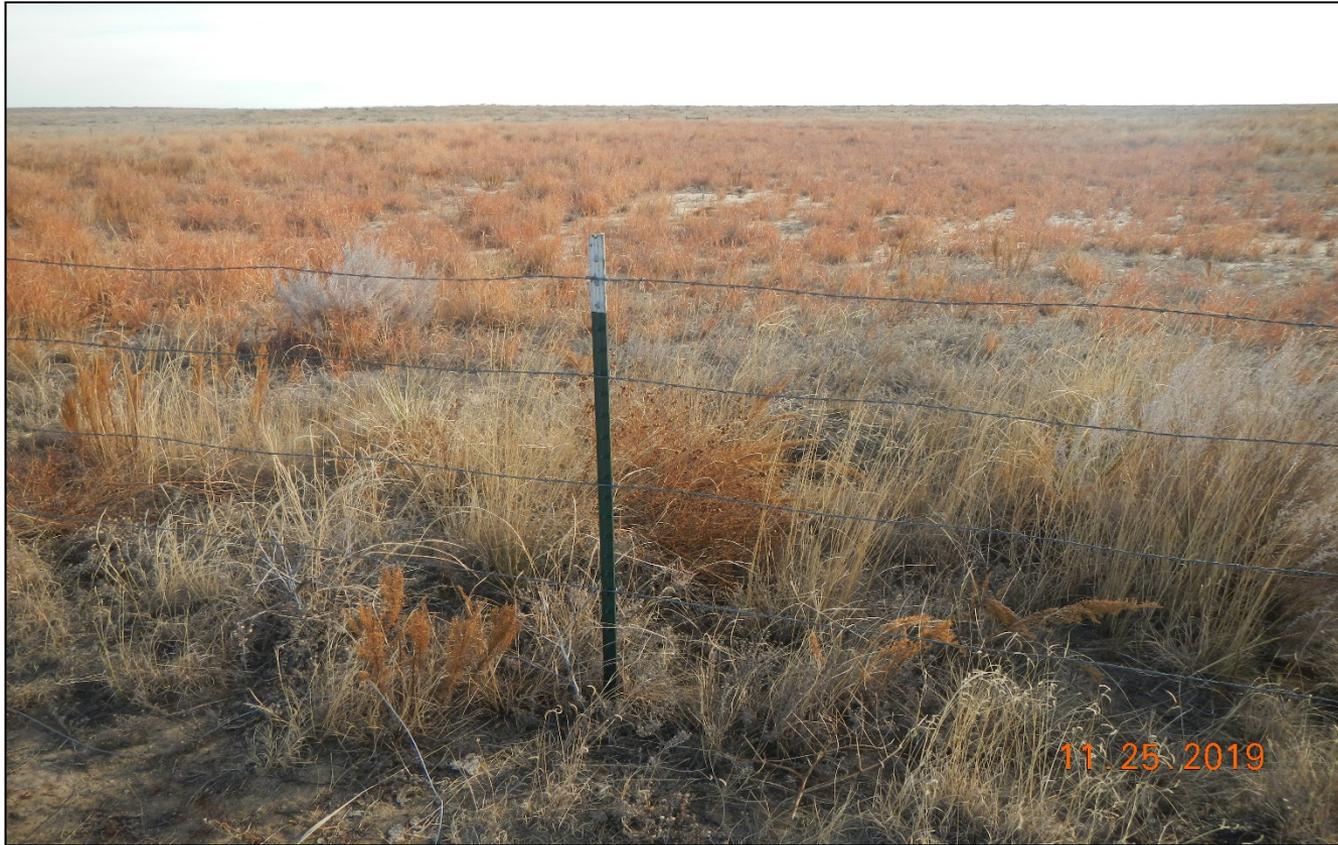
**Photo 6.** Facing east at the location. Perimeter is fenced and in good condition.

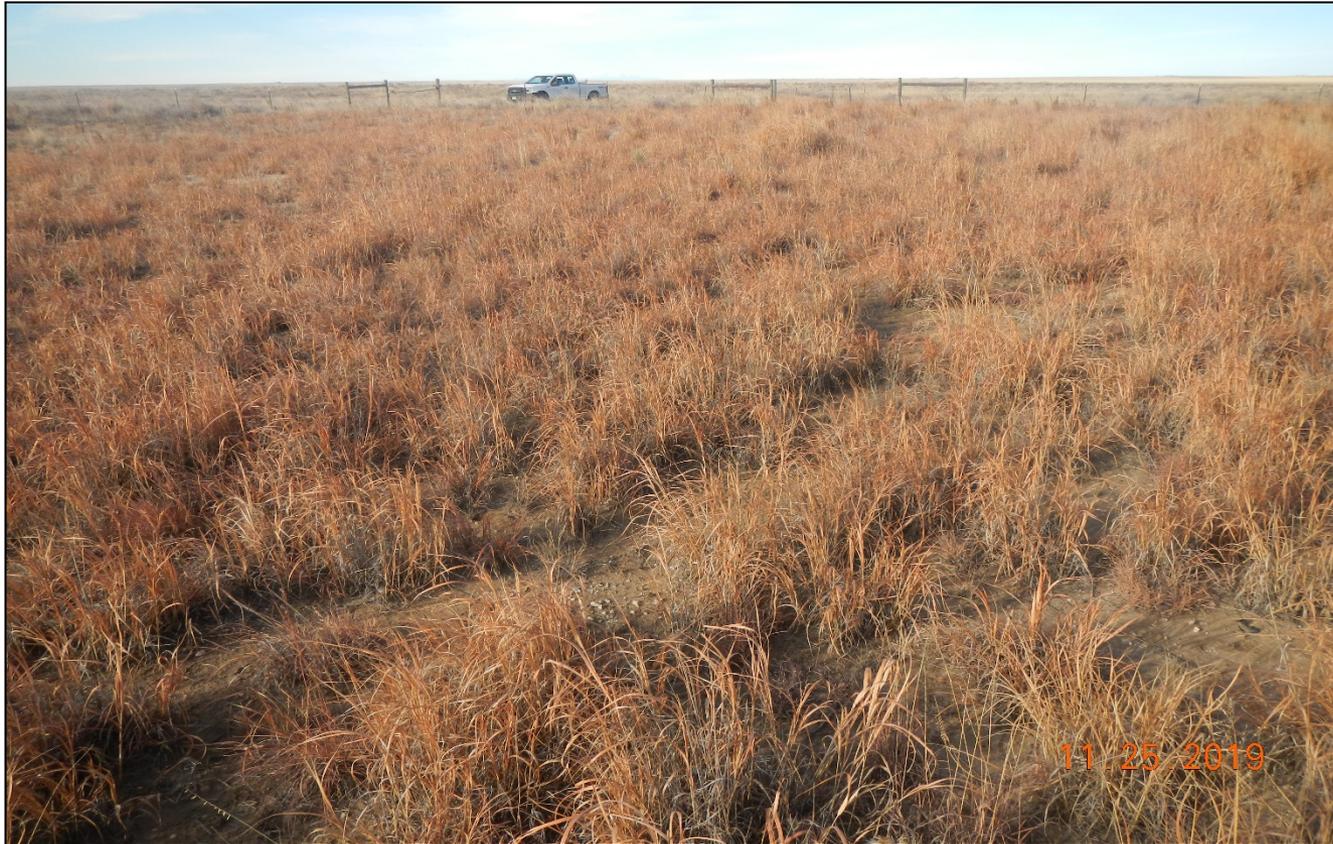
**Photo 8.** Facing west at the location. Vegetation is well established at this area.
