Inspection Photos

API: 05-041-06072

Operator: HILCORP ENERGY COMPANY

Inspection and Photo Date: 11/25/2019

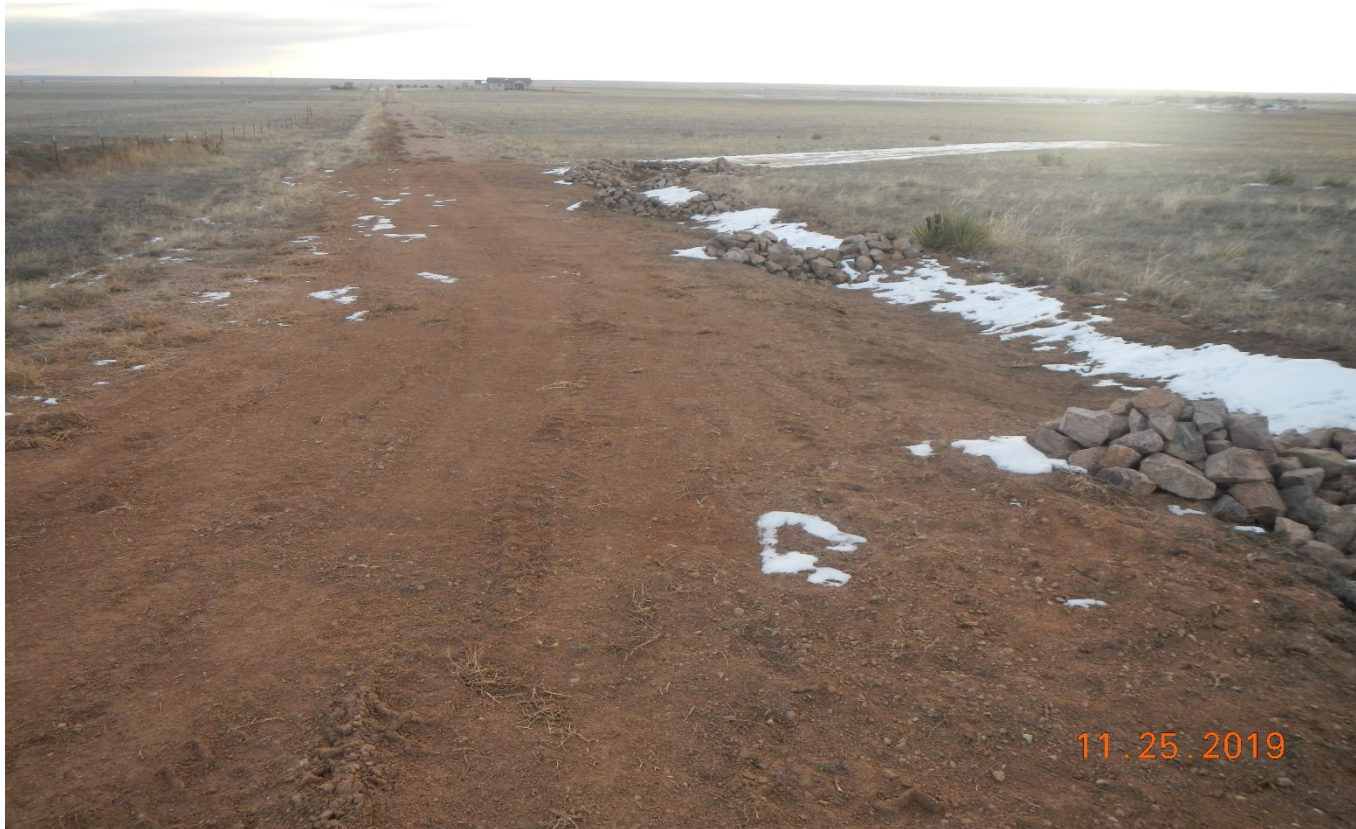
Photo 1. Facing east on the access road. Rock rip/rap check dams have been installed along the road since the previous inspection. The center of the check dams are at least 6 inches lower than the edges as required.

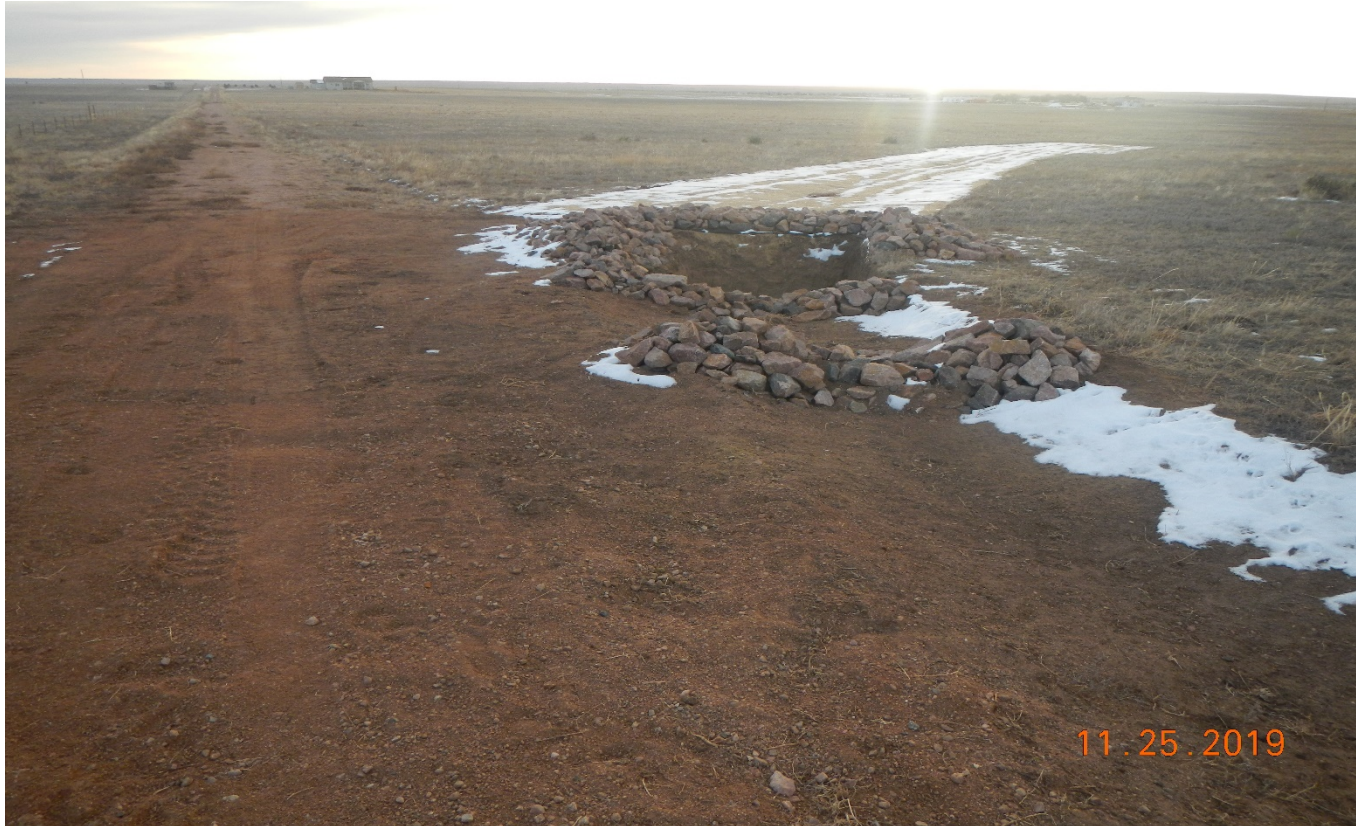
Photo 2. Facing southeast toward the area of erosion which extended out into the pasture which was identified in the previous inspections. The erosion in the pasture has been reclaimed. Rock check dams and a sediment trap have been installed since the previous inspection.

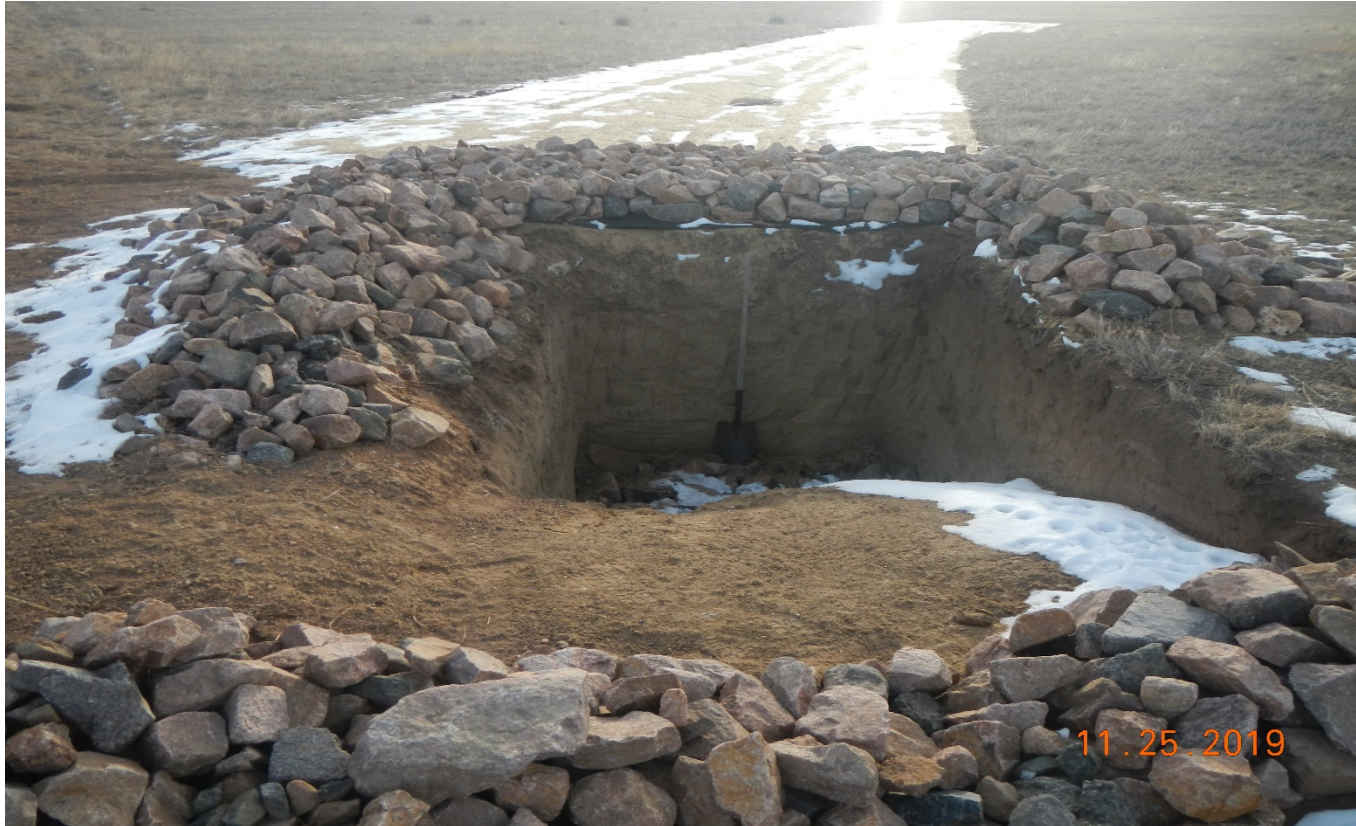
Photo 3. The sediment trap was not installed in accordance to good engineering practice. The depth of the spillway should be 1 ft. below the low point of the embankment.

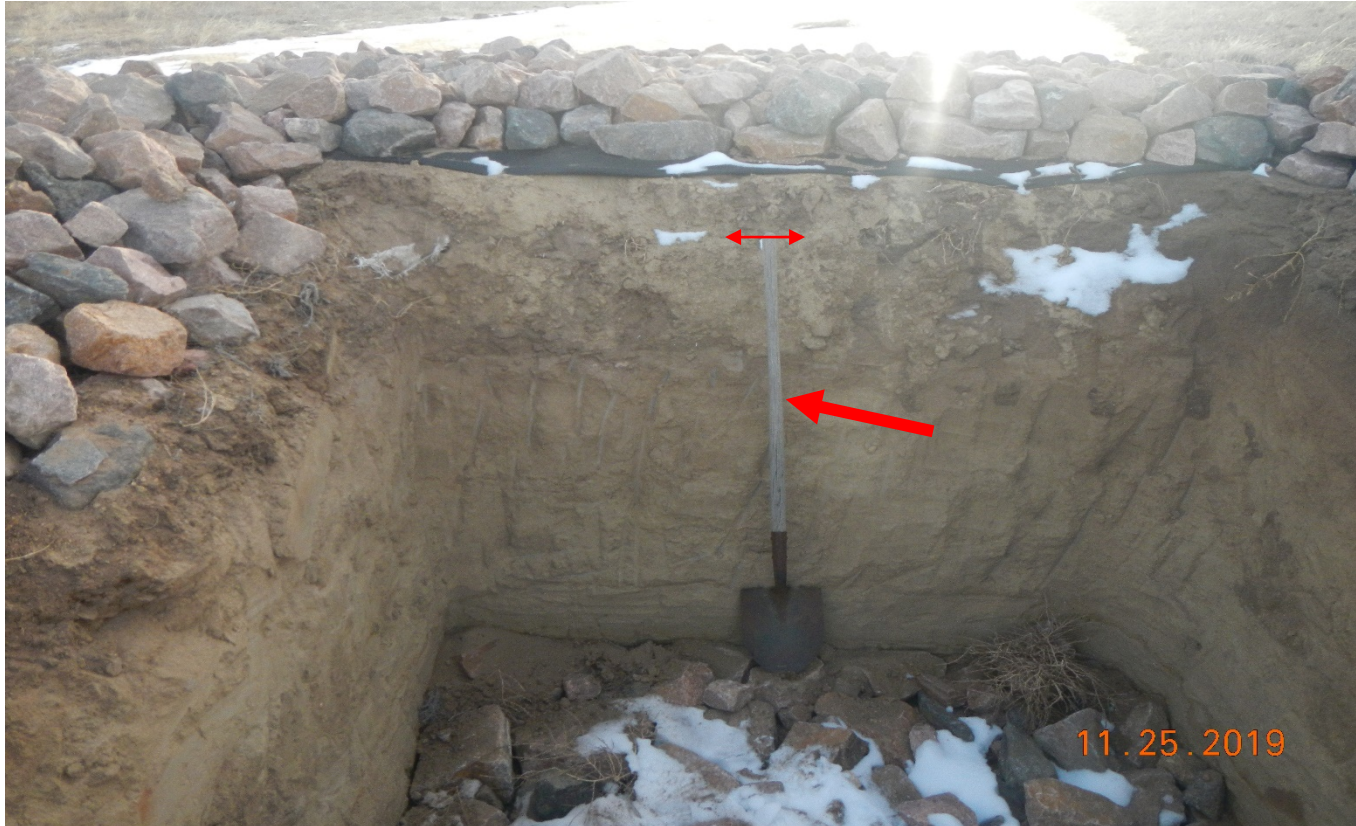
Photo 4. The sediment trap was not installed in accordance to good engineering practice. The arrow points to a 4'8" shovel placed in the sediment trap. The 3 sides of the sediment trap are vertical and per good engineering practice, should not be installed steeper than 2:1 slope.

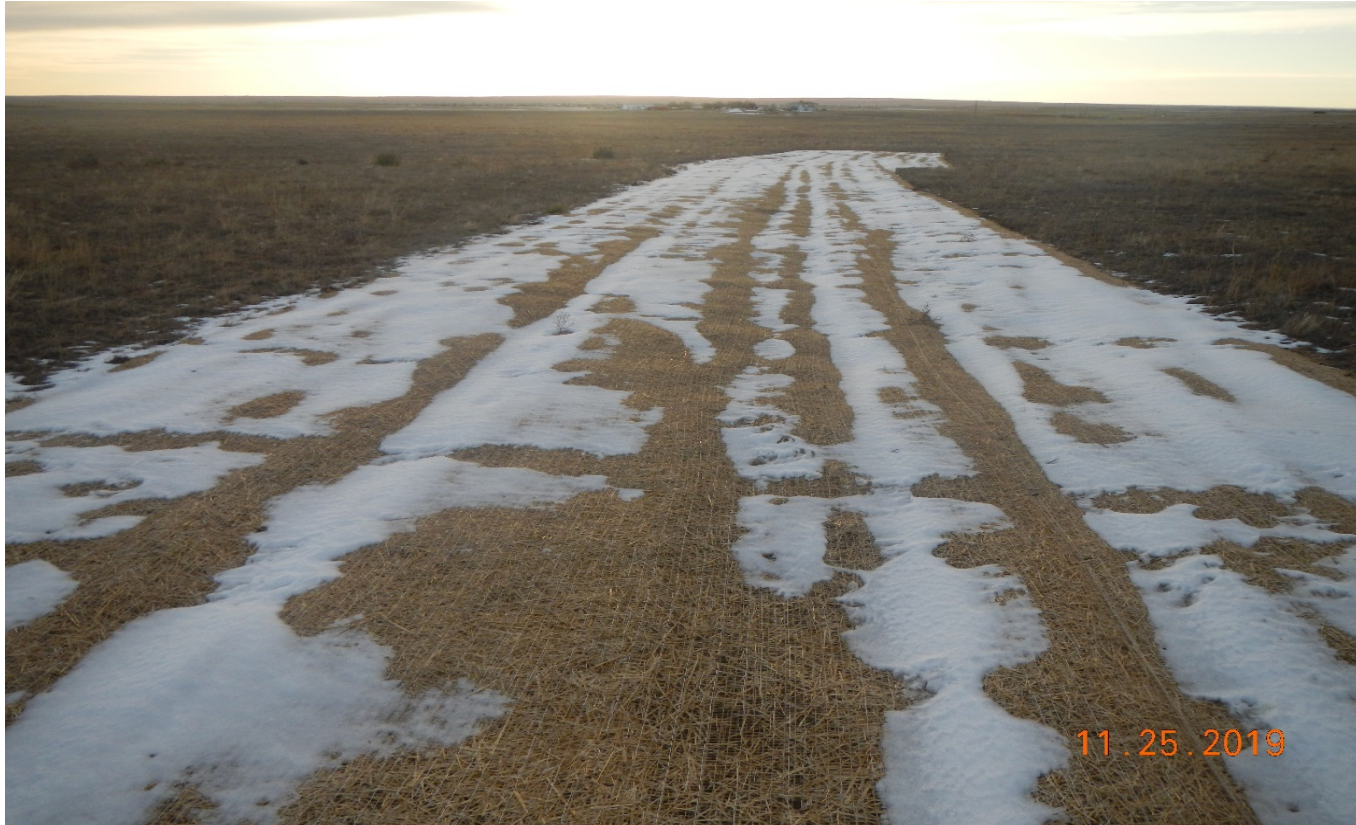
Photo 5. The erosion channel which extended out into the pasture has been reclaimed since the previous inspection. This photo depicts compliance of the corrective action.

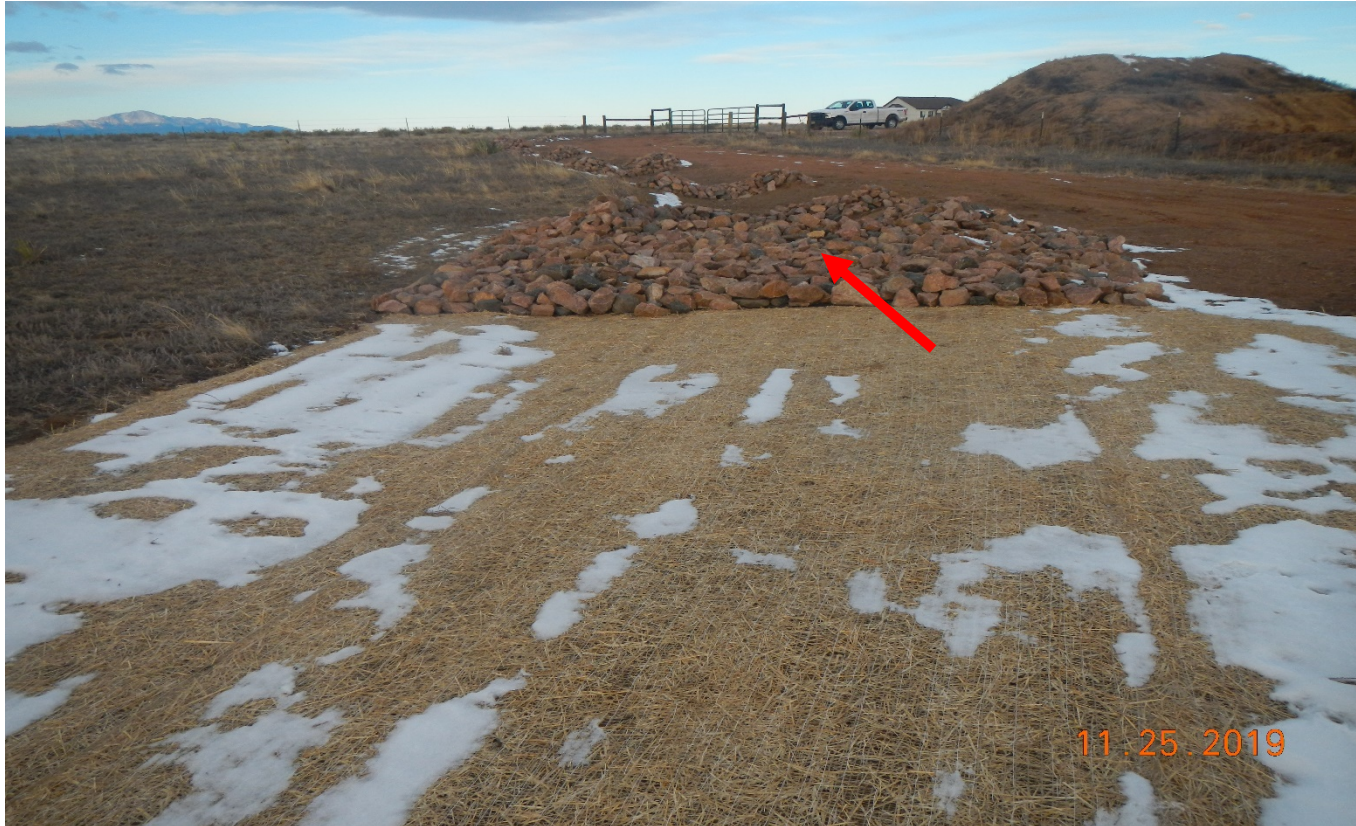
Photo 6. Facing northwest toward the road. Sediment trap is located where red arrow is shown. Rock check dams are installed further up along the road toward the gate.

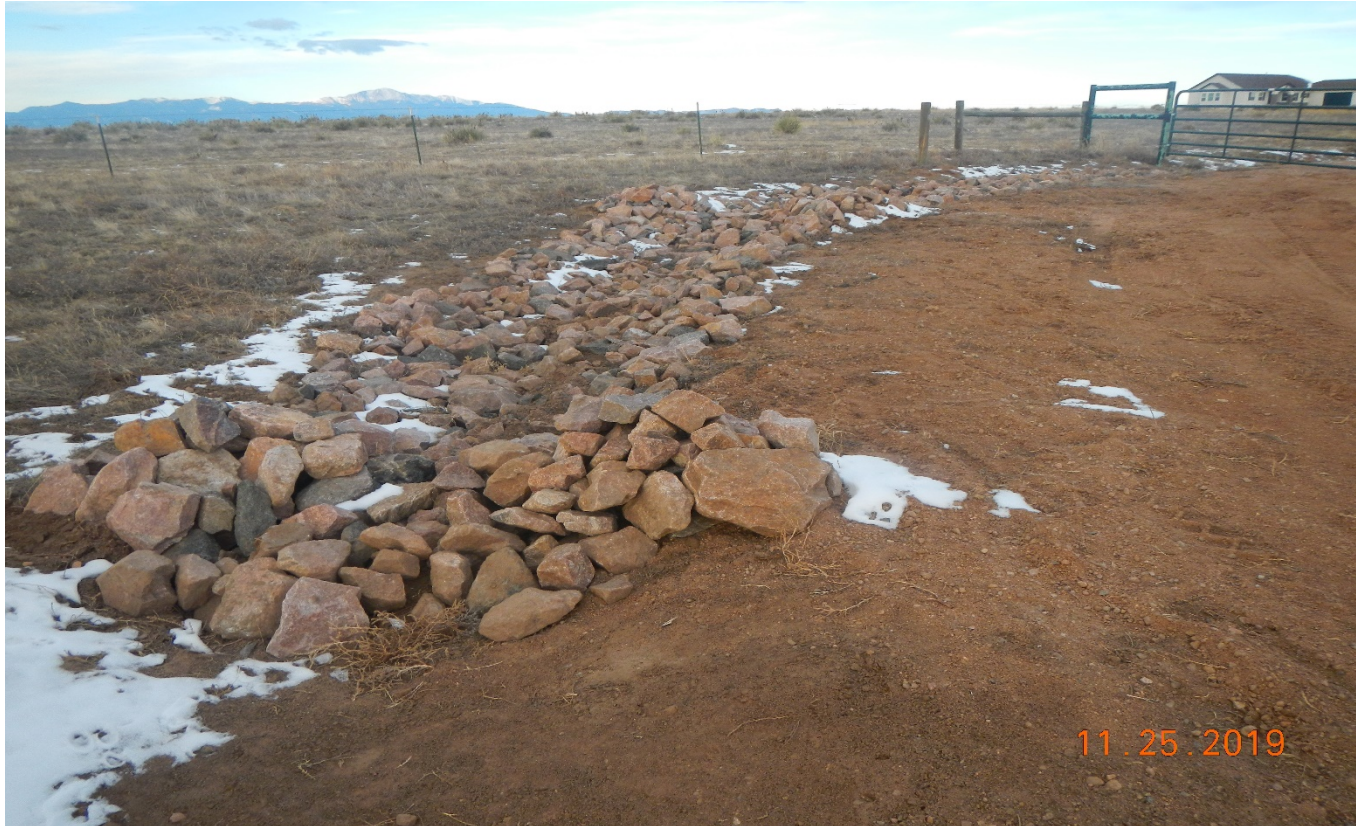
Photo 7. Rock rip/rap was installed along the road near the double gates. This photo depicts compliance of the corrective action.

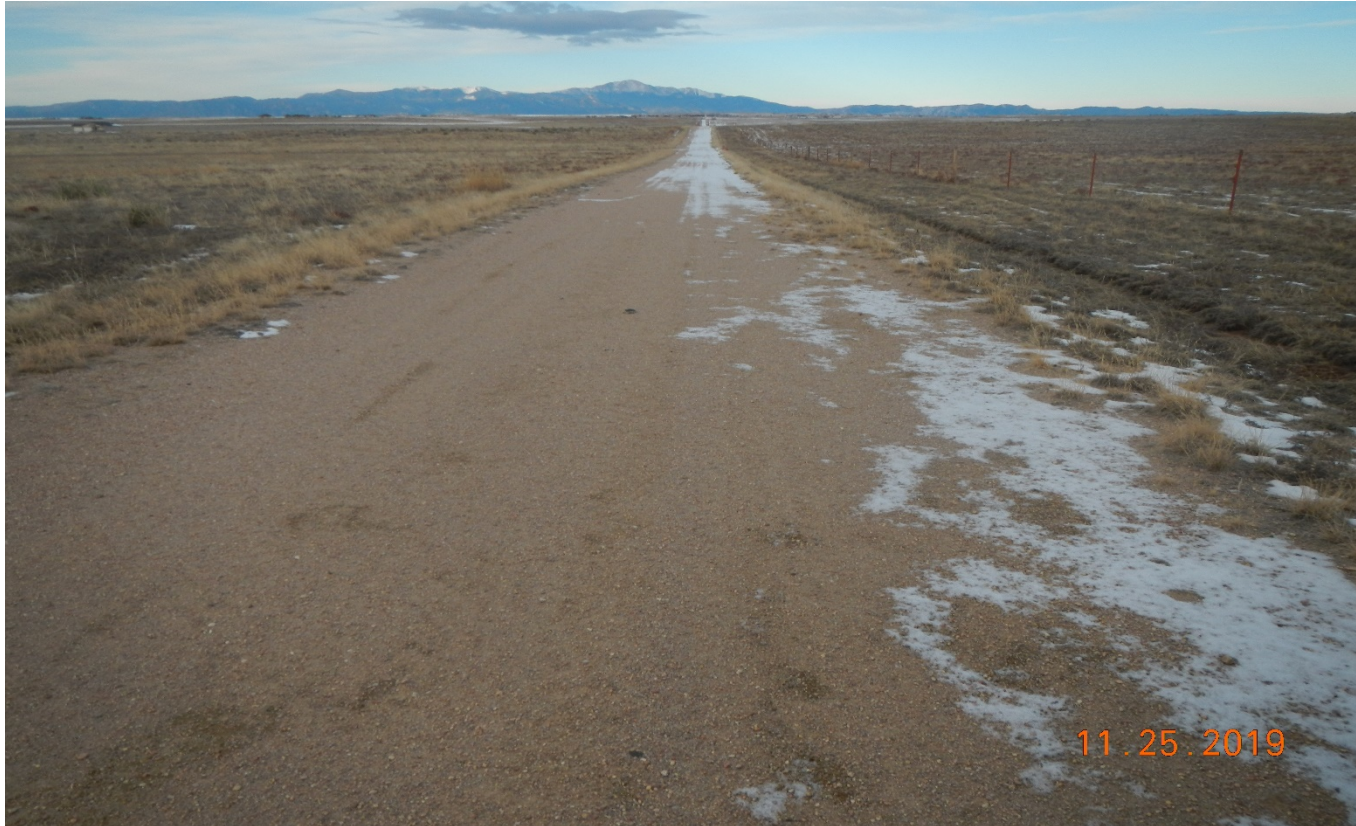
Photo 8. Facing west along the access road.

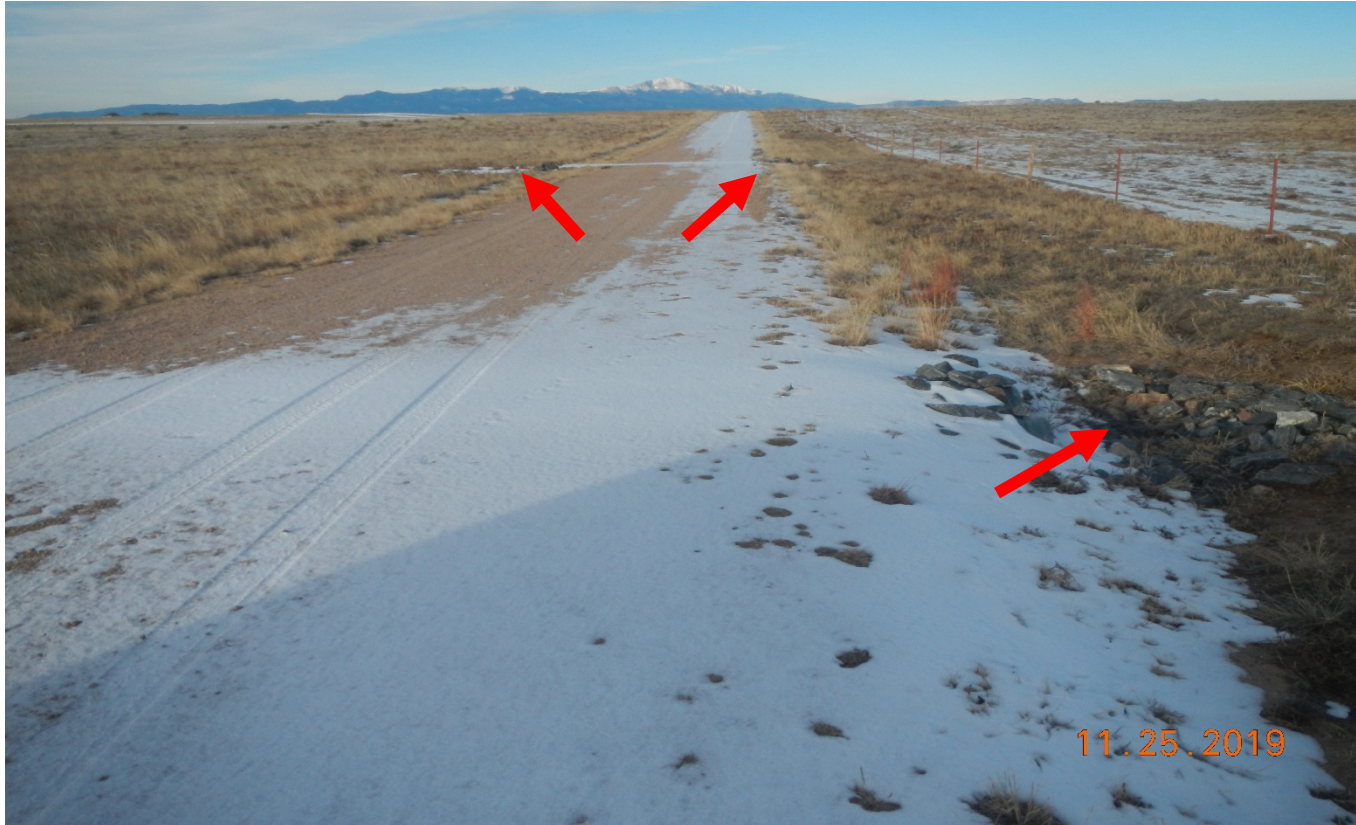
Photo 9. Facing west along the access road . There are culverts at this area of the road with inlet and outlet protection installed shown by red arrows. This photo depicts compliance of the corrective action.

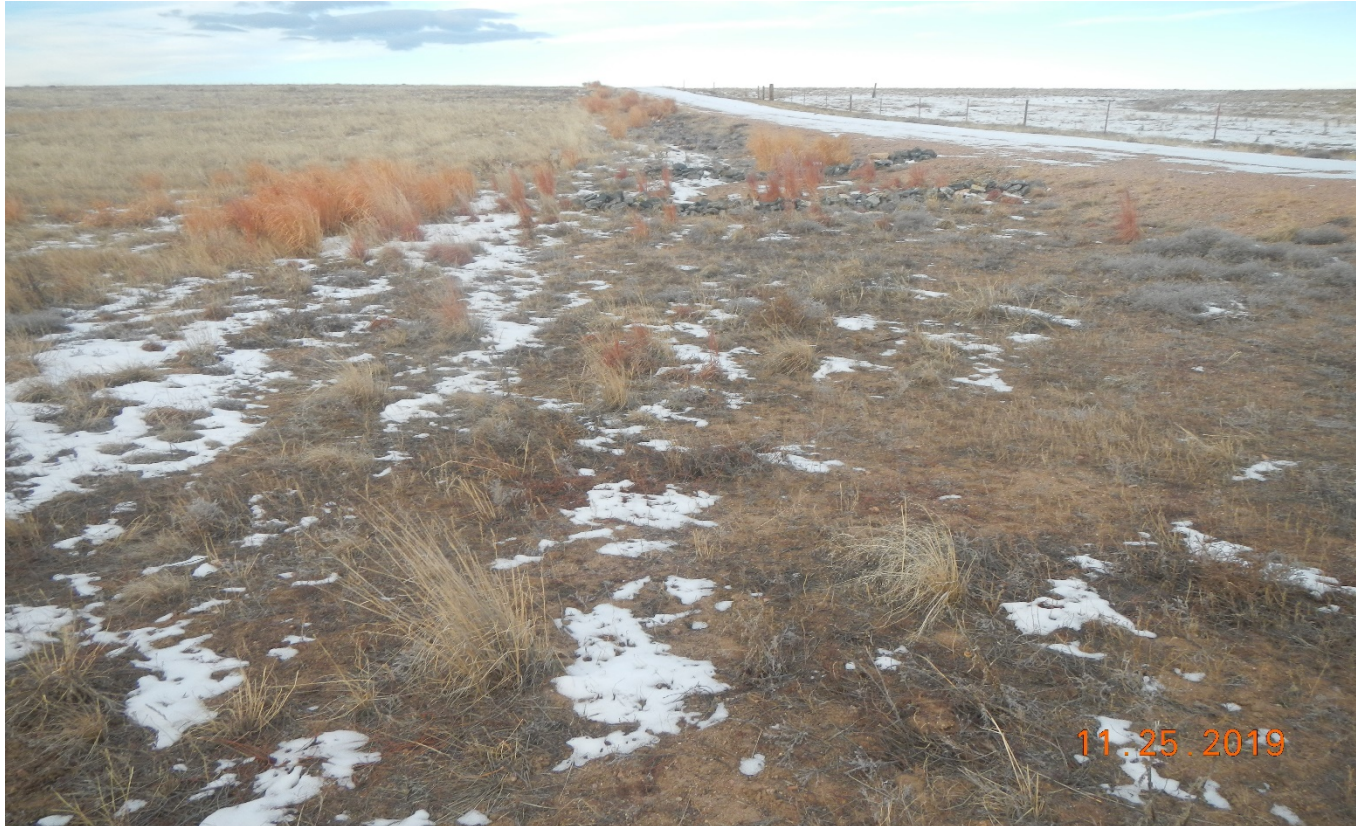
Photo 10. Vegetation is beginning to establish along the side of the access road where seeding was performed during previous growing season. This area has not met the revegetation standard and needs to be monitored for successful revegetation.

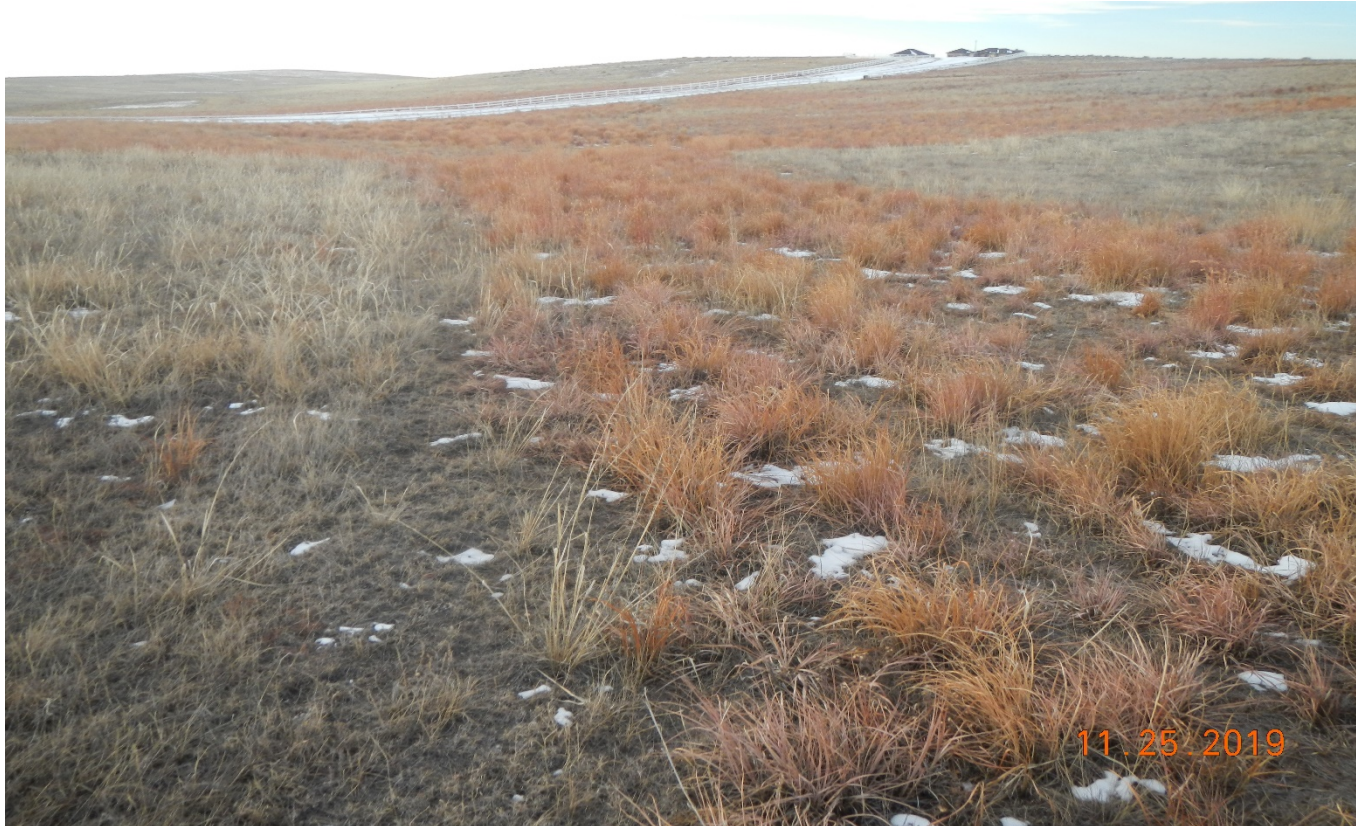
Photo 11. Facing south toward the reclaimed access road and location.

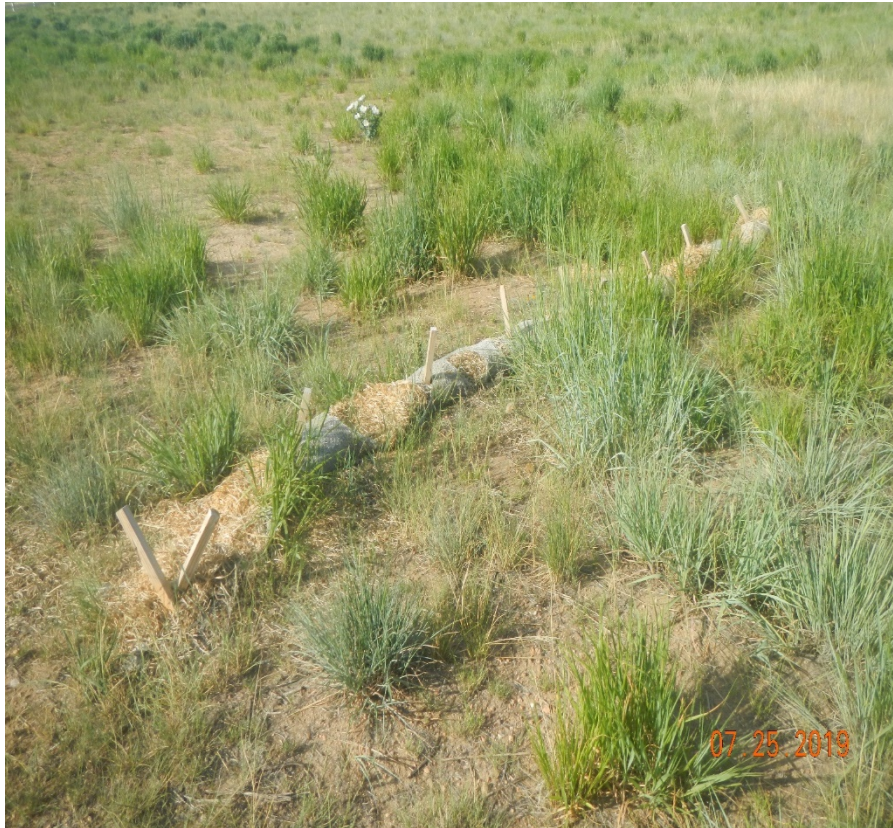
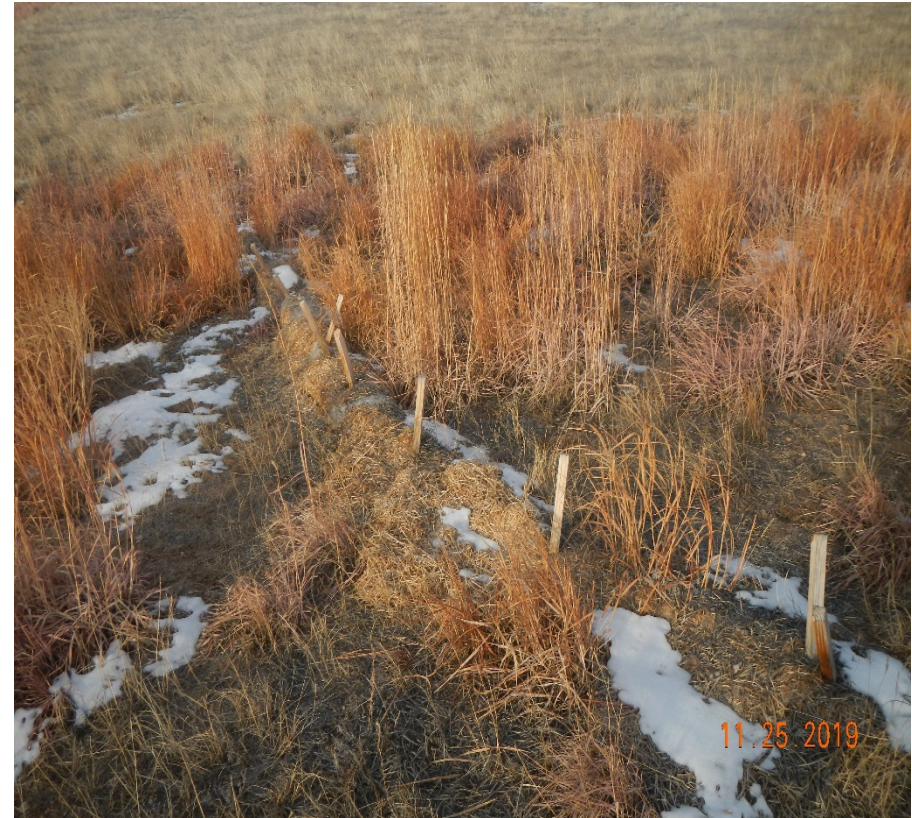
Photo 12. Wattles installed at the location have degraded and need to be removed or replaced. The left photo shows the wattles in the previous inspection on 7/25/2019. The right photo taken 11/25/2019 shows the same degraded wattles remain. The photos depict noncompliance of the corrective action.

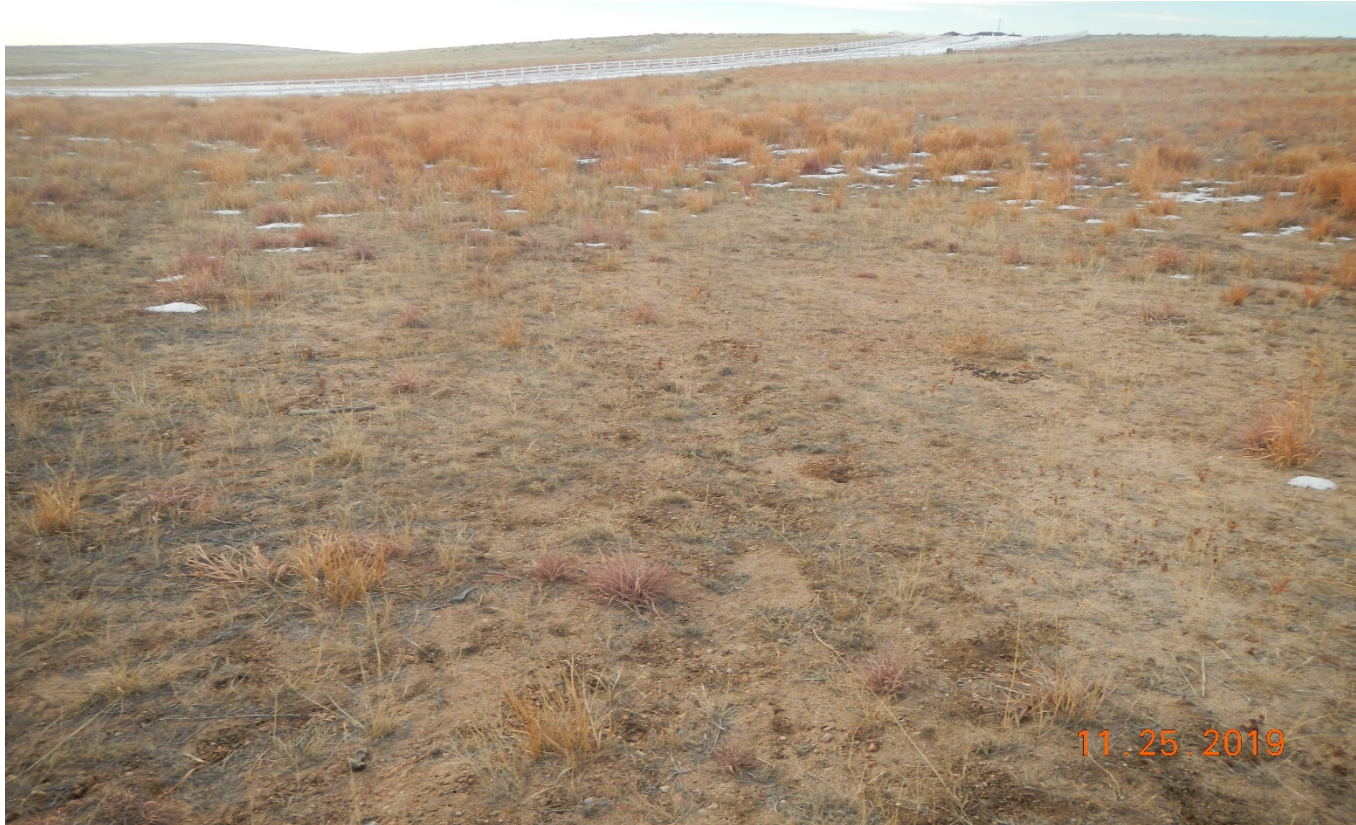
Photo 13. Facing southwest at the location. Vegetation is beginning to establish in this area where seeding was performed during previous growing season. This area has not met the revegetation standard and needs to be monitored for successful revegetation.

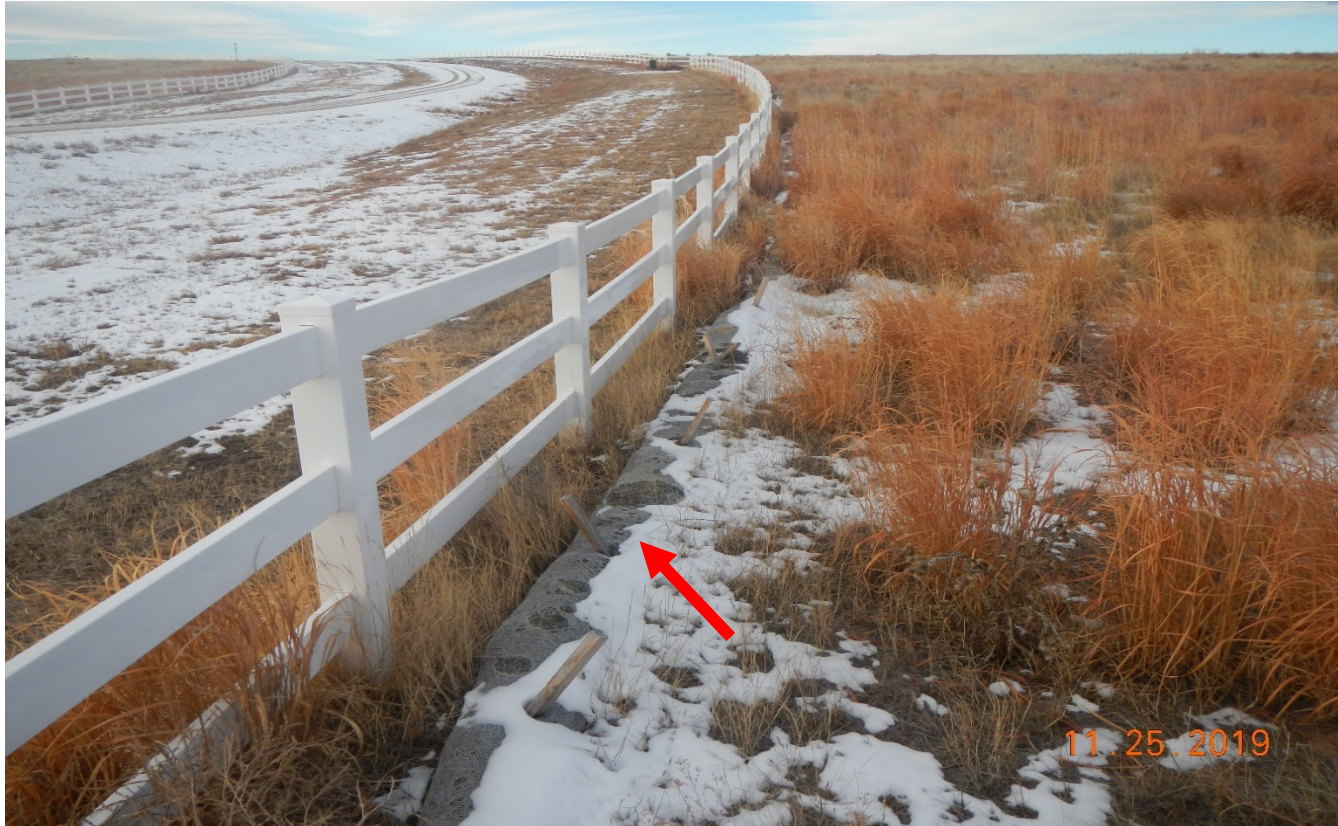
Photo 14. The degraded wattles have not been removed since the previous inspection. The photo depicts noncompliance of the corrective action.

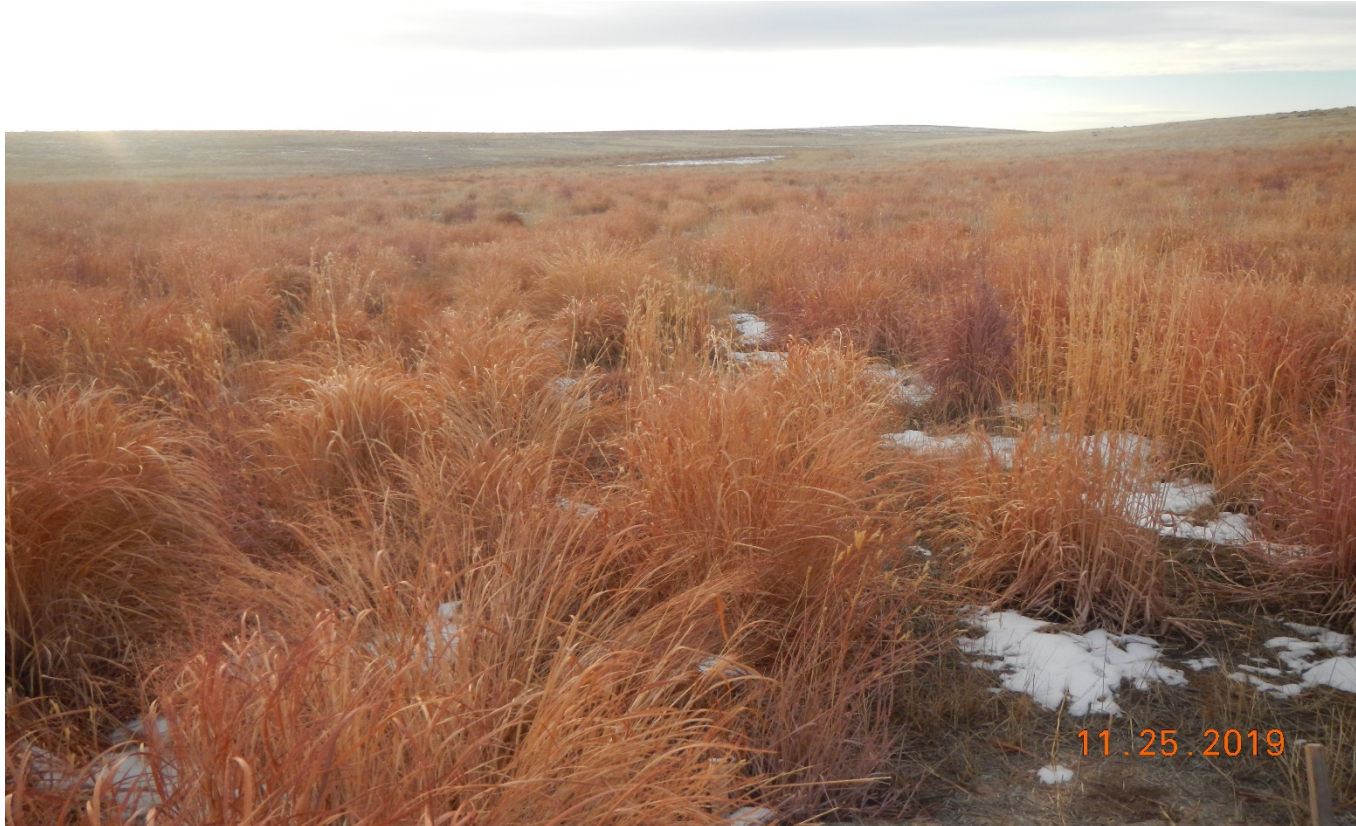
Photo 15. Vegetation is well established at the southern portion of the location.

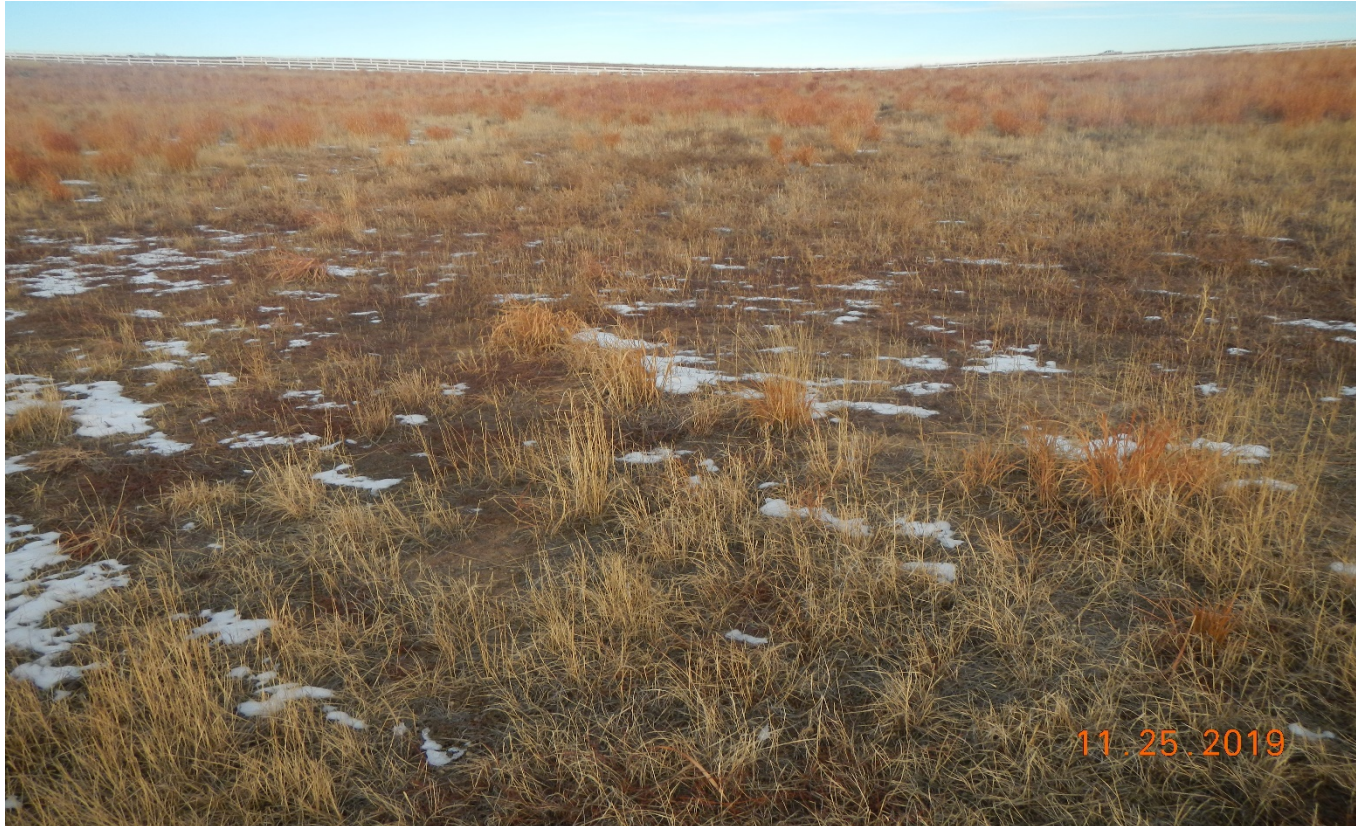
Photo 16. Facing northwest at the southern portion of the location. This area was reseeded and vegetation is establishing. This photo depicts compliance of the corrective action, however this area needs to be monitored for successful revegetation.

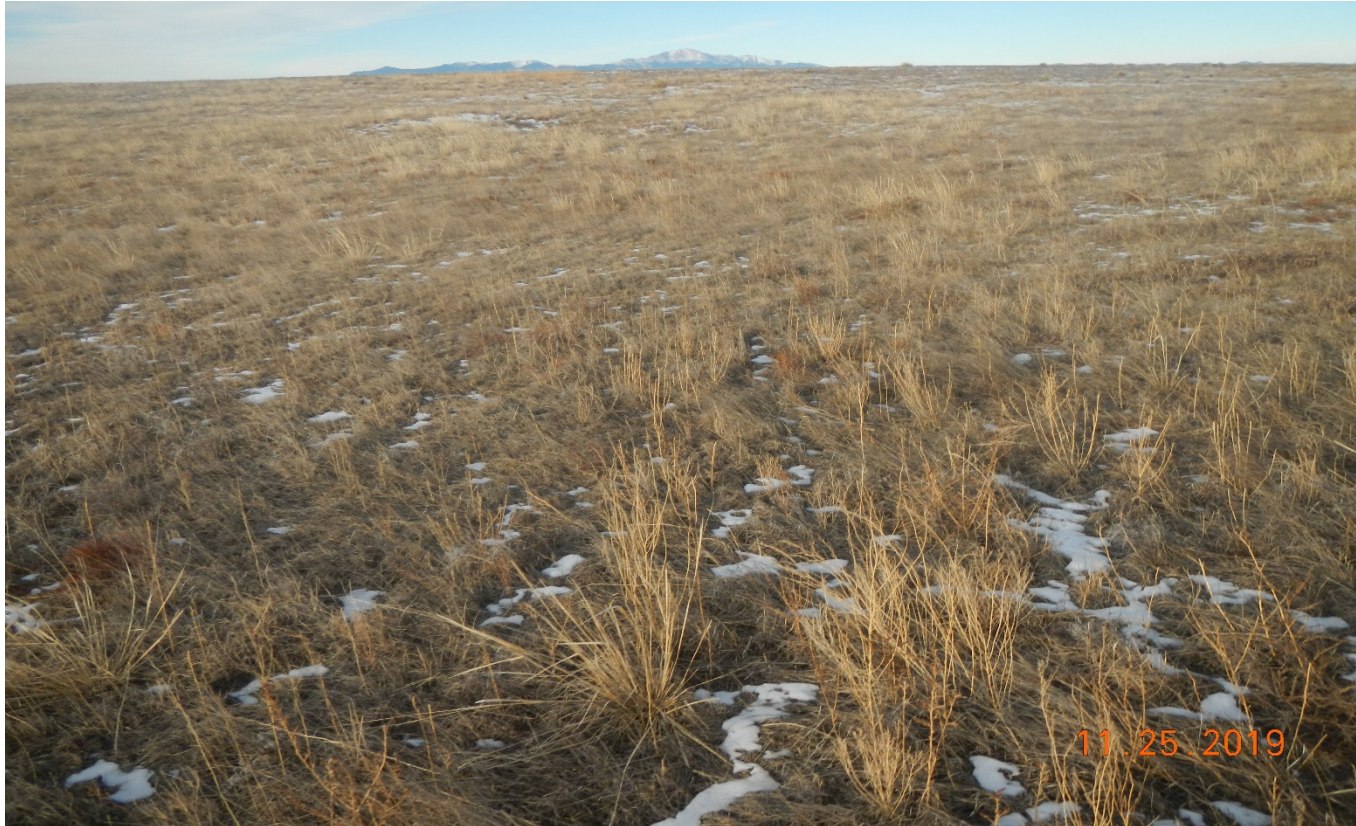
Photo 17. Facing west toward the undisturbed reference area.
