Inspection Photos

11/25/2019

Operator: WESTERN OPERATING COMPANY -
95620

Location ID: 312291
Logan County, CO

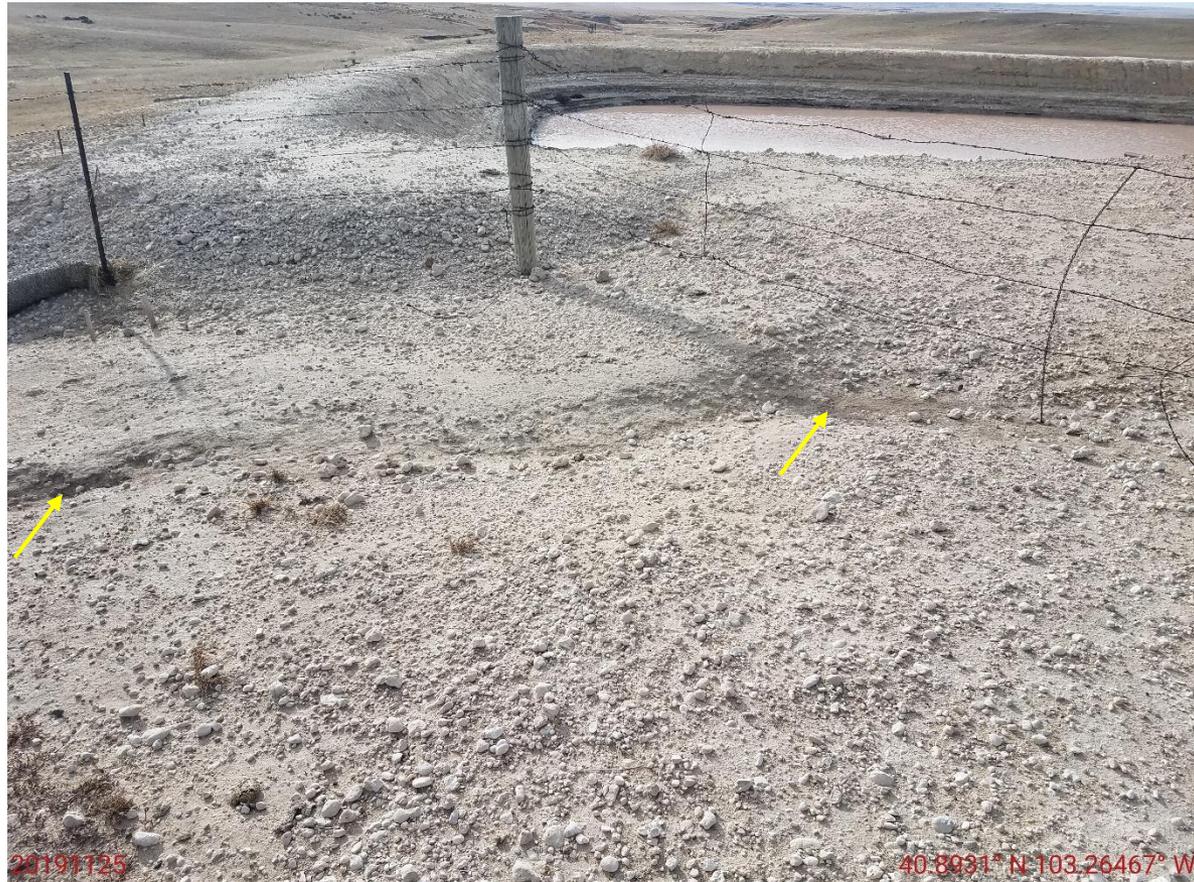
Photo 1: Photo taken from the east end of the location, facing south. Photo shows stormwater erosion degradation has been allowed to continue on the location.

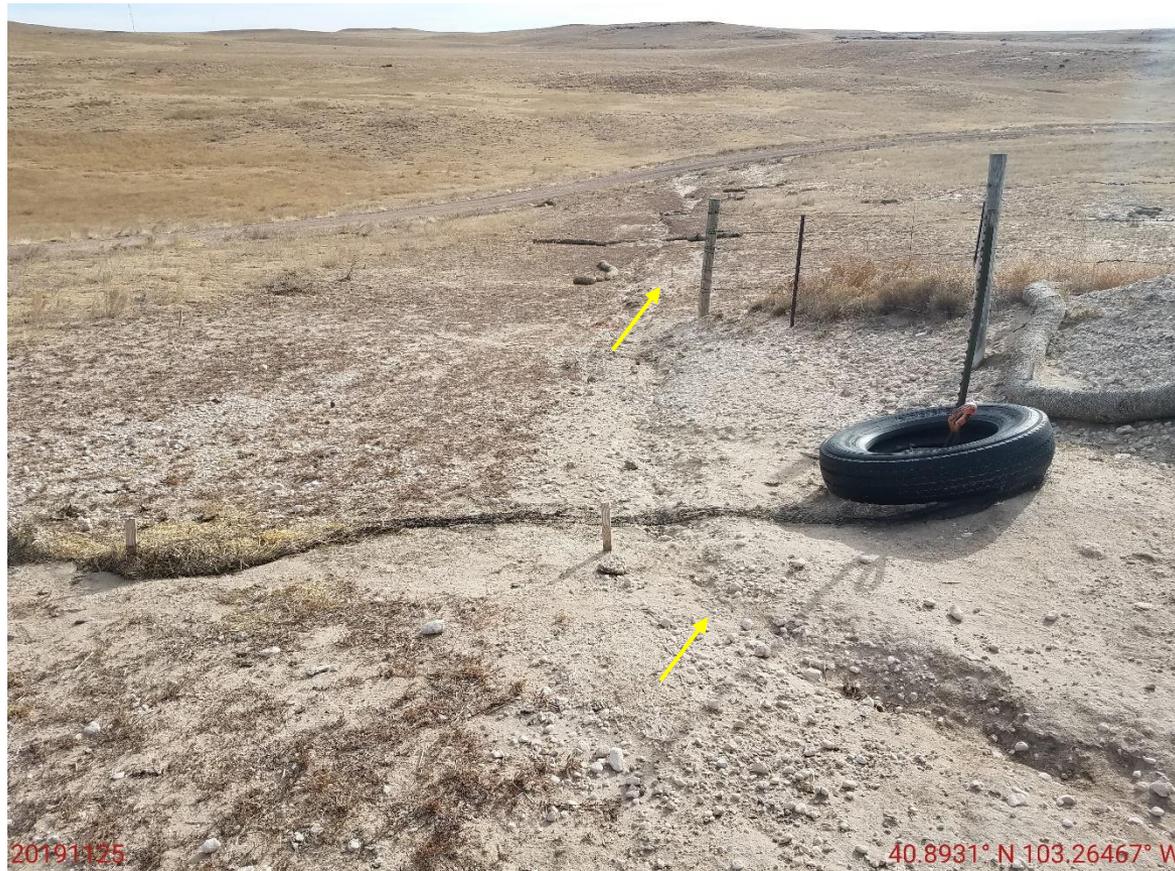
Photo 2: Continued from photo 1. Photo facing east. Photo shows stormwater erosion degradation has been allowed to continue on the location. Photo also shows wattles in disrepair and that no additional BMPs to stabilize the soils have been installed per corrective actions and 1002.f.

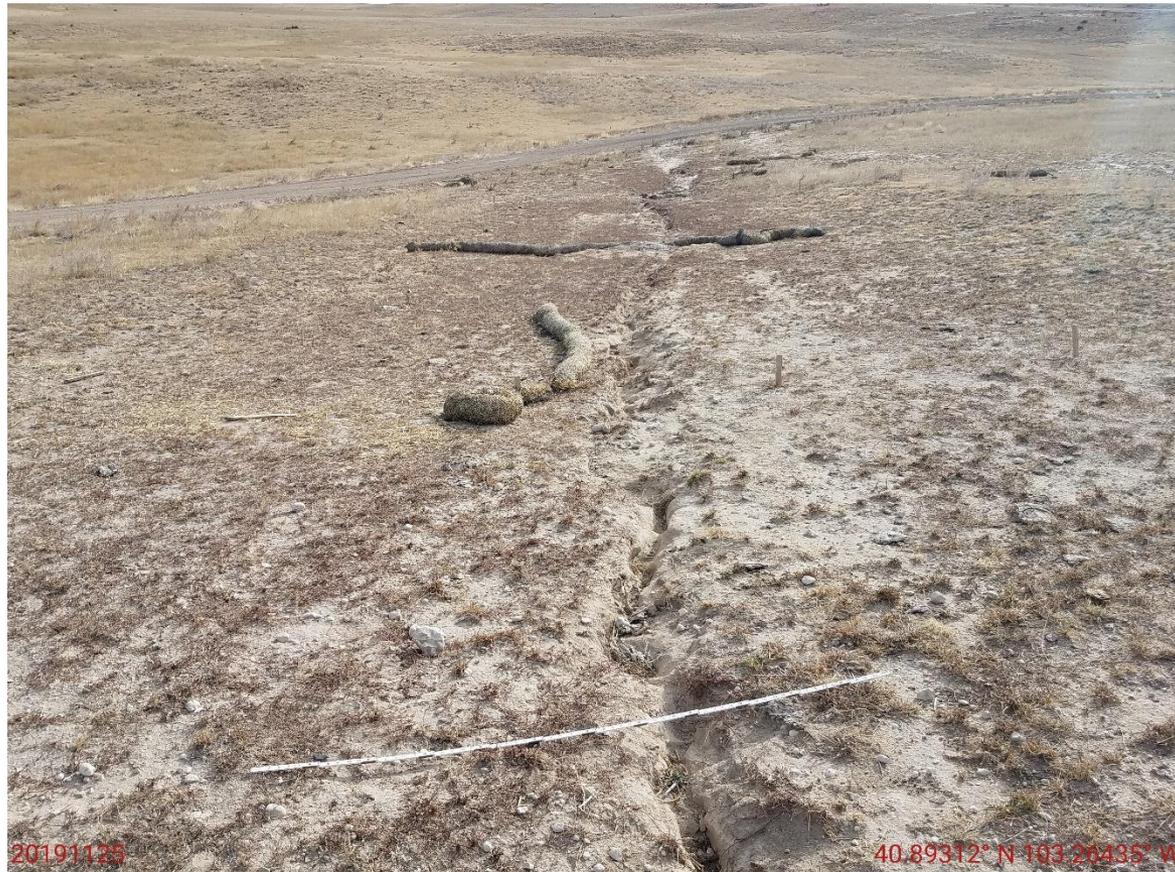
Photo 3: See comments under photo 2. 6 foot measuring stick for reference.

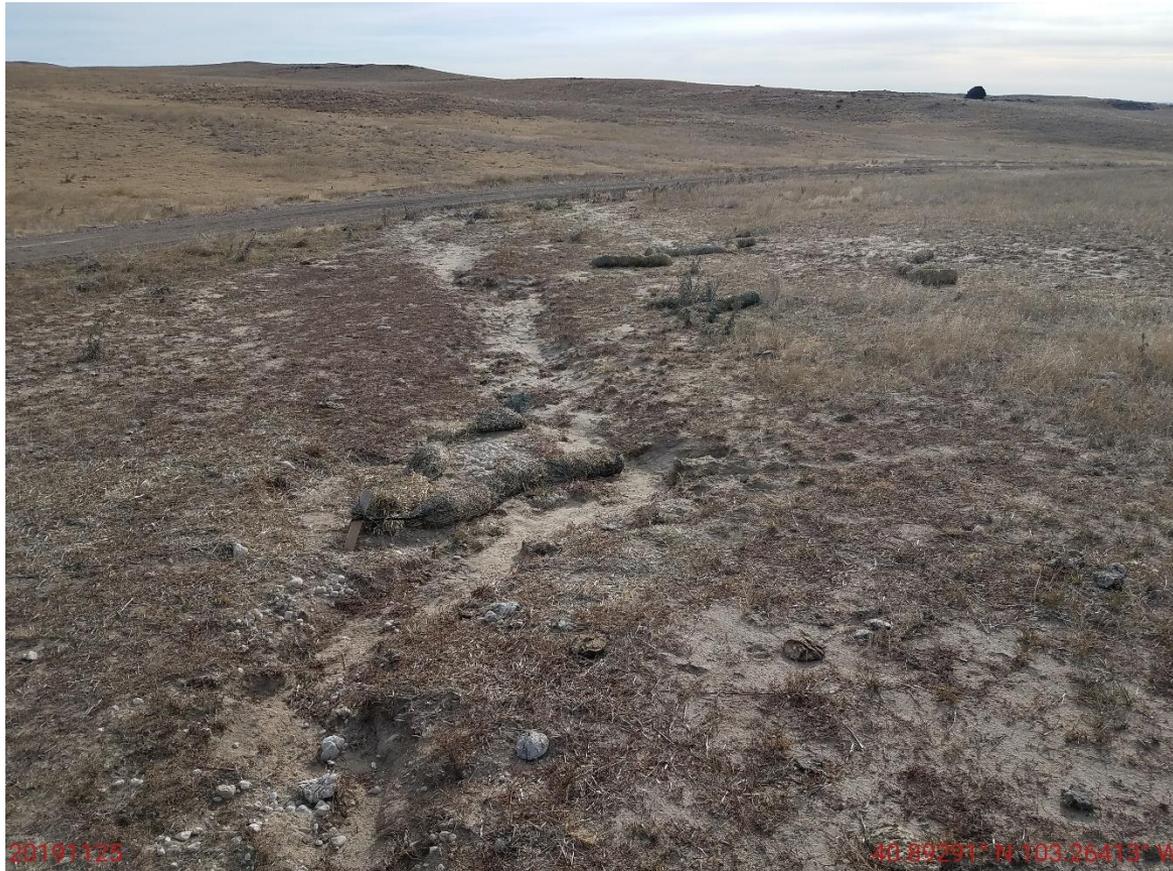
Photo 4: See comments under photo 3.

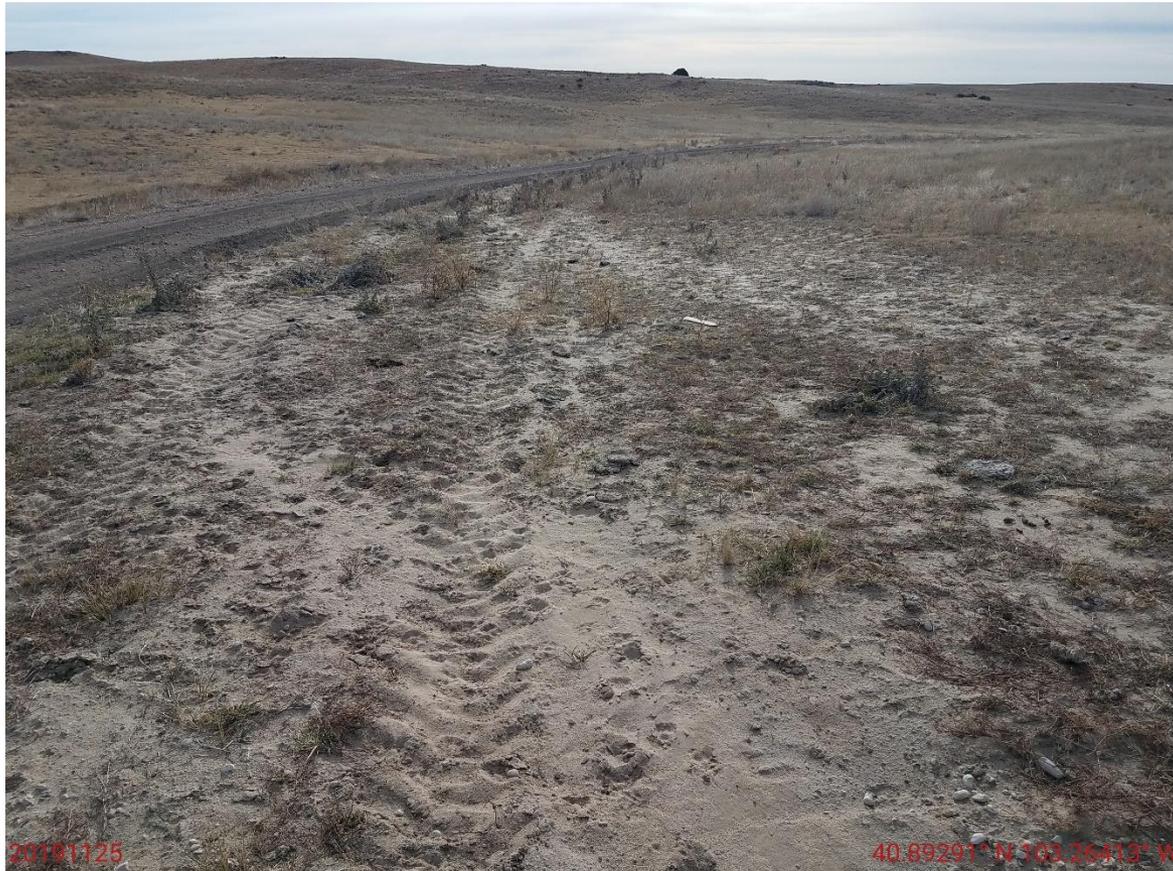
Photo 5: Photo taken from the east of the location, facing southeast. Photo shows sediment deposition due to sediment laden stormwater discharge from the location and unstabilized slopes.

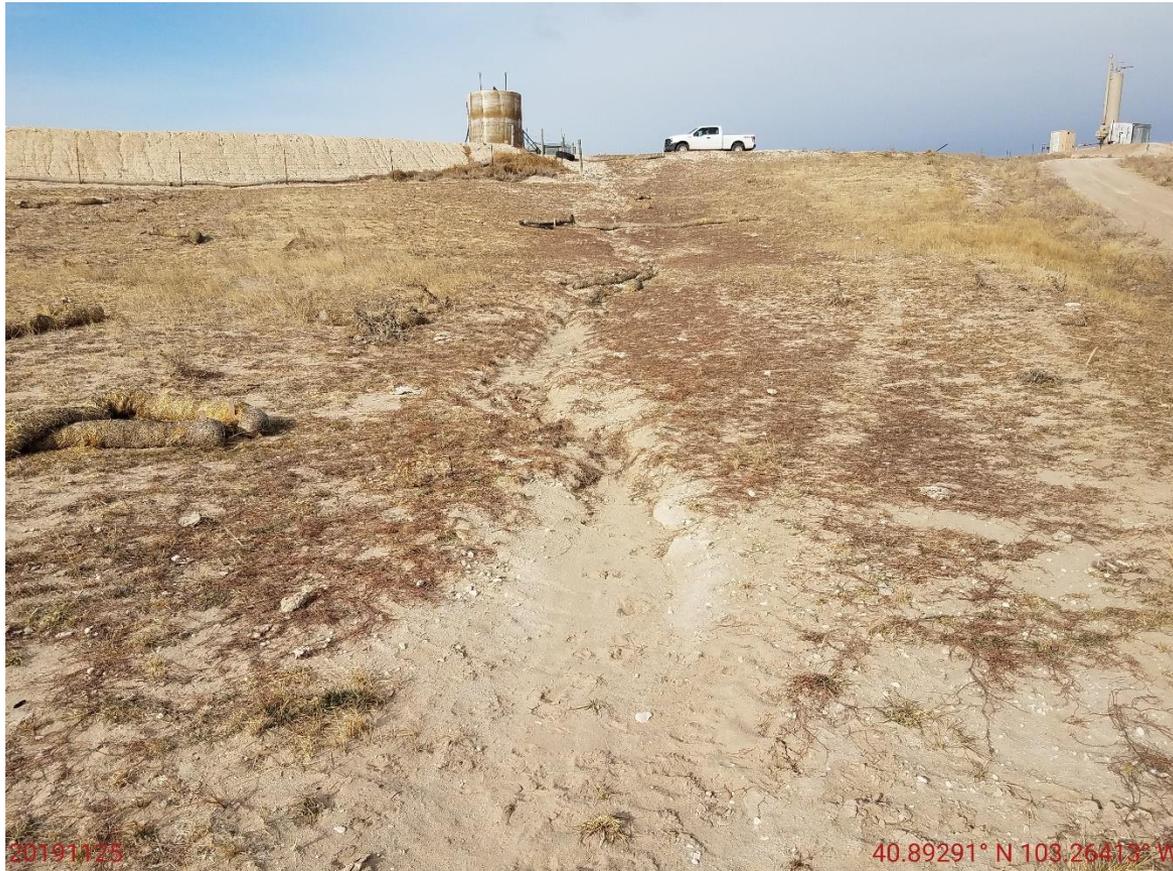
Photo 6: See comments under photo 4.

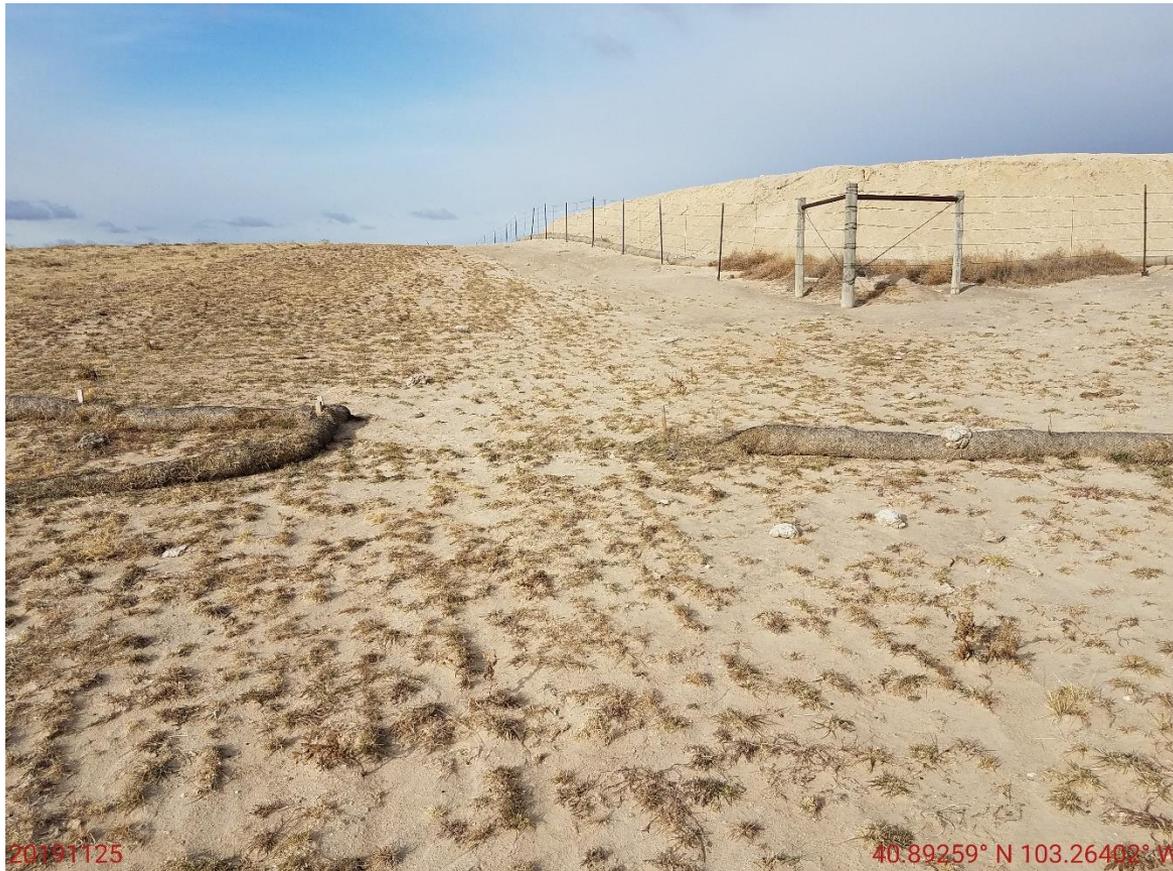
Photo 7: Photo taken from the southeast end of the pit, facing west. Photo shows straw wattles in disrepair; Operator failed to install BMP in accordance with good engineering practices.

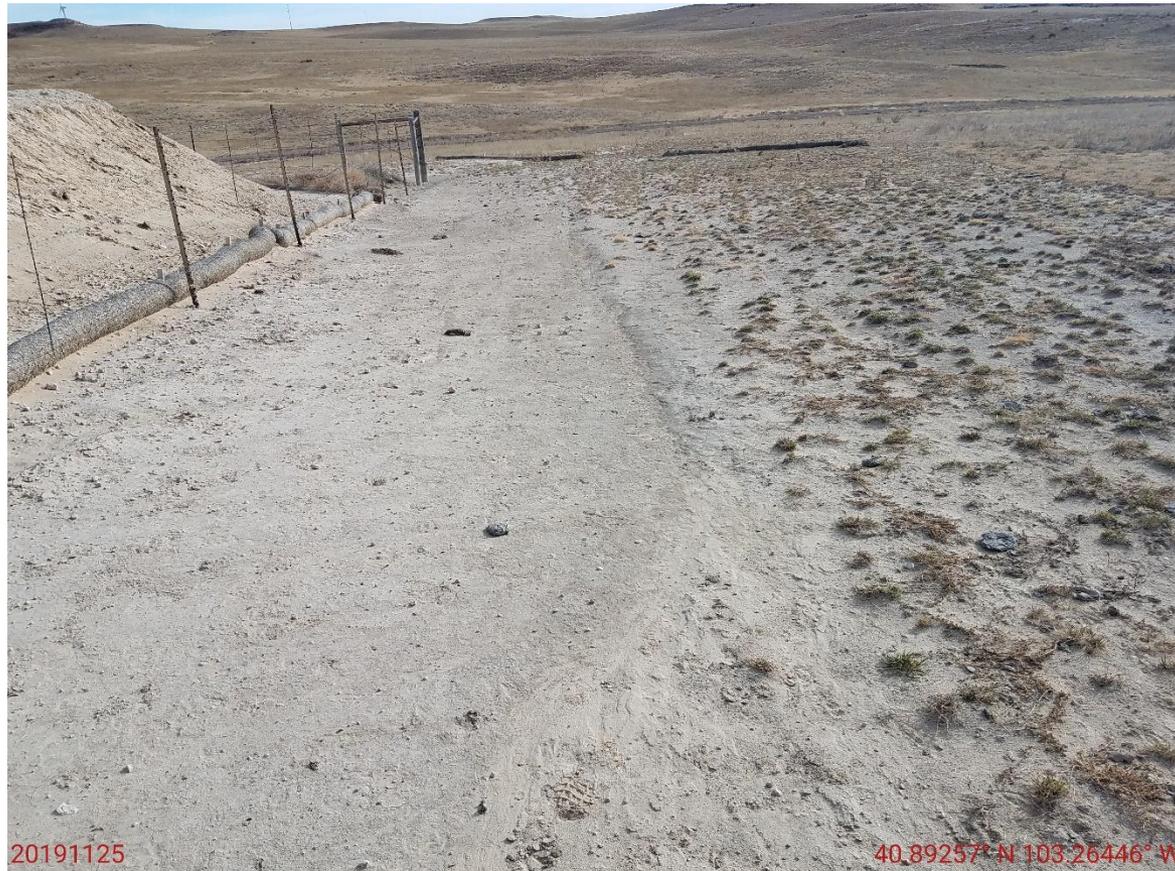
Photo 8: Photo taken from the south end of the pit, facing west. Photo shows areas where vegetative establishment is not occurring. Impacted soils likely remain.

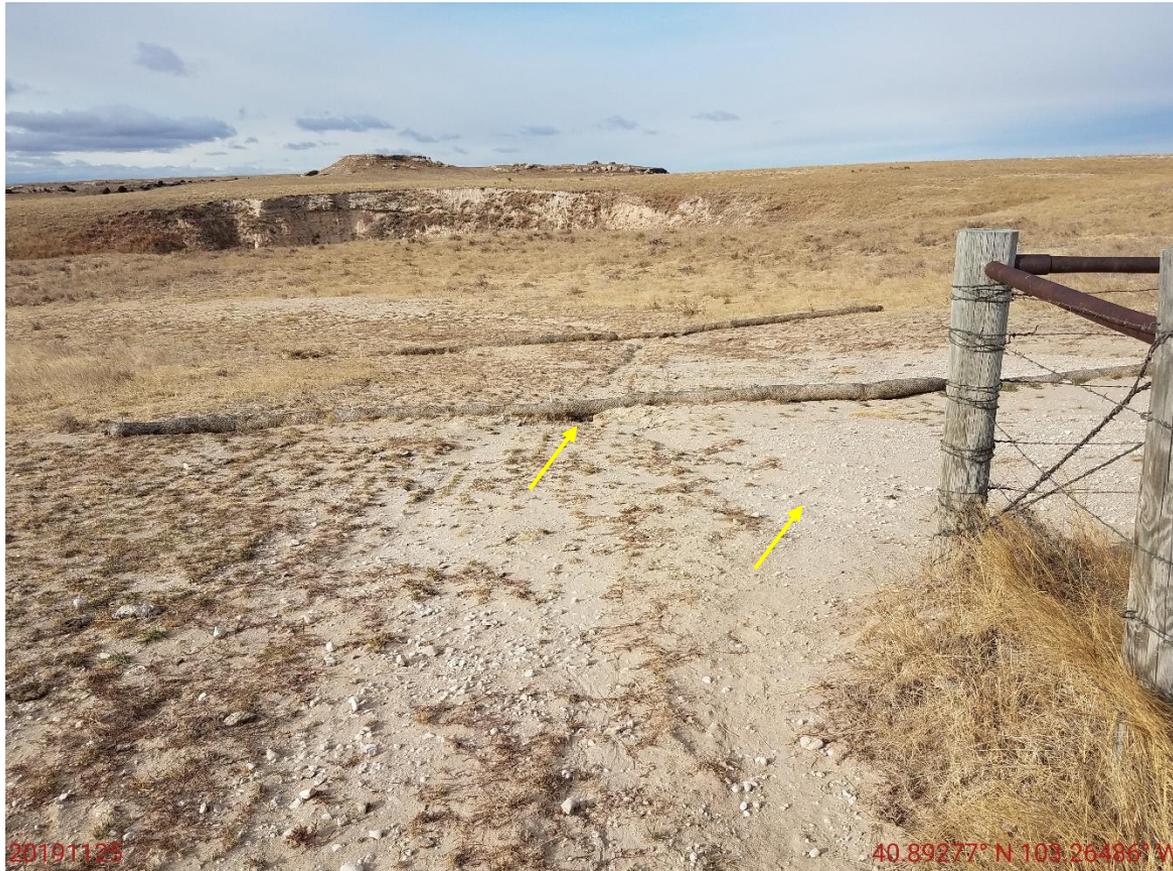
Photo 9: Photo taken from the southwest end of the pit, facing west. Photo shows areas where desirable vegetative establishment is not occurring, and erosion degradation.

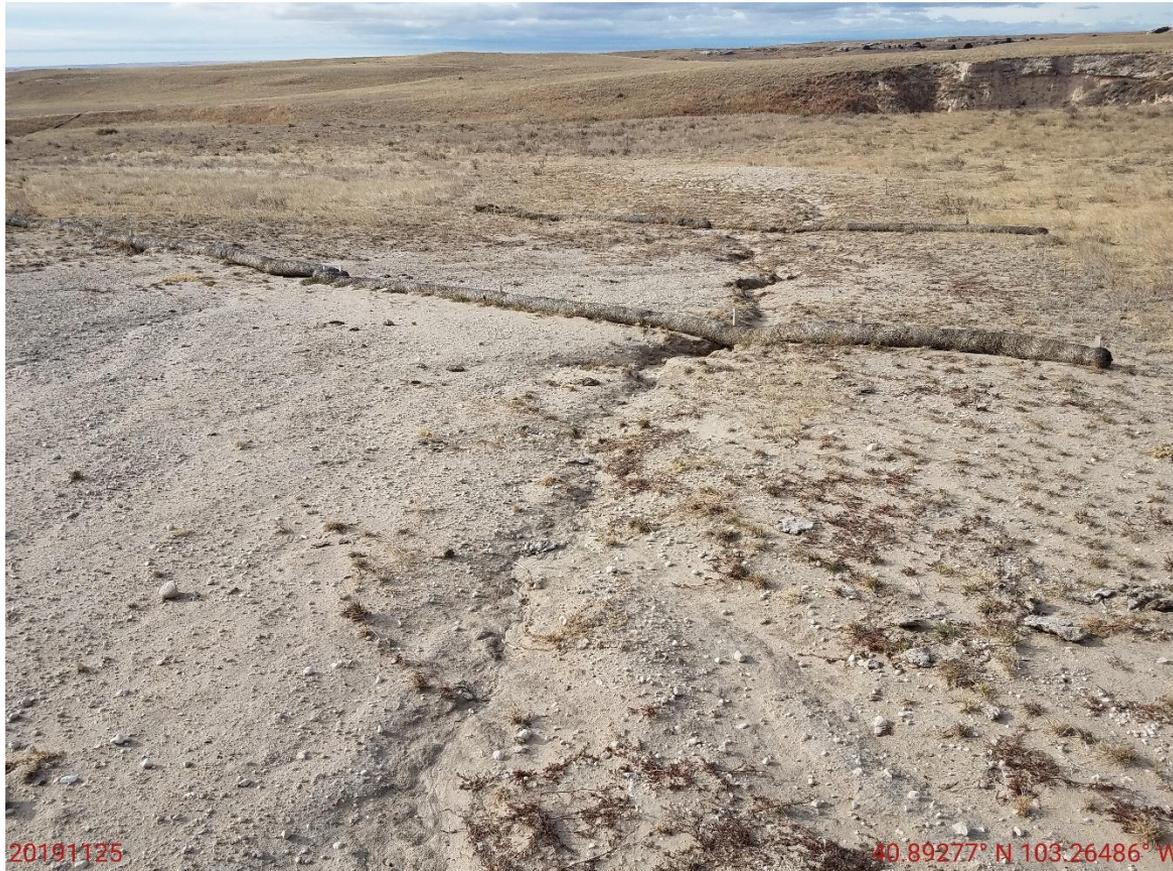
Photo 10: Continued from photo 9.

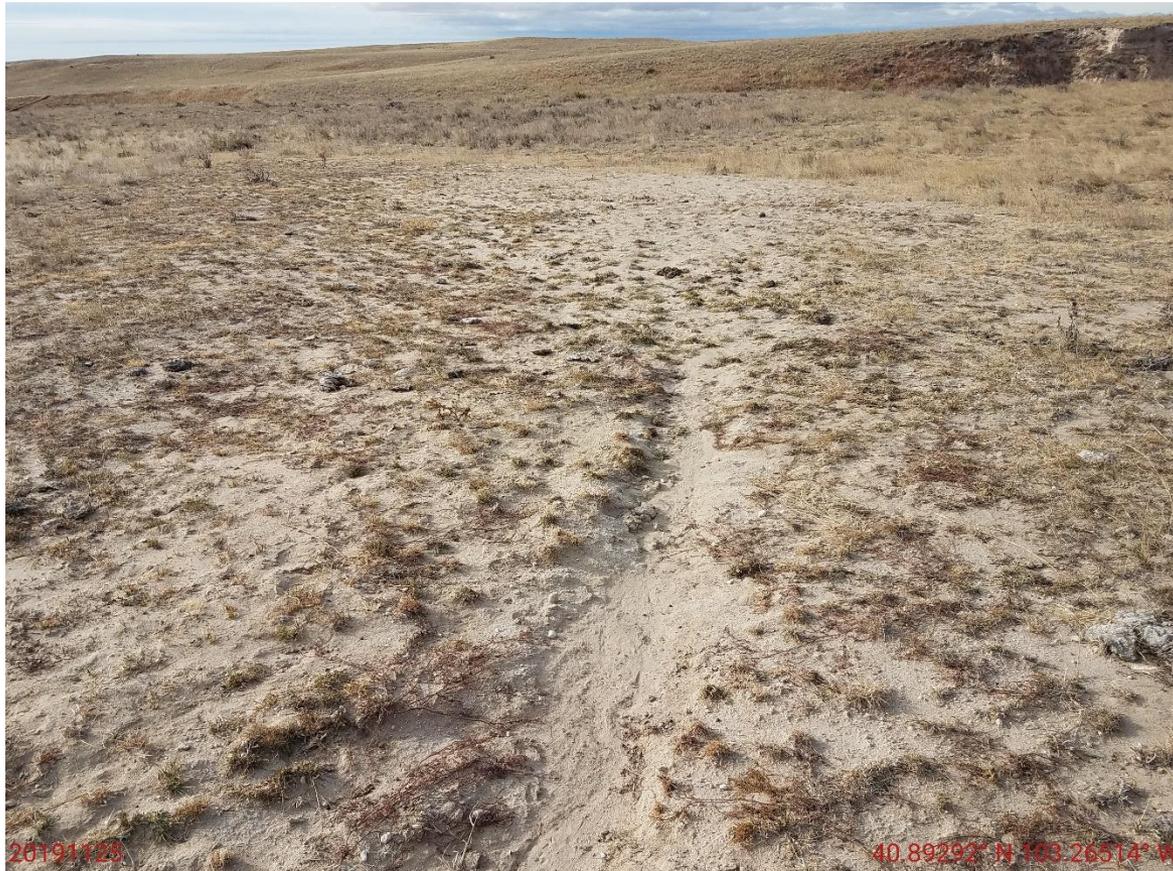
Photo 11: Photo taken from the southwest end of the pit, facing southwest. Photo shows erosion degradation and sediment deposition onto the adjacent lands.

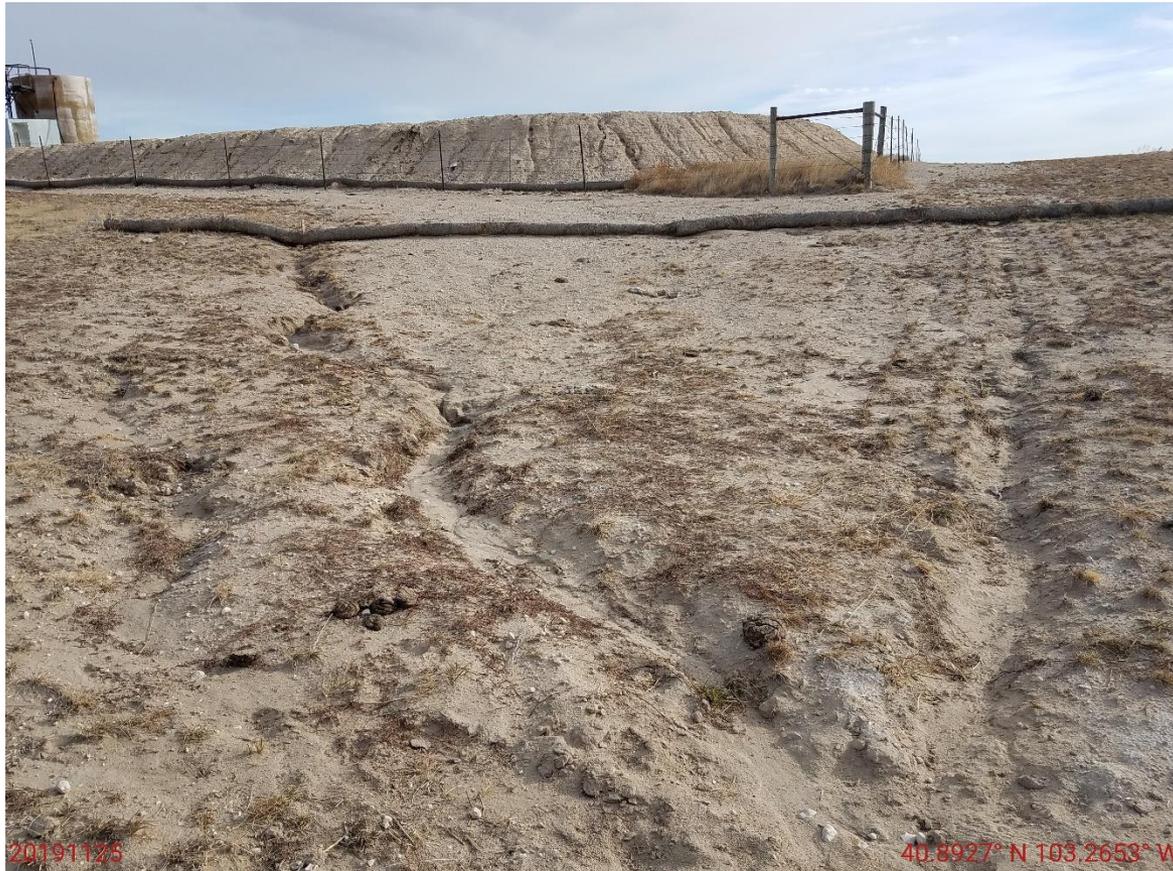
Photo 12: Photo taken from the southwest end of the pit, facing east. Photo shows erosion degradation.

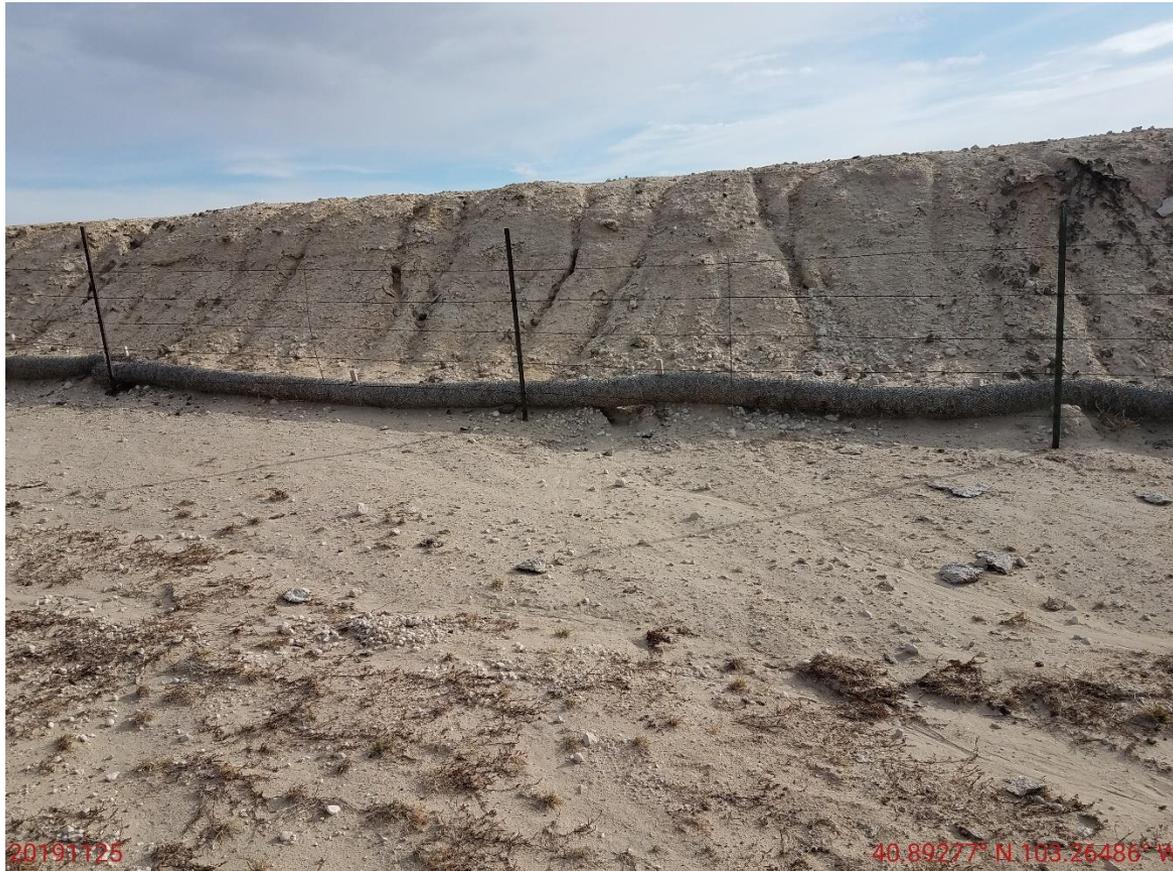
Photo 13: Photo taken from the southwest end of the pit, facing east. Photo shows erosion degradation and wattles in improper functioning condition.

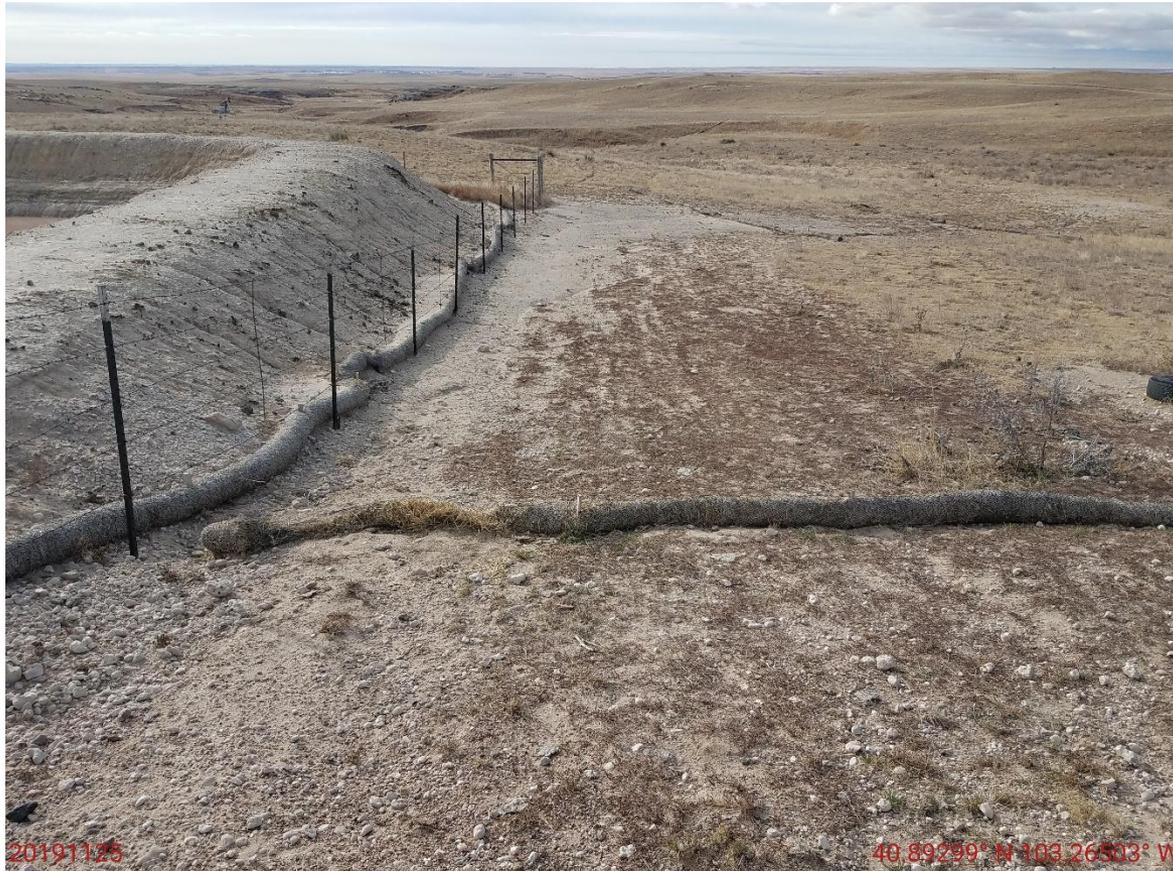
Photo 14: Photo taken from the southwest end of the location, facing south. Photo shows areas where desirable vegetative establishment is not occurring, and erosion degradation.

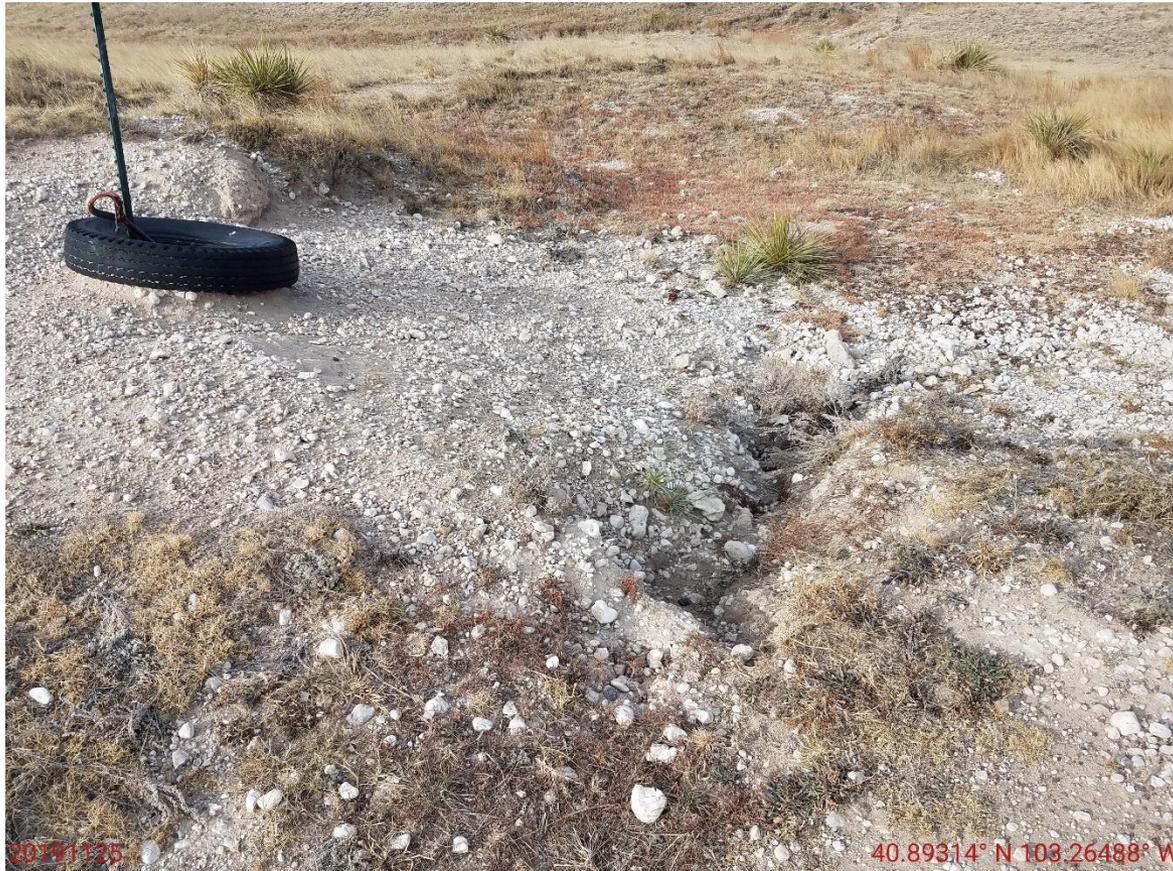
Photo 15: Photo taken from the west end of the location. Photo shows erosion degradation has not been repaired or stabilized.

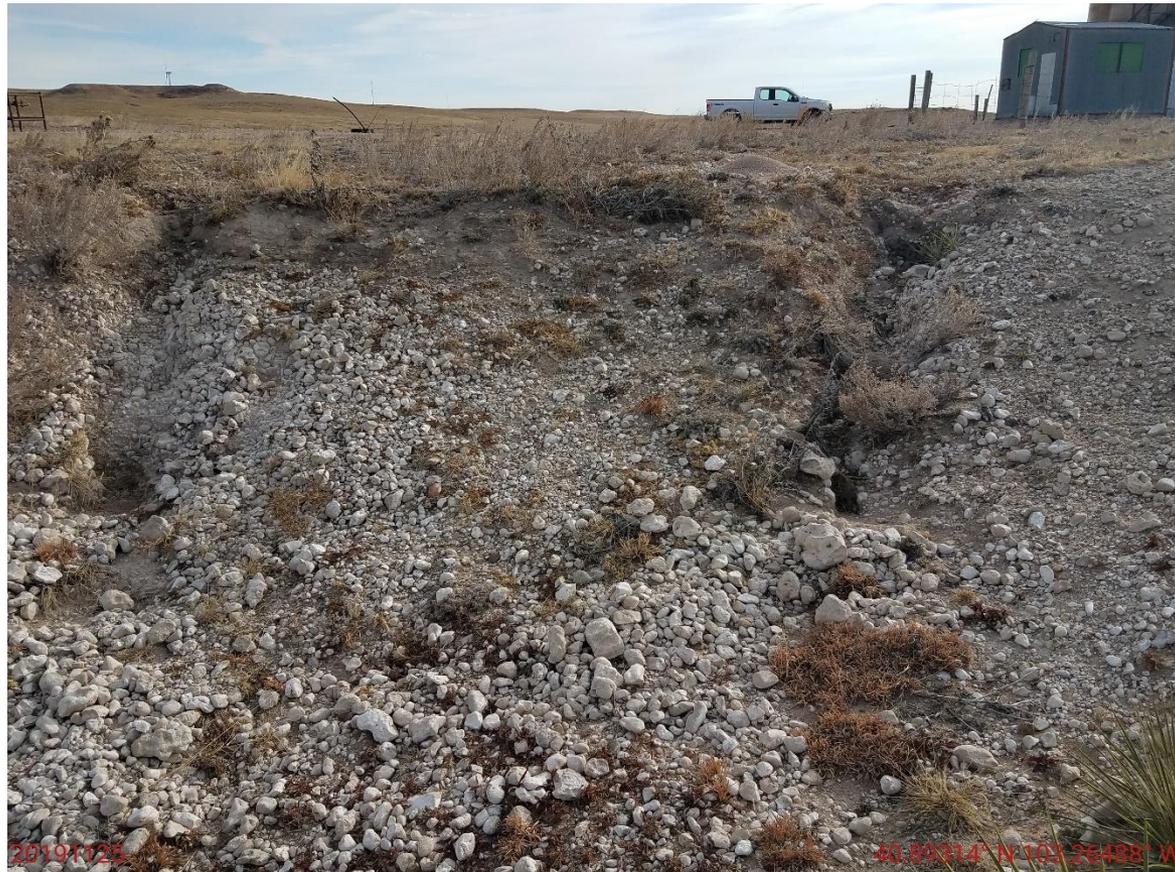
Photo 16: Continued from photo 15.
