Inspection Photos
Location Name: Fitzhugh #6
API: 05-007-05038

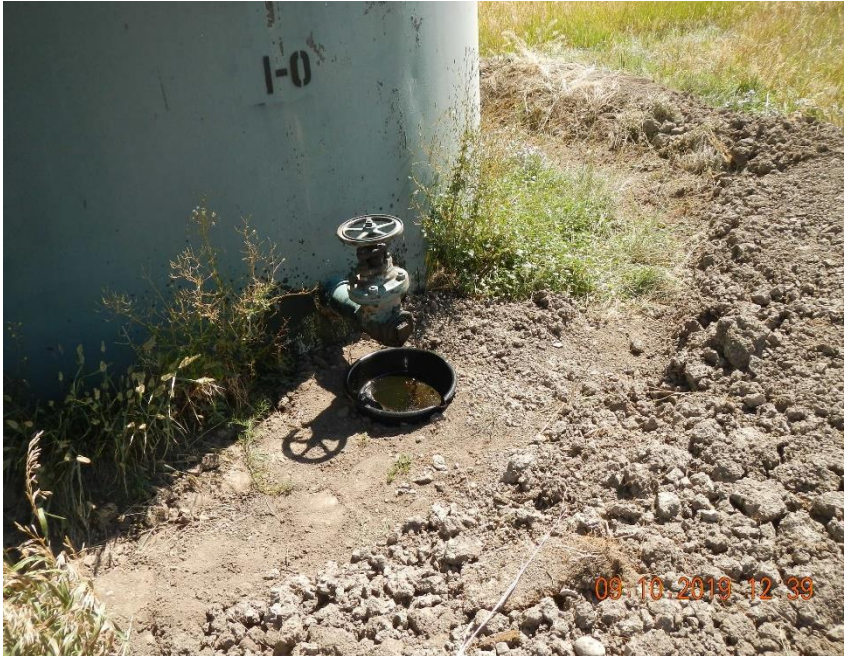
Recently constructed secondary containment berm around AST. Drip pan beneath load out valve.

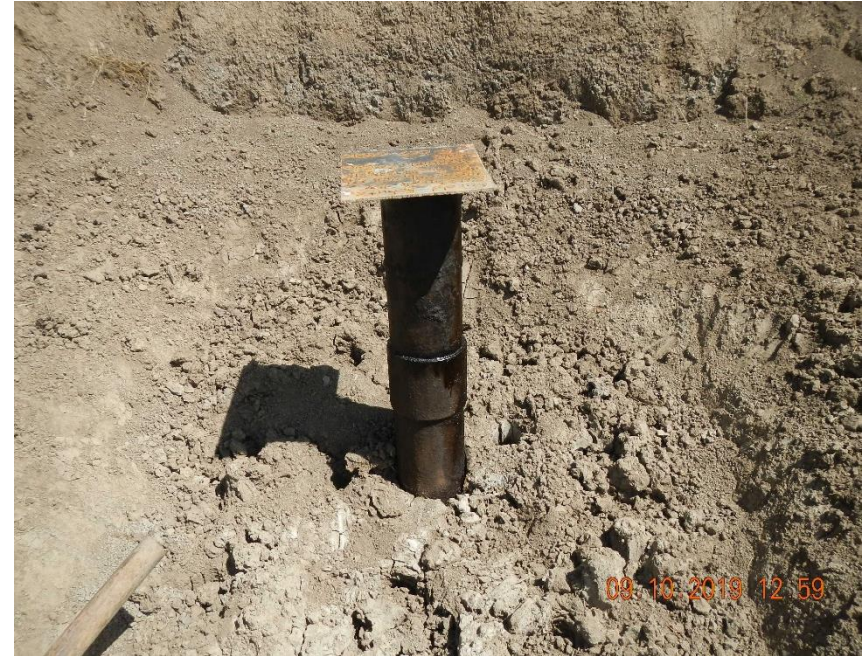
Fitzhugh #7 casing with oil staining.

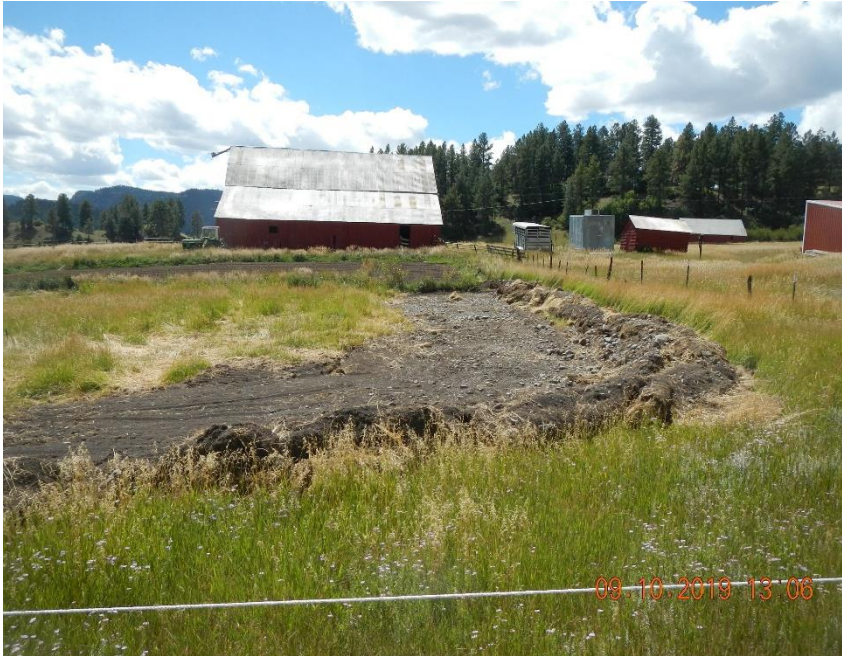
**Recently constructed addition to land farm treatment area.
Entire treatment area is now fenced.**

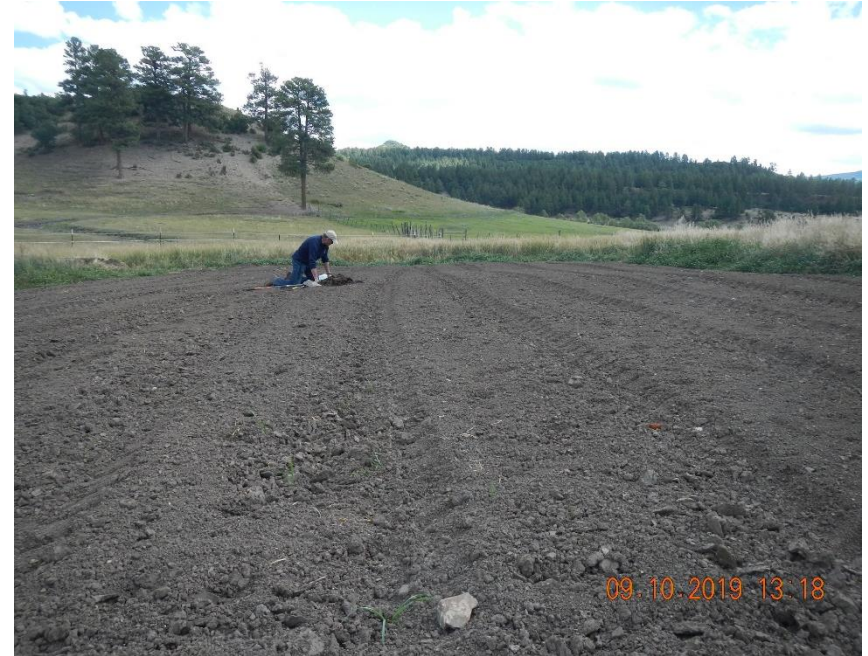
**Soil grab samples being collected from existing land farm
treatment cell.**
