Inspection Photos

API: 05-071-06094

Operator: AMOCO PRODUCTION COMPANY

Inspection Date: 11/8/2019

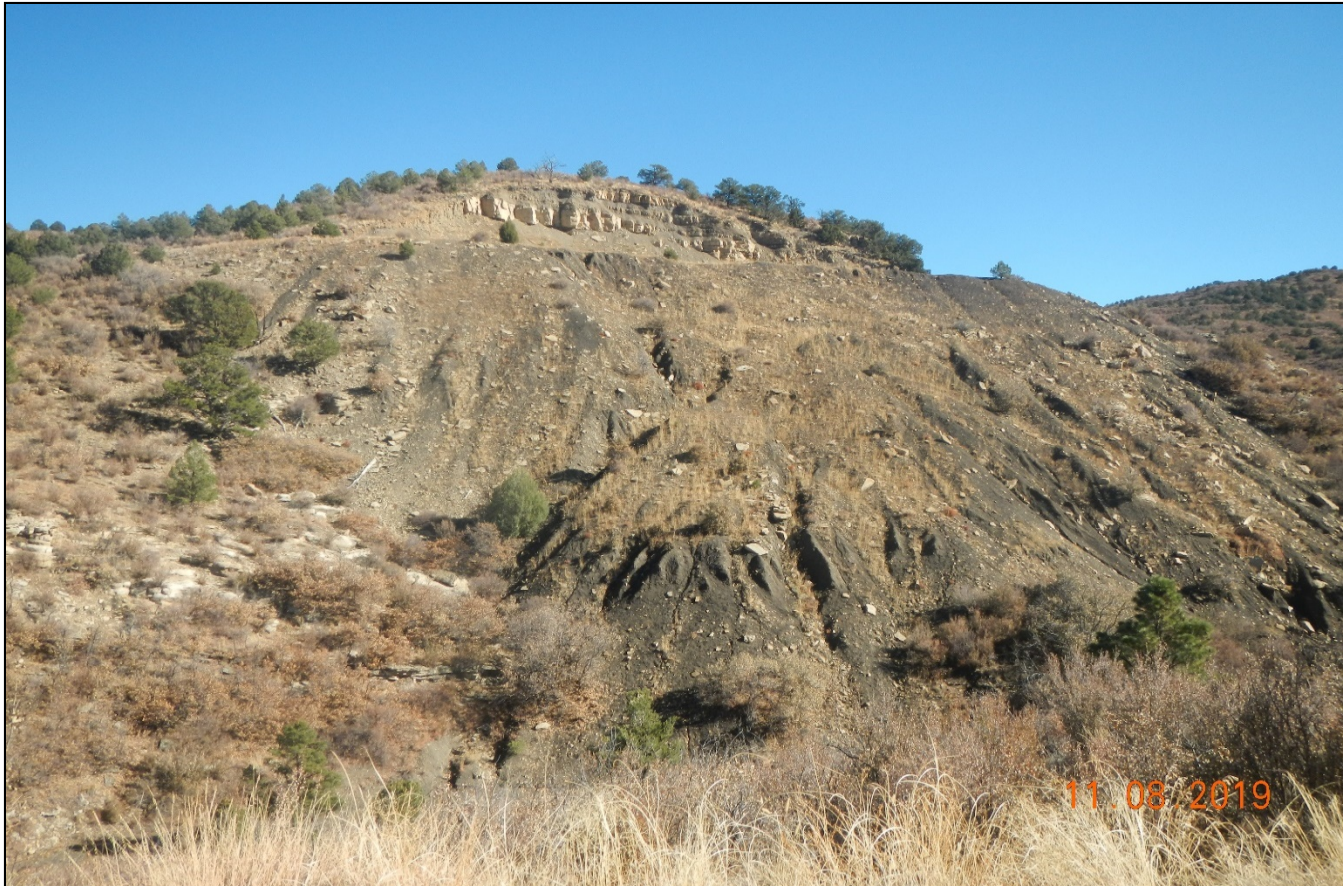
Photo 1. Facing east toward the location from across the canyon. Reclamation has not been performed. This photo was taken on 11/8/2019. The following photos were taken during previous inspections.

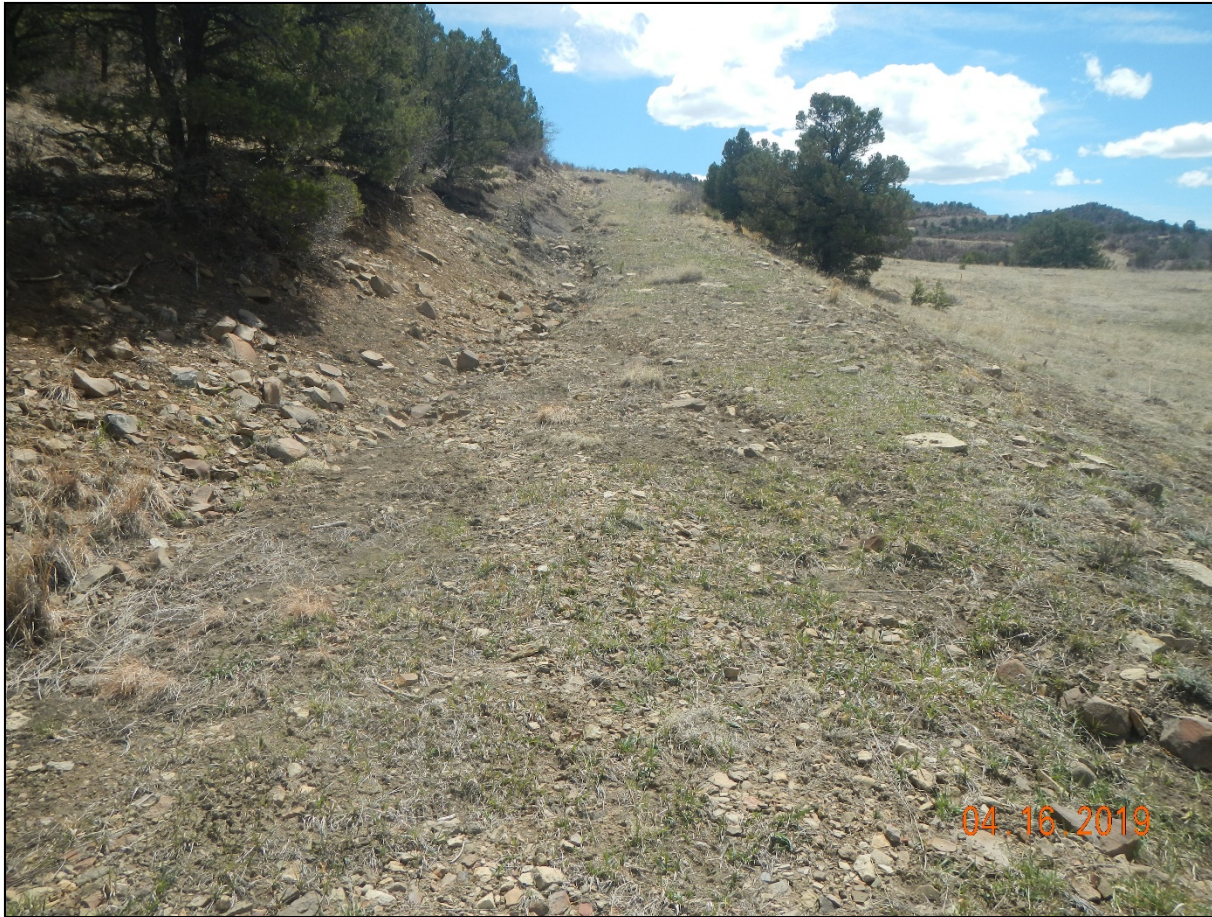
Photo 2. Facing south at the beginning of the access road.

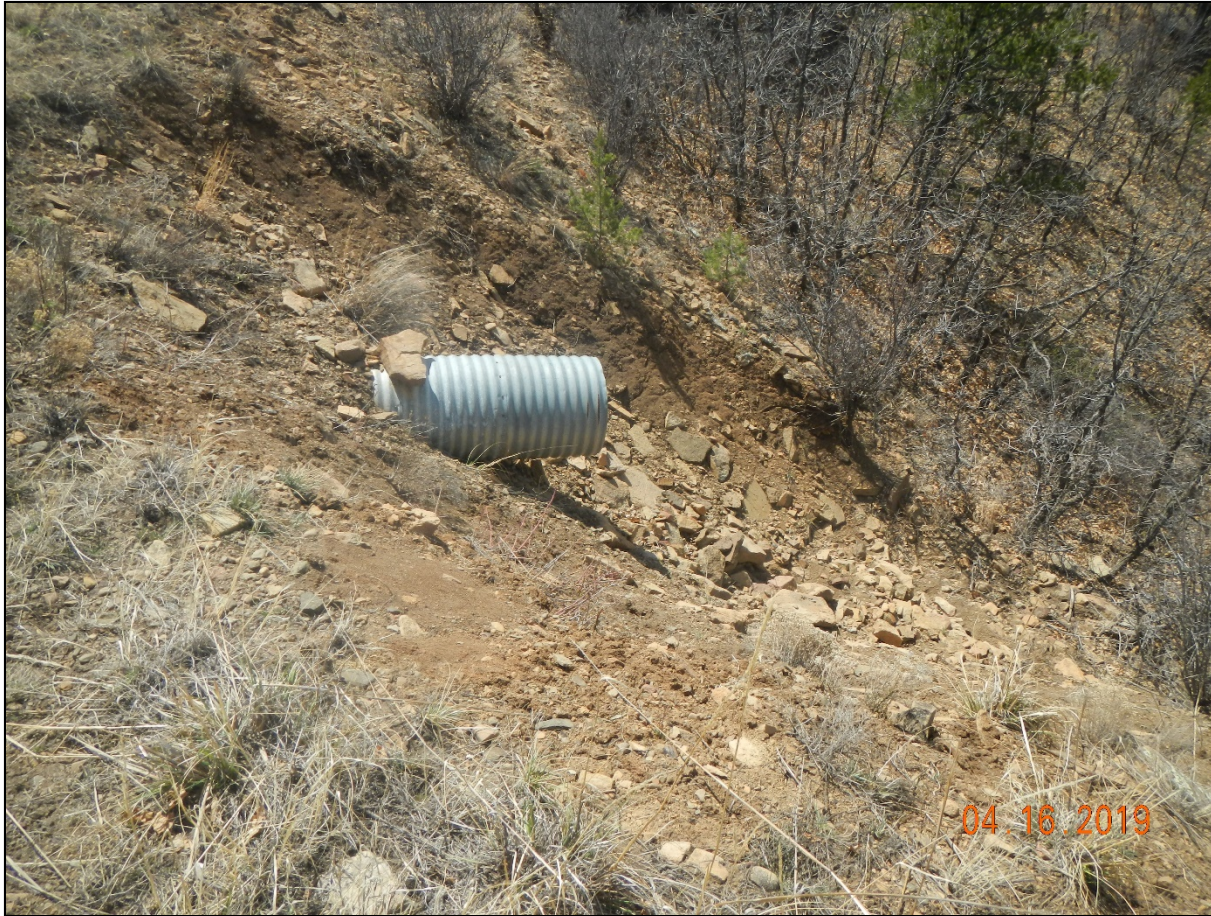
Photo 5. Culvert remains along the road. Erosion is occurring around the outlet.

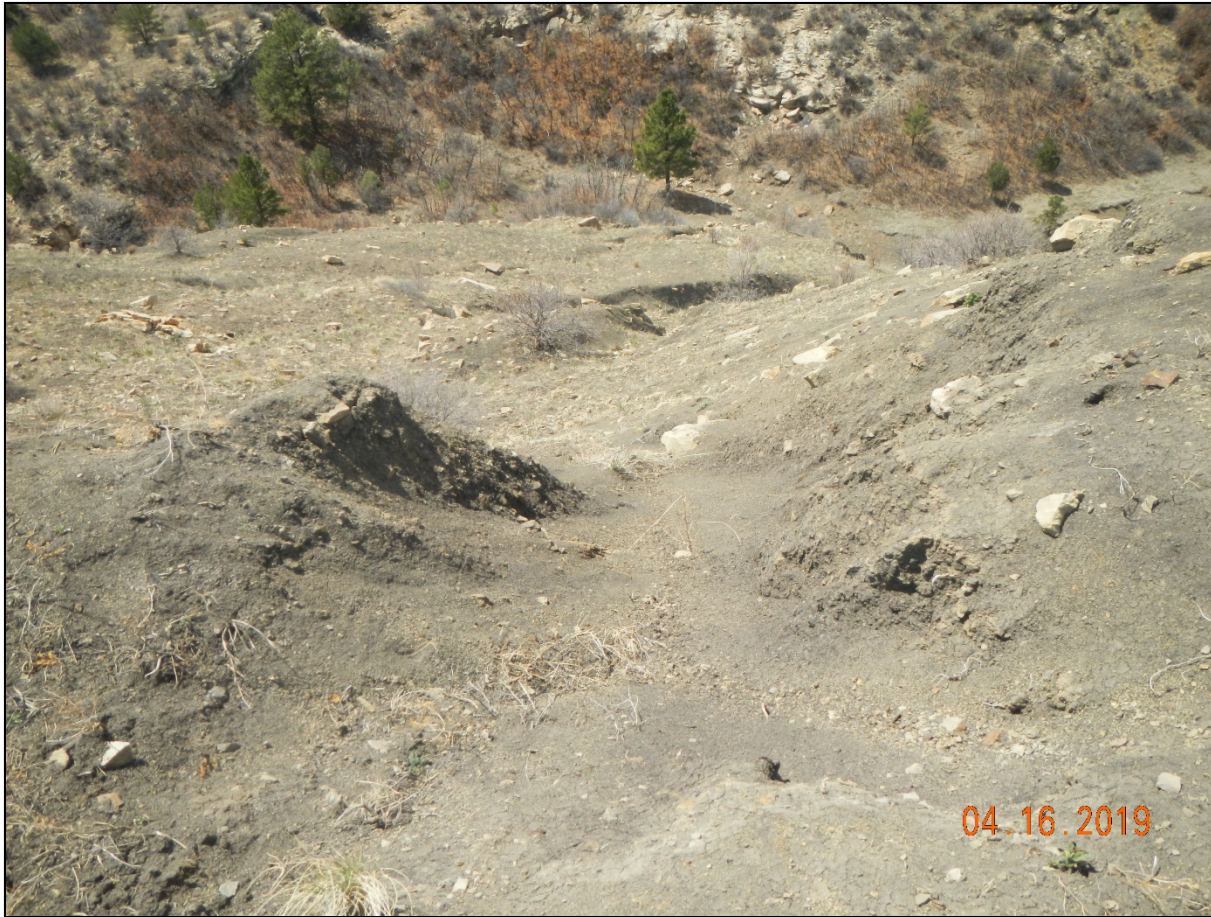
Photo 8. Facing down the fill slope shows signs of erosion.

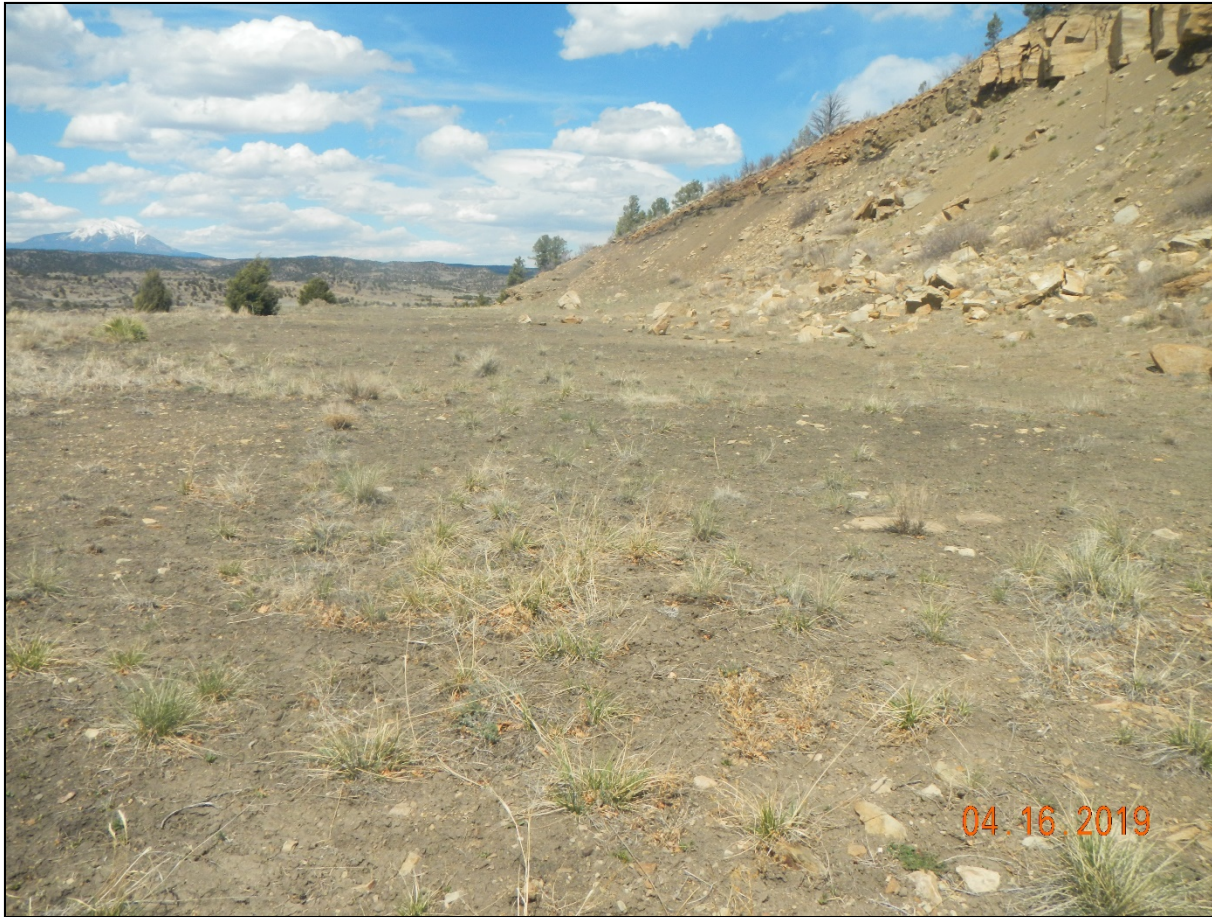
Photo 11. Facing north at the pad.

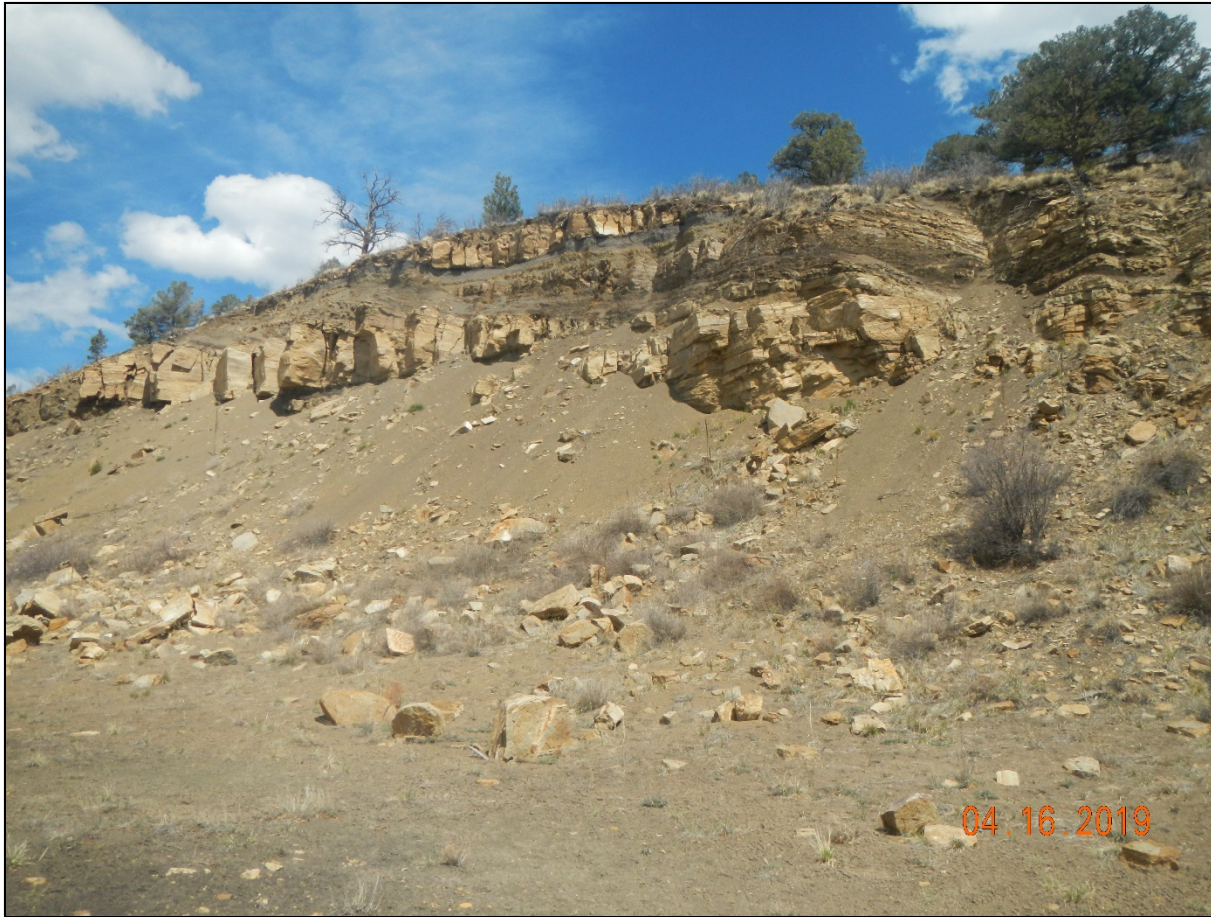
Photo 12. Facing towards the unstable vertical cut slope. Estimated to be 75' high.
