# Inspection Photos

API: 05-073-06398

Operator: KTM OPERATING LLC

Inspection Date: 11/25/2019

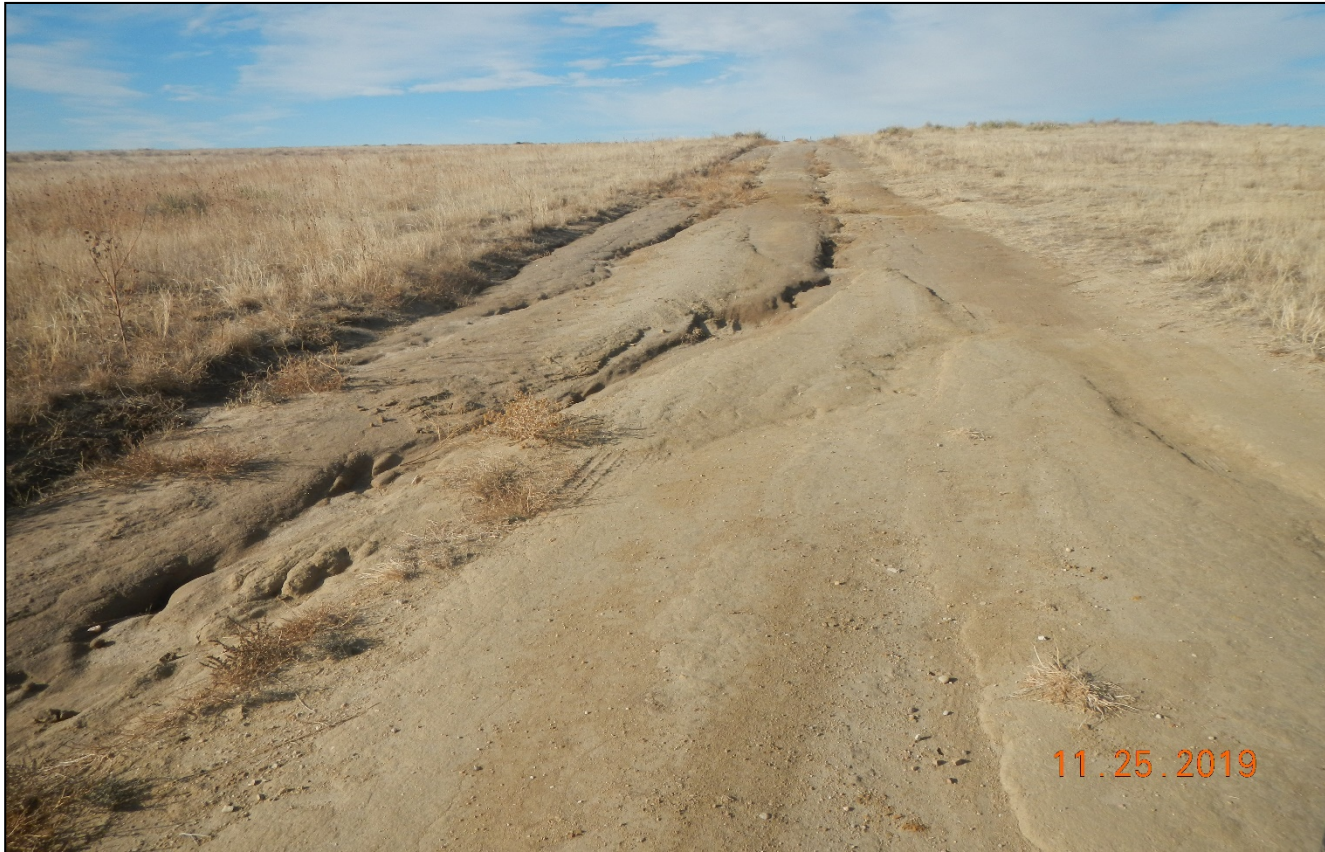
**Photo 1.** Facing west along the access road toward the location. There is erosion occurring down the road which is not maintained.

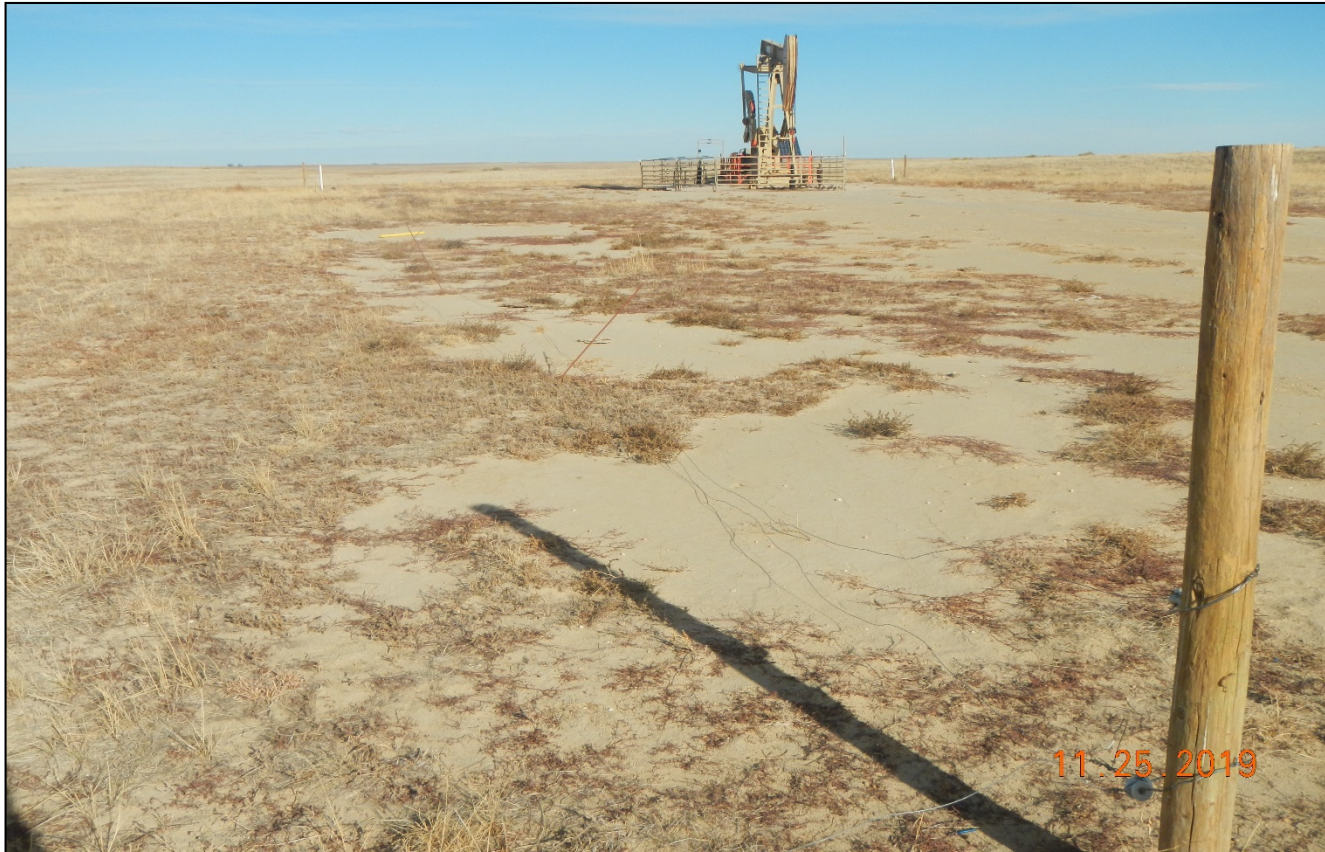
**Photo 2.** Facing northeast toward the location. The perimeter electric fence is in disrepair around the location.

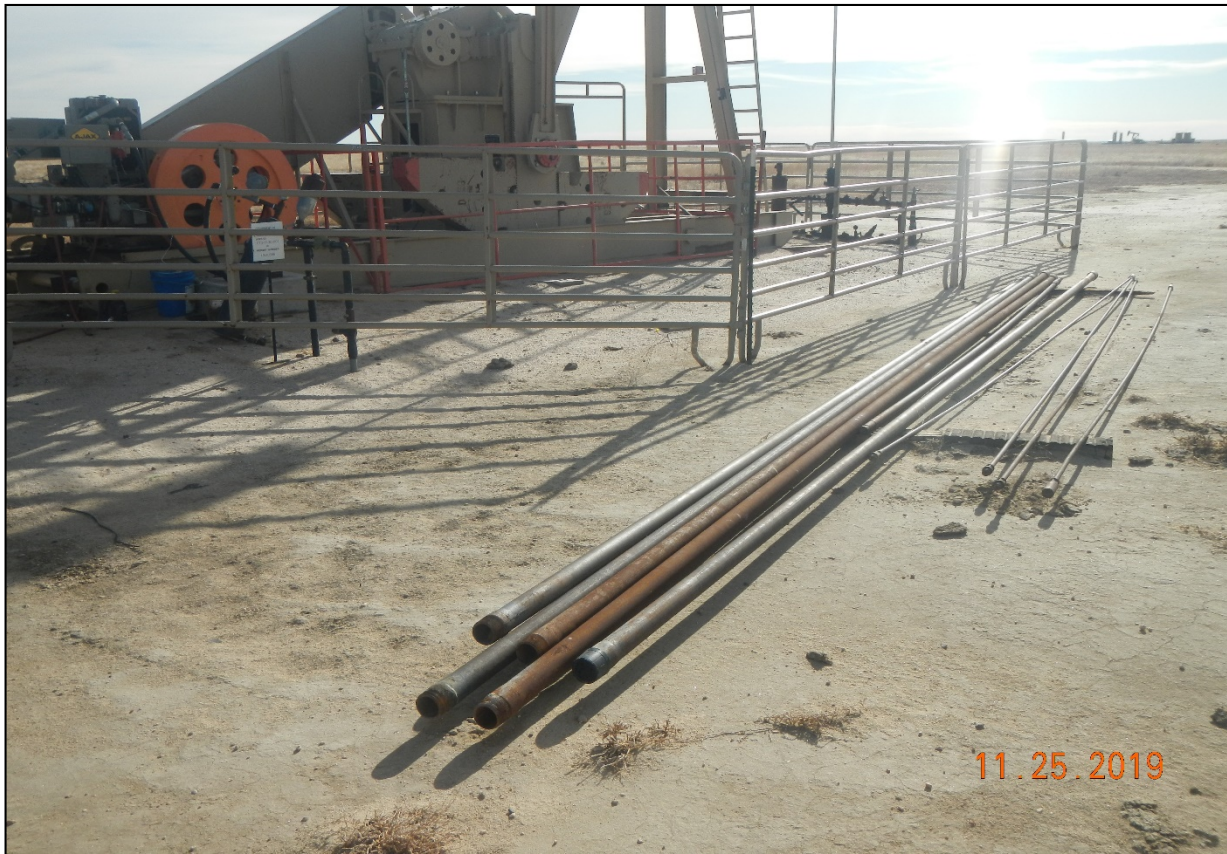
**Photo 3.** Unused pipe will need to be removed.

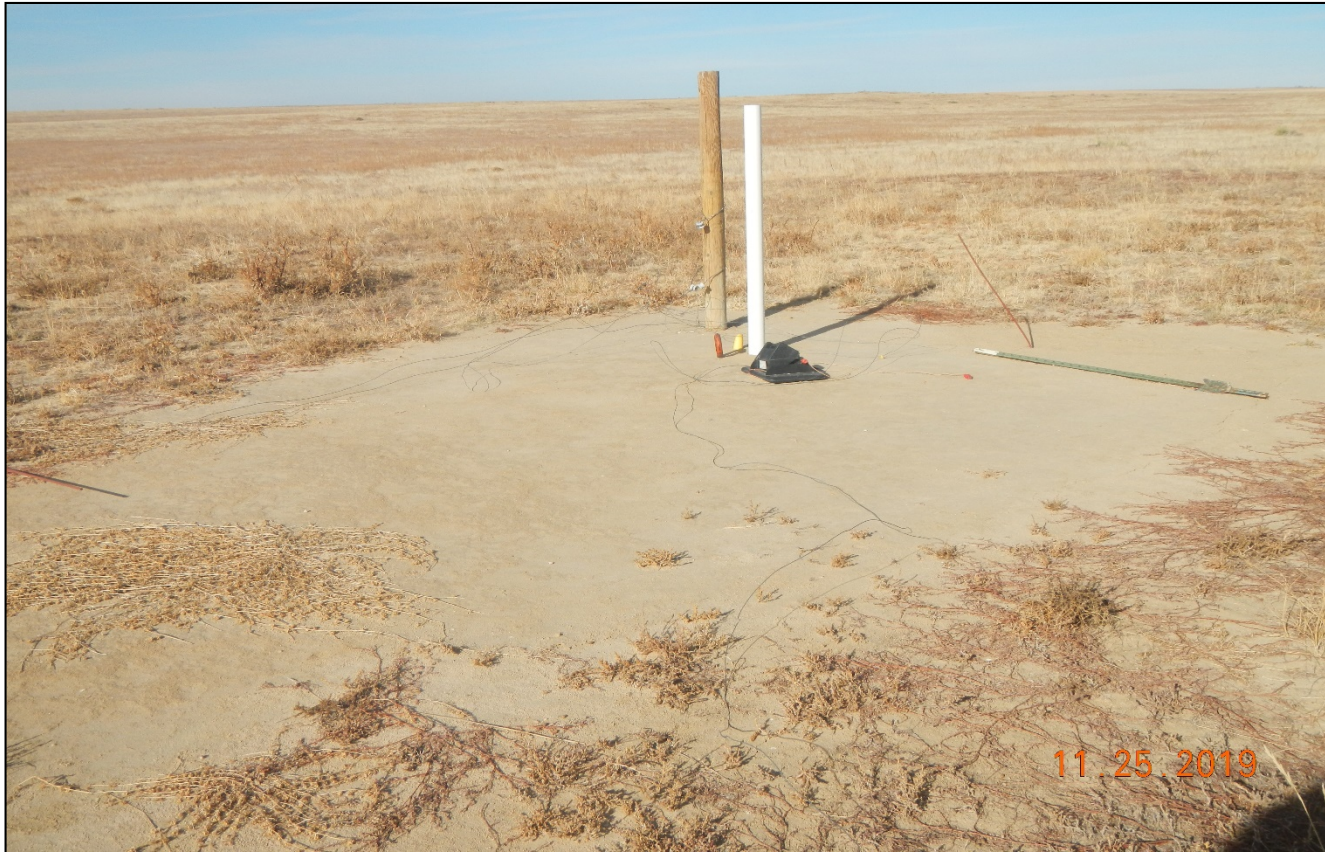
**Photo 4.** Electric fence is in disrepair.
