Inspection Photos

API: 05-073-06404

Operator: KTM OPERATING LLC

Inspection Date: 11/25/2019

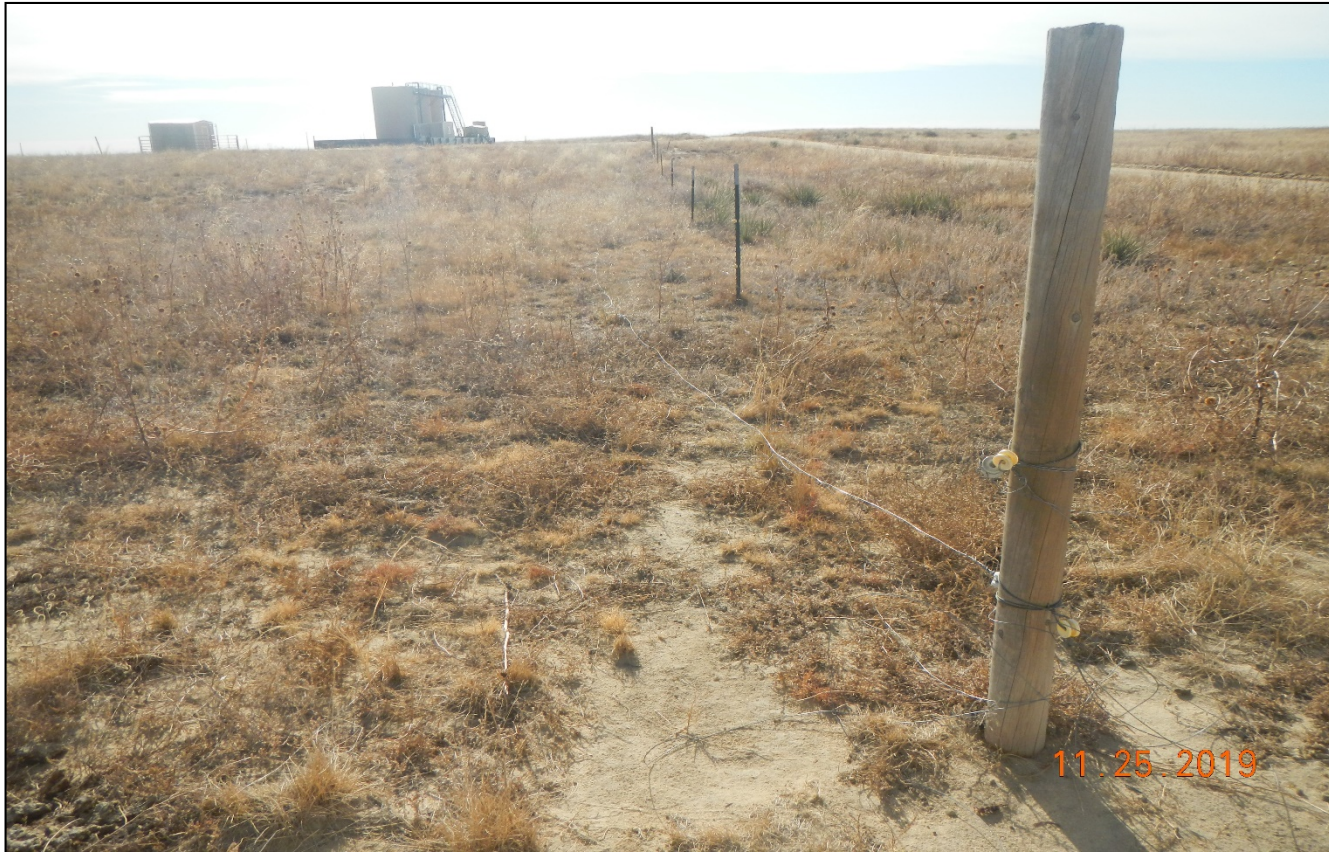
Photo 1. Facing south at the west side of the location. The perimeter electric fence is in disrepair around the location.

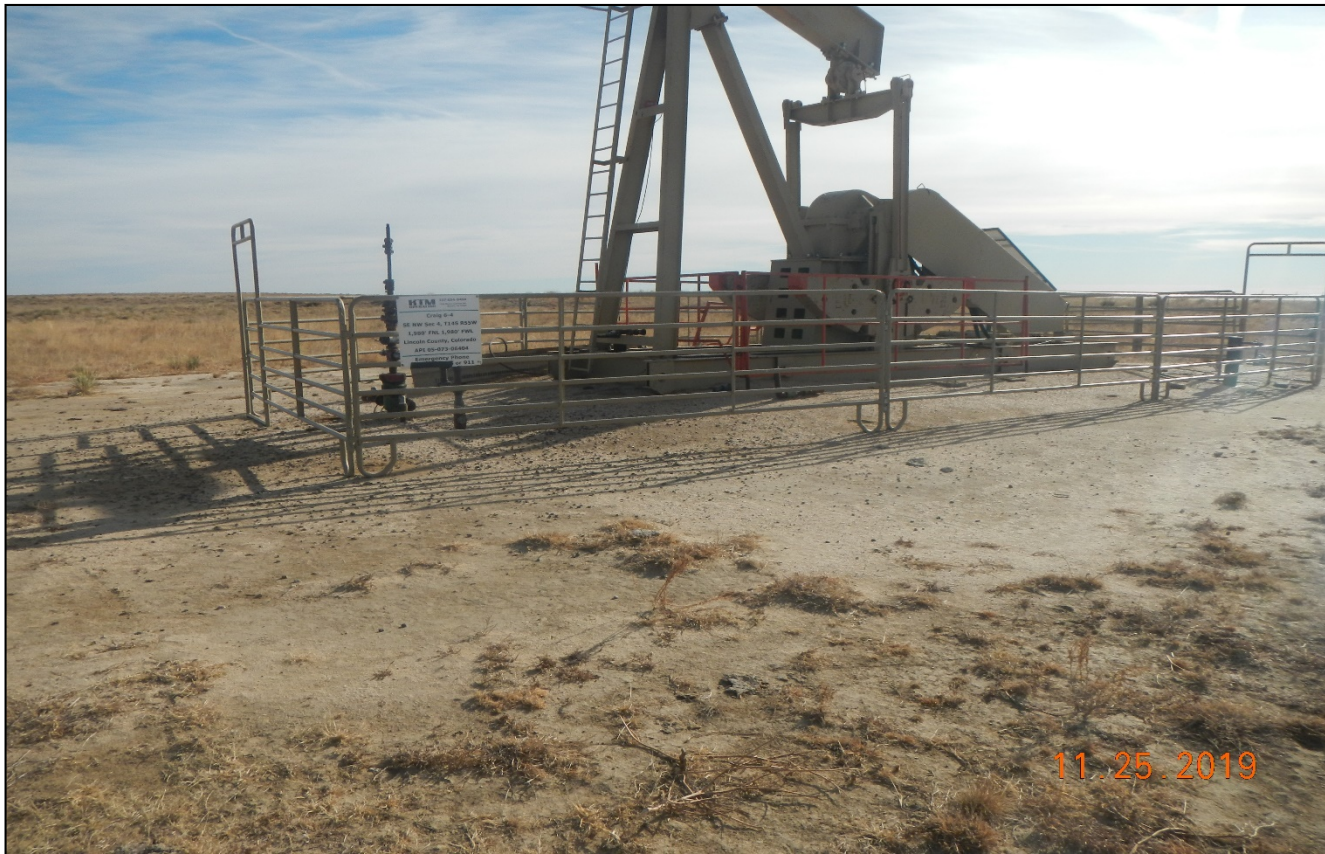
Photo 2. Well sign is posted.

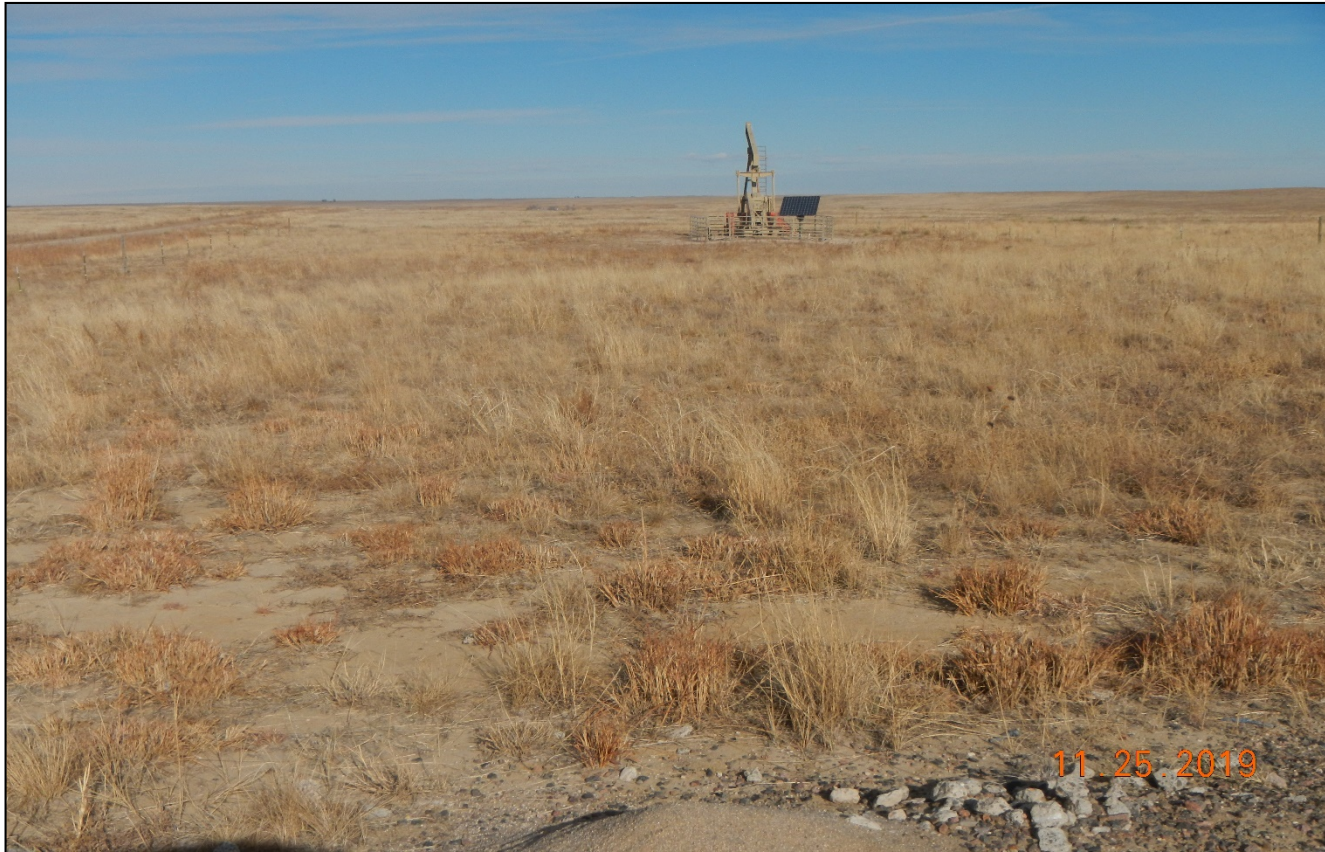
Photo 3. Facing north toward the location. Vegetation is progressing in the interim area.
