## Inspection Photos

Location Name: Keinath Federal 17-11H (C16OU) Pad and C16OU Flowline Release

Location ID: #334416 & Spill/Release ID: #469290

Inspection Date: November 25, 2019

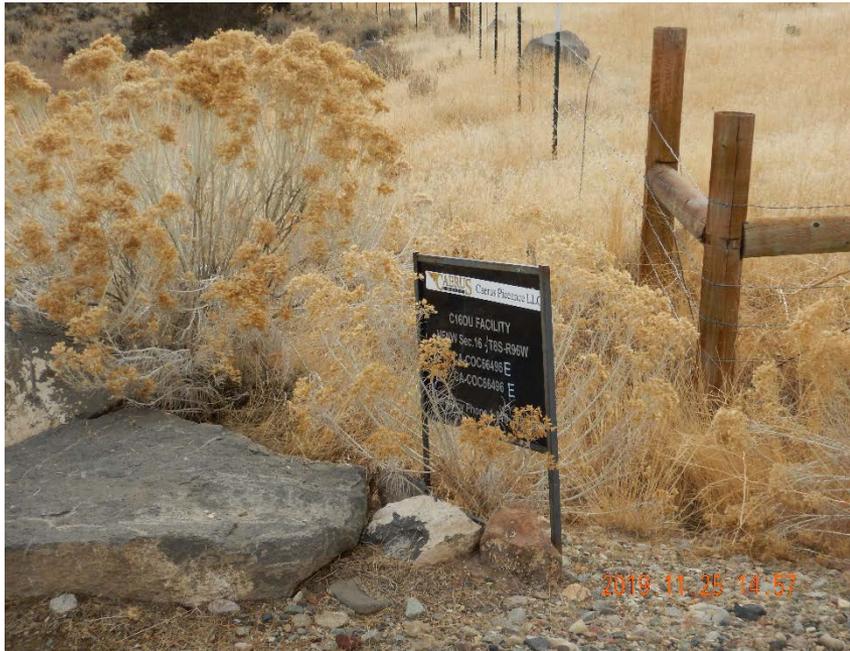
Photo #1 – Sign located at entrance to facility.

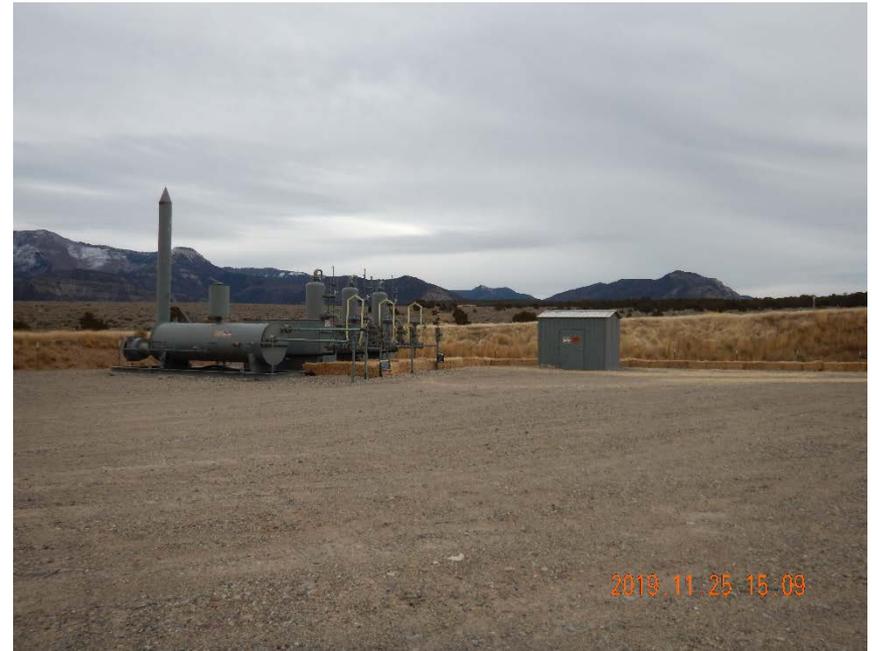
Photo #2 – View of separators, looking southeast.

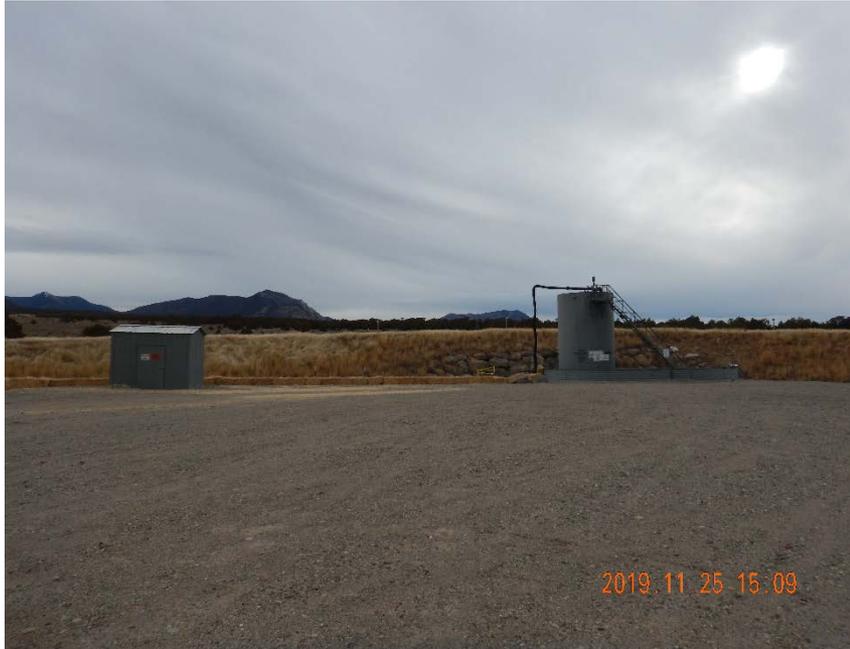
Photo #3 – View of tank battery, looking southwest.

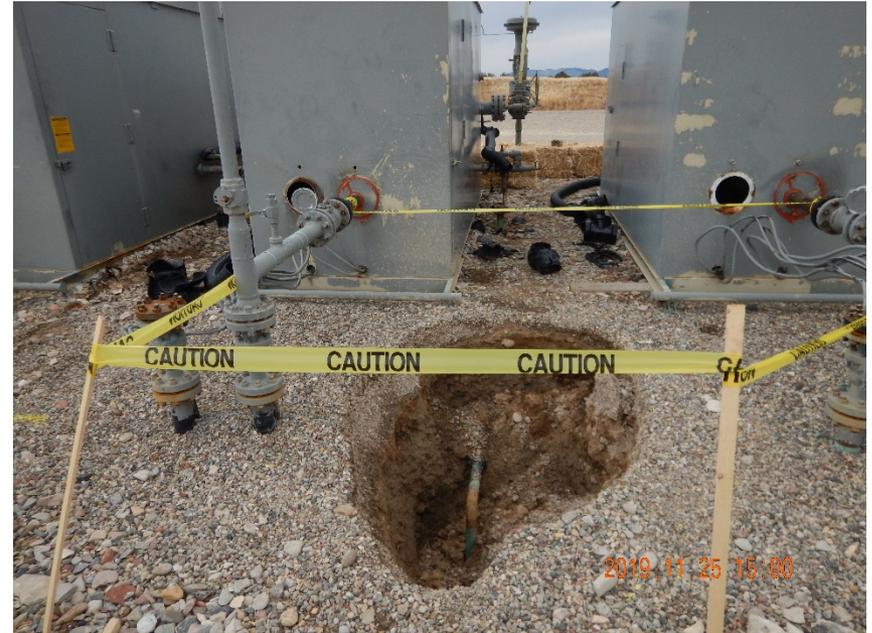
Photo #4 – View of pothole located east of separators.

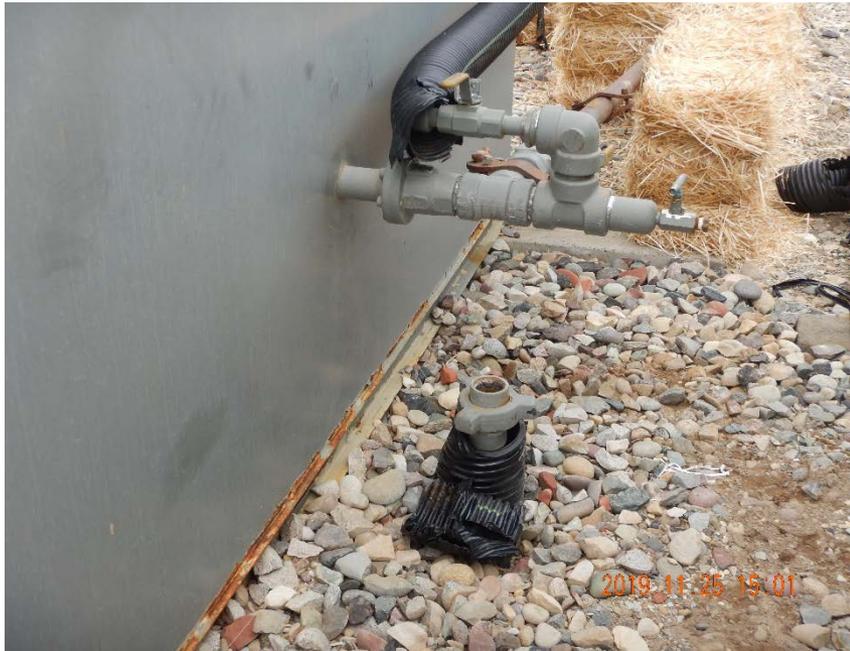
**Photo #5 – Uncapped, unused 2” flowline risers located on north sides of separators (1).**

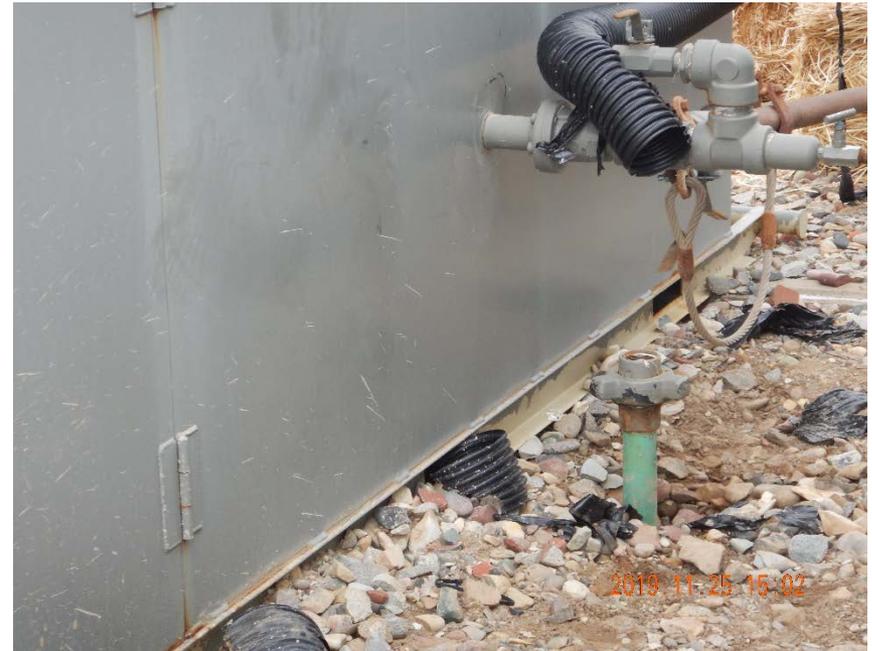
**Photo #6 - Uncapped, unused 2” flowline risers located on north sides of separators (2).**

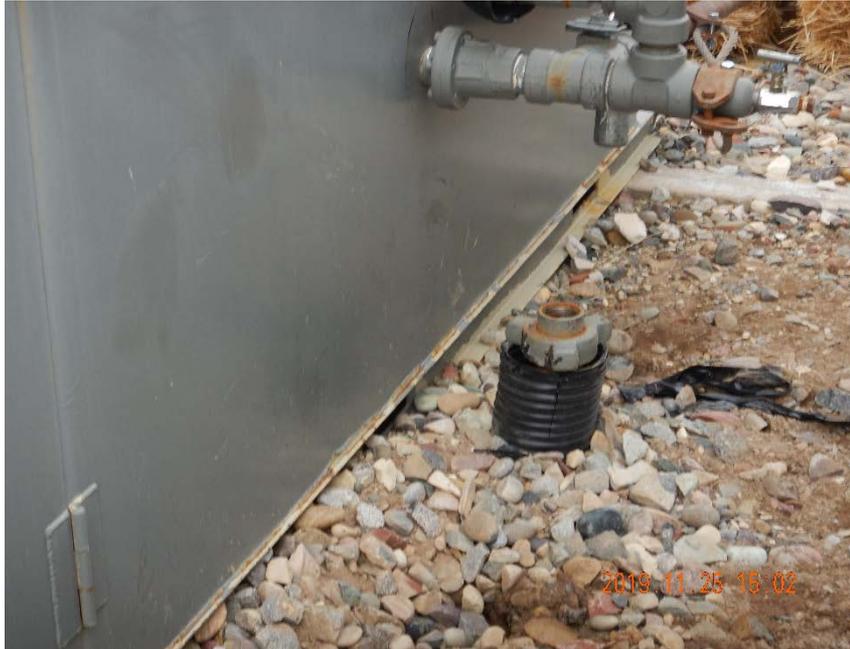
**Photo #7 - Uncapped, unused 2" flowline risers located on north sides of separators (3).**

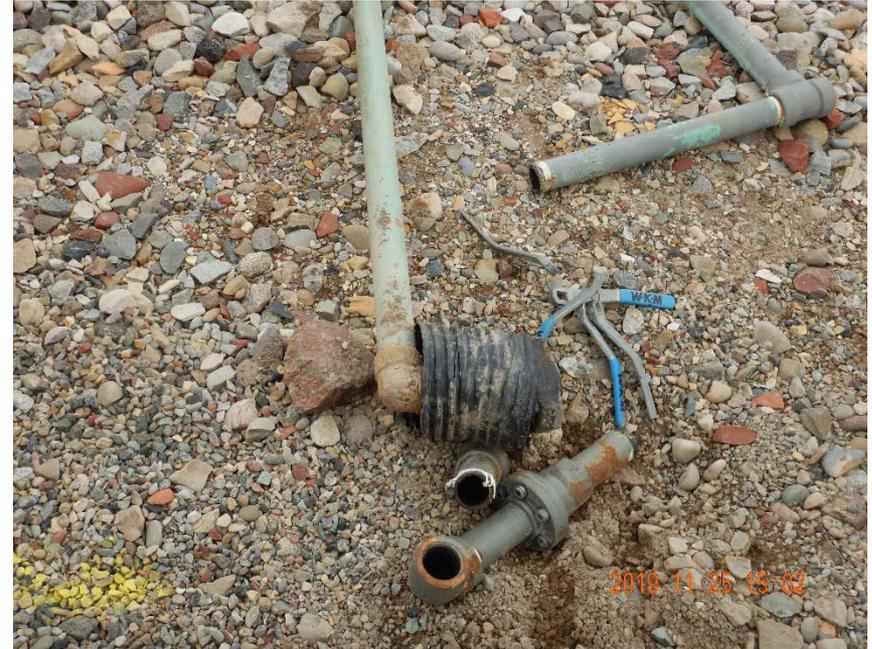
**Photo #8 – Unused equipment stored southeast of separators.**

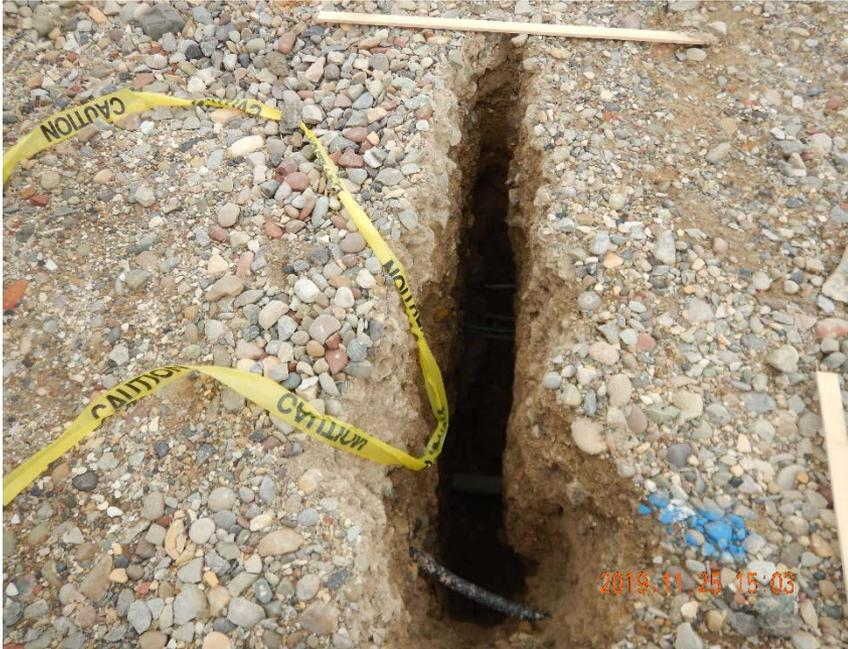
Photo #9 – Additional pothole located south of separators.

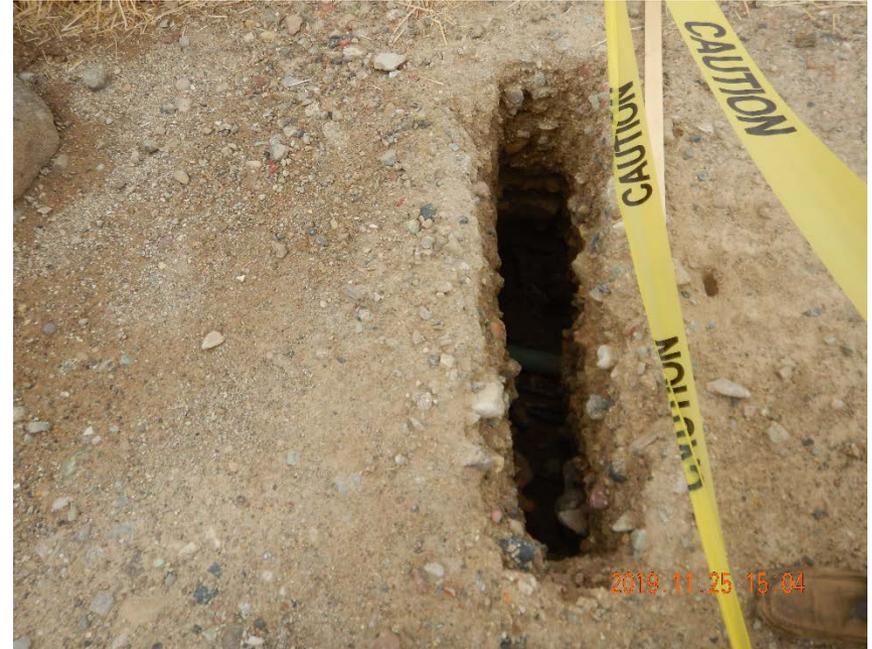
Photo #10 – Pothole located southeast of tank battery.

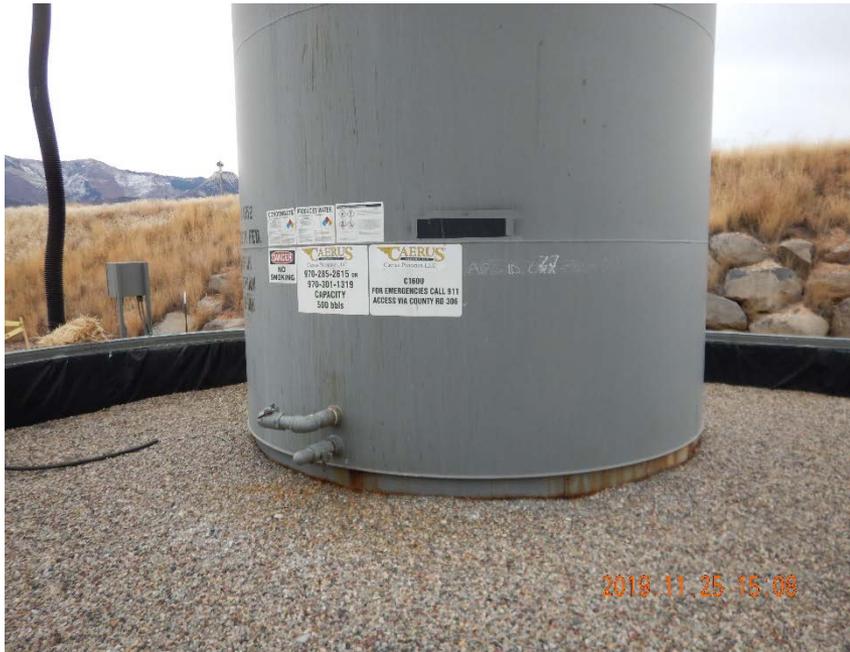
Photo #11 – Caerus sign on north side of 500 bbl AST.

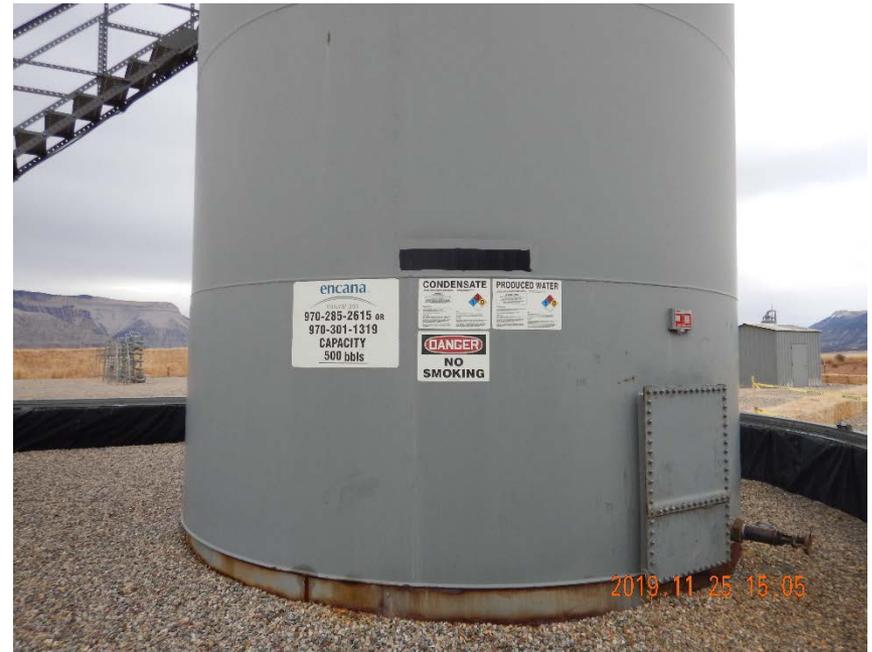
Photo #12 – Sign on south side of 500 bbl AST still reads Encana.

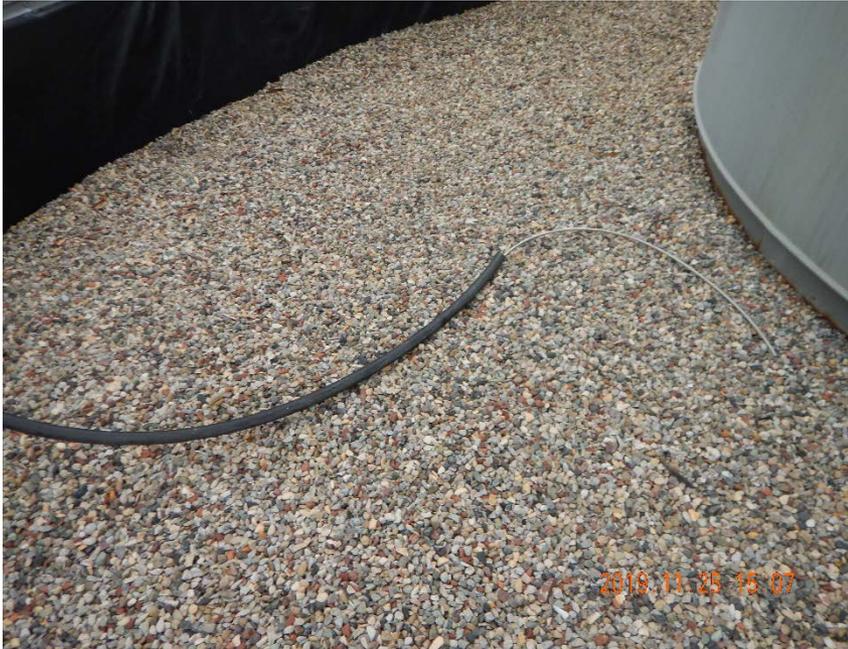
**Photo #13 – Unused process pipe stored inside of tank battery.**

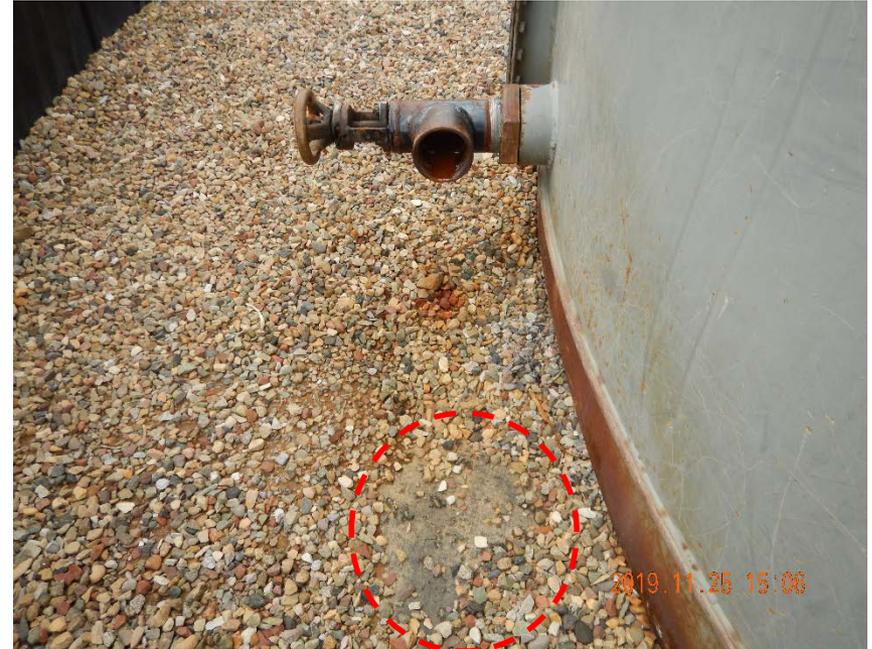
**Photo #14 – View of valve on south side of tank. Note section of visible liner (red circle).**

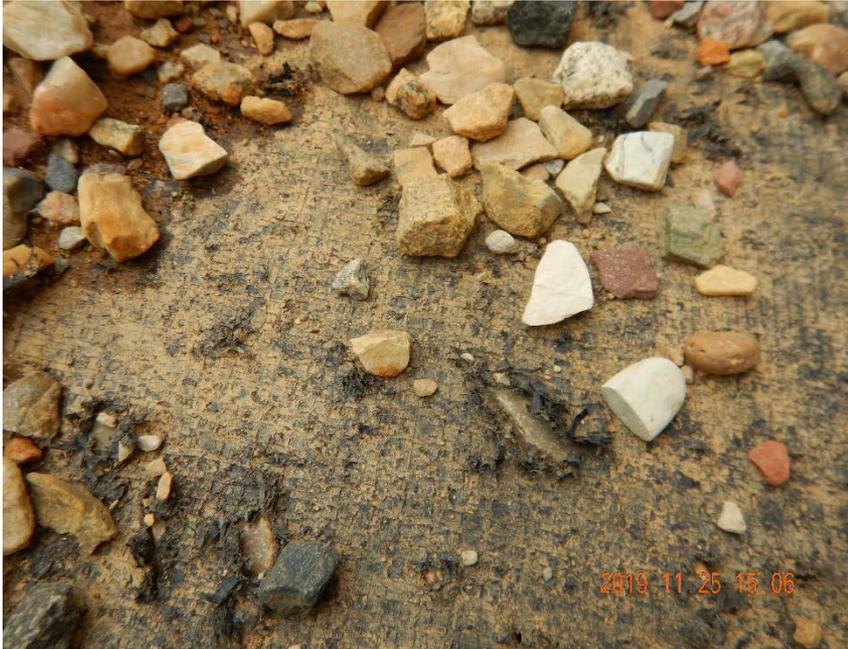
Photo #15 – Holes in base of tank battery liner beneath valve on south side of 500 bbl AST (i.e., in area circled in previous photo).

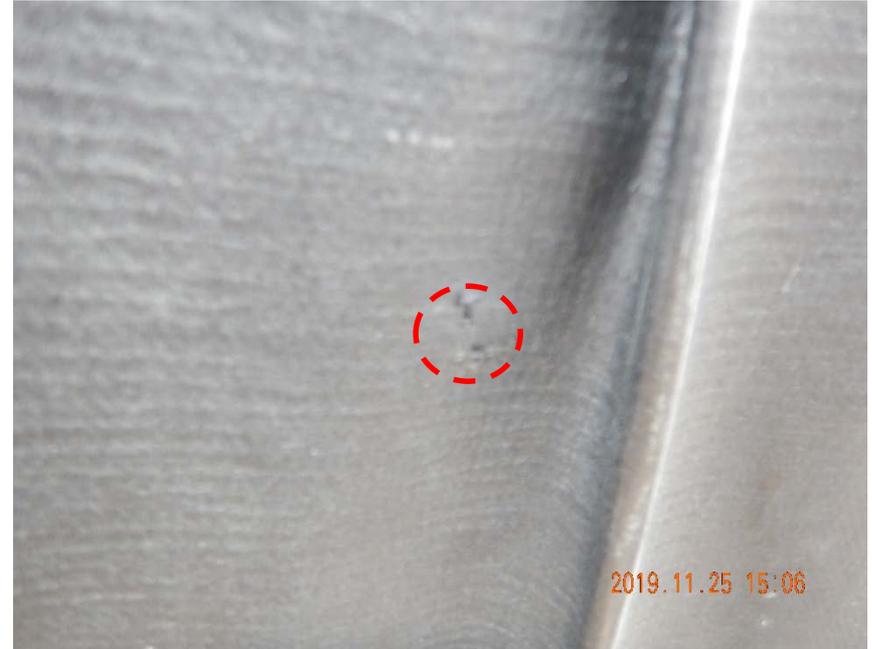
Photo #16 – Pinhole (red circle) observed in tank battery liner along south wall (1).

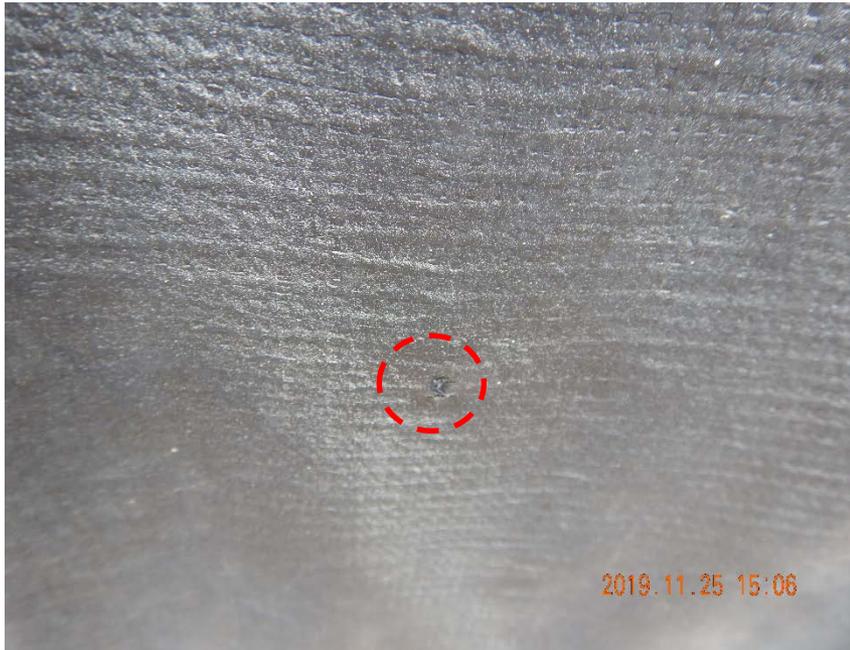
Photo #17 - Pinhole (red circle) observed in tank battery liner along south wall (2).

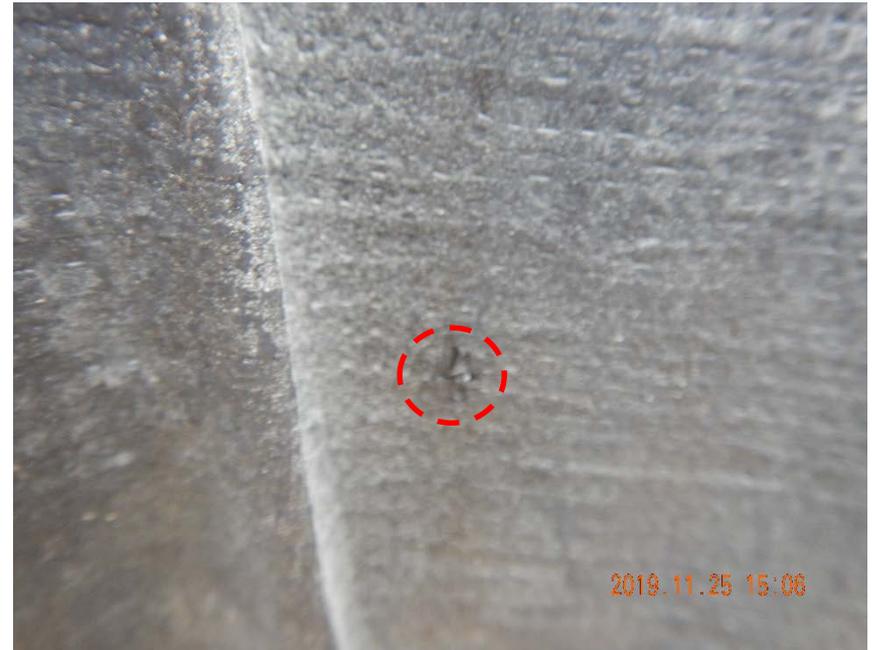
Photo #18 - Pinhole (red circle) observed in tank battery liner along south wall (3).

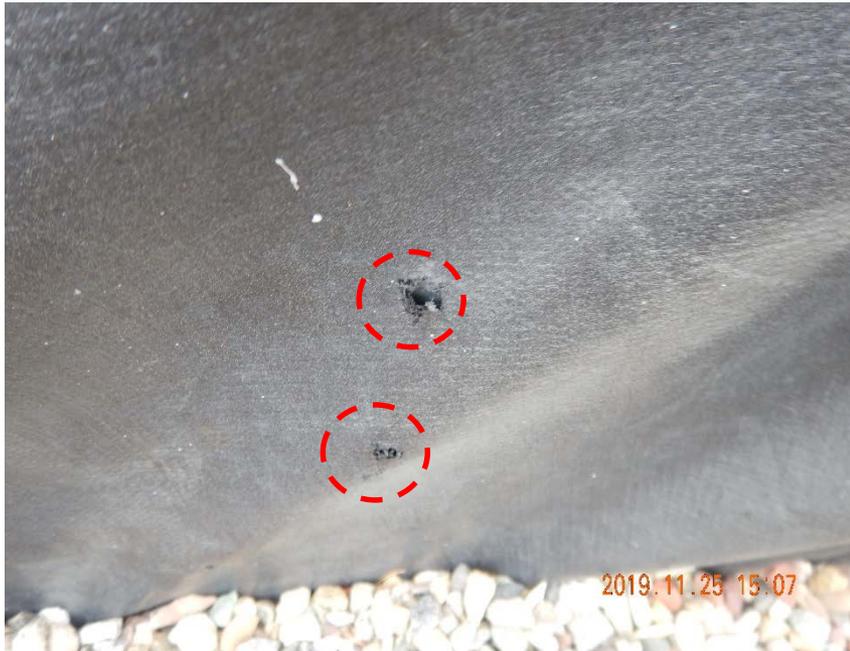
Photo #19 – Pinholes (red circles) observed in tank battery liner along south wall (4).

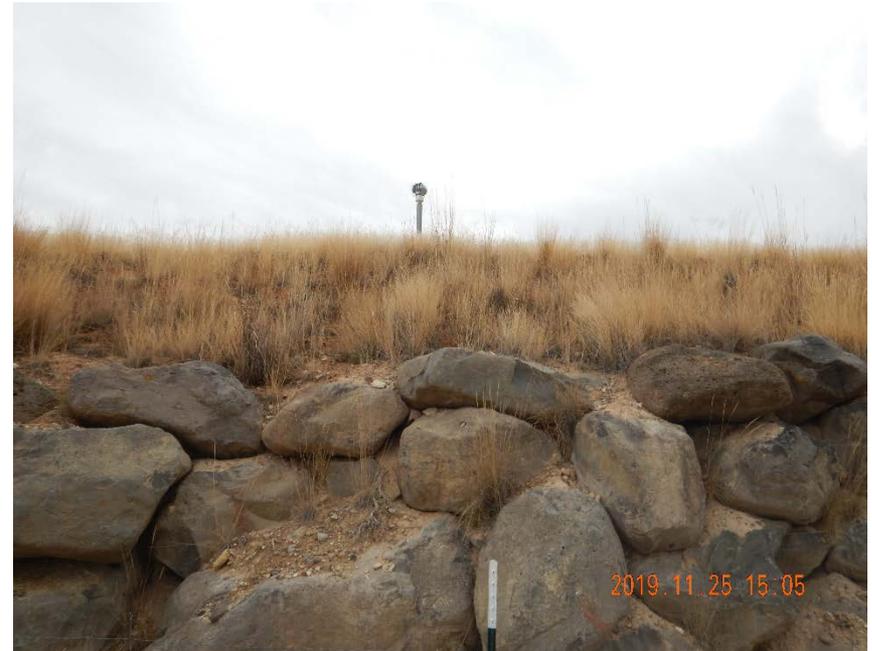
Photo #20 – Passive SVE well located south of tank battery is related to Remediation Project #7602.
