State of Colorado
Oil and Gas Conservation Commission

FIELD INSPECTION FORM

Facility ID	Type	Status	Status Date	Well Class	API Num	Facility Name	Insp Status
229313	WELL	PR	05/01/2019	OW	103-06413	C T CARNEY 20X35	PR

Carney 20X35
API: 05-103-06413
Inspection: 679706417

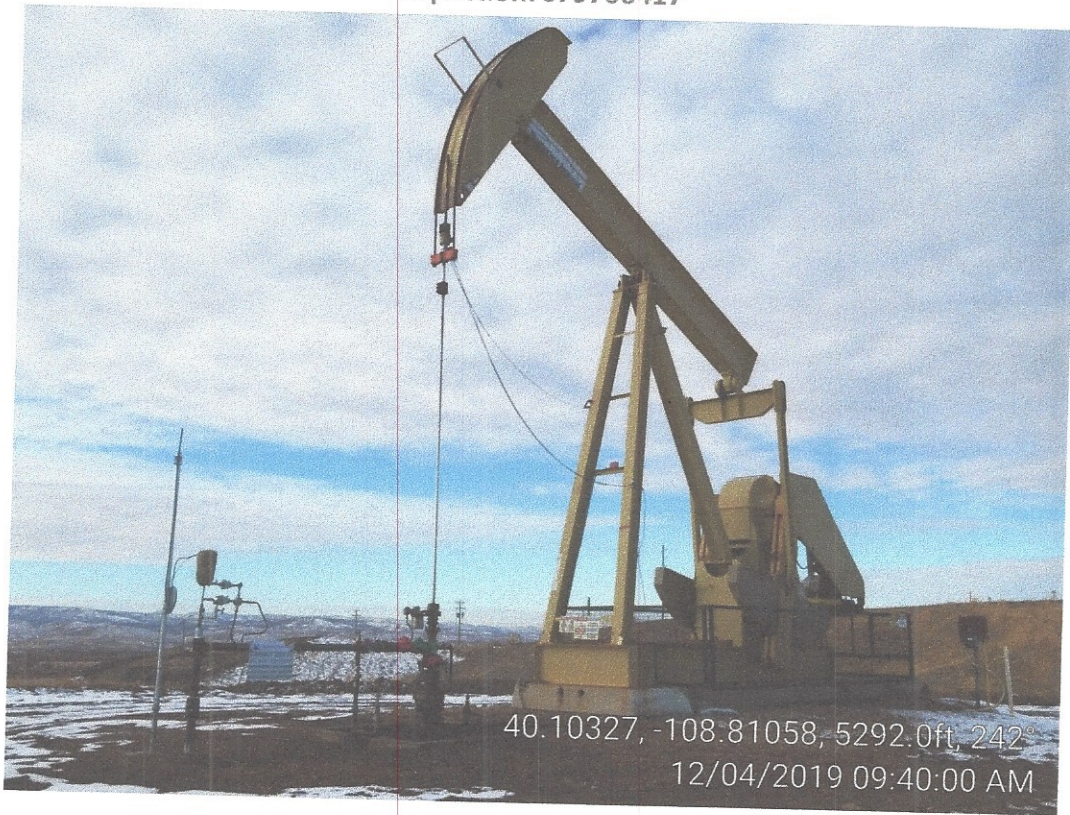
Photo 1. Location.

Comment: Pump jack idle at time of inspection.

Comment: No apparent significant soil migration, erosion, or soil movement on location.Corrective Action: Date: Pits: ☒ NO SURFACE INDICATION OF PIT**Attached Documents**You can go to COGCC Images (<https://cogcc.state.co.us/weblink/>) and search by document number:
