# Inspection Photos

Operator: Enduring Resources  
Location/API #: 067-07758  
Date: 11-14-2019

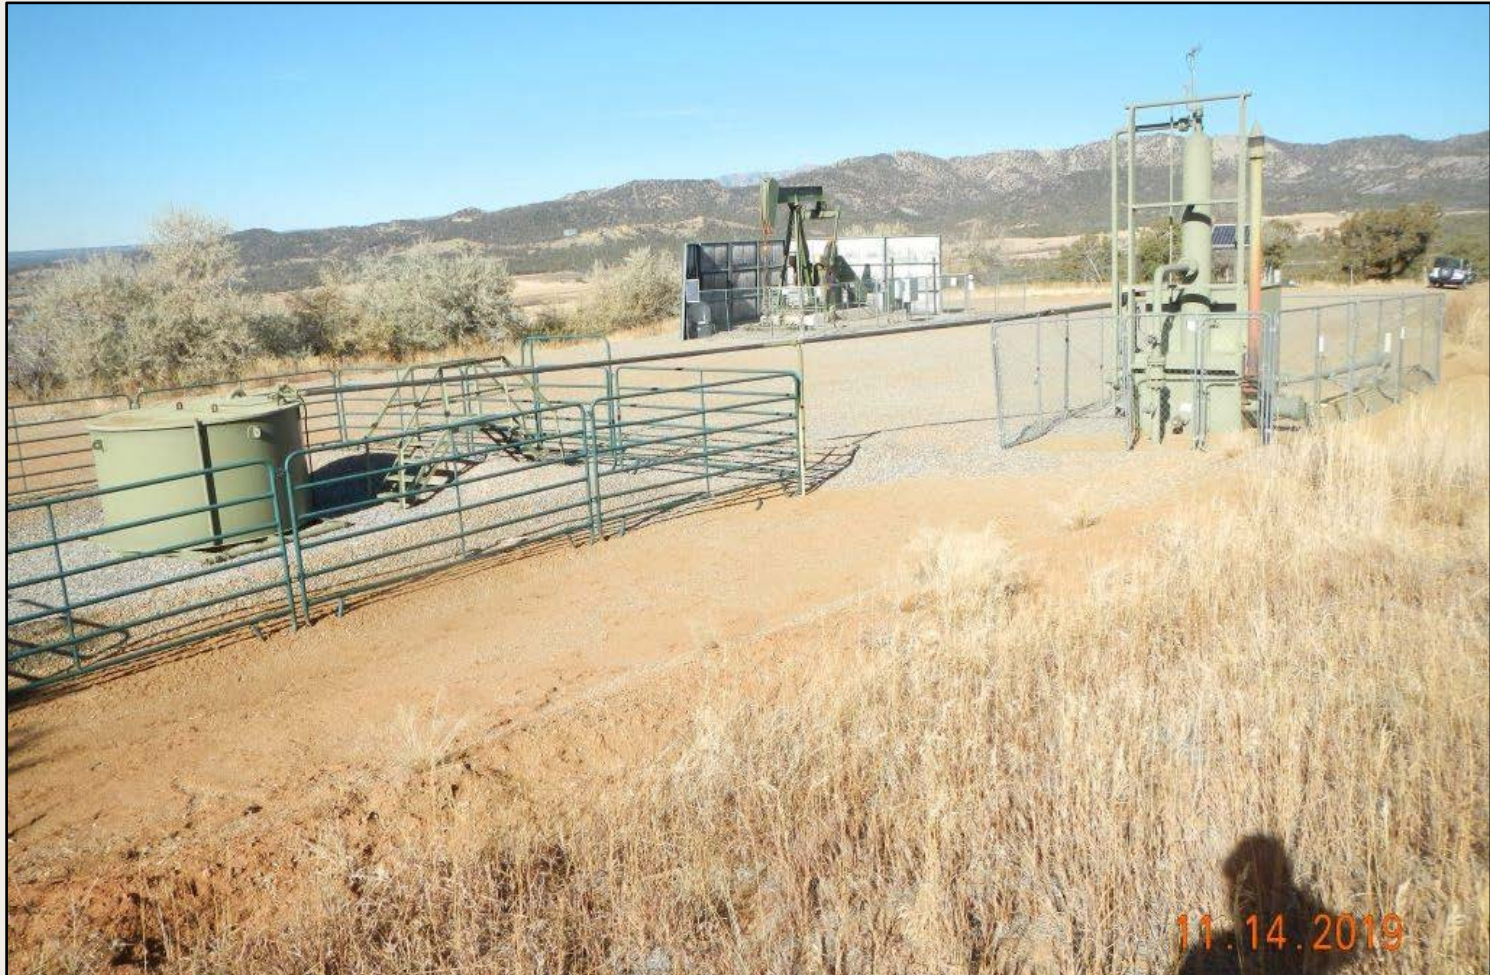
Photo 1. View of the project area from the southeastern corner facing center.

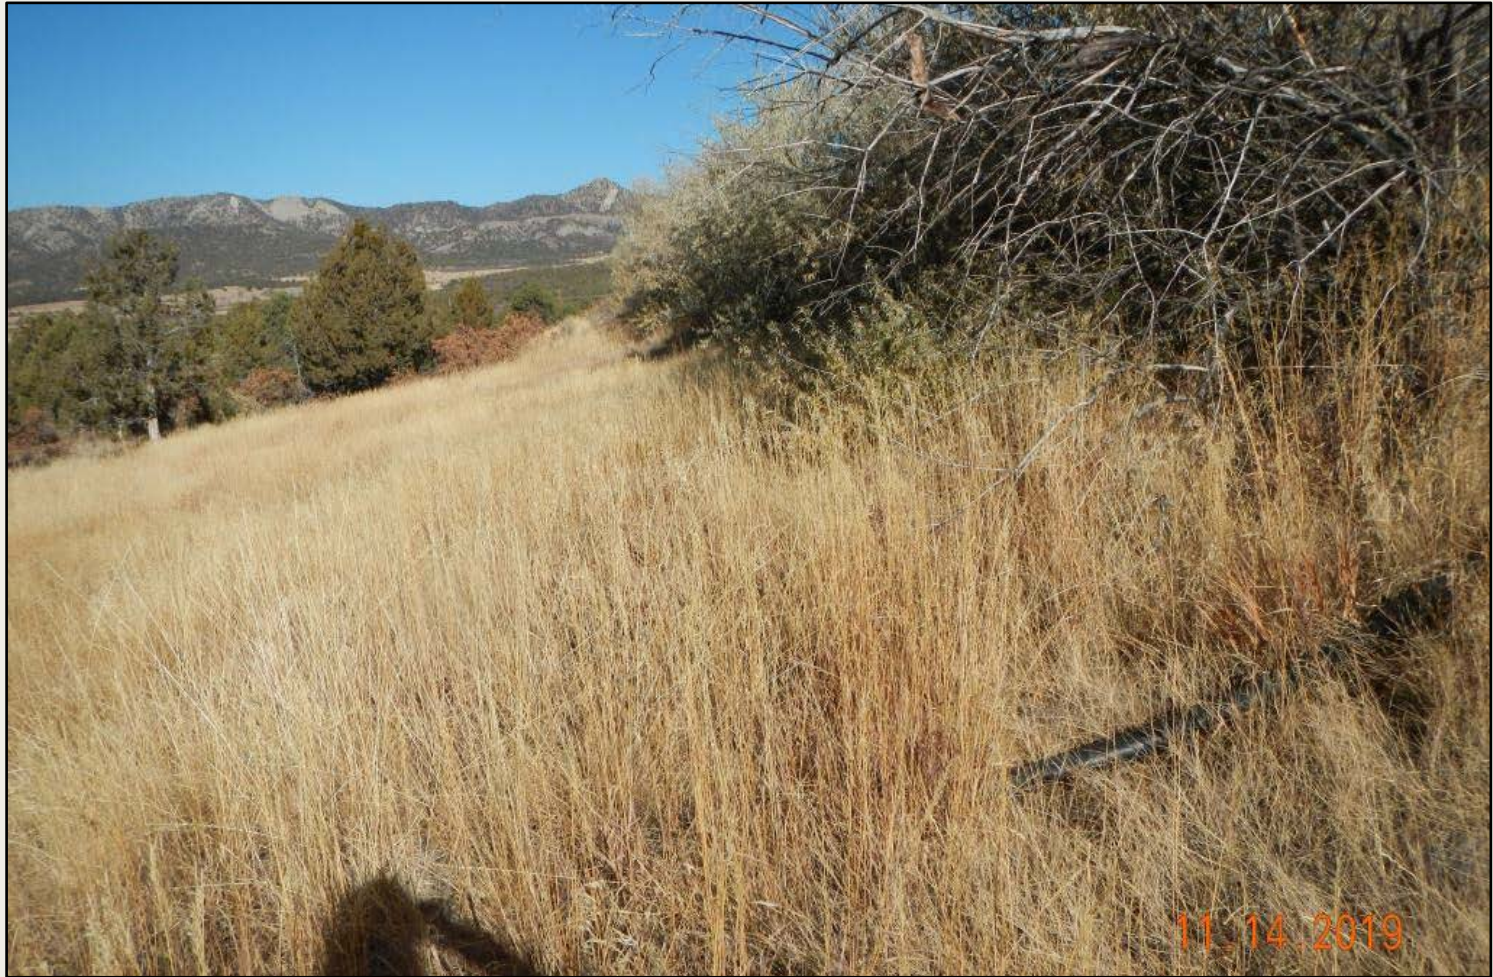
Photo 2. View of the western fill slope from the southwestern corner facing northward. Revegetation is progressing, largely with grasses such as smooth brome, western wheatgrass, crested wheatgrass, and sand dropseed. Russian olive trees are planted along the western edge of the working area.

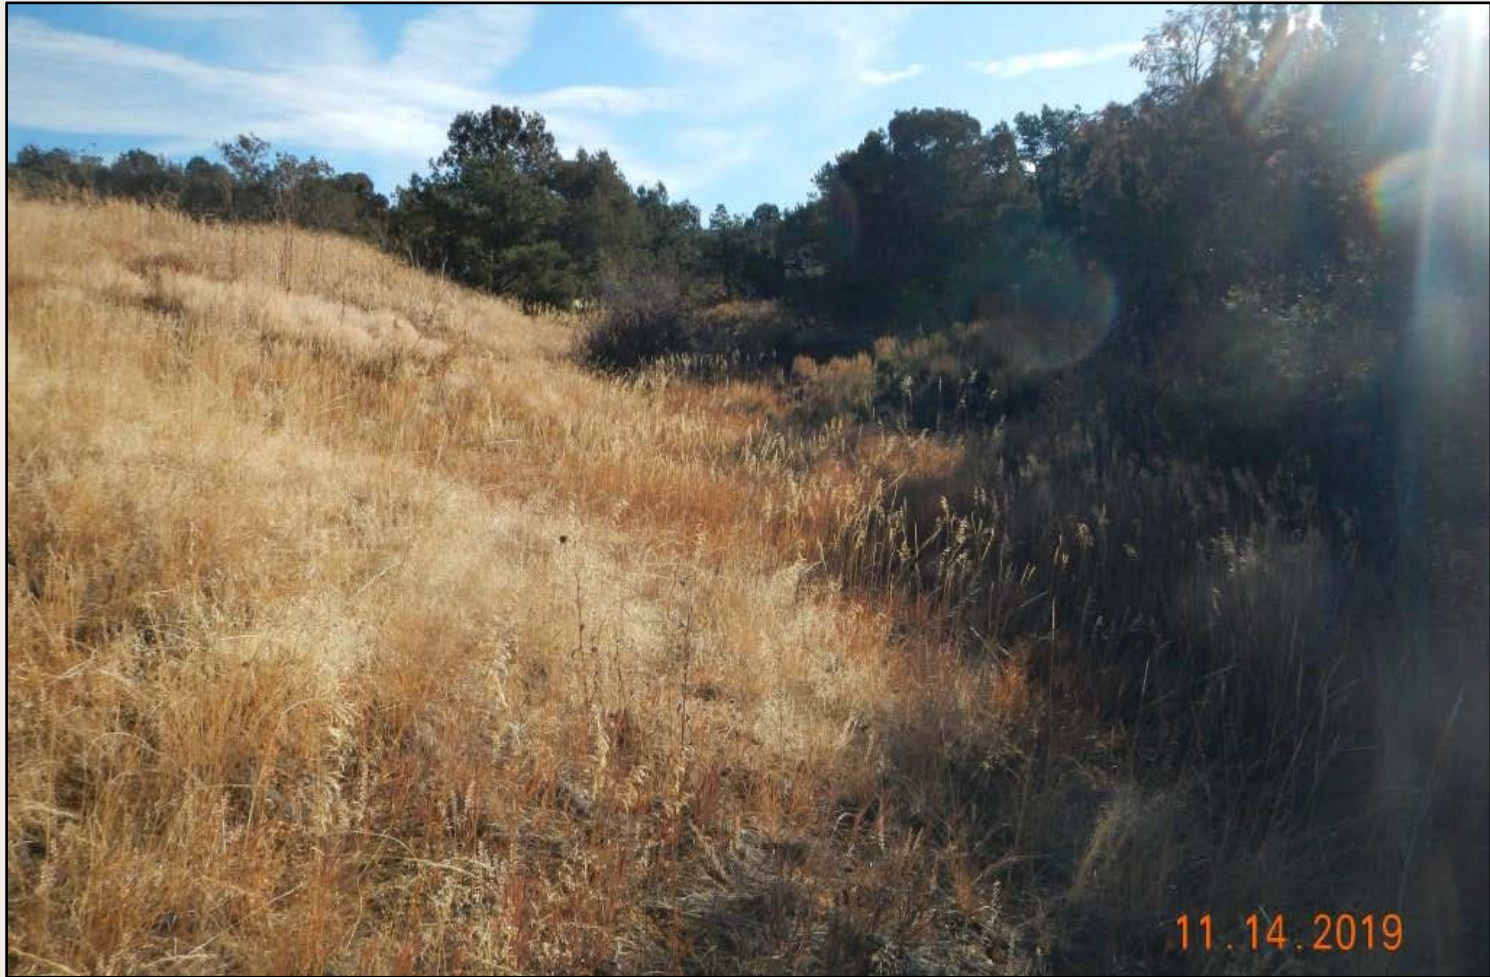
Photo 3. View of the southern project area from the southwestern corner facing eastward. Revegetation is progressing on fill slopes as described above.

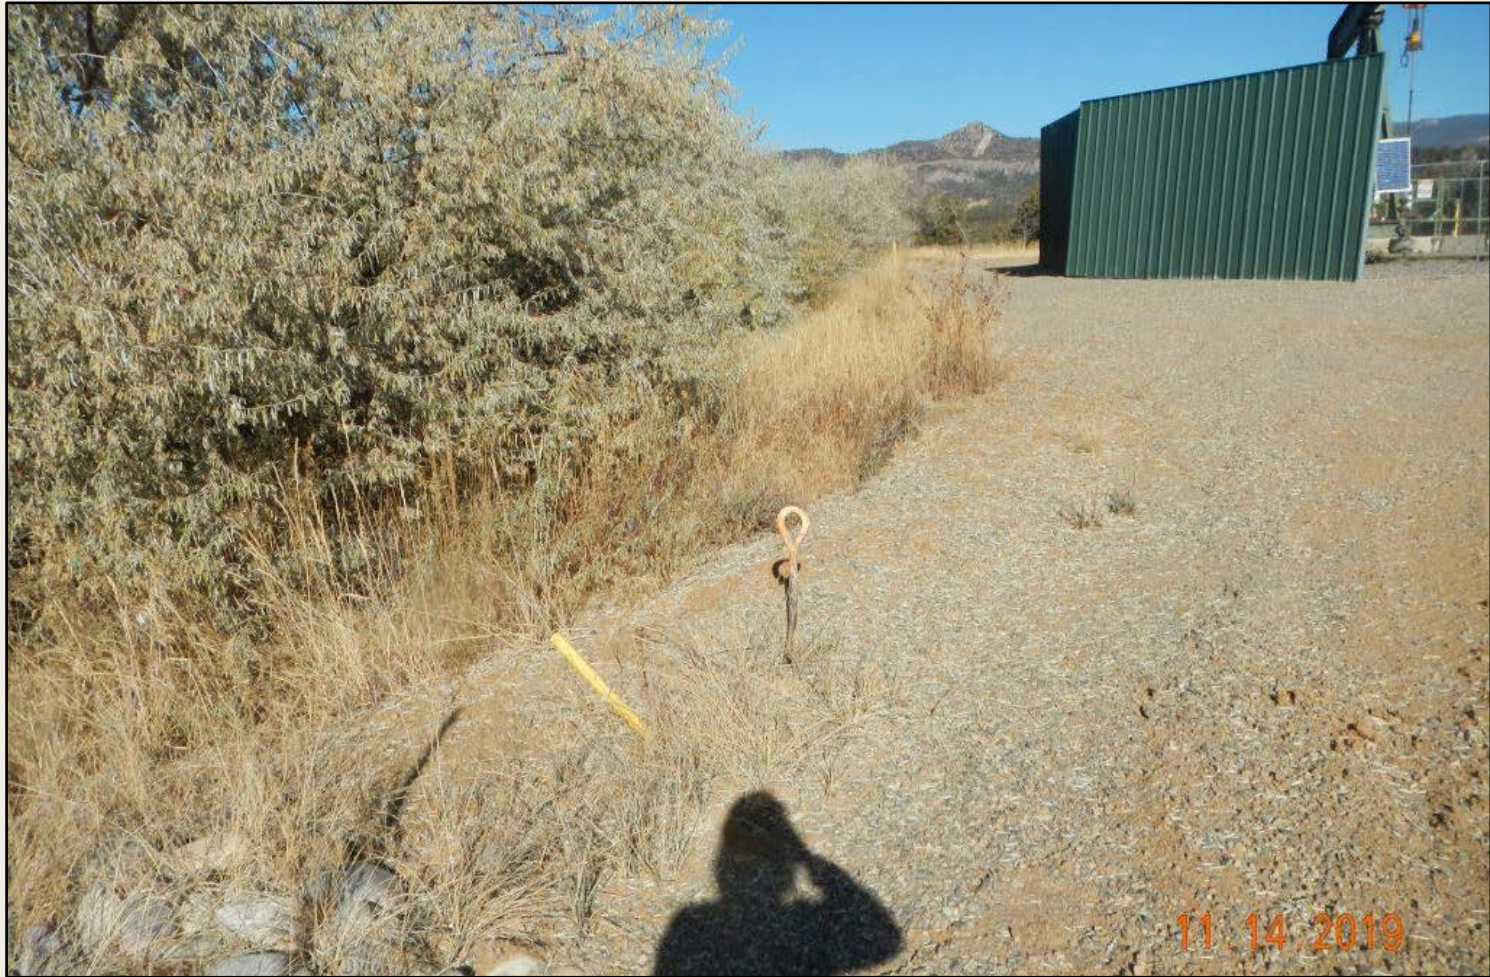
Photo 4. View of the western edge of the working area. Russian olive (*Eleagnus angustifolia*) trees line the edge of the working area. Russian olive is a state and La Plata County-B-List noxious weed species and needs to be removed.

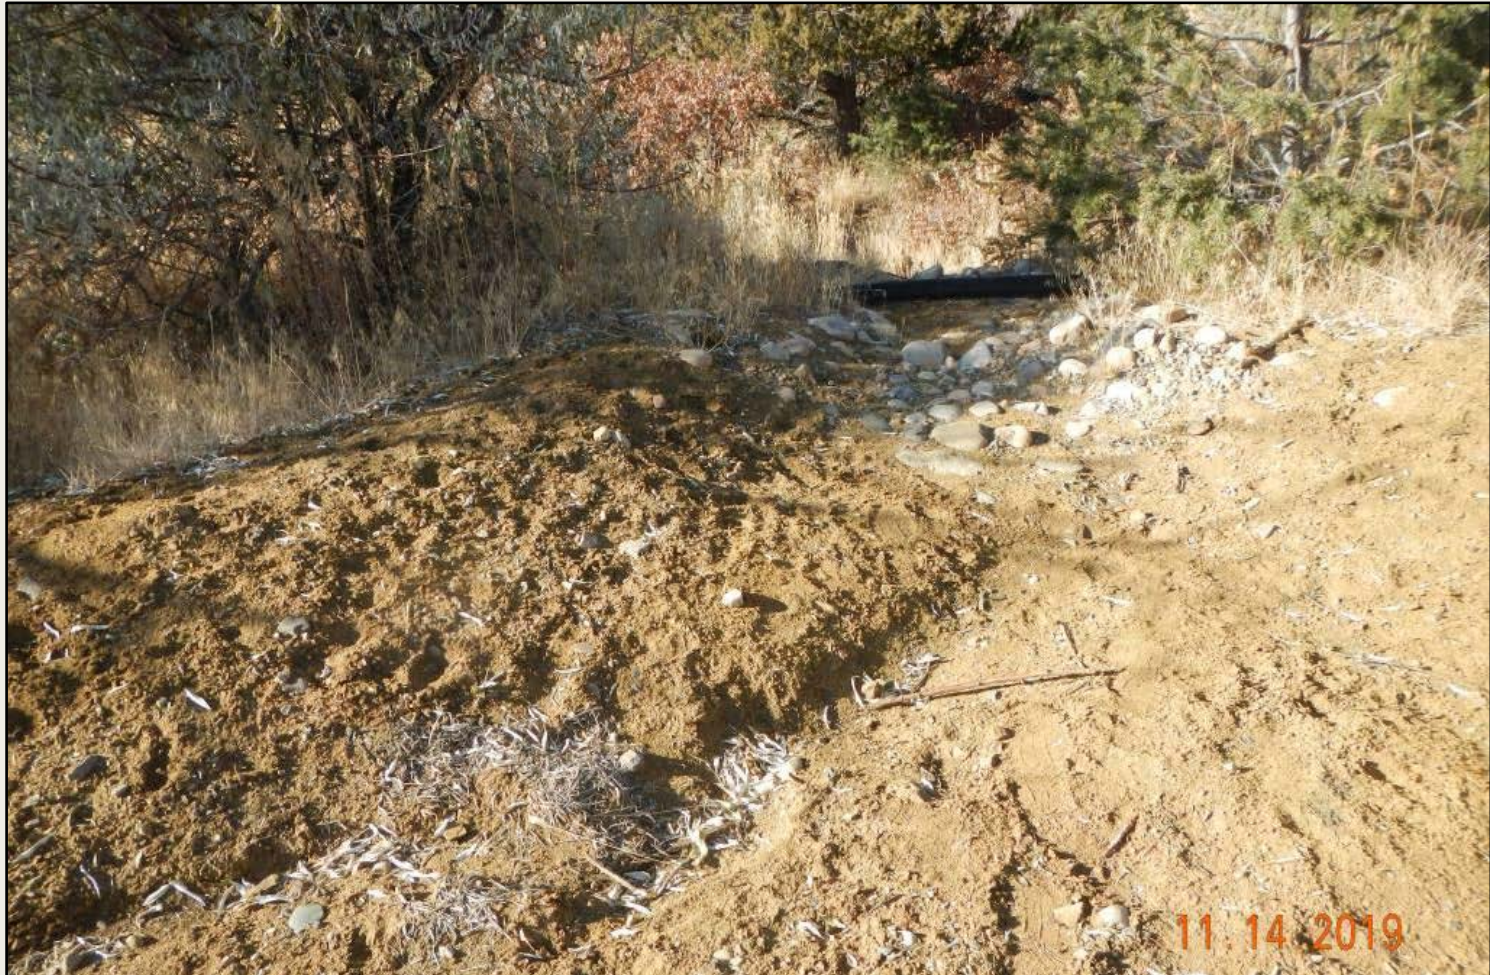
Photo 5. View of erosional rilling at the well pad entrance. BMPs are full of sediment.
