# Inspection Photos

Operator: Enduring Resources  
Location/API #: 067-08398  
Date: 11-14-2019

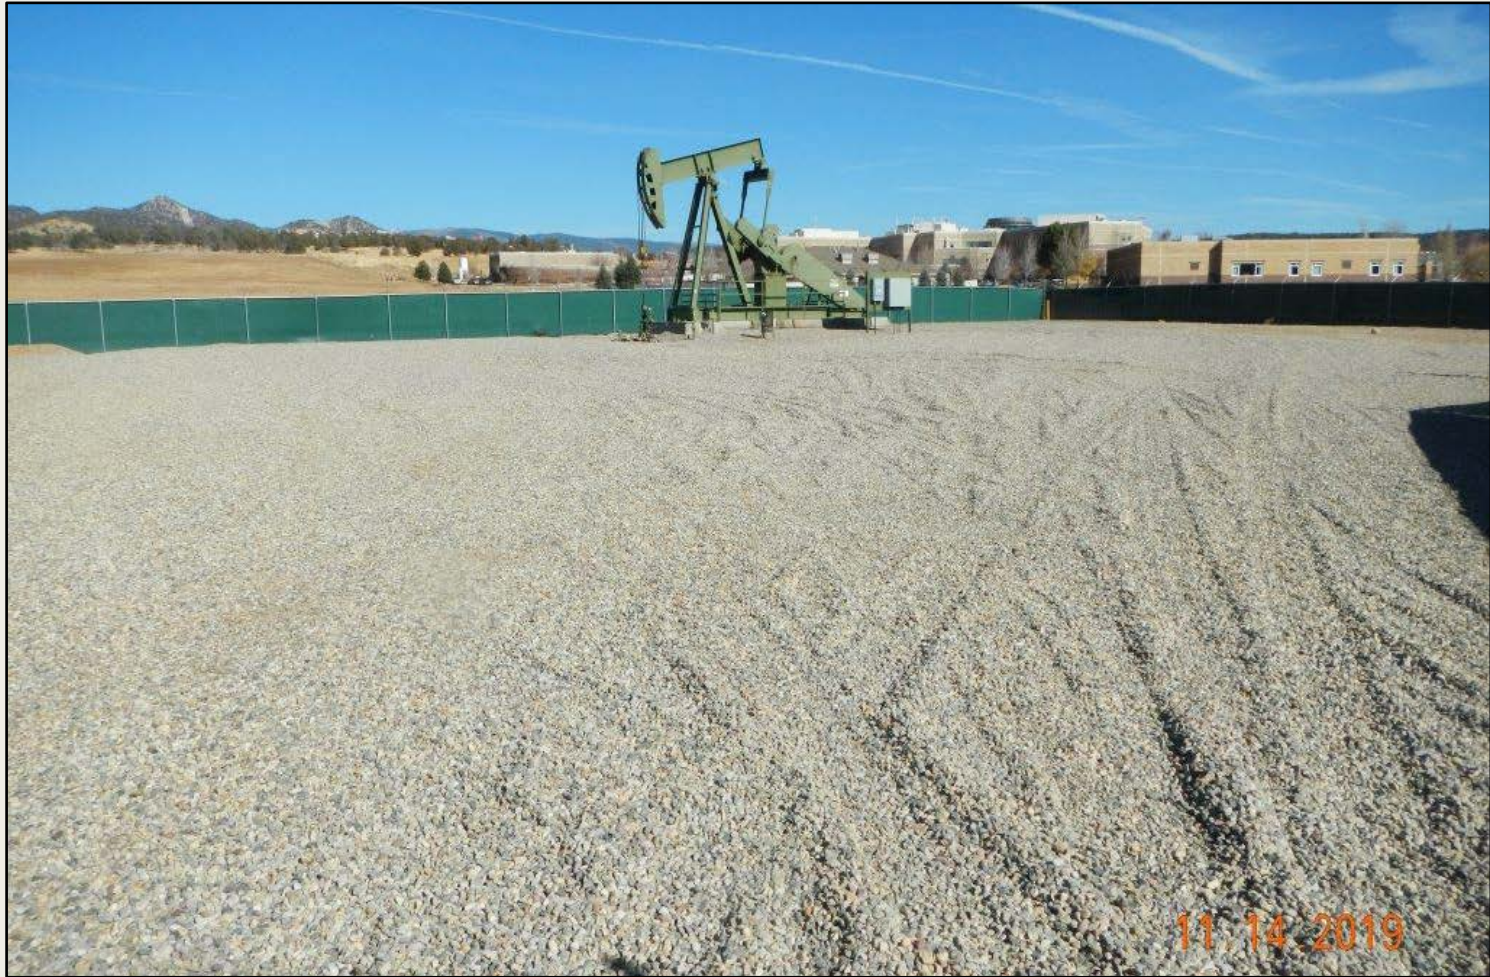
Photo 1. View of the project area from the well pad entrance facing center.

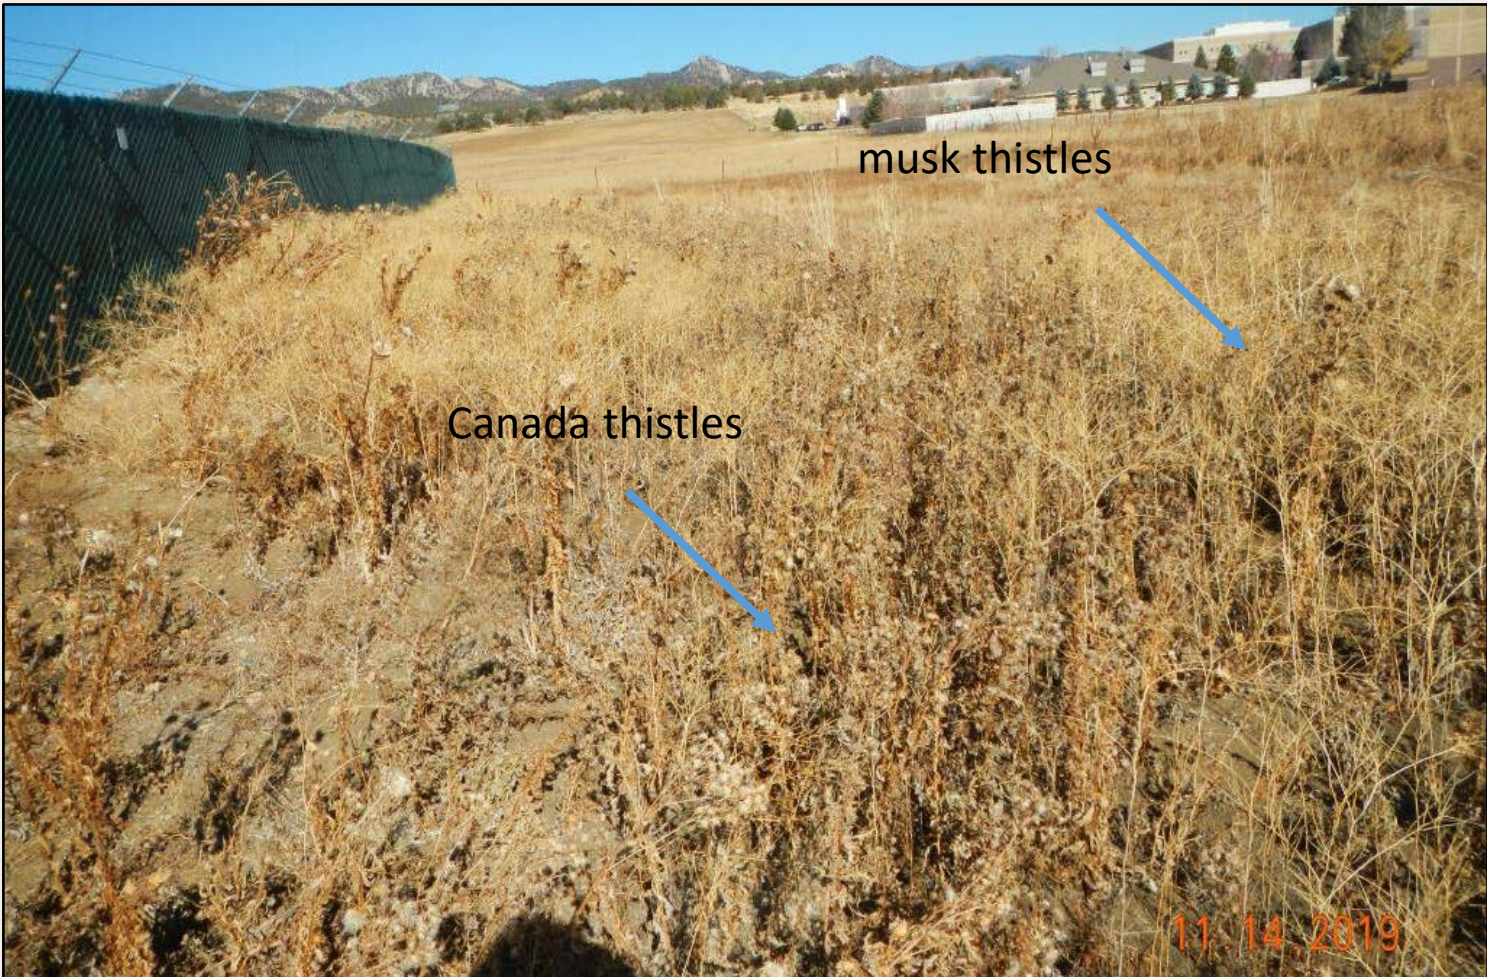
Photo 2. View of musk thistle and Canada thistle infestation in the eastern project area facing northward.

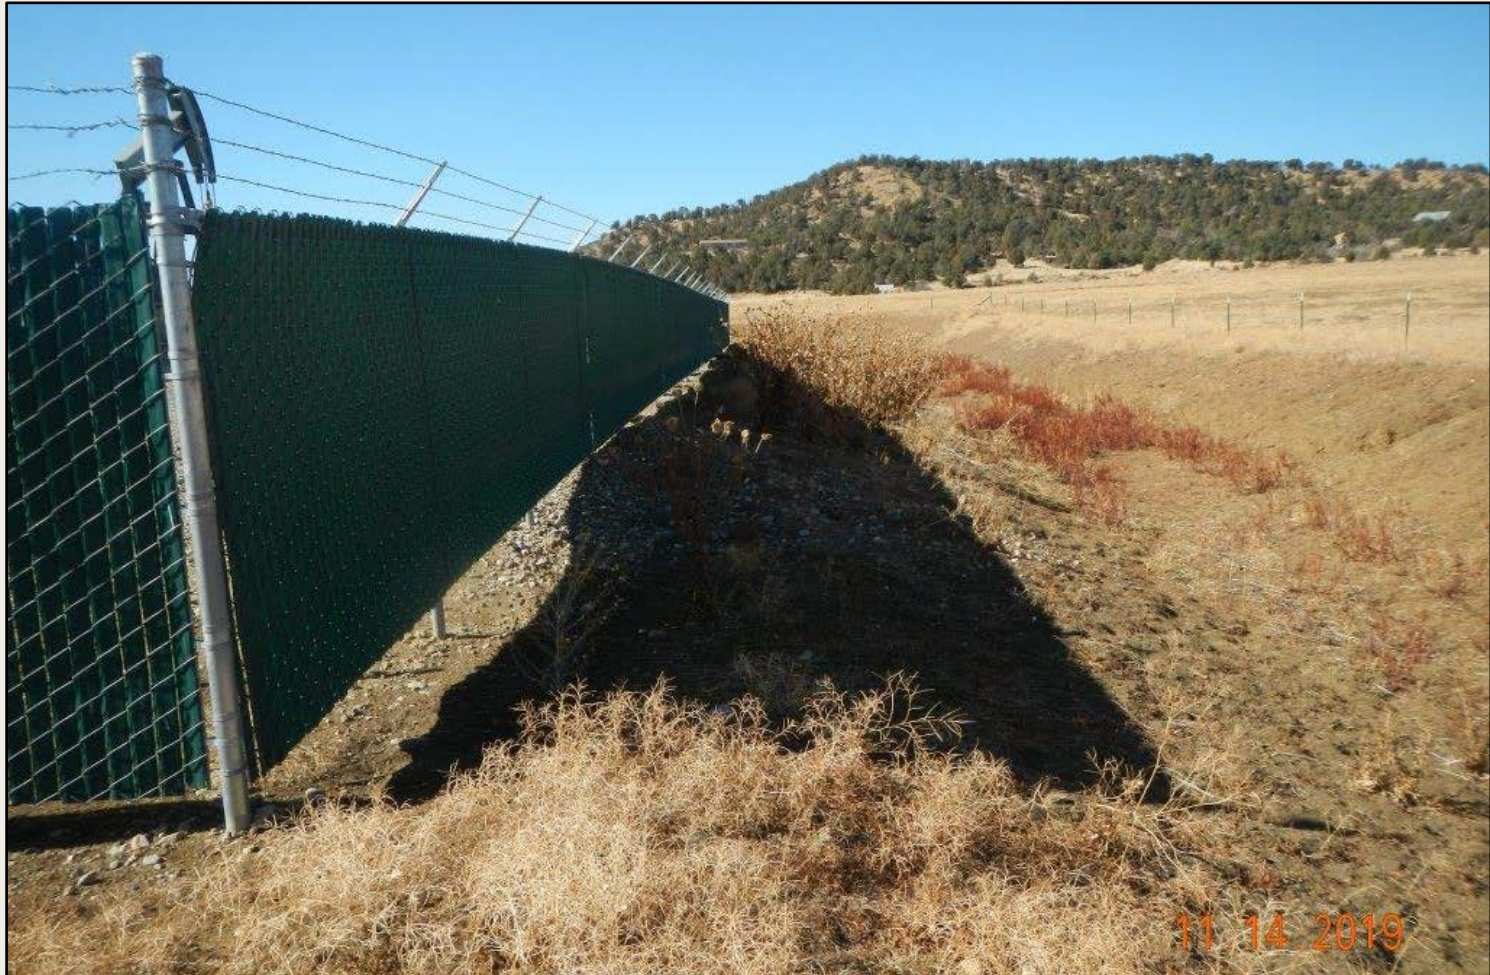
Photo 3. View of the northern project area from the northeastern corner facing westward. Area is infested with musk thistles, with little desirable vegetation present.

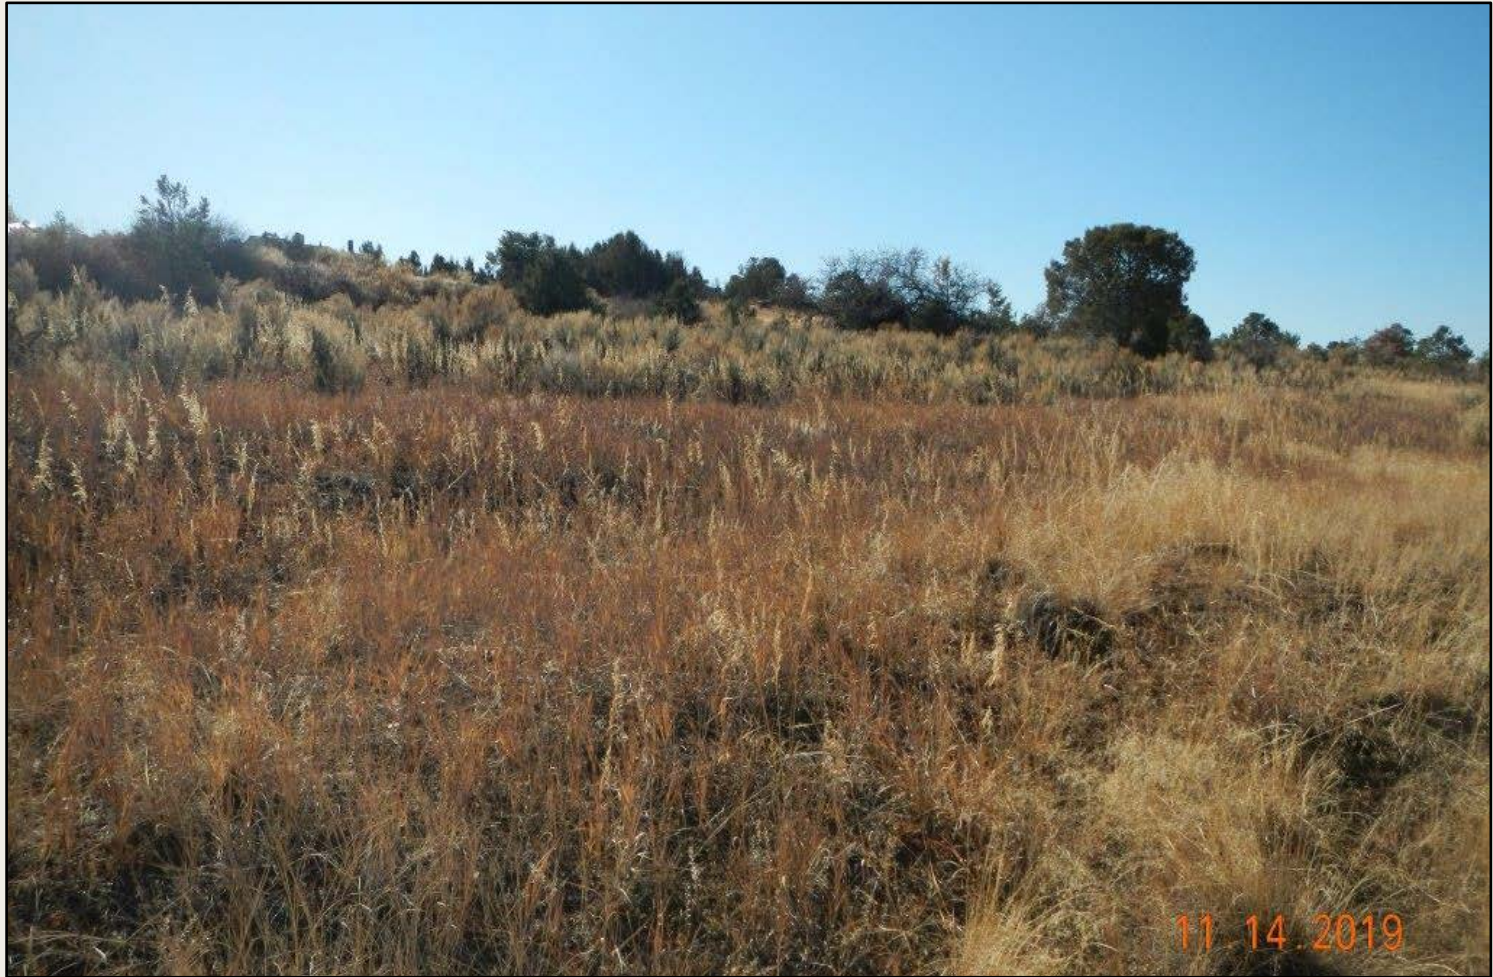
Photo 4. View of reference area, comprised of sagebrush shrubland, with grasses planted in openings.
