Inspection Photos  
Operator: Williford Resources  
Location/API #: 067-06719  
Date: 11-19-2019

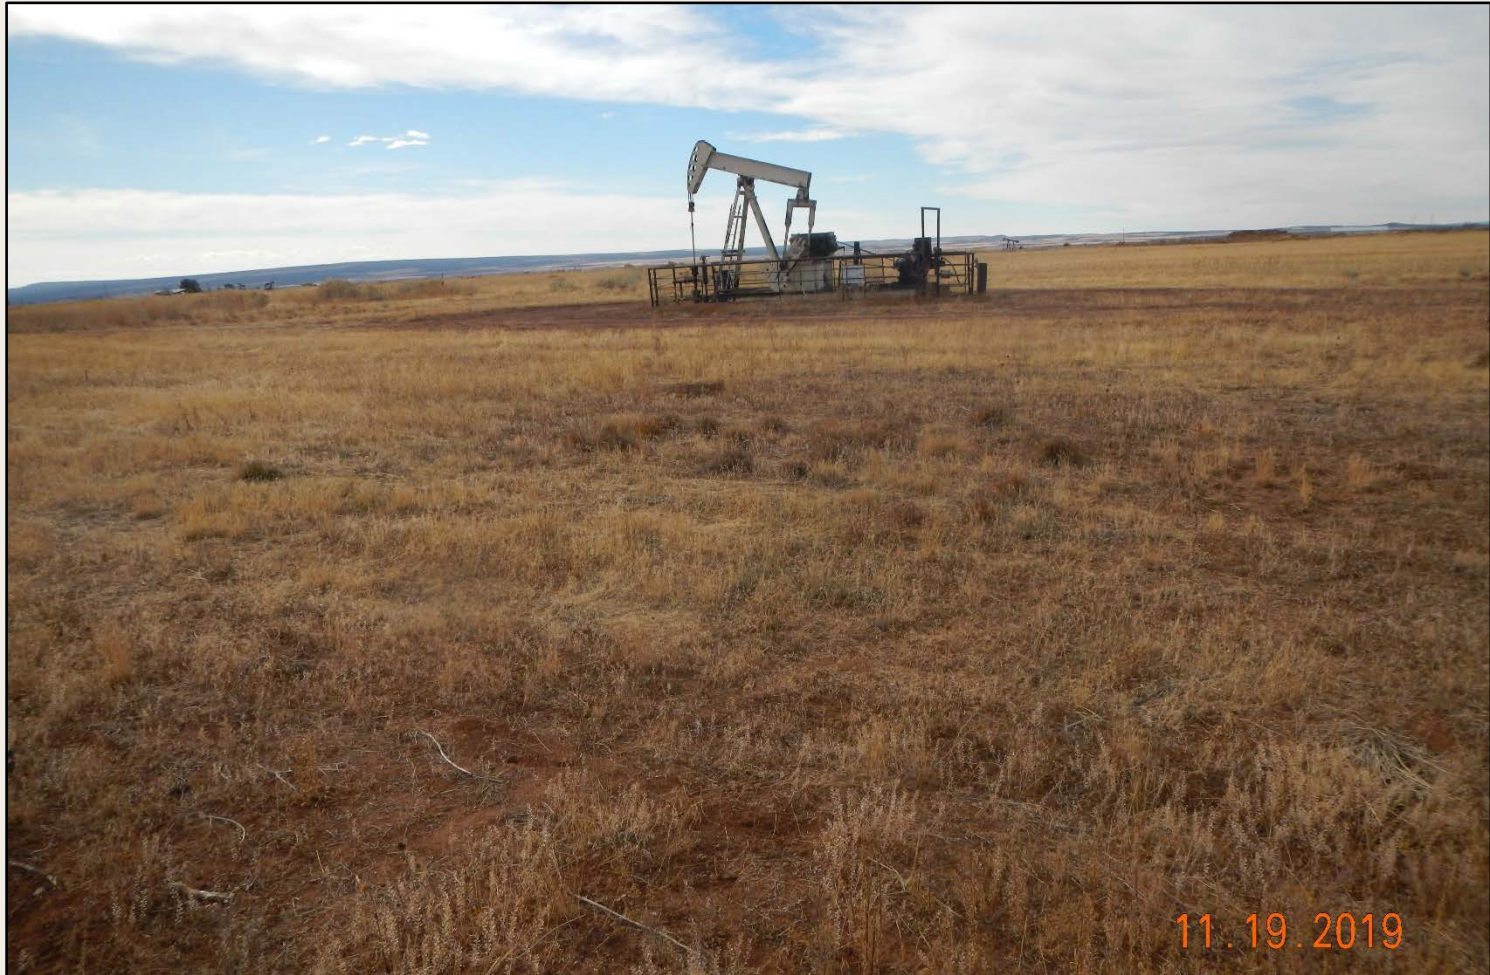
Photo 1. View of the project area from the northeastern corner facing center.

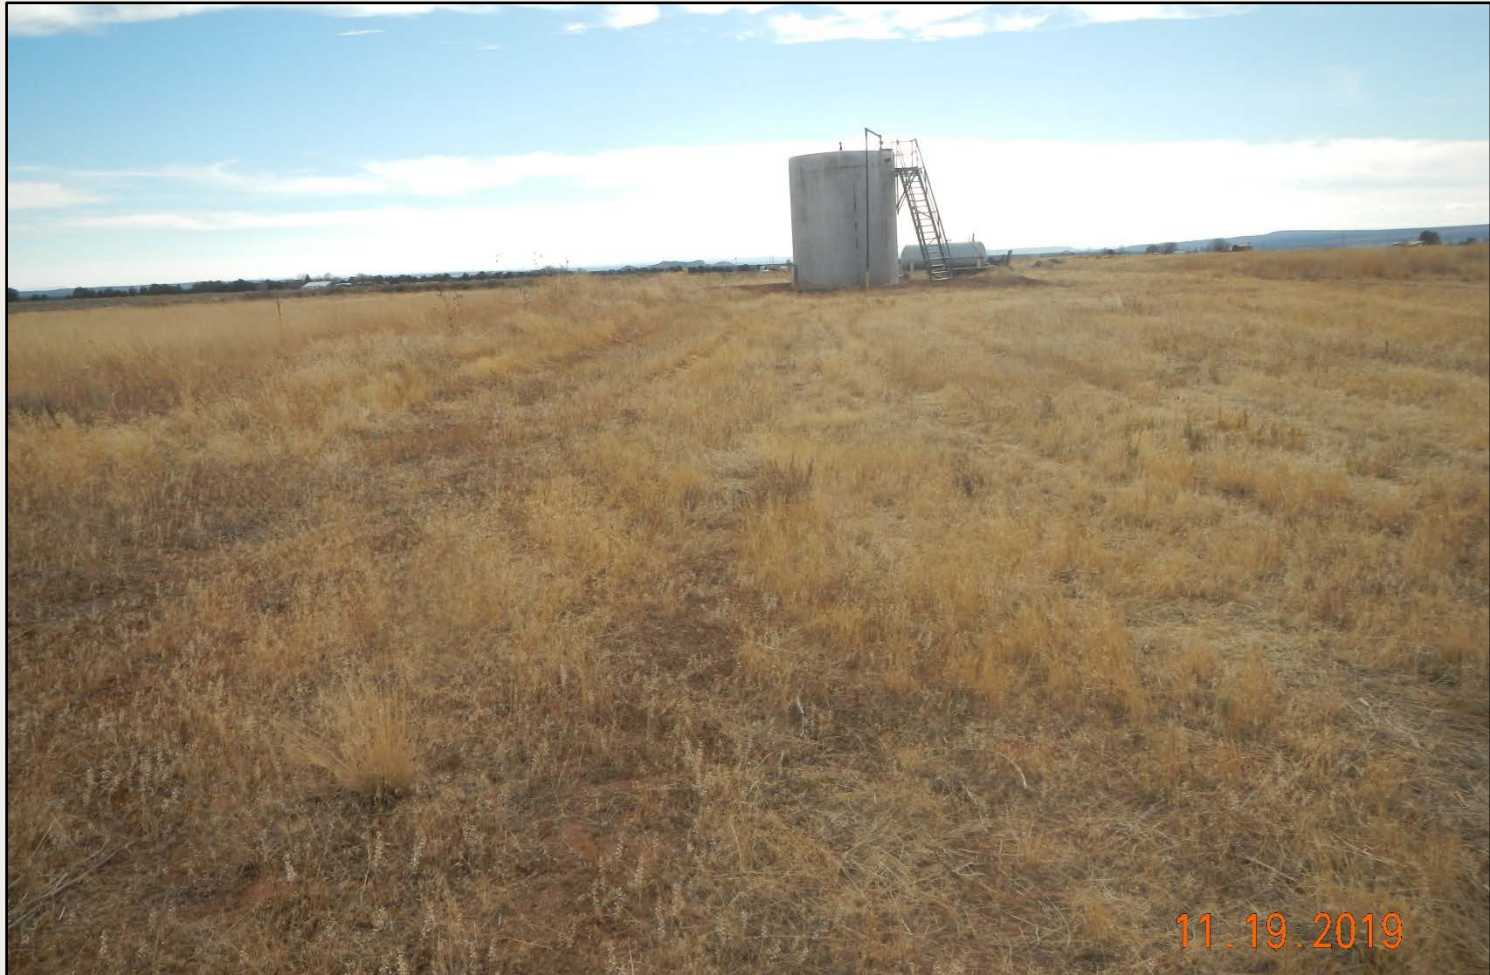
Photo 2. View of the eastern project area from the northeastern corner facing southward. Revegetation is progressing in portions of the project area with mixed wheatgrasses, such as crested wheatgrass and western wheatgrass, as well as annual weeds such as cheatgrass and alyssum.

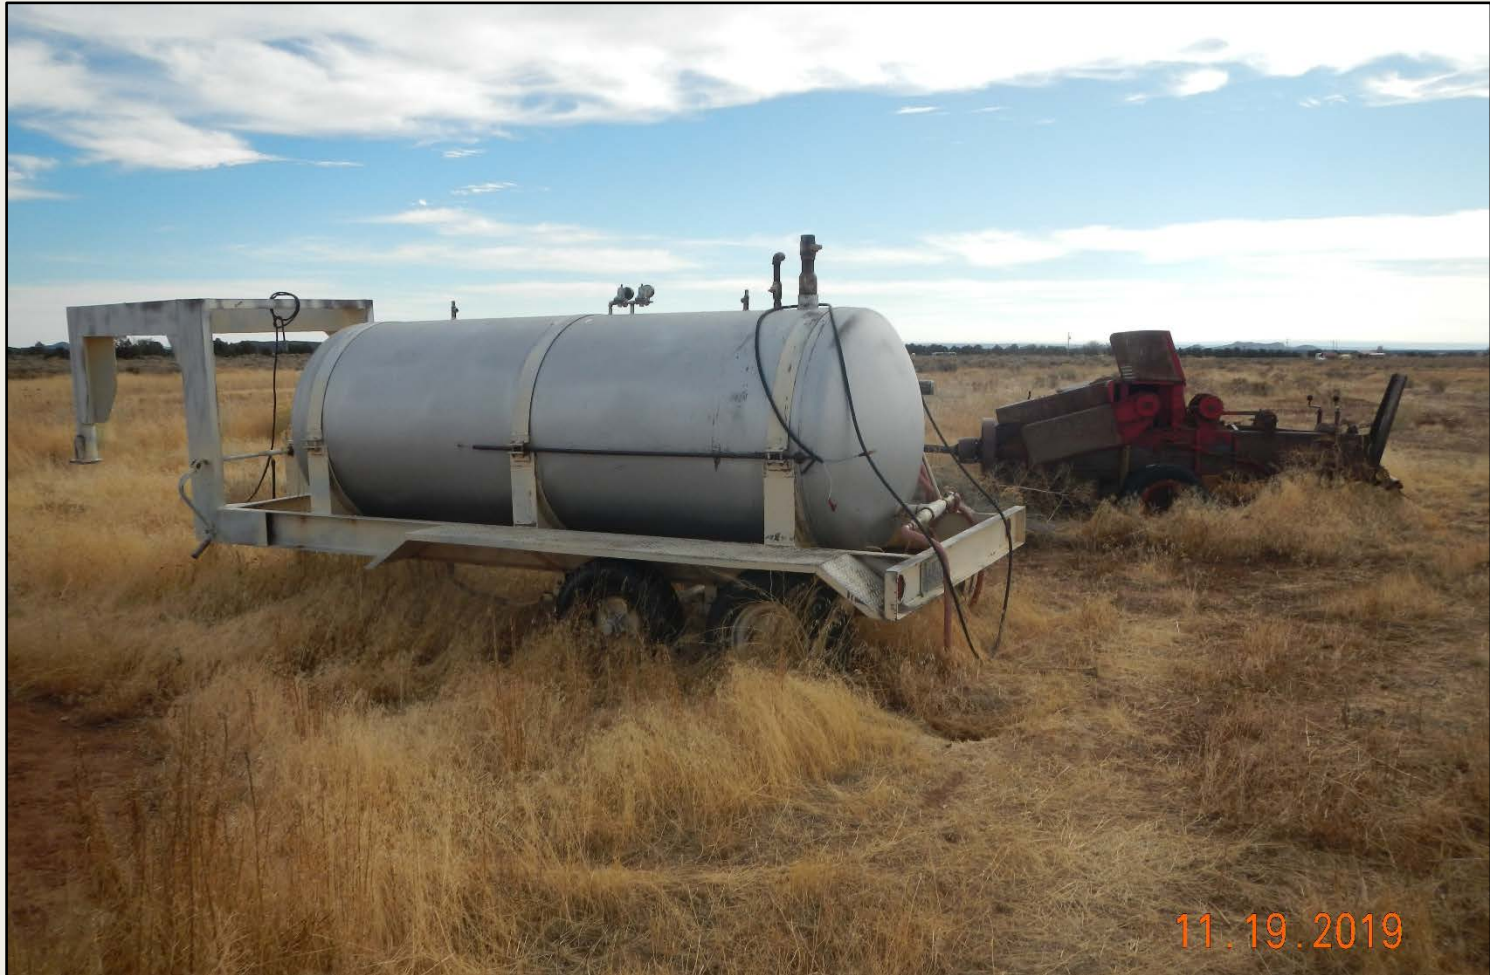
Photo 3. View of unused equipment within the southeastern project area.

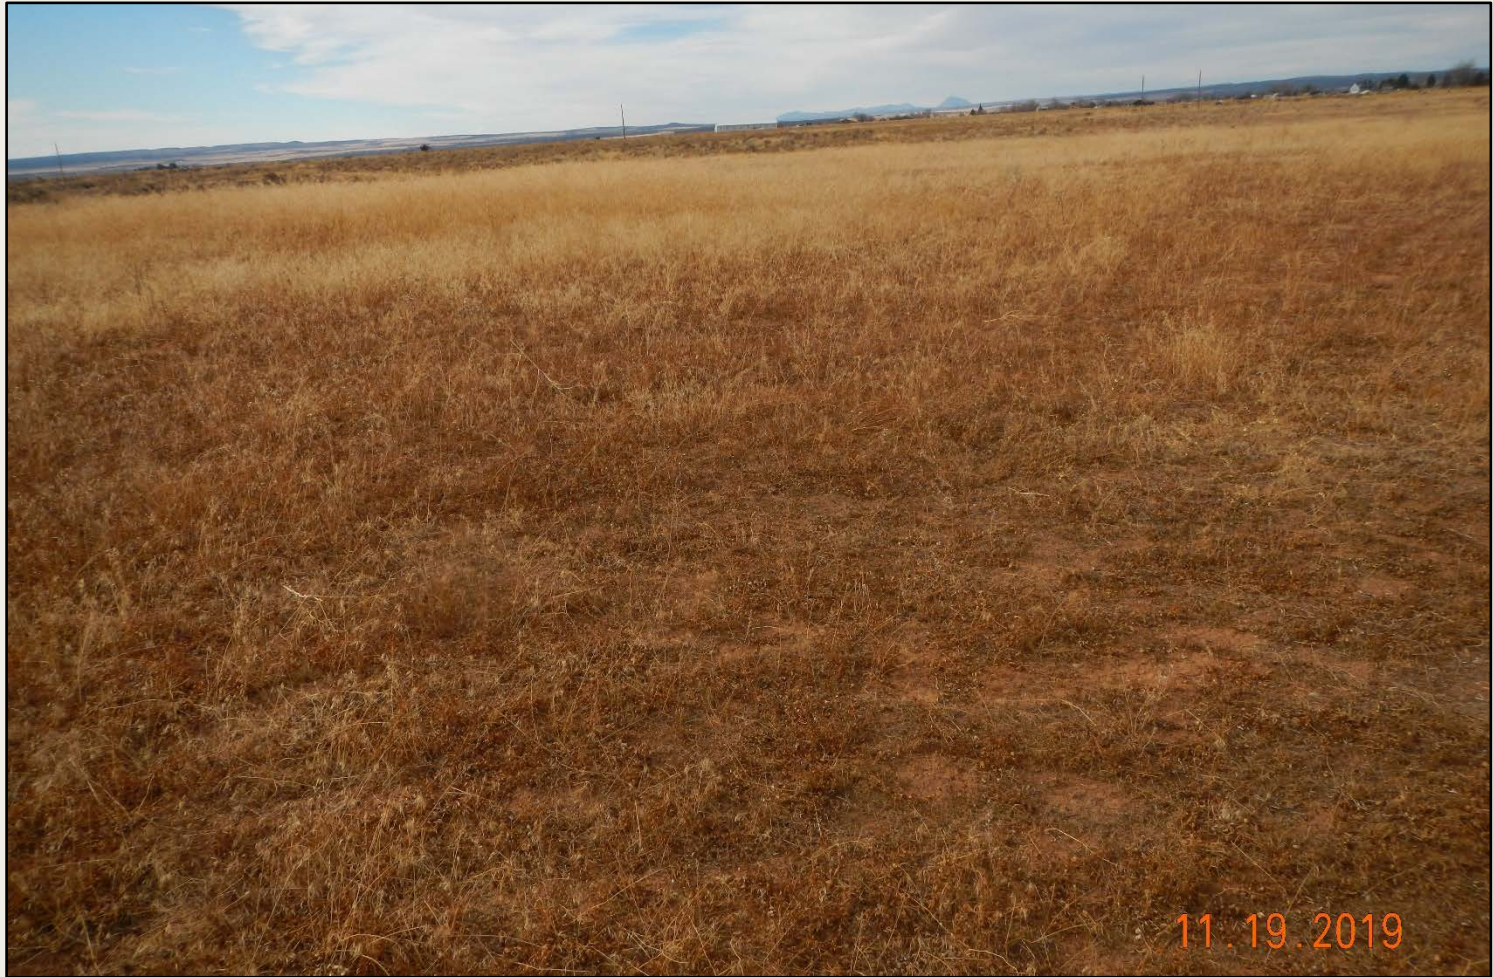
Photo 4. View of reference area, comprised of open grass field.
