Inspection Photos
Operator: Williford Resources
Location/API #: 067-06624
Date: 11-19-2019

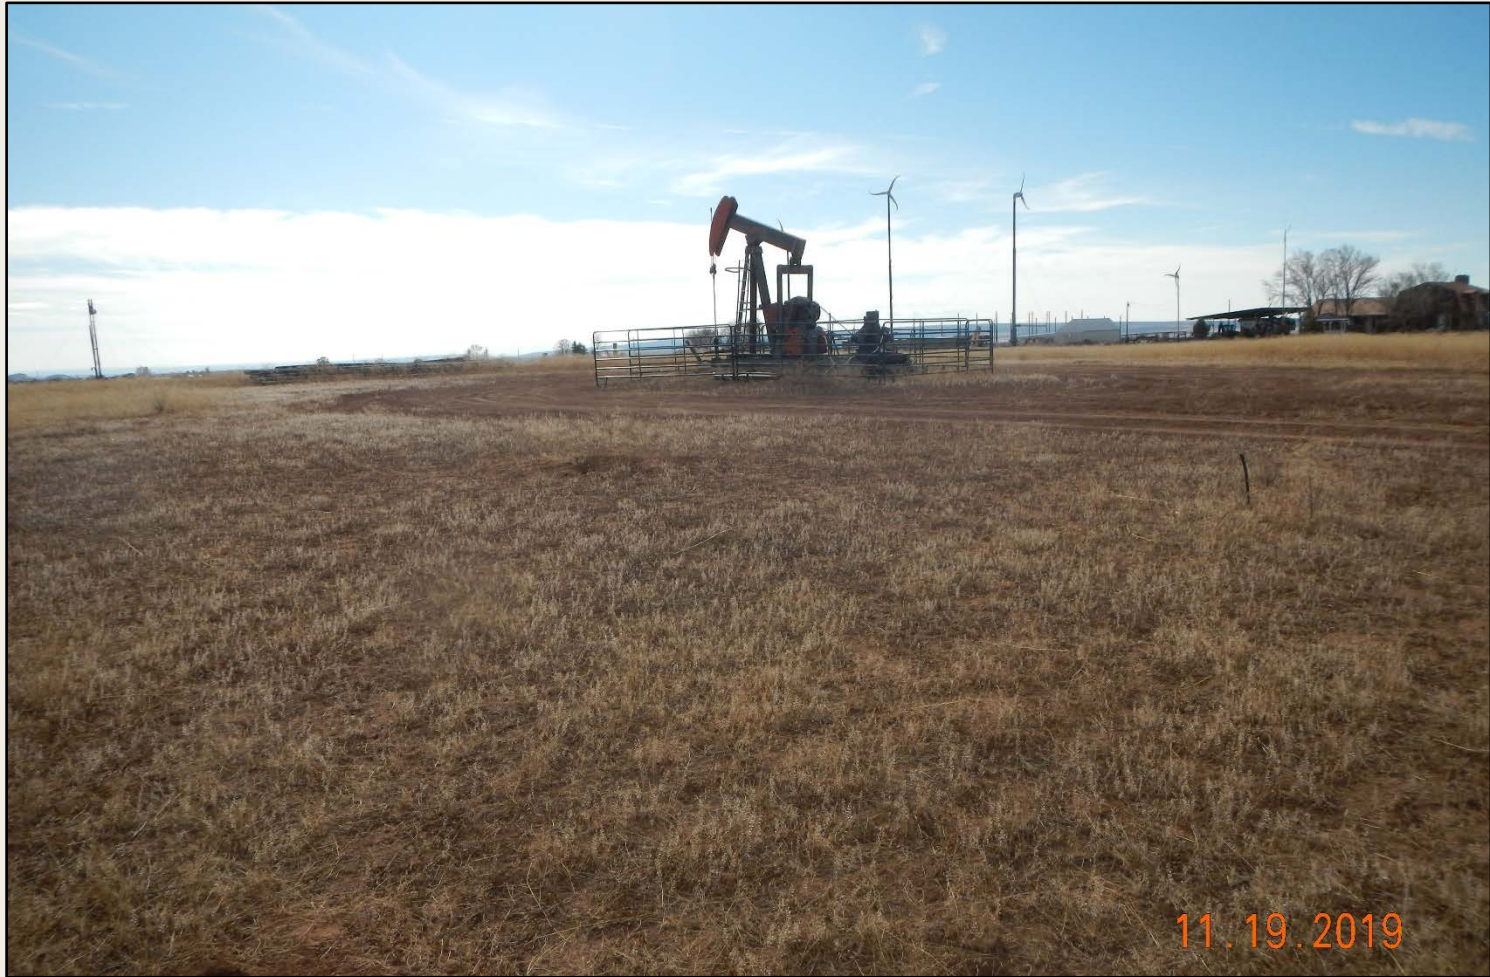
Photo 1. View of the project area from the northeastern corner facing center. Revegetation is progressing in portions, with grasses such as crested wheatgrass, but remains weedy in other portions with annual weeds such as yellow tumble mustard and alyssum.

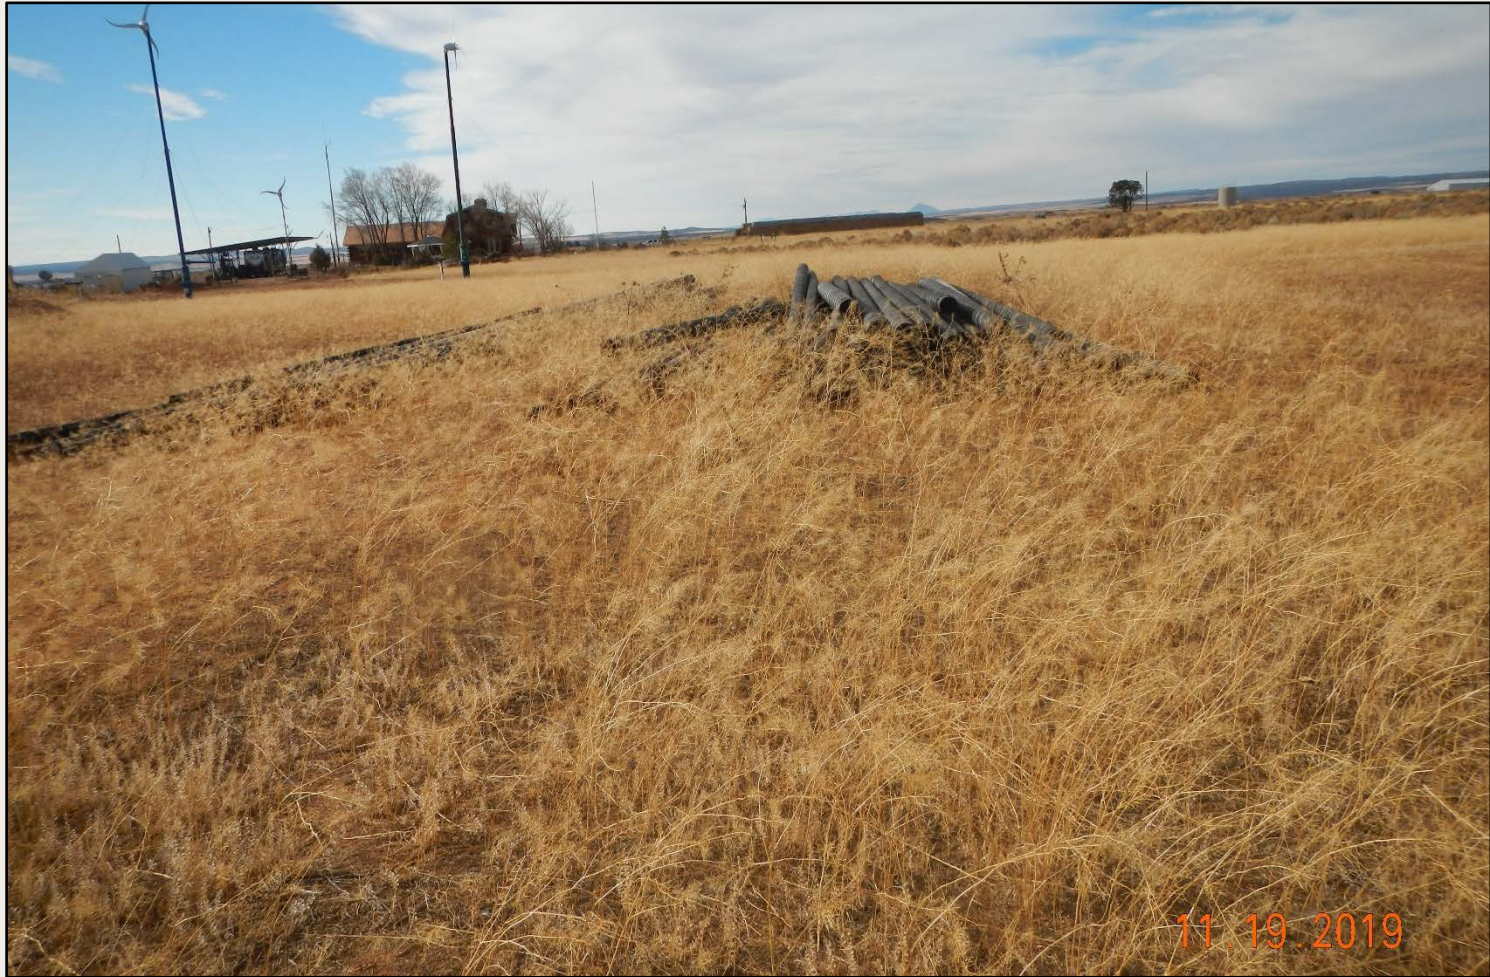
Photo 2. View of unused pipe within the southeastern project area.

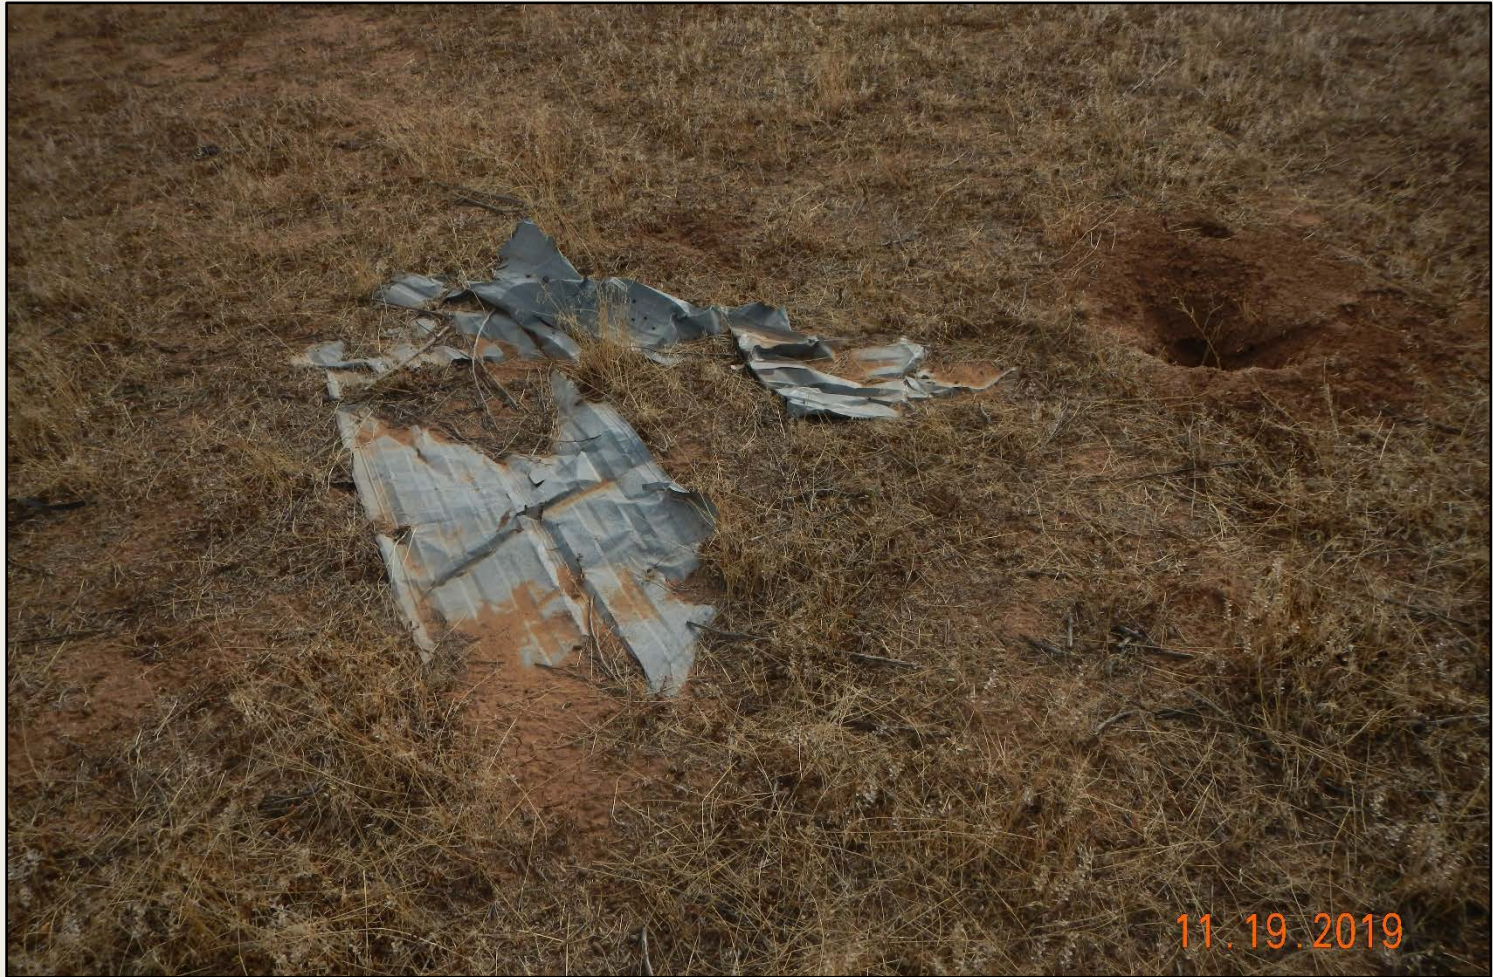
Photo 3. View of metal debris in the eastern project area.

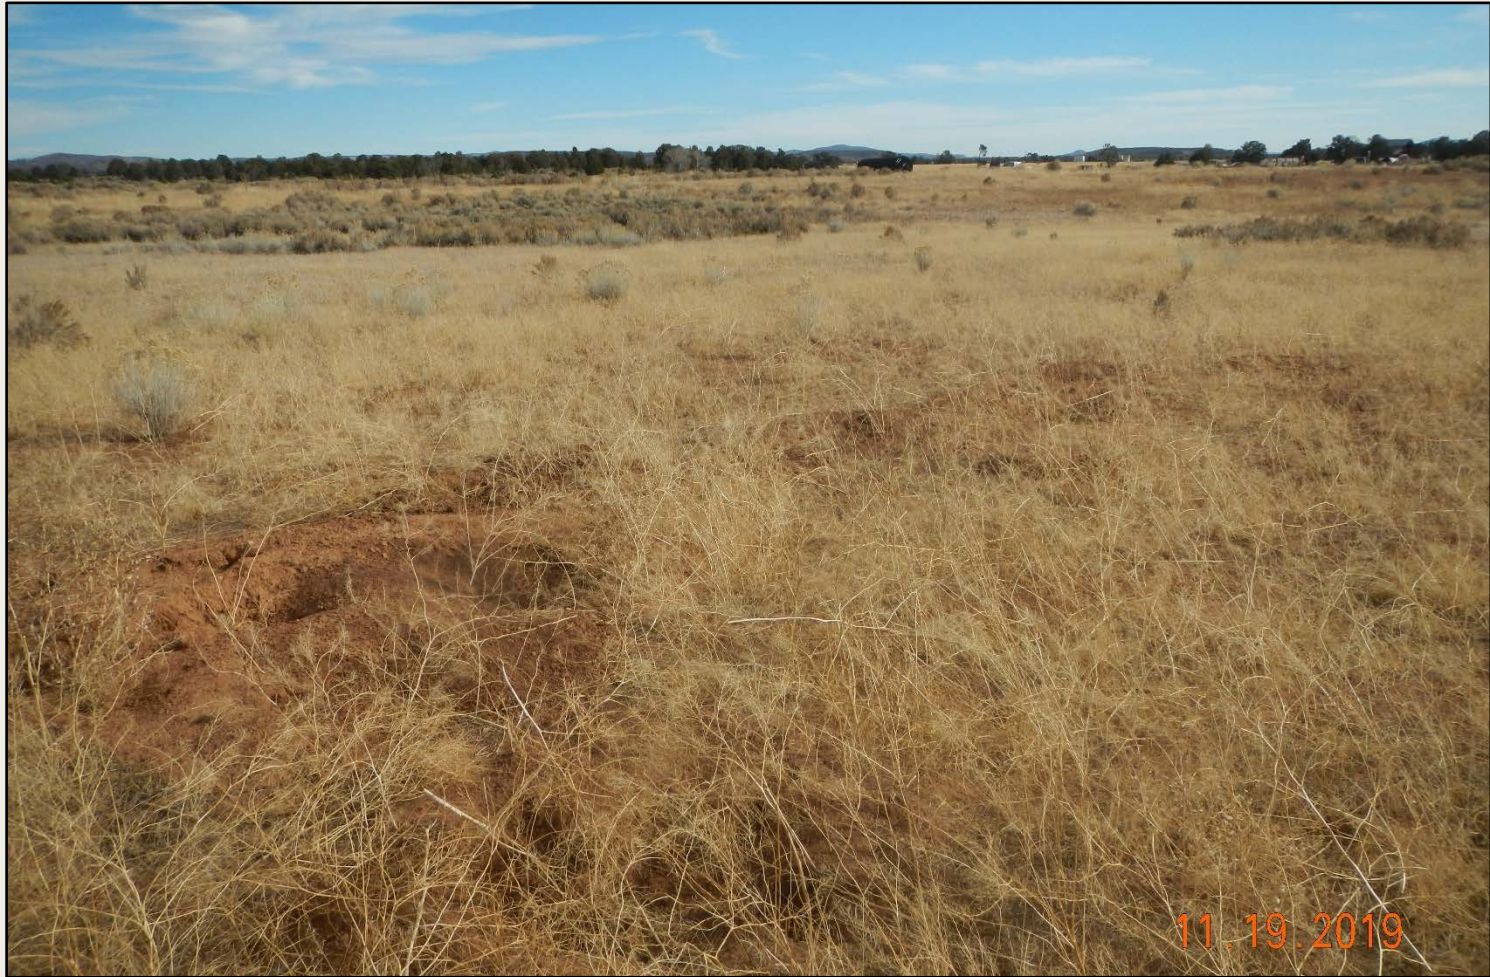
Photo 4. View of reference area, comprised of sagebrush shrubland/grass field mosaic, with grasses (crested wheatgrass) and annual weeds in openings.
