Inspection Photos

API: 05-043-06222

Operator: INCREMENTAL OIL & GAS (FLORENCE) LLC

Inspection Date: 12/4/2019

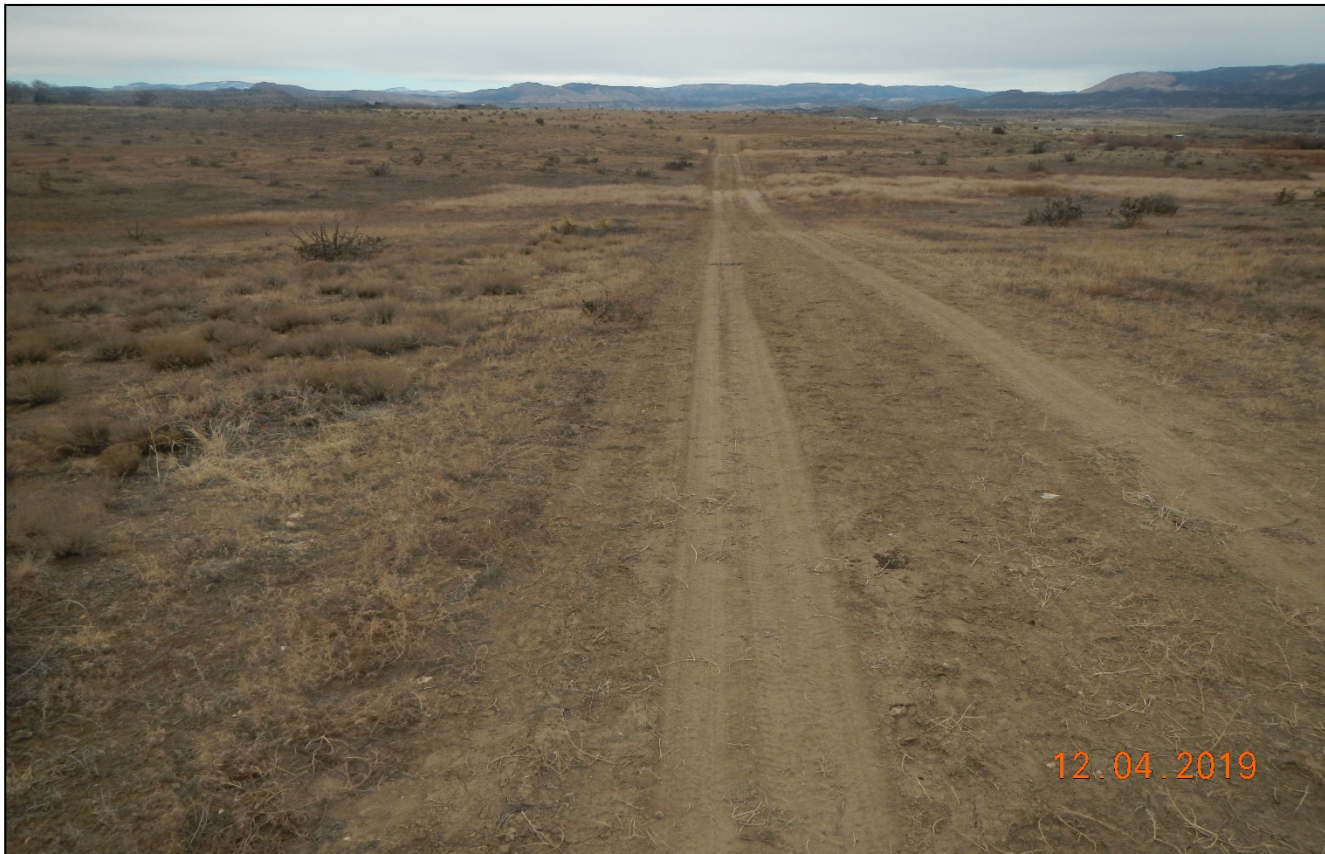
Photo 1. Facing northwest along the access road which appears to be driven on and not reclaimed.

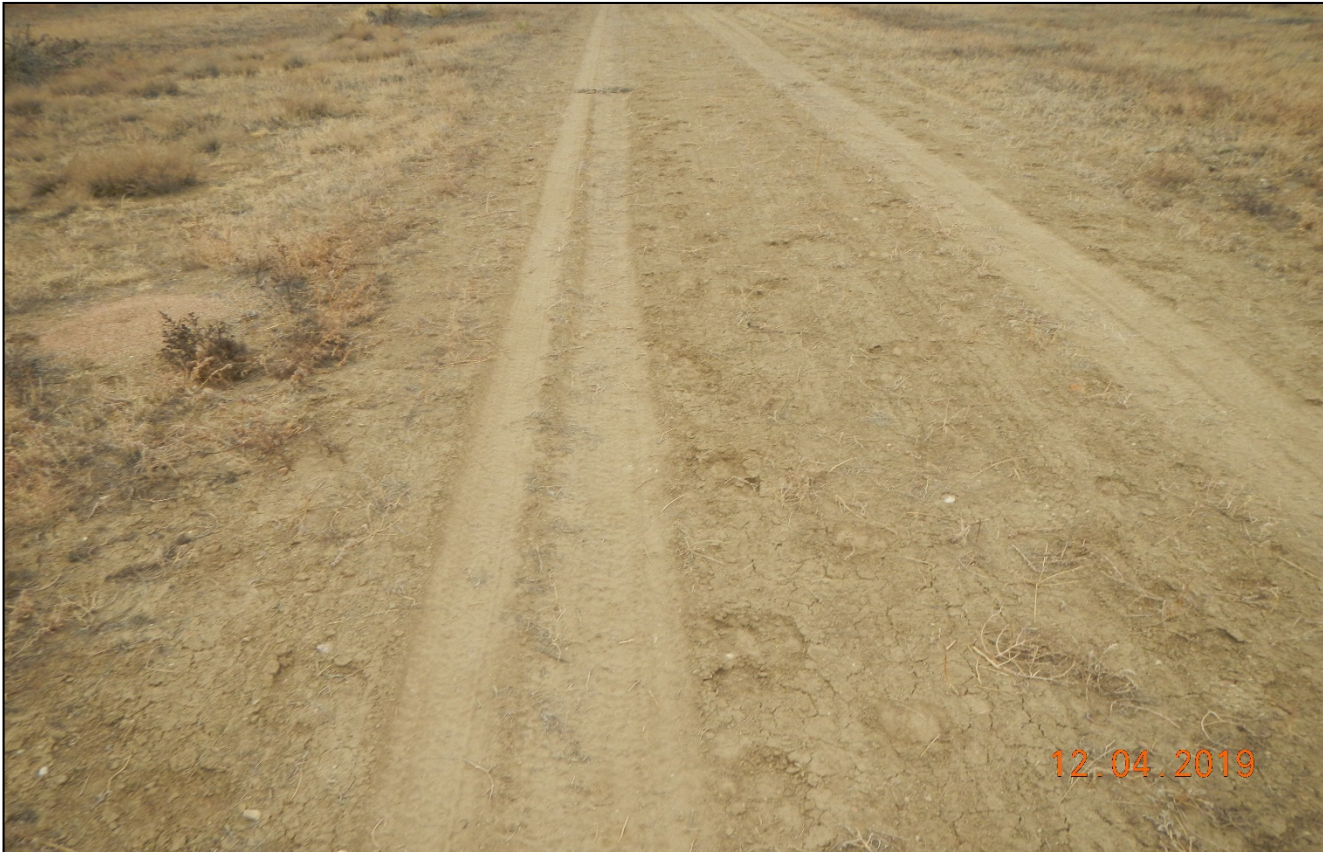
Photo 2. Vegetation is not established along the former access road.

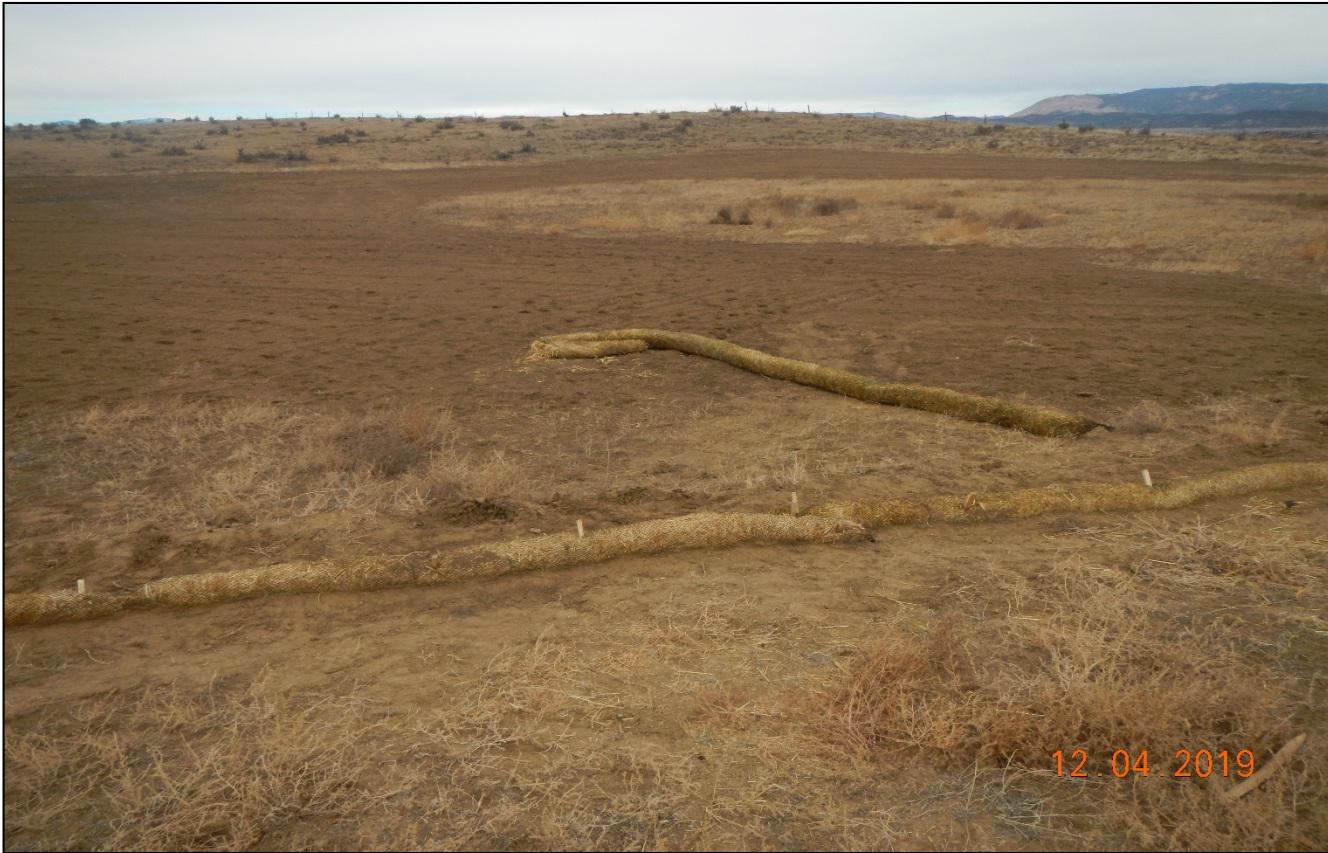
Photo 3. Facing northwest toward the location. There are wattles displaced at the southeast side.

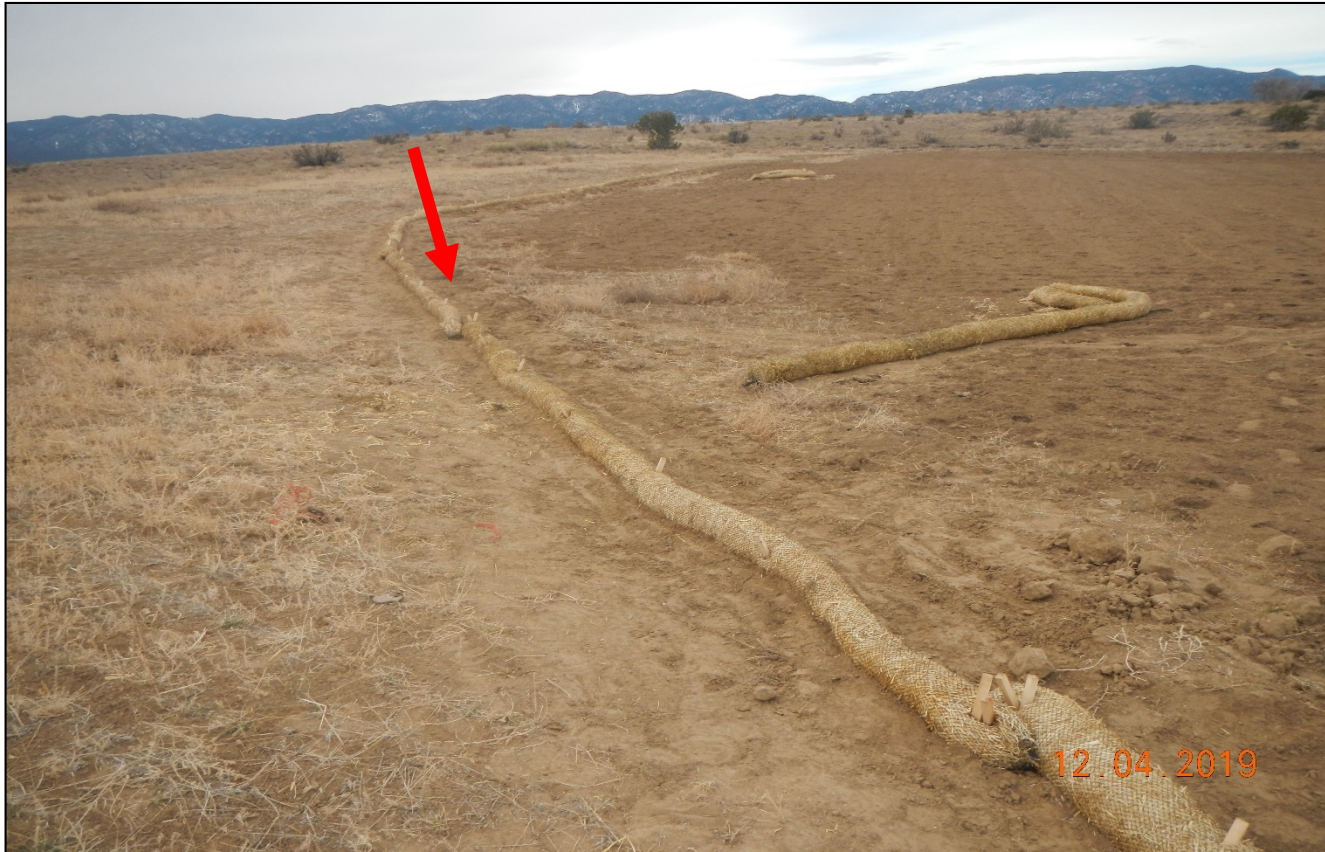
Photo 4. Facing west toward the southern portion of the location. A berm, small ditch, and wattles are installed around the southern perimeter. The concern is that the ditch is directed downhill which can accelerate stormwater and cause erosion.

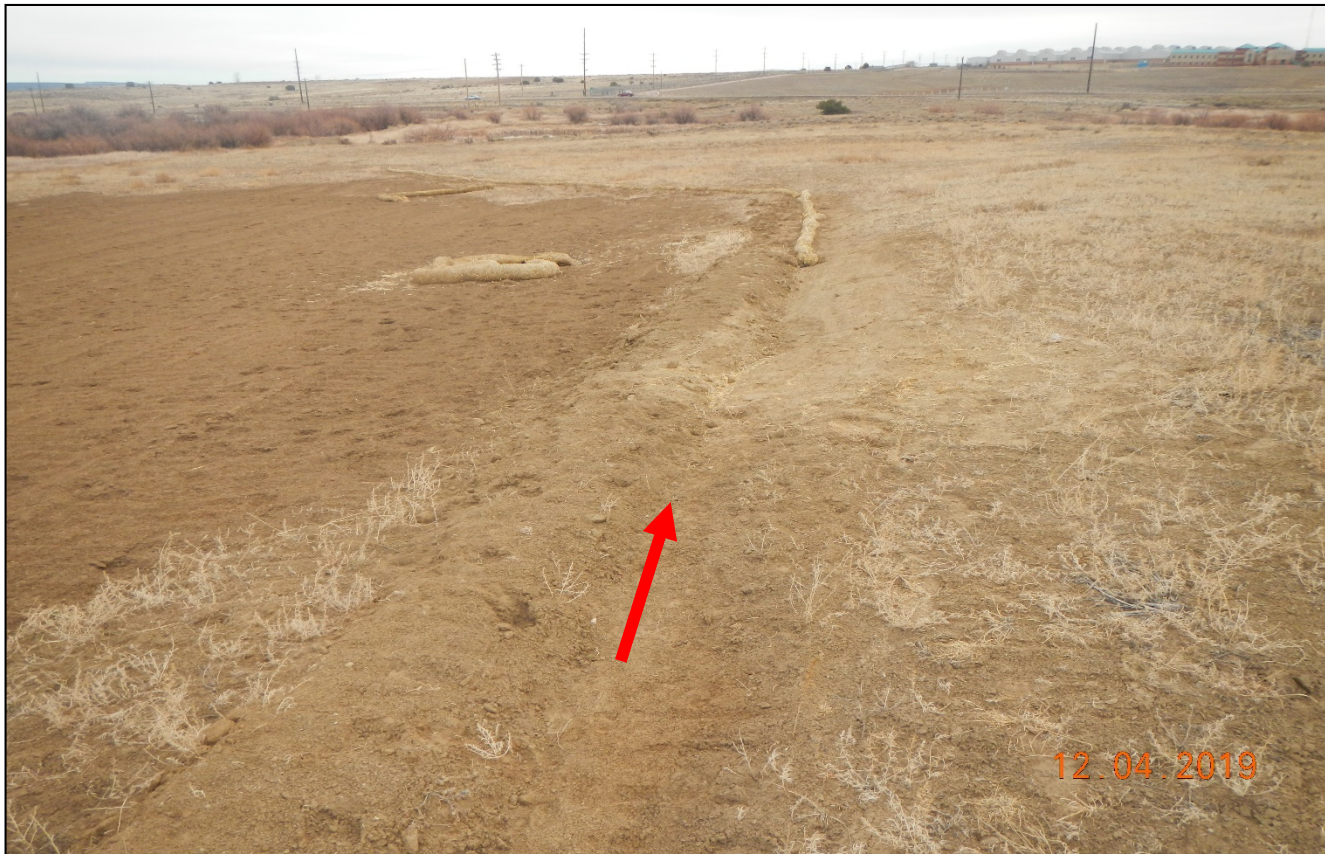
Photo 5. Facing east. The small ditch and berm is directed down hill.

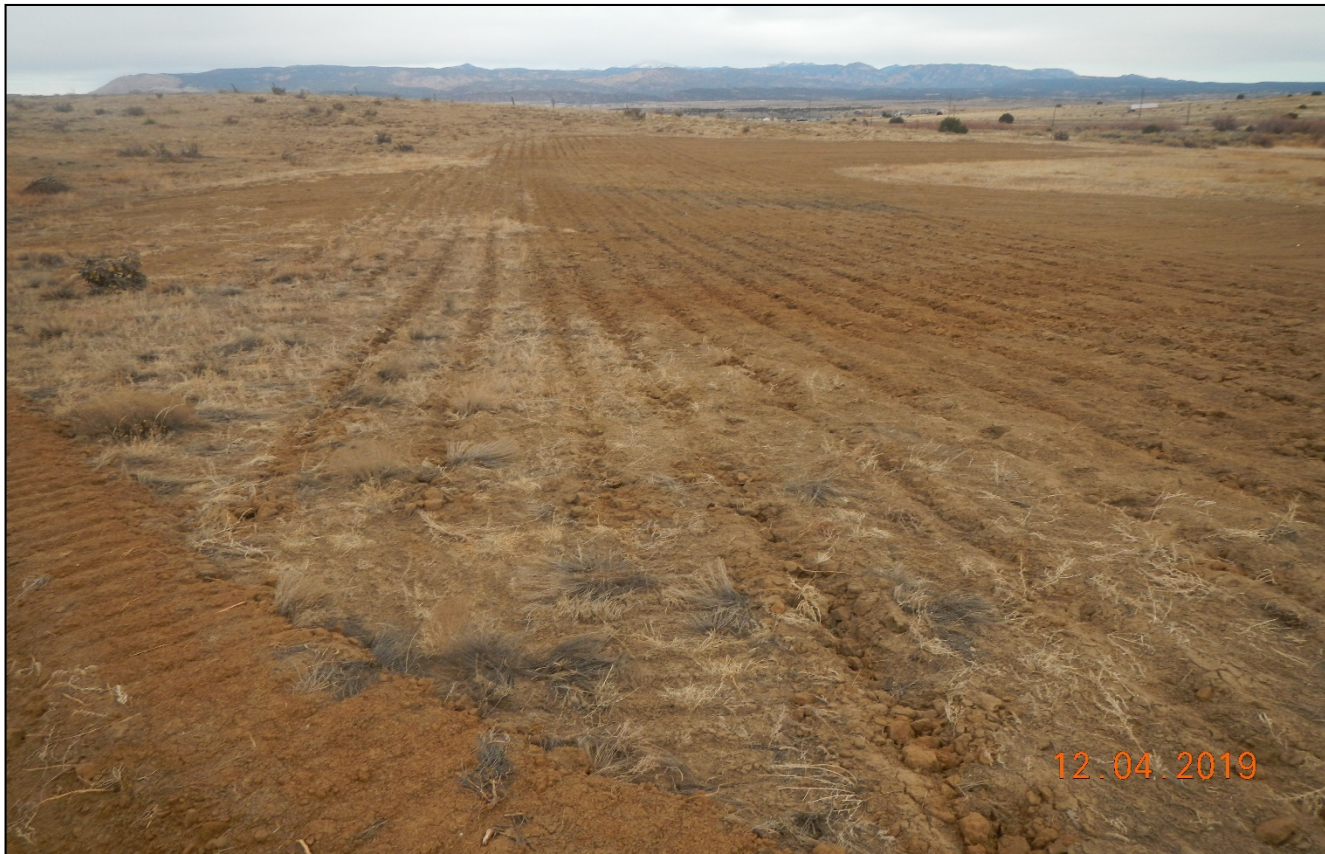
Photo 6. Facing north at the west side of the location.

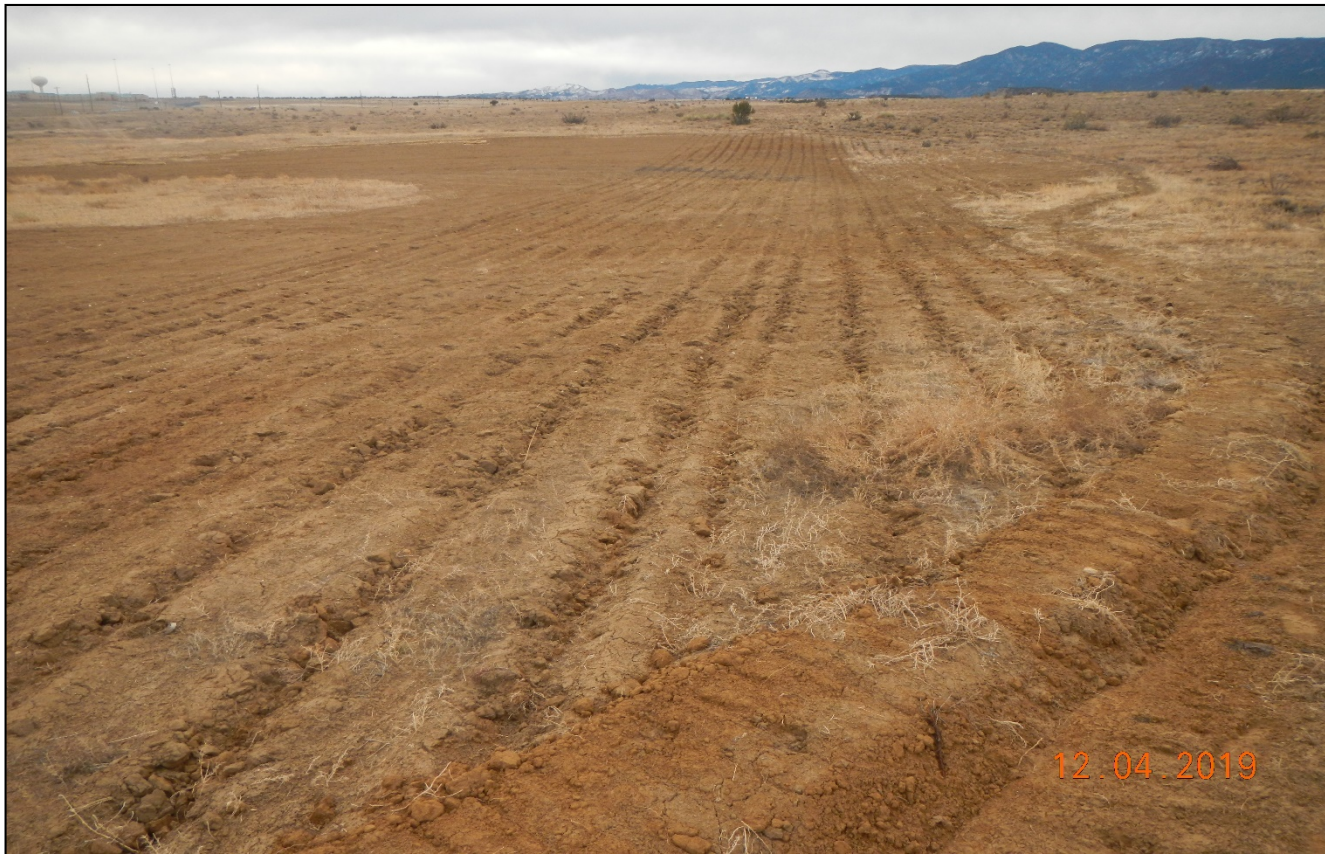
Photo 7. Facing north at the west side of the location.

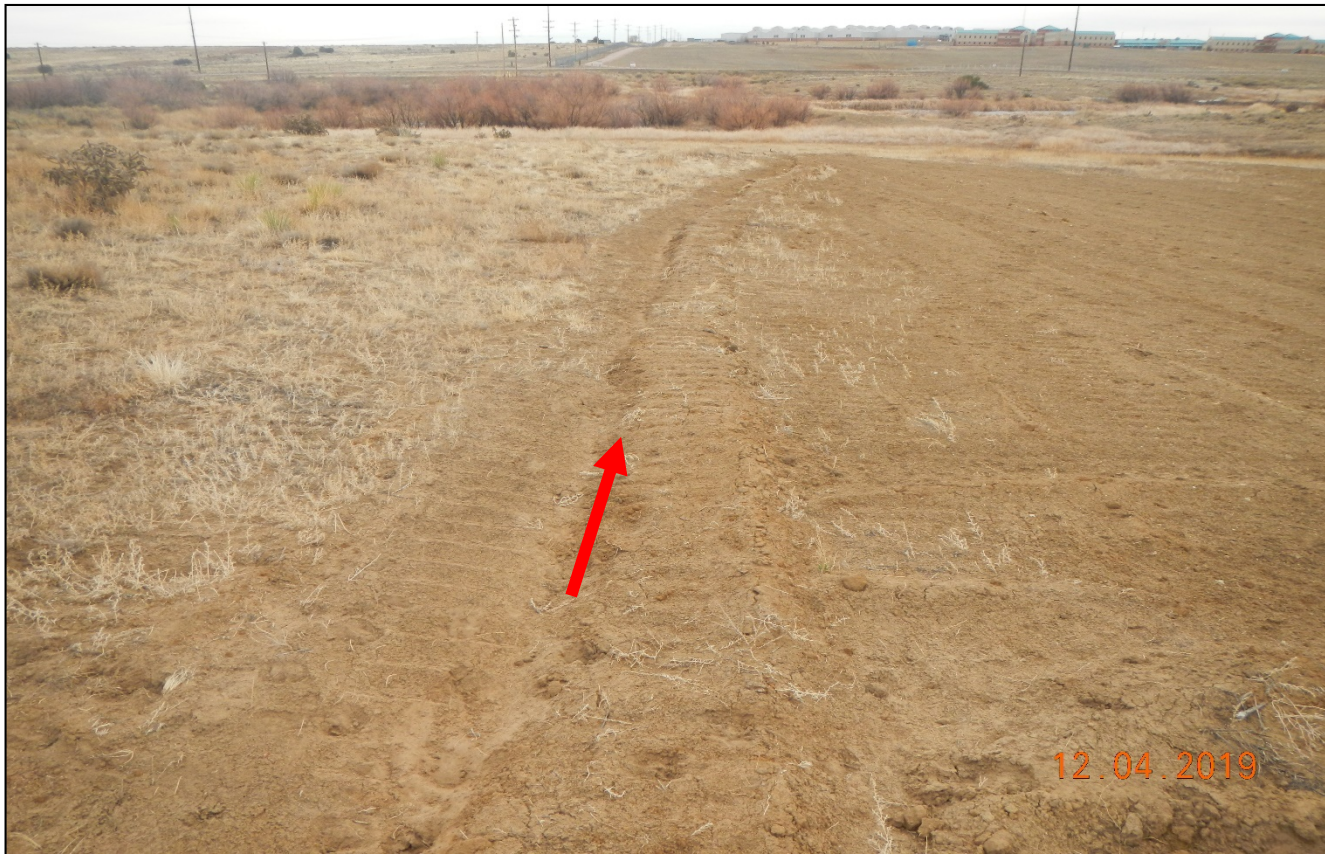
Photo 8. Facing east toward the northern portion of the location. A berm and small ditch are installed around the southern perimeter. The concern is that the ditch is directed downhill which can accelerate stormwater and cause erosion.

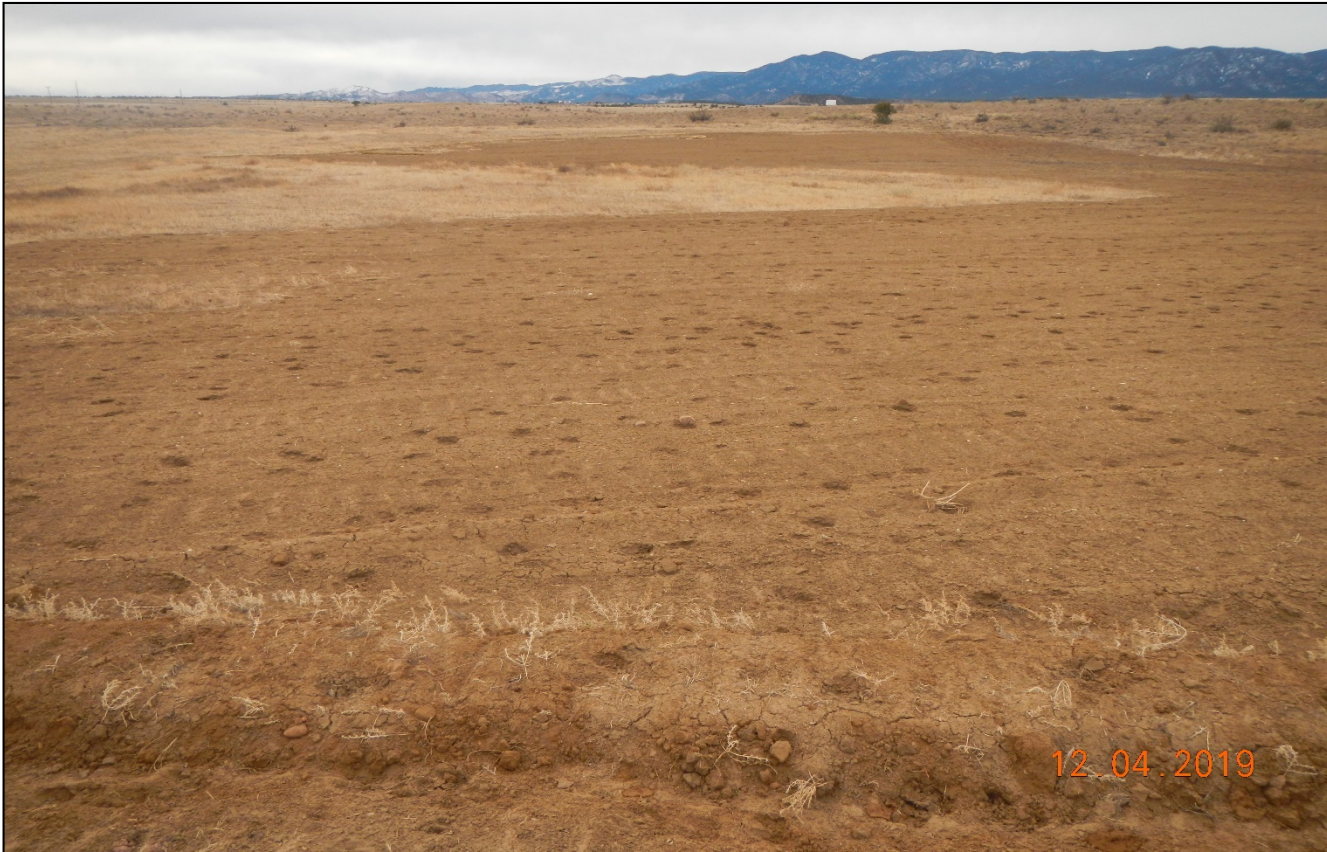
Photo 9. Facing south toward the location. The soils are bare and not protected from wind erosion.

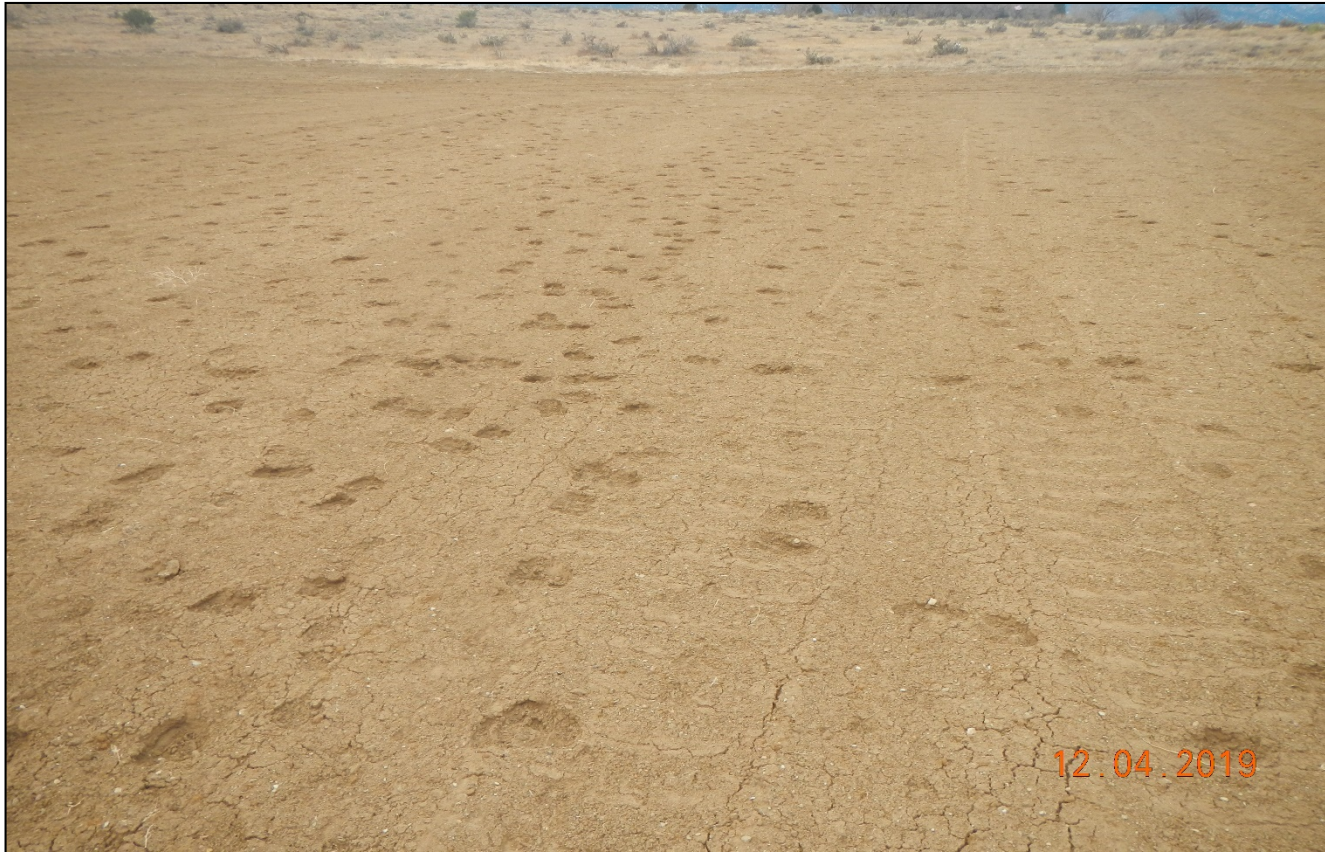
Photo 10. View of groundcover at the location. There is no vegetation establishing. It is uncertain if soils have been seeded. Seed soils should be and stabilized.

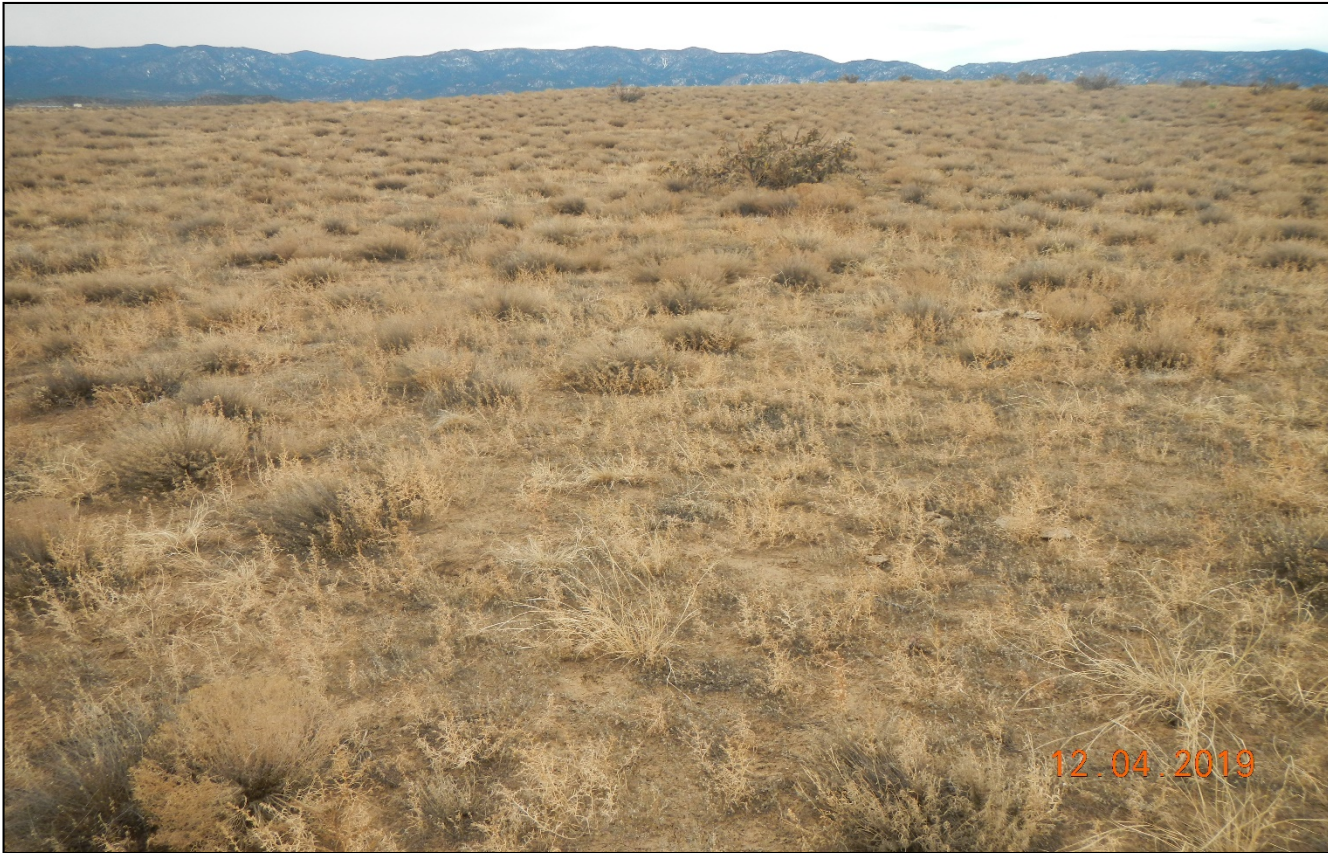
Photo 10. Facing east toward the surrounding undisturbed reference area.
