Inspection Photos

12/09/2019

Operator: BISON OIL & GAS II LLC # 10661

Location ID: 452871

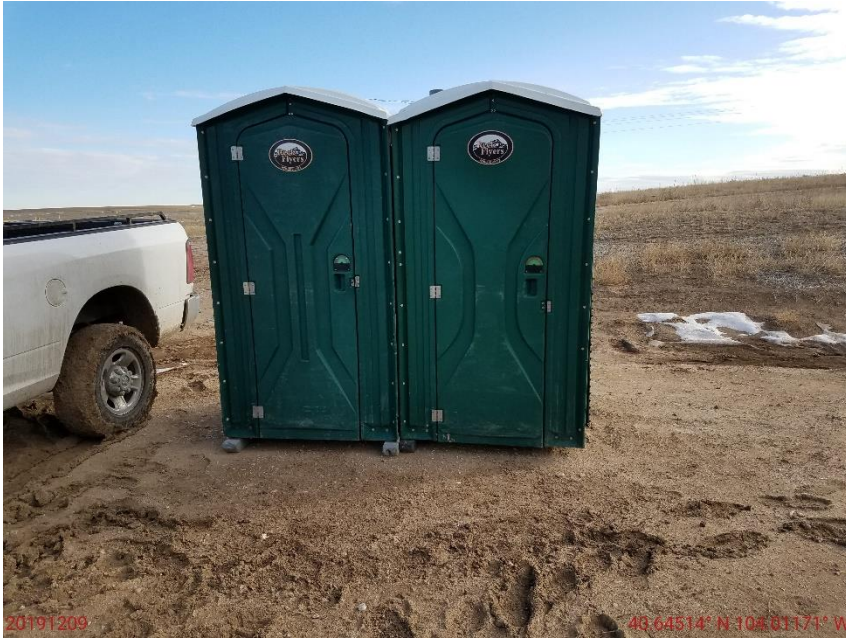
Photo 1: Photo shows porta-johns appear sufficiently secured down.

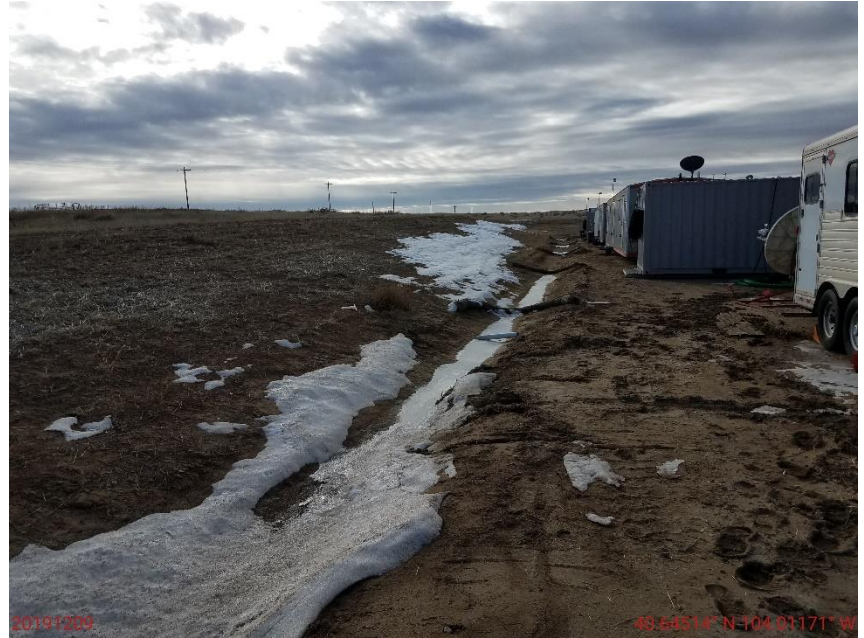
Photo 2: Photo taken from the east end of the location, facing south. Photo of perimeter stormwater diversion ditch.

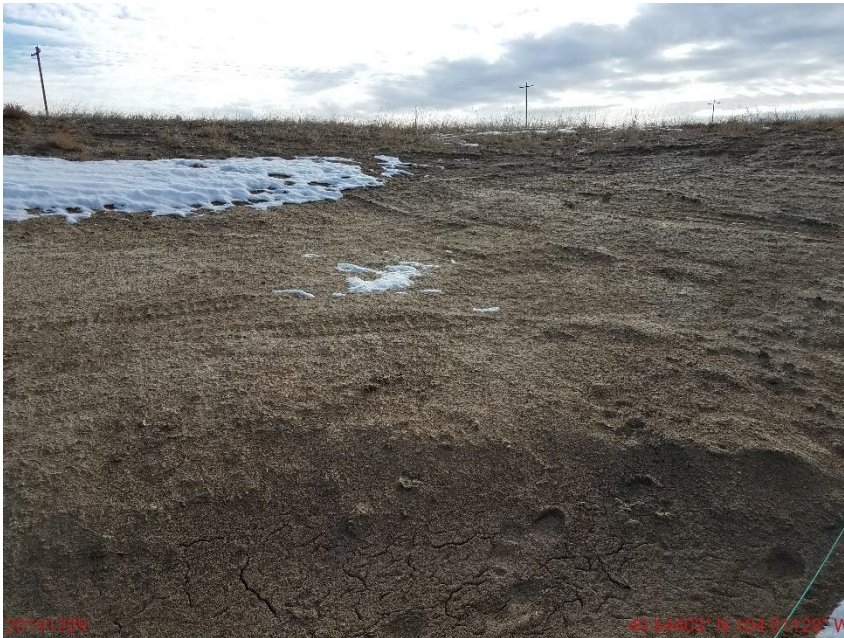
Photo 3: Photo taken from the southeast corner of the location. Photo shows area of cut-slope where erosion degradation was previously observed. Operator appears to have installed a tackifier mulch on the cut slopes. BMP appears to be degrading and is unlikely to remain sufficient to maintain slope stabilization without maintenance, or additional BMPs installed in conjunction.

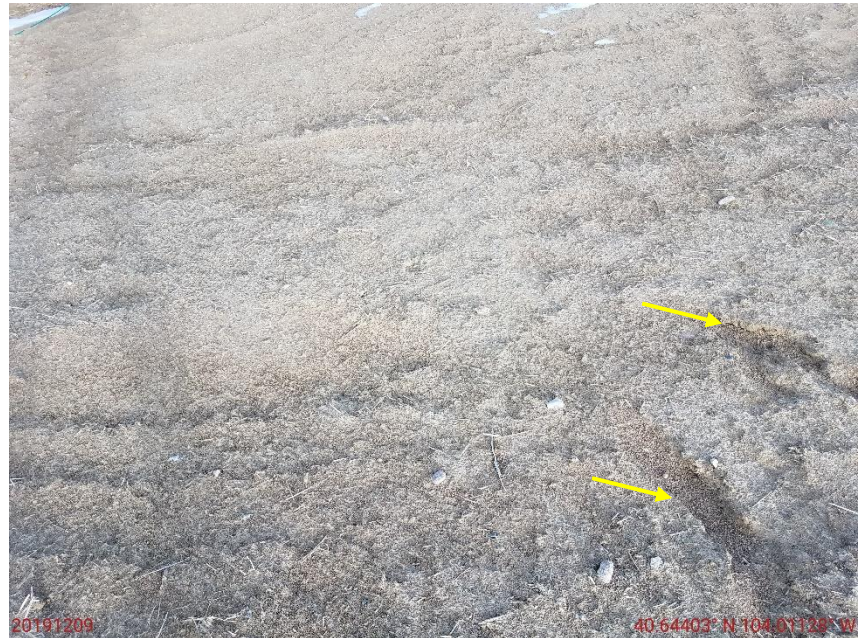
Photo 4: Continued from photo 3. Photo shows cut slopes on the southeast corner of the location. Photo shows signs that erosion degradation is beginning to recur. Tackifier appears to be degrading.

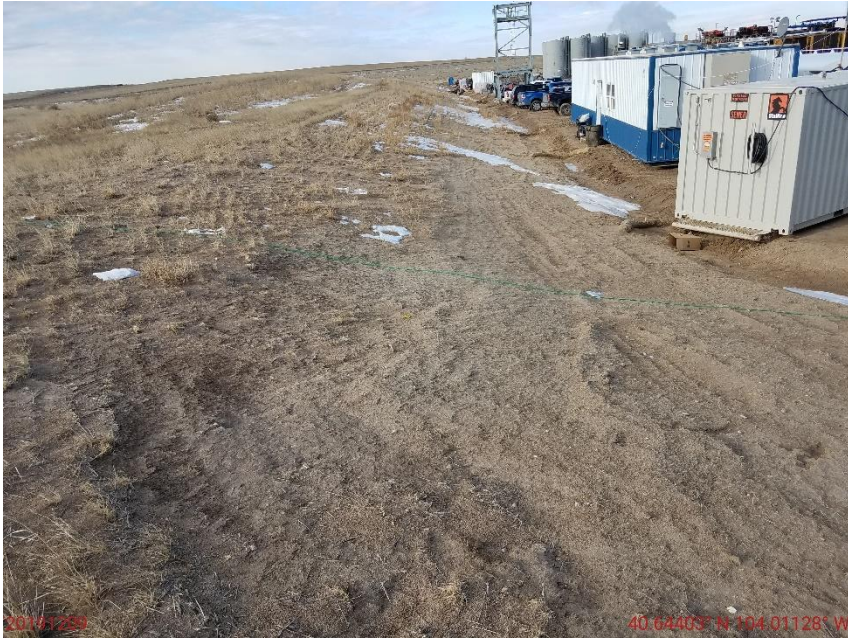
Photo 5: Photo taken from the south east end of the location, facing west. Photo shows cut slopes of location.

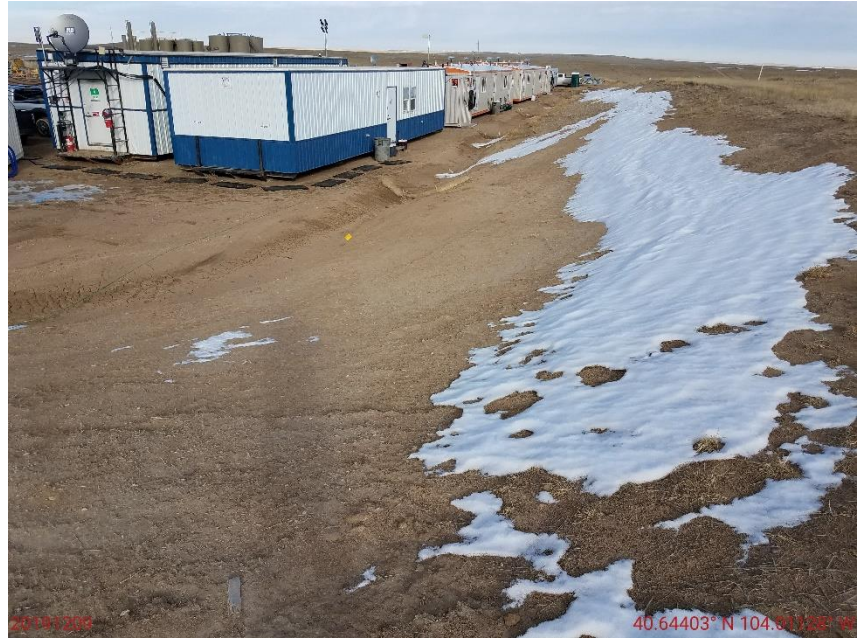
Photo 6: Photo taken from the south east end of the location, facing north. Photo shows cut slopes of location.

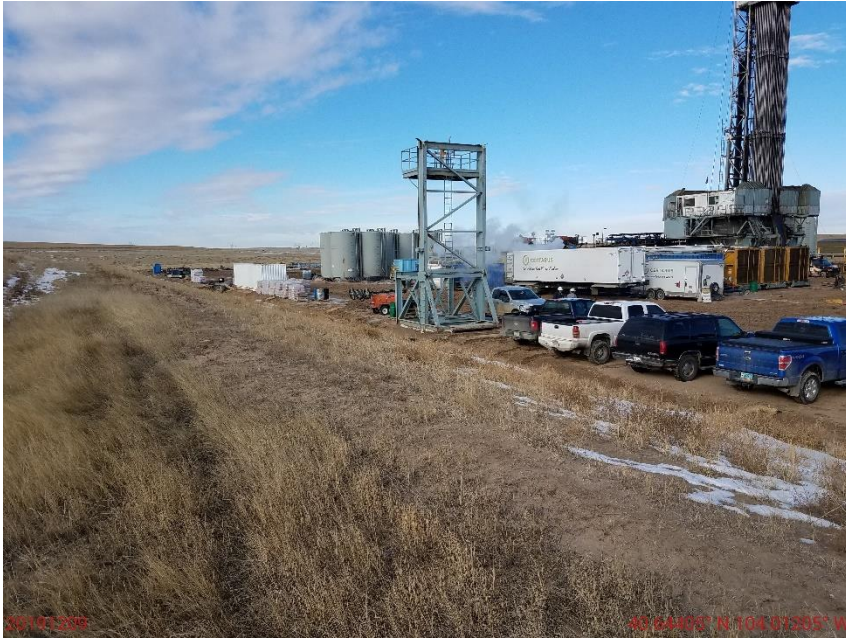
Photo 7: Photo taken from the south end of the location, facing northwest. Photo shows overview of drilling operations.

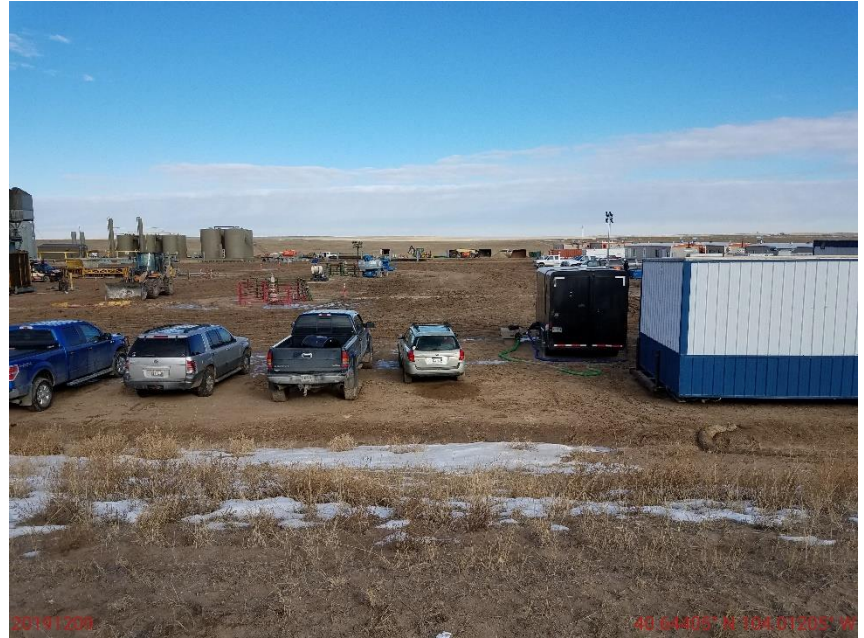
Photo 8: Photo taken from the south end of the location, facing north. See comments under photo 5.

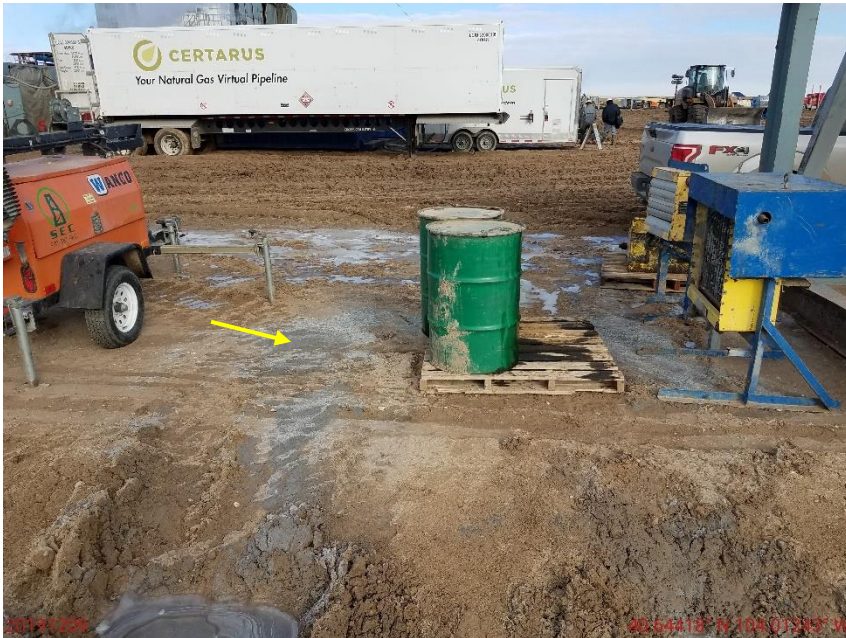
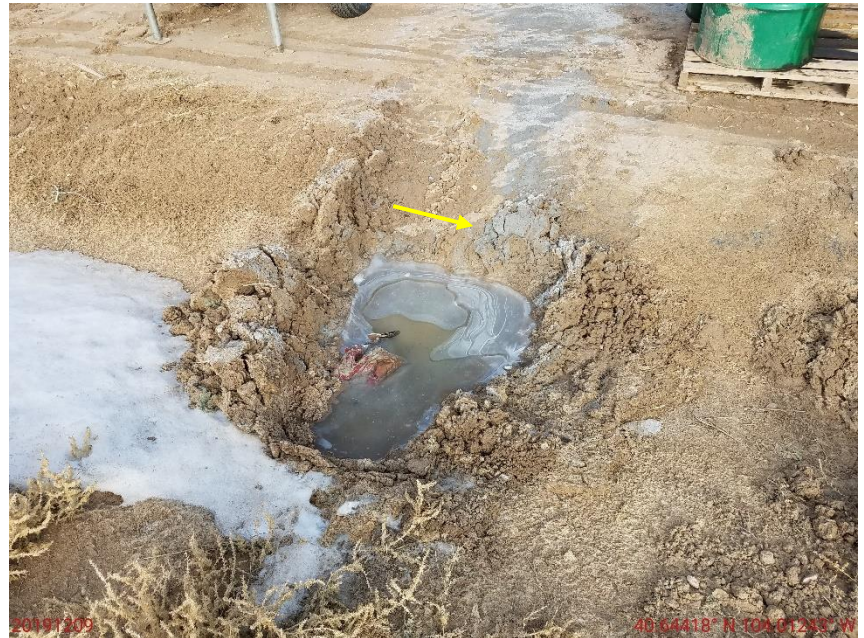
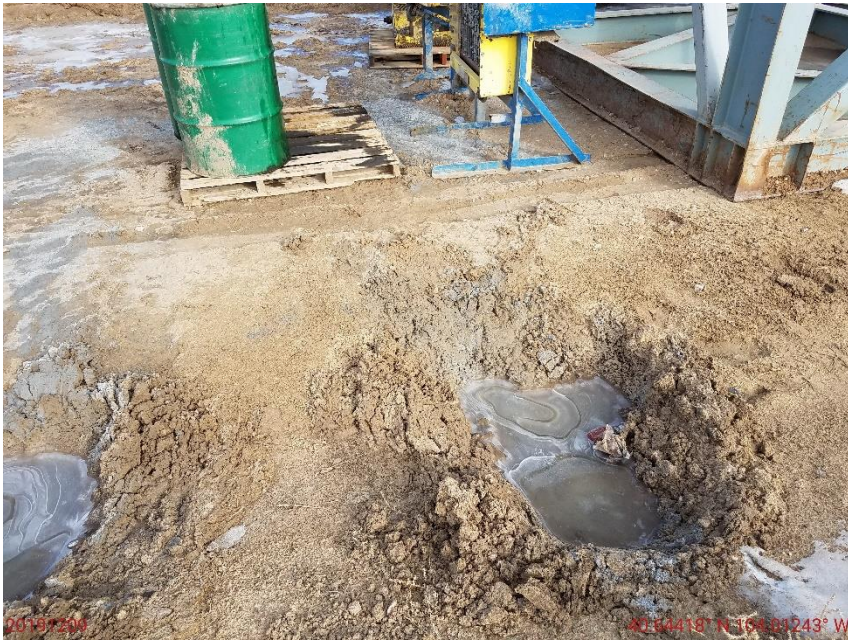
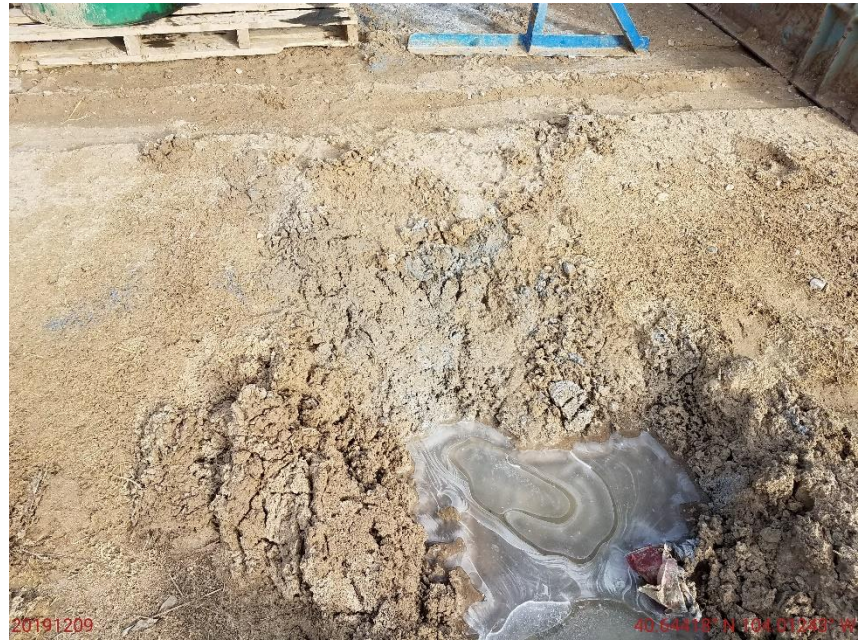
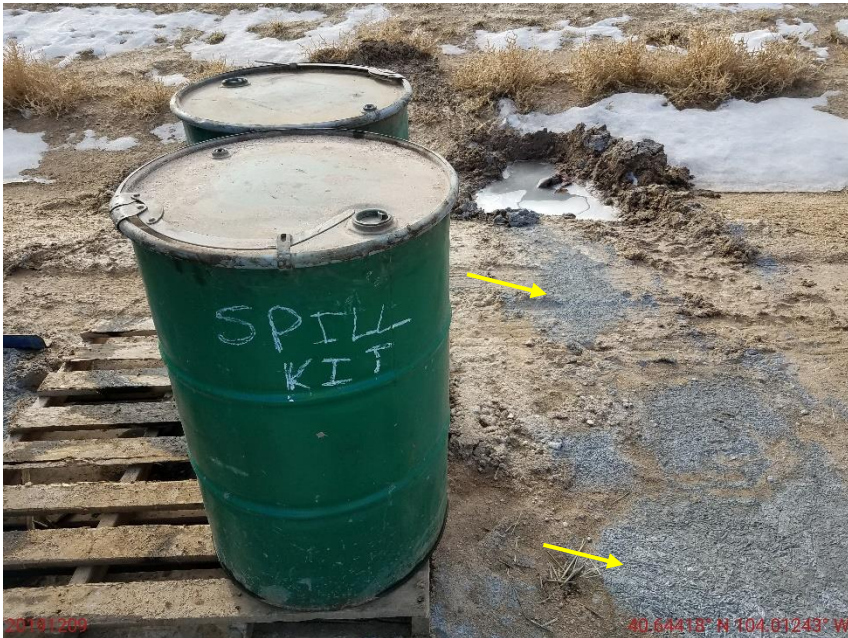
Photo 10: See comments under photo 9.

Photo 9: Photo taken from the south end of the location. Photo shows potential E&P waste spilled upon the soil surface with discharge into the perimeter stormwater diversion ditch. Outlet of ditch leads off location. It is noted that the materials observed in this photo have comingled with ice/precipitate.

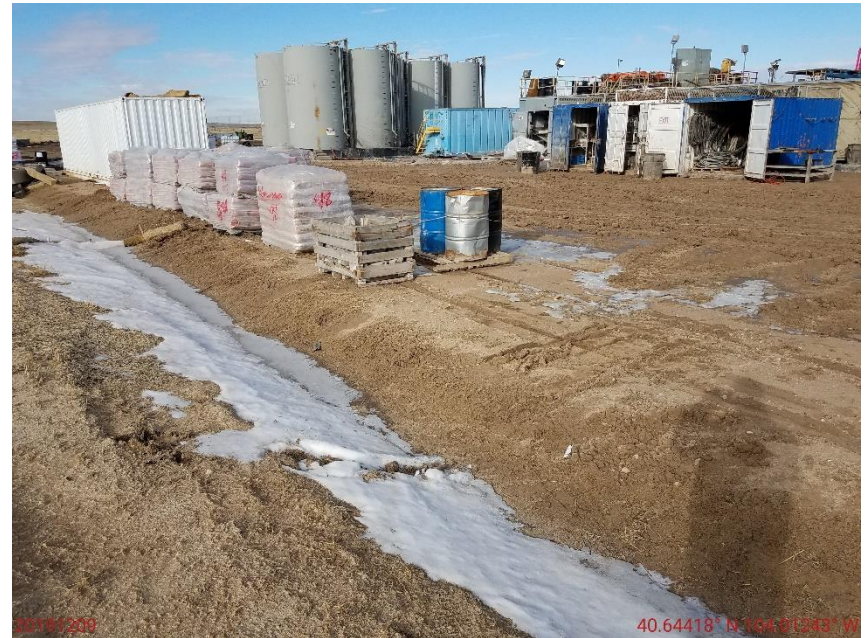
Photo 14: Photo taken from the south end of the location. Photo shows materials stored on Location. Photo also show three (3) chemical barrels stored without secondary containment.

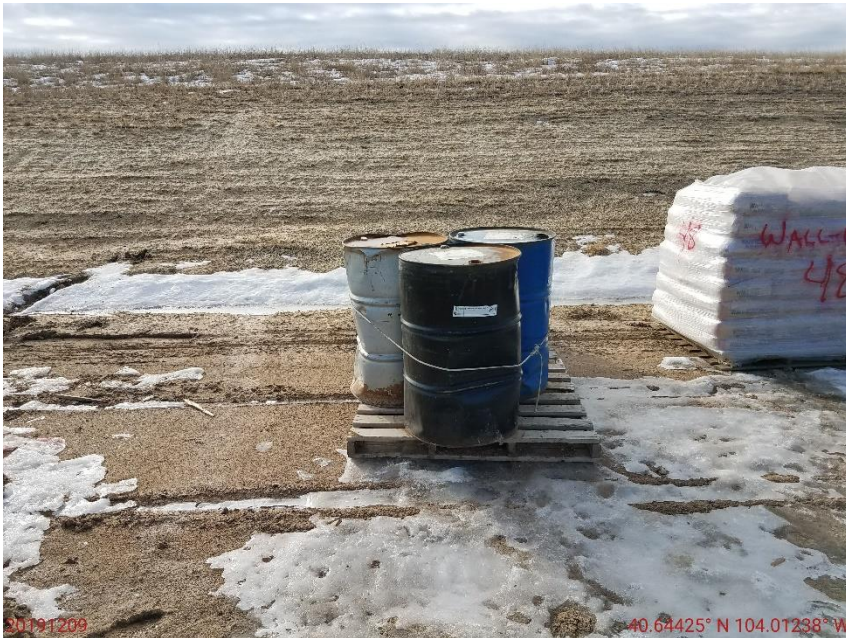
Photo 15: Continued from photo 14. Photo shows three (3) chemical barrels stored without secondary containment.

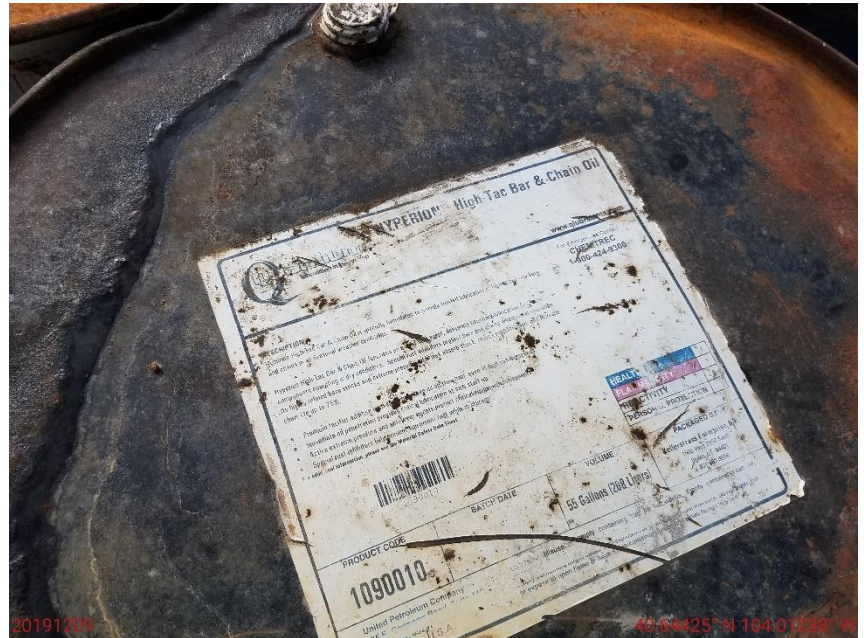
Photo 16: Continued from photo 14. Photo shows label of one of the three barrels indicating contents to be "High Tac Bar & Chain Oil".

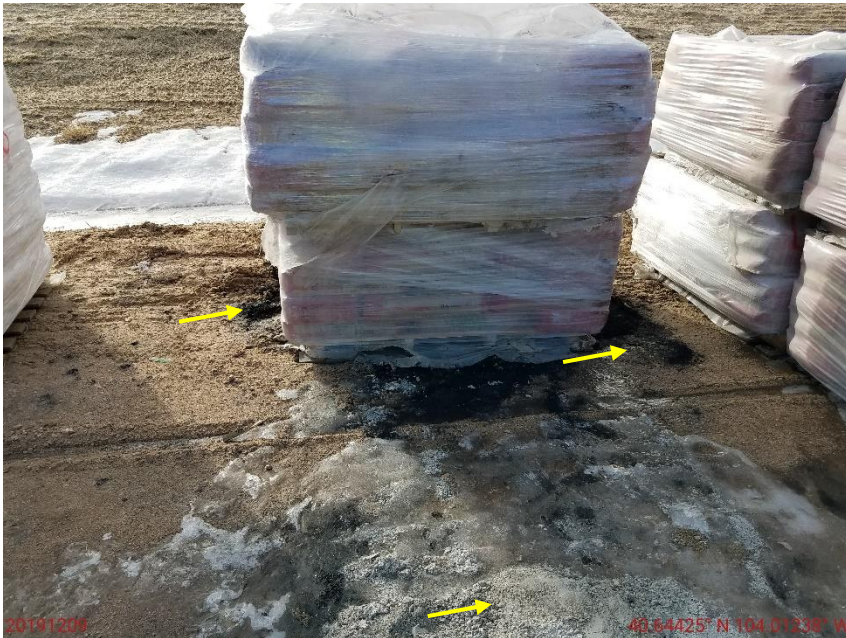
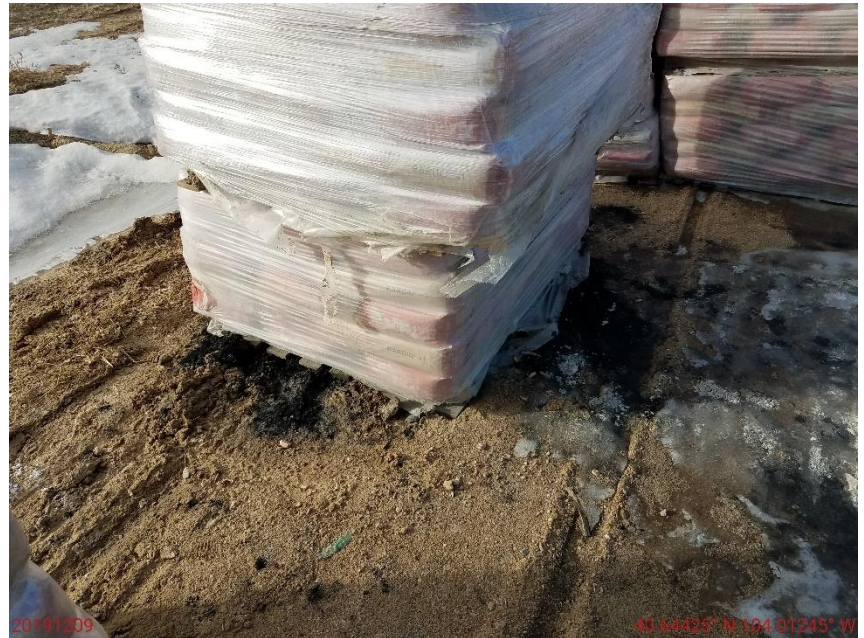
Photo 18: Continued from photo 17.

Photo 17: Photo taken from the south end of the location. Photo shows chemical/materials appear to have been spilled onto the soil surface of the pad. Material sits adjacent to the stormwater diversion ditch which transports stormwater runoff off location. It is noted that the materials observed in this photo have comingled with ice/precipitate.

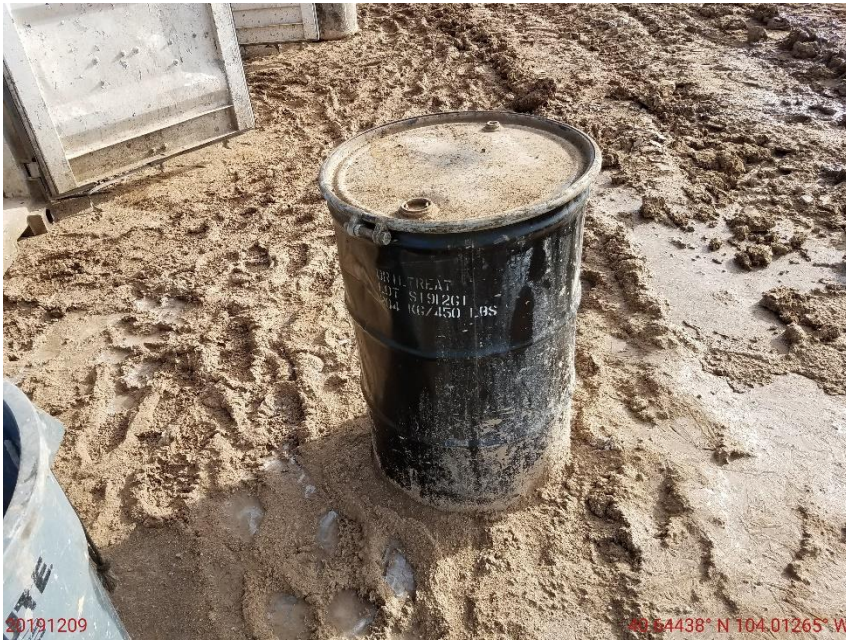
Photo 19: Photo shows barrel not stored within secondary containment. Writing on side of barrel says "Driltreat"

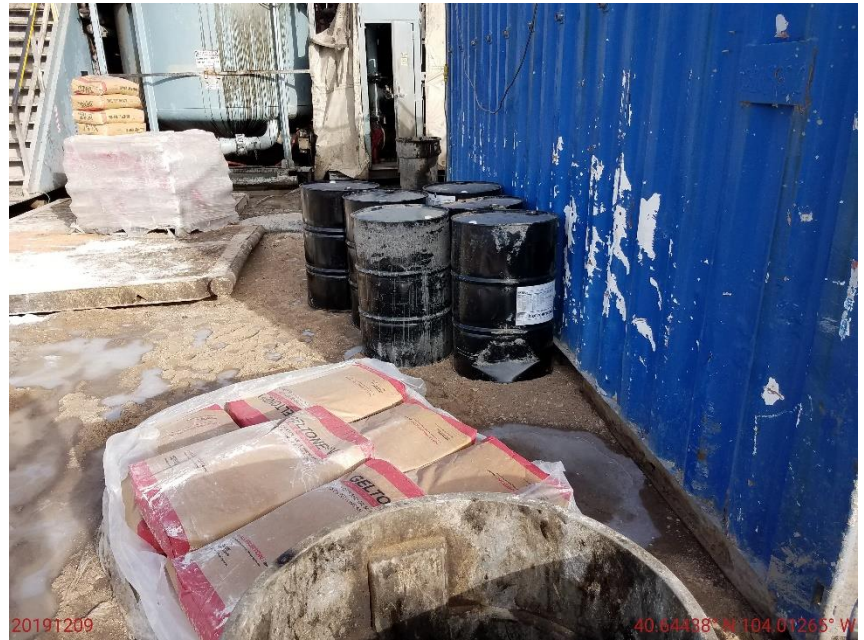
Photo 20: Photo shows six (6) chemical barrels stored without secondary containment. A seventh (7th) barrel was observed laying on its side on other side of barrels observed in this photo (see photo 21)

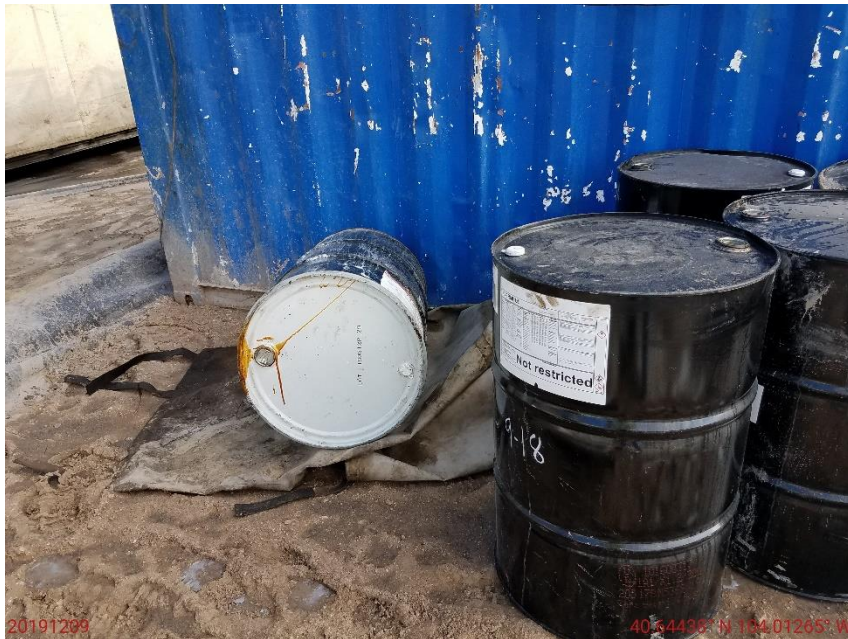
Photo 21: Continued from photo 20. Photo shows chemical barrels stored without secondary containment, with one stored on its side.

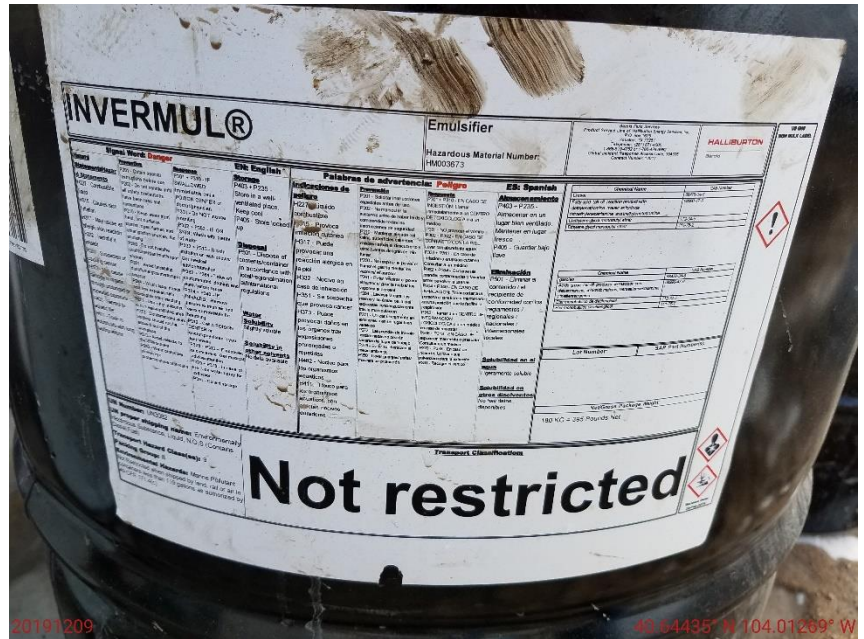
Photo 22: Photo of label on chemical barrels in photos 20-21.

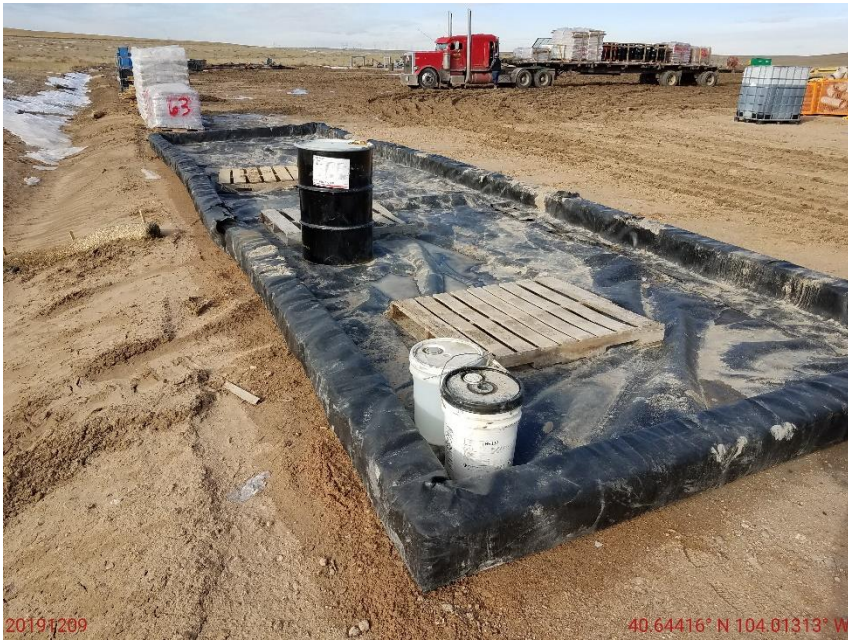
Photo 23: Photo taken from the south end of the location. Photo shows secondary containment BMP in place on location available for use.

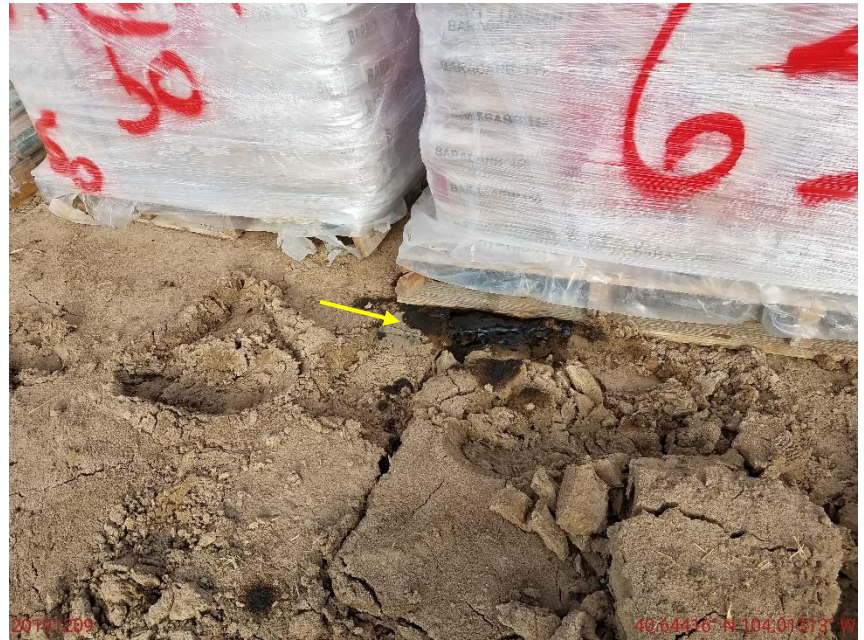
Photo 24: Photo taken from the south end of the location. Photo shows chemical spill under a material pallet.

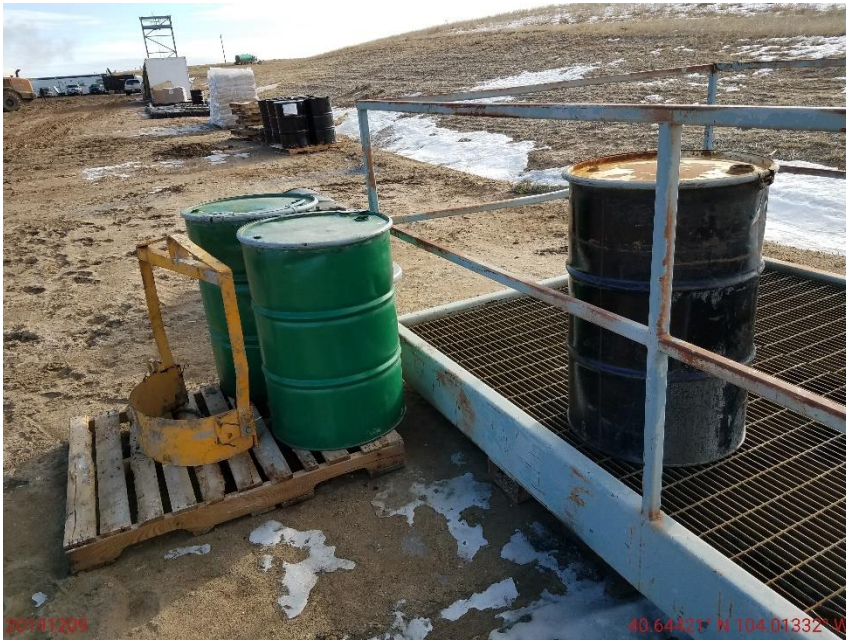
Photo 25: Photo taken from the south end of the location. Photo shows additional barrels stored on location.

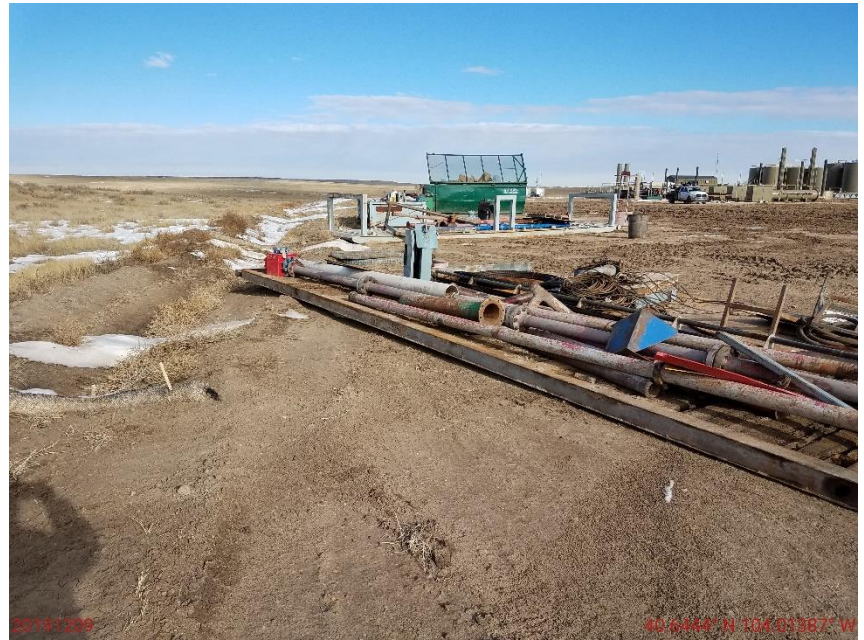
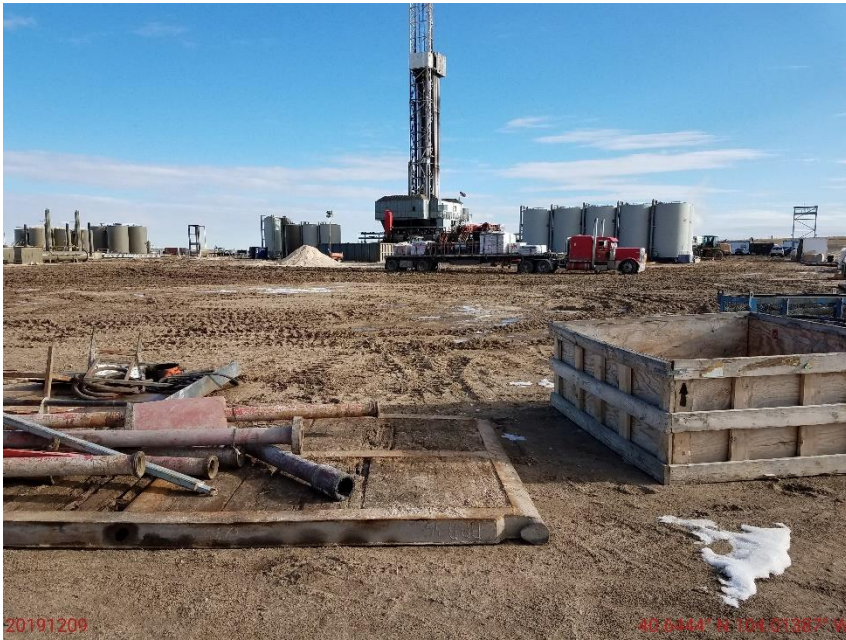
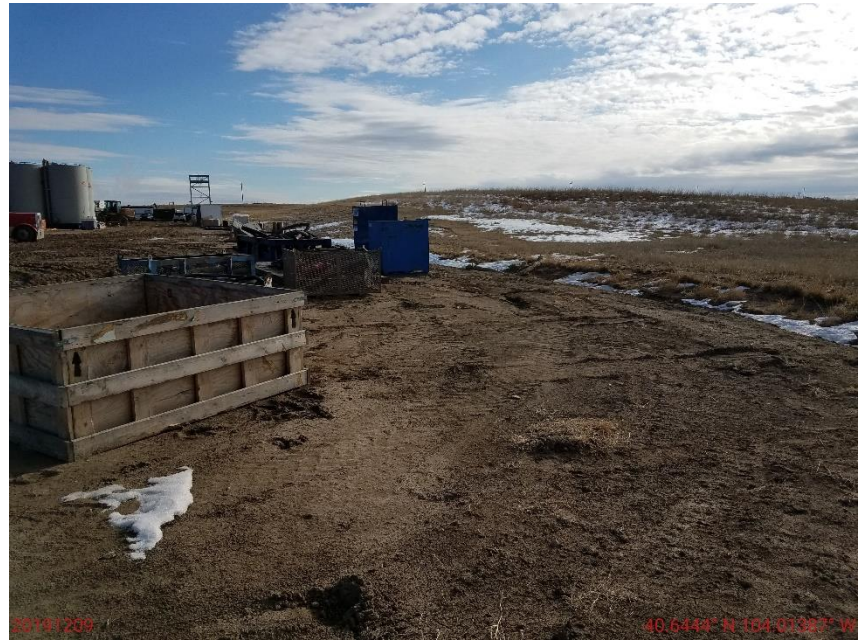
Photo 27: See comments under photo 26.

Photo 26: Photo taken from west end of the location, facing north. Photos 26-28 provide an overview of the location from north, east, to southeast.

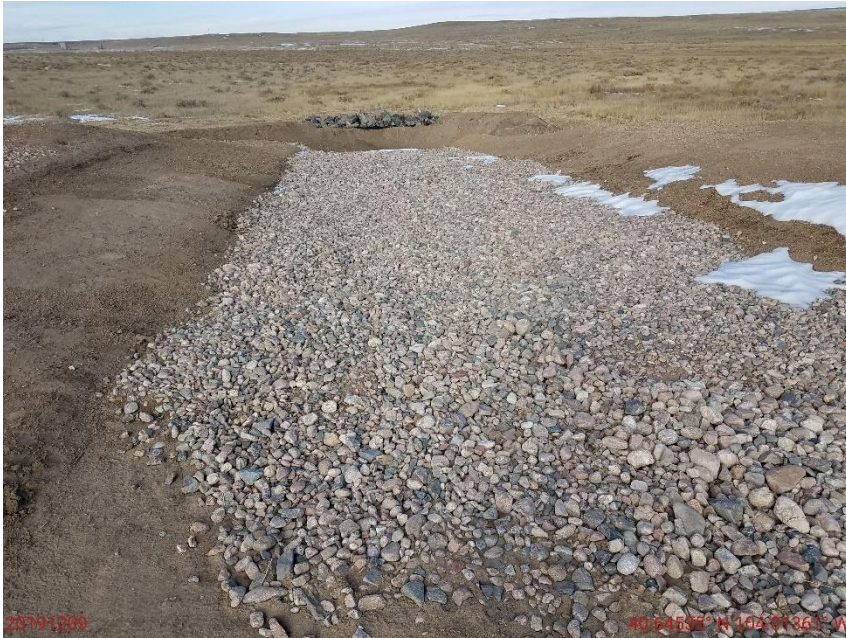
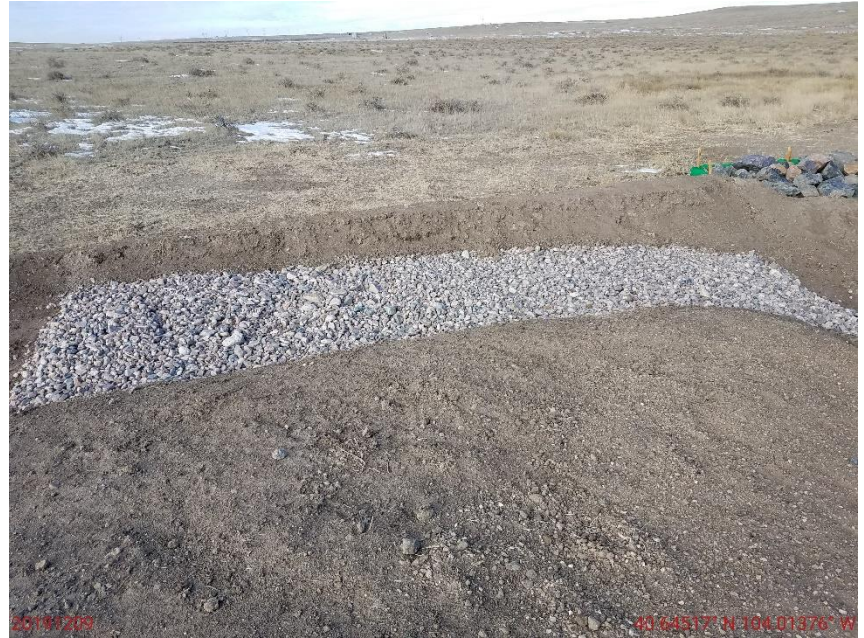
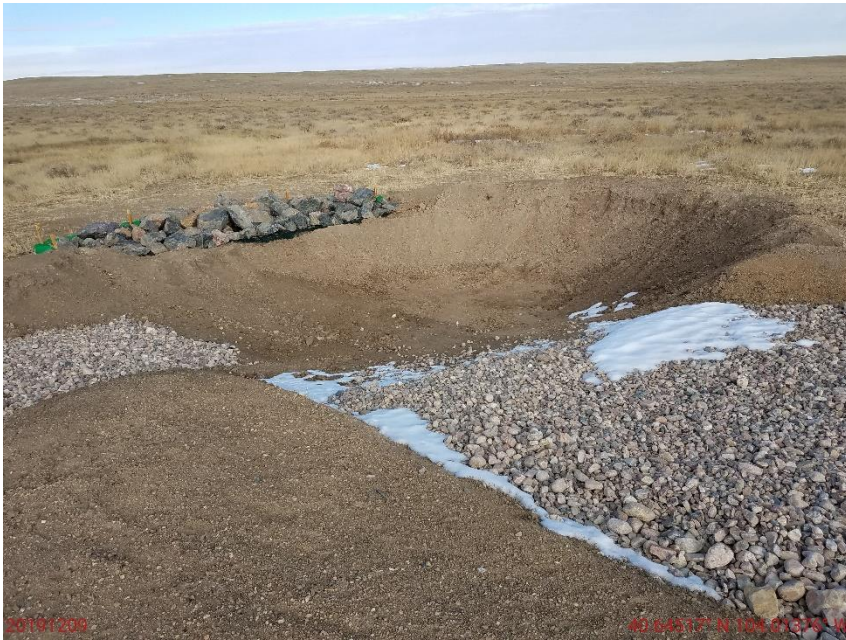
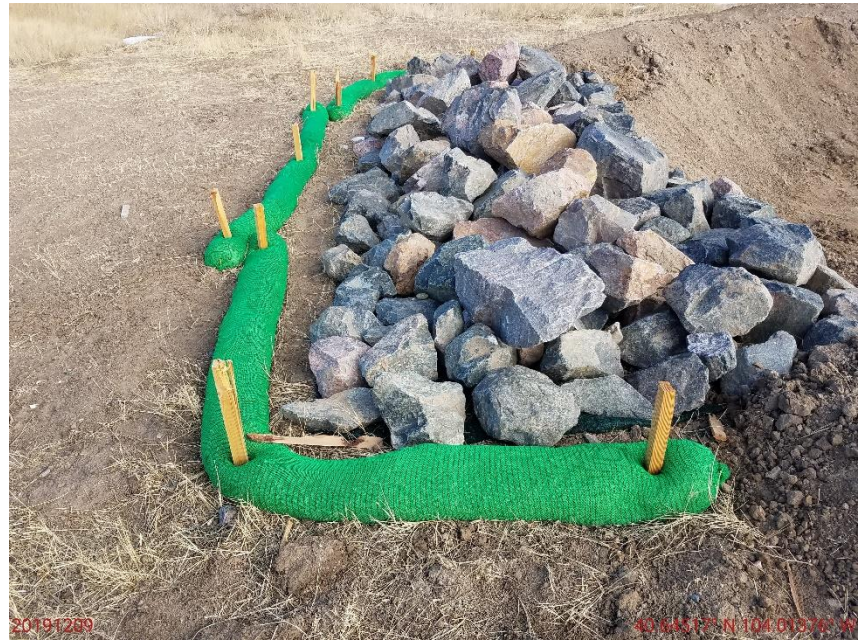
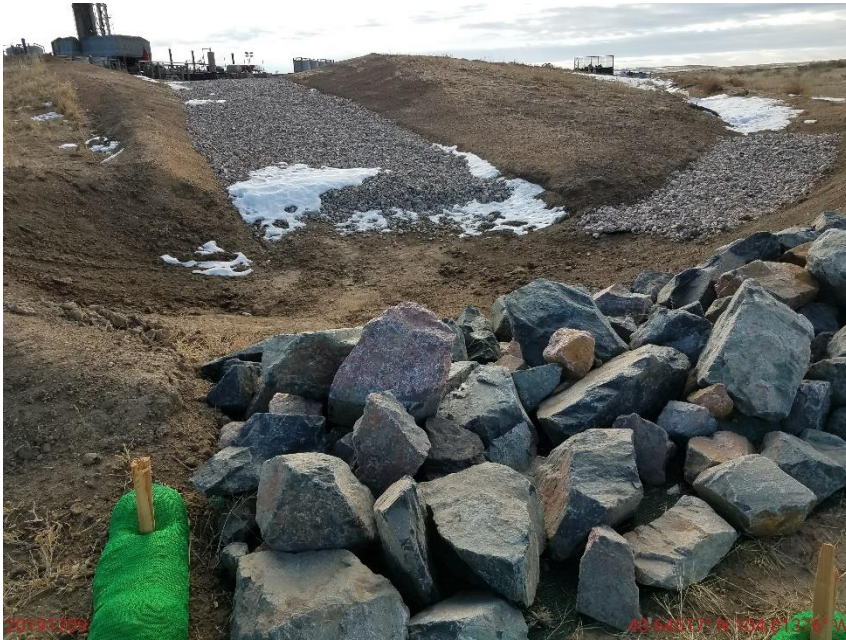
Photo 30: Continued from photo 29.

Photo 29: Photo taken from the sediment trap on the northwest corner of the location. Photo shows additional maintenance appears to have been conducted on the BMP. At time of inspection, BMP appeared to be in proper functioning condition and installed in accordance with good engineering practices.

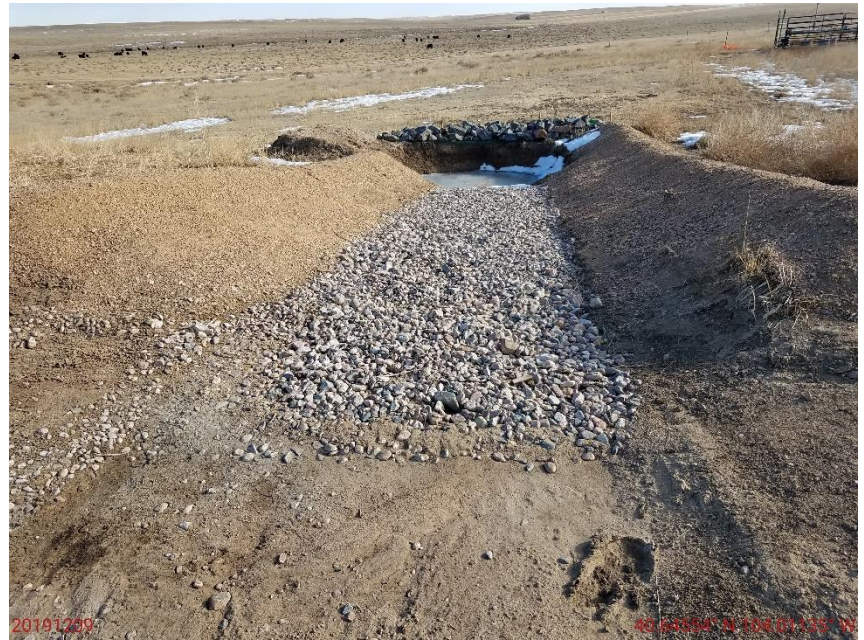
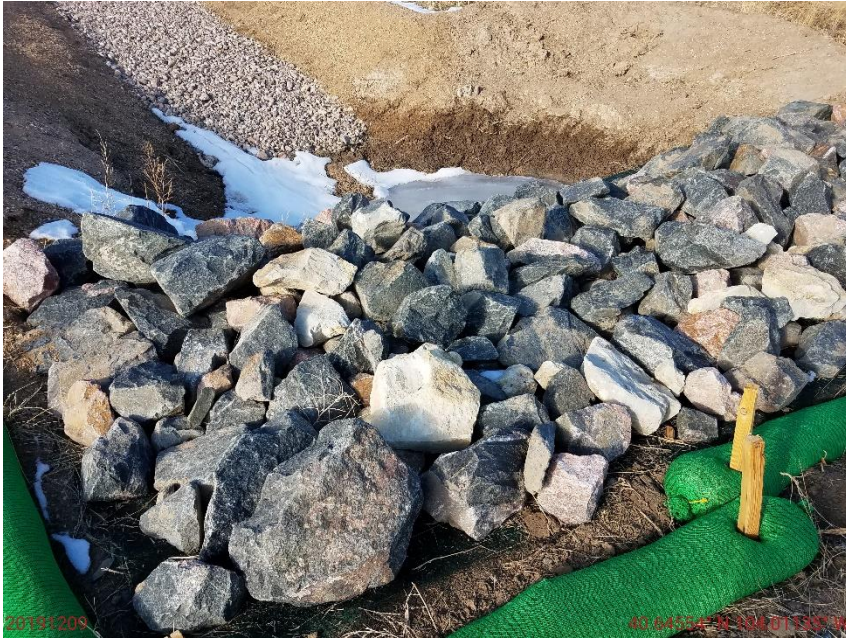
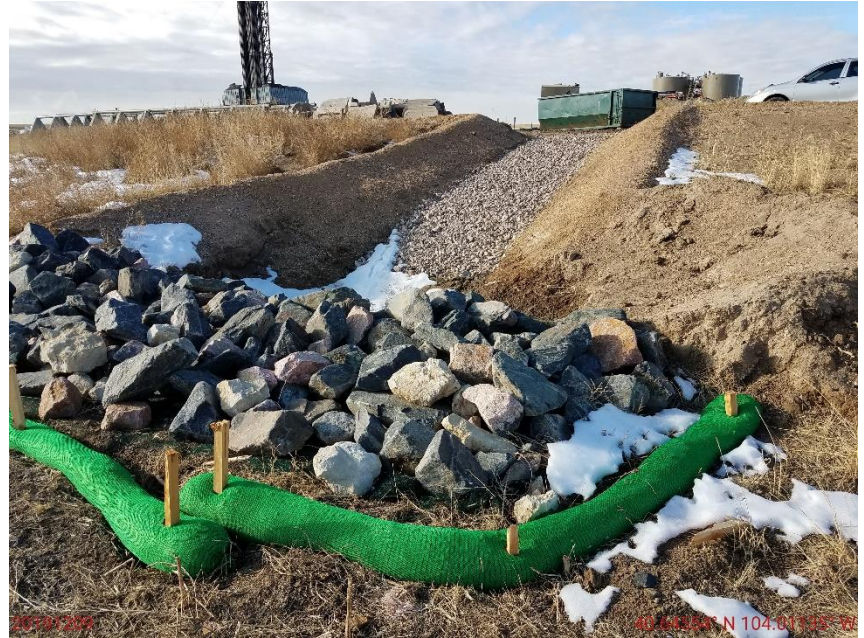
Photo 35: Continued from photo 34.

Photo 34: Photo taken from the sediment trap on the northeast corner of the location. Photo shows additional maintenance appears to have been conducted on the BMP. At time of inspection, BMP appeared to be in proper functioning condition and installed in accordance with good engineering practices.

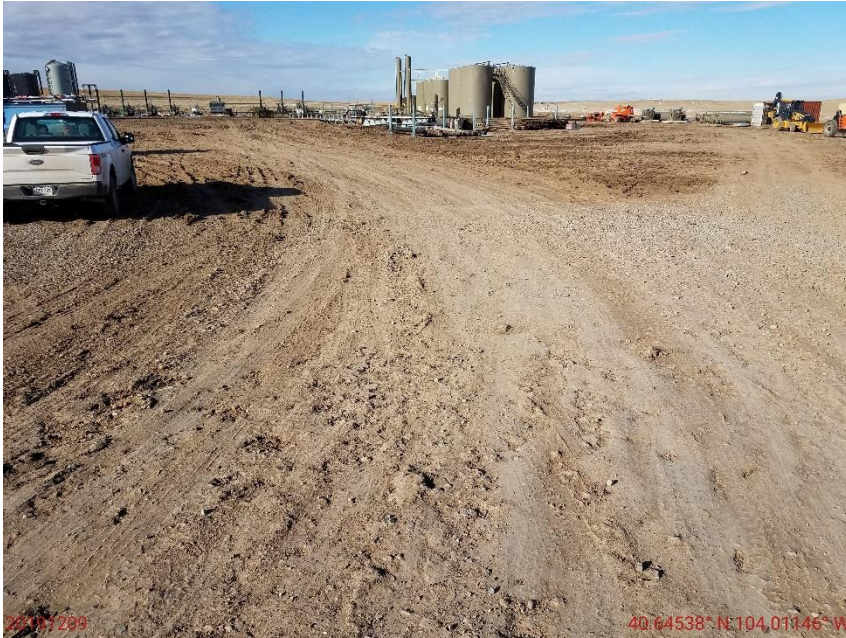
Photo 37: Photo taken from the location entrance on the east end of the location, facing west. Photo shows tracking pad. Operator has failed to maintain BMP; BMP has filled with sediment and is no longer in proper functioning condition.

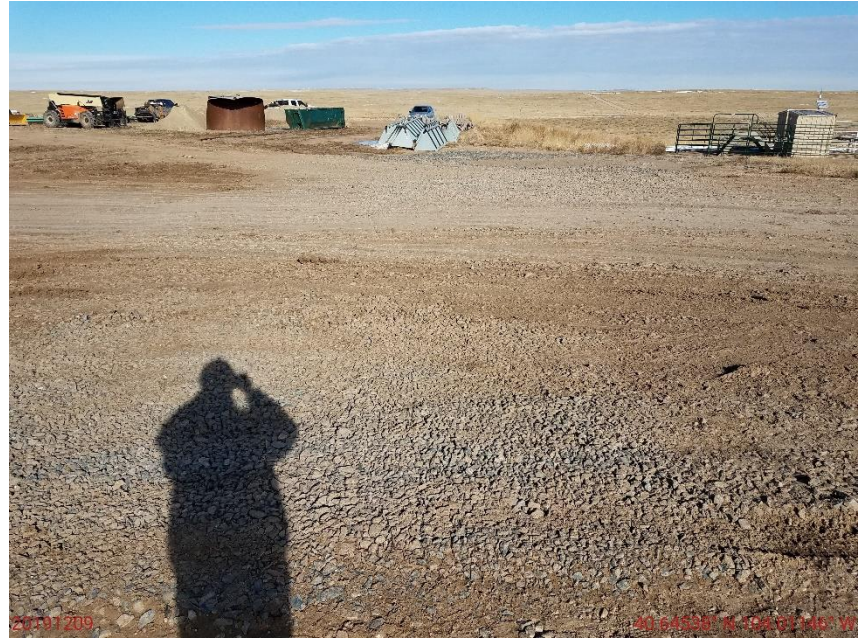
Photo 38: Photo taken from the location entrance on the north end of the location, facing west. Photo shows tracking pad. Operator has failed to maintain BMP; BMP has filled with sediment and is no longer in proper functioning condition.
