Inspection Photos
Operator: Williford Resources
Location/API #: 067-06771
Date: 11-19-2019

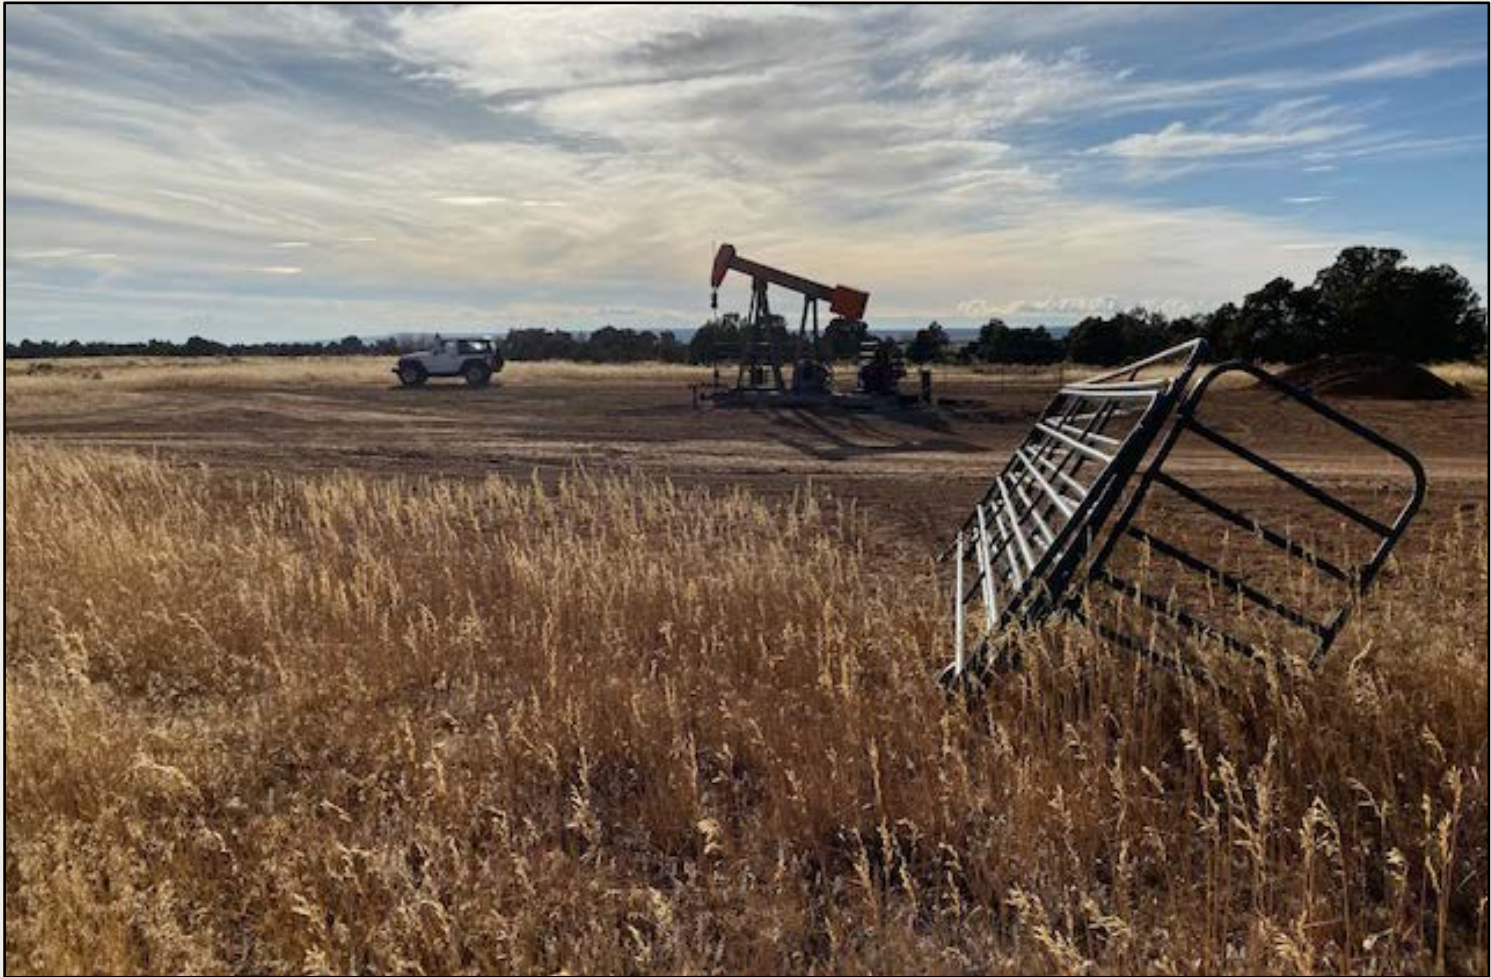
Photo 1. View of the project area from the northeastern corner facing center.

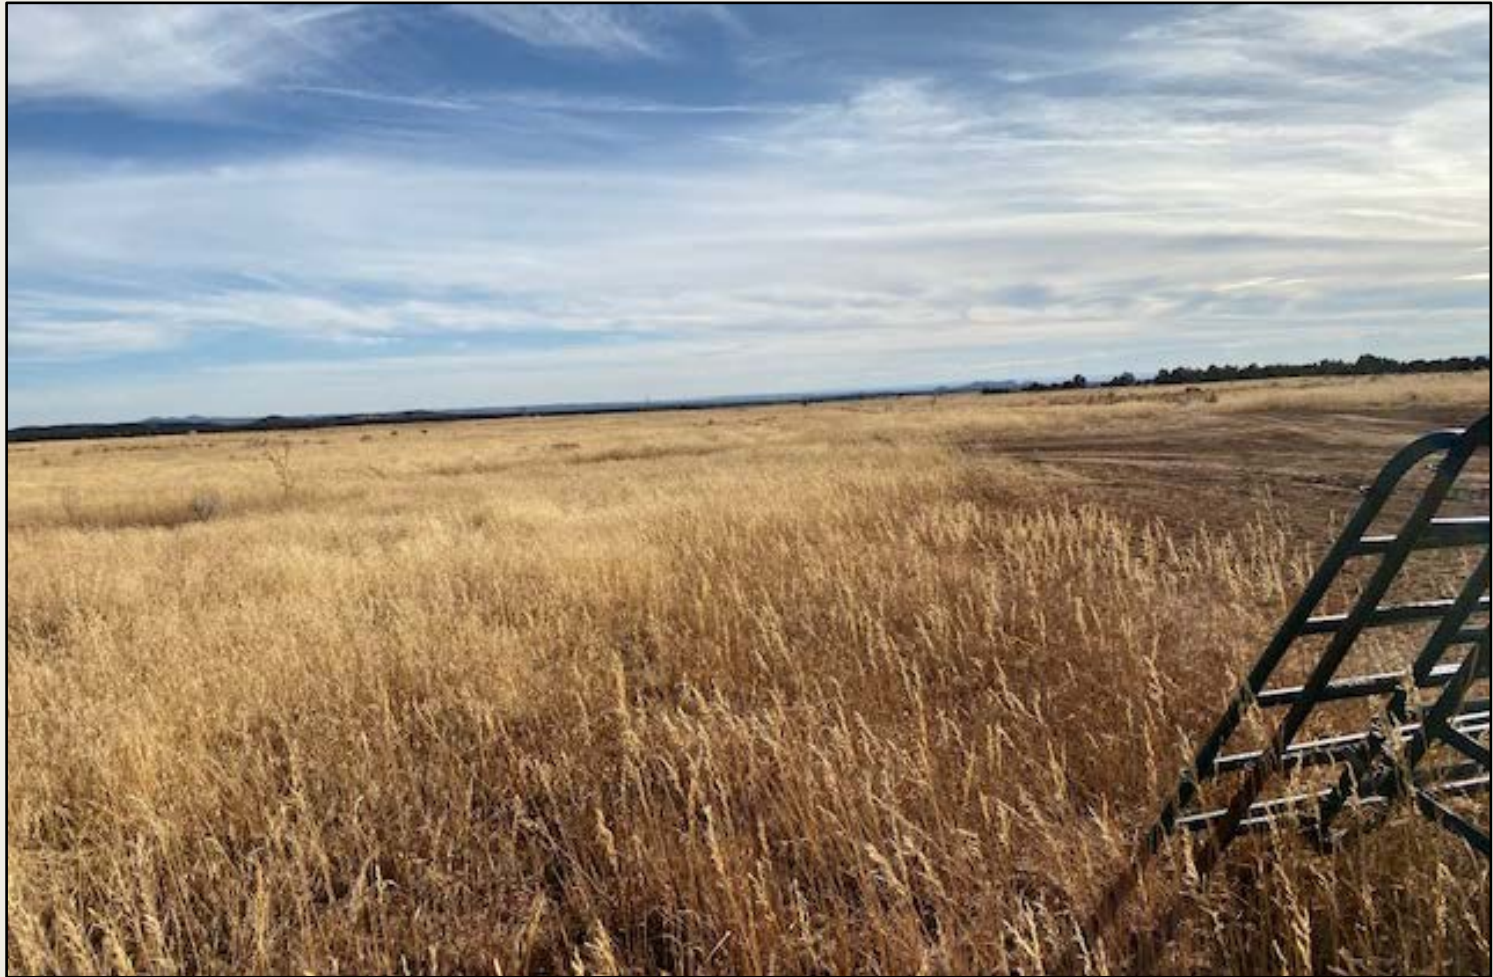
Photo 2. View of the eastern project area from the northeastern corner facing southward. Vegetation is largely comprised of smooth brome.

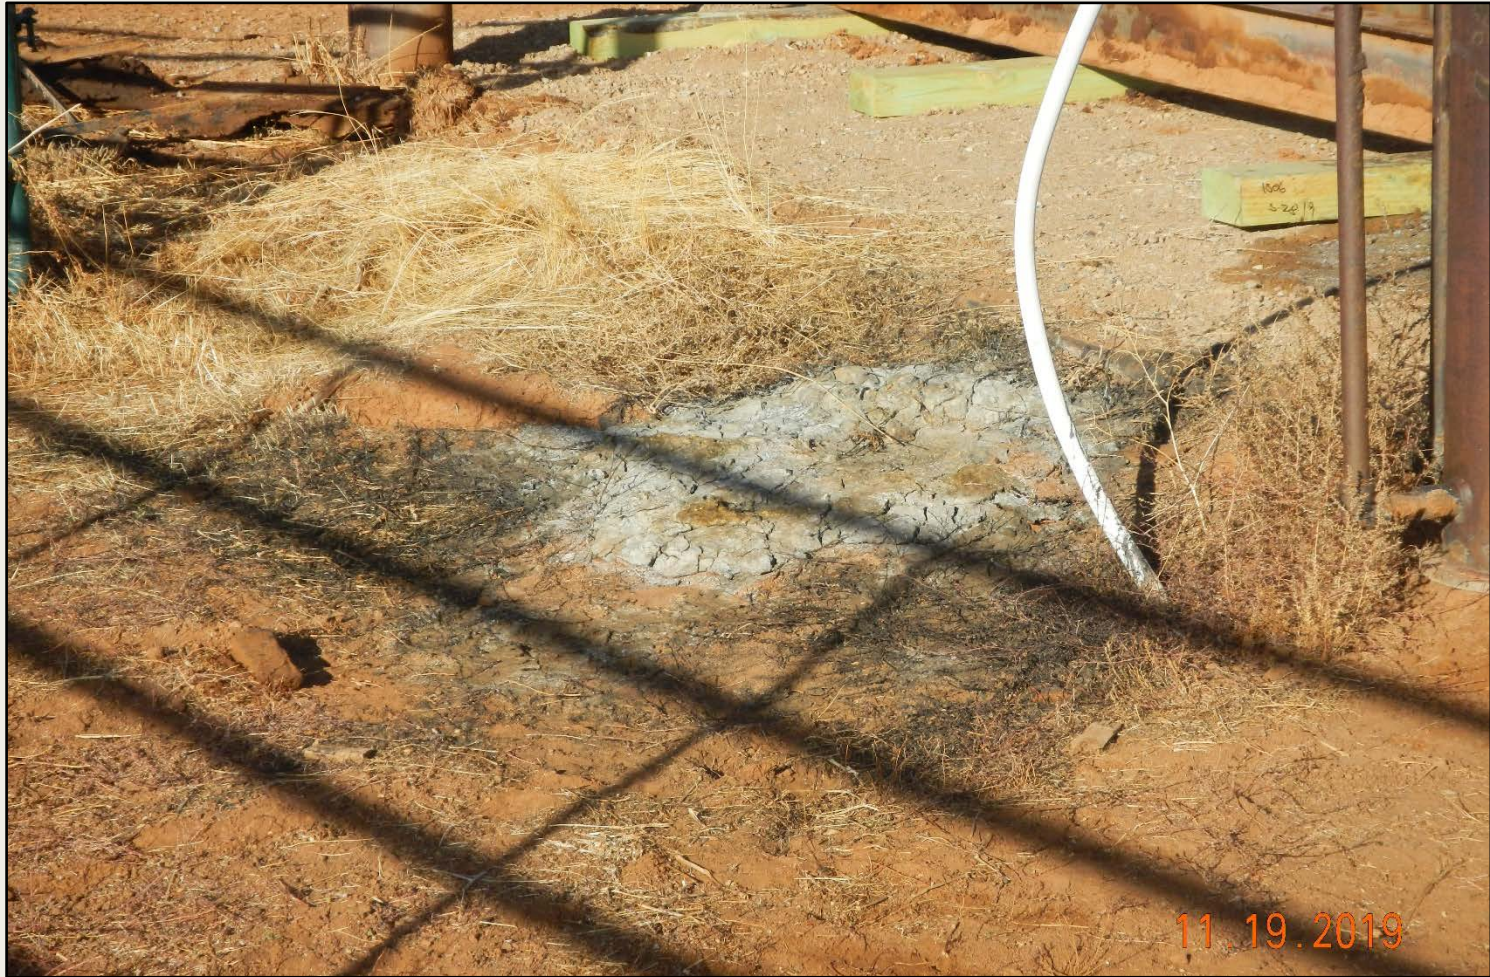
Photo 3. View of stained soils, approximately two feet long and wide at the well pump jack.

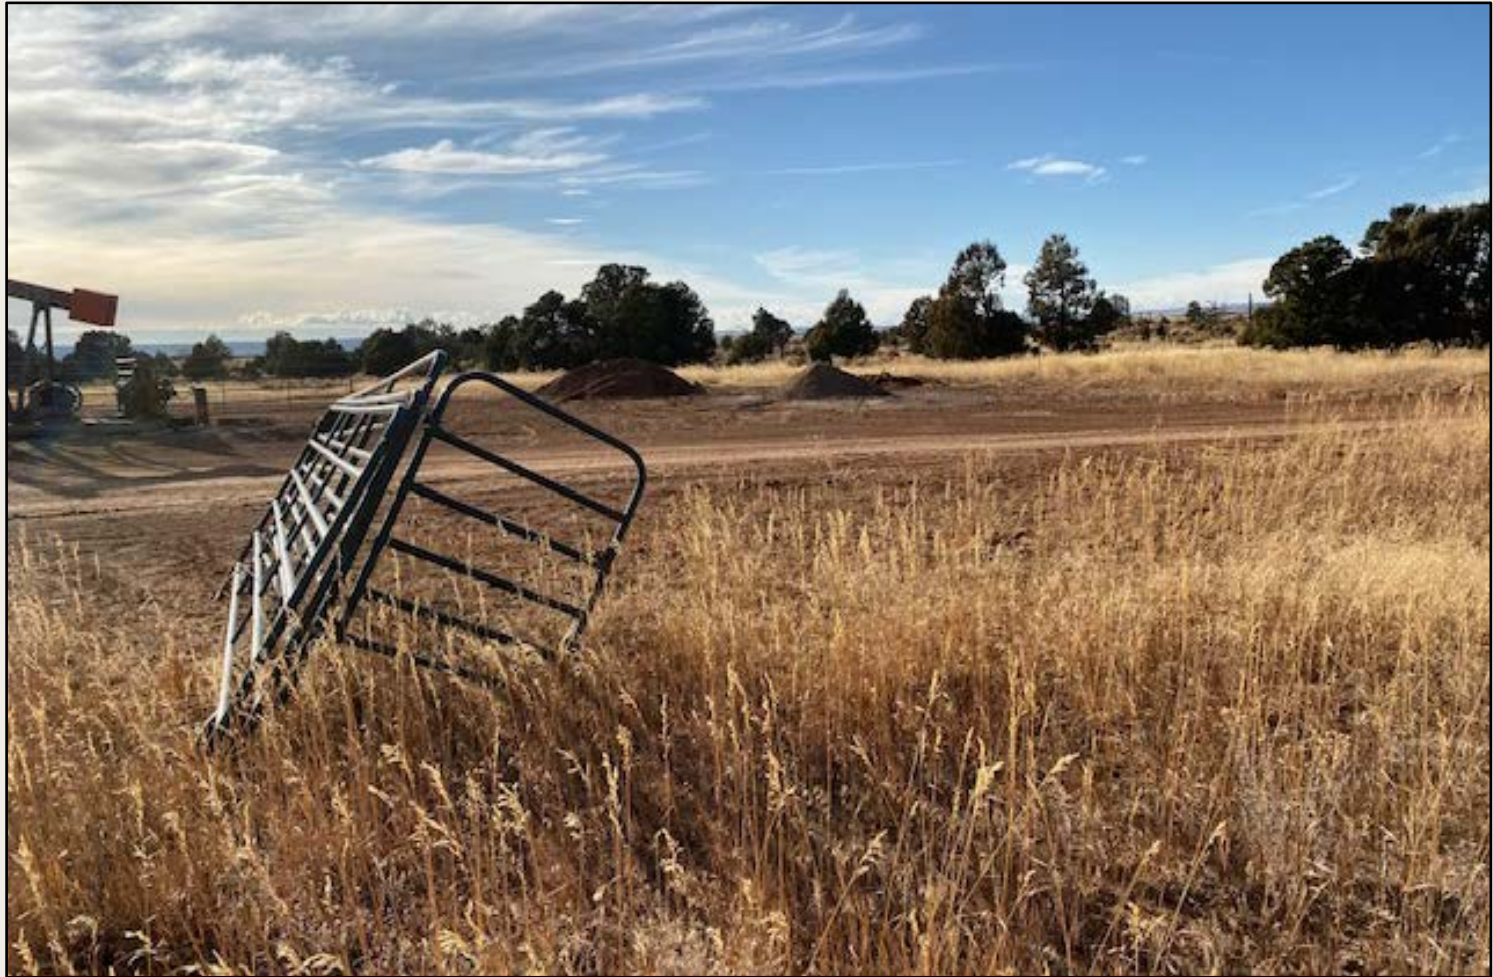
Photo 4. View of the northern project area from the northeastern corner facing westward. Piles of what appears to be hydrocarbon-impacted material stored within the northwestern project area.

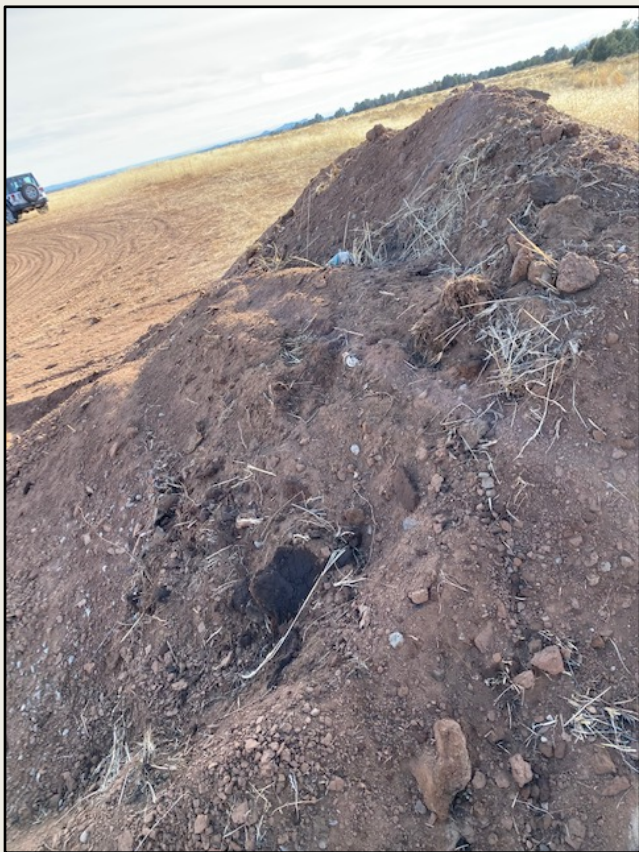
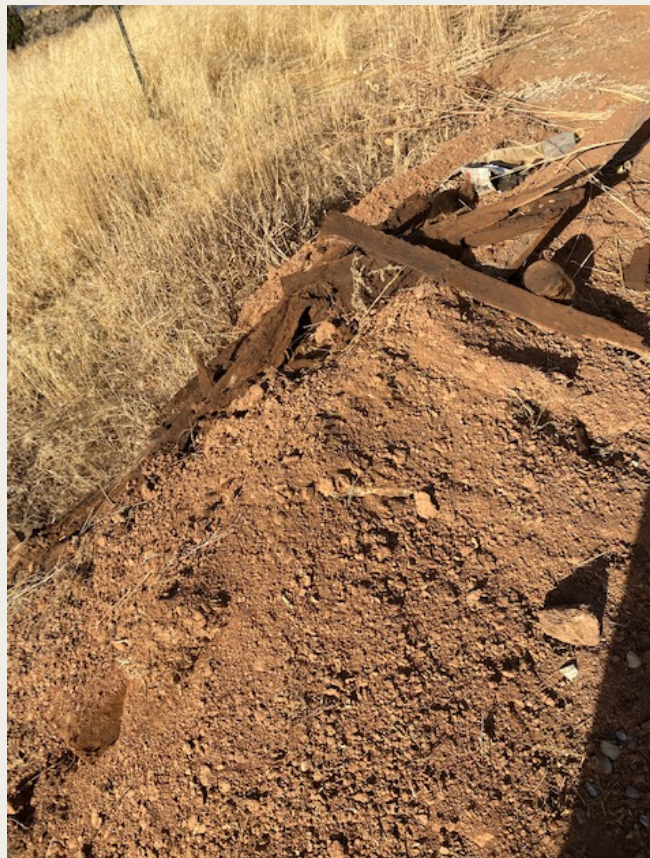
Photos 5/6. View of soil material that appears to be impacted by hydrocarbon waste, stored within the northwestern project area.

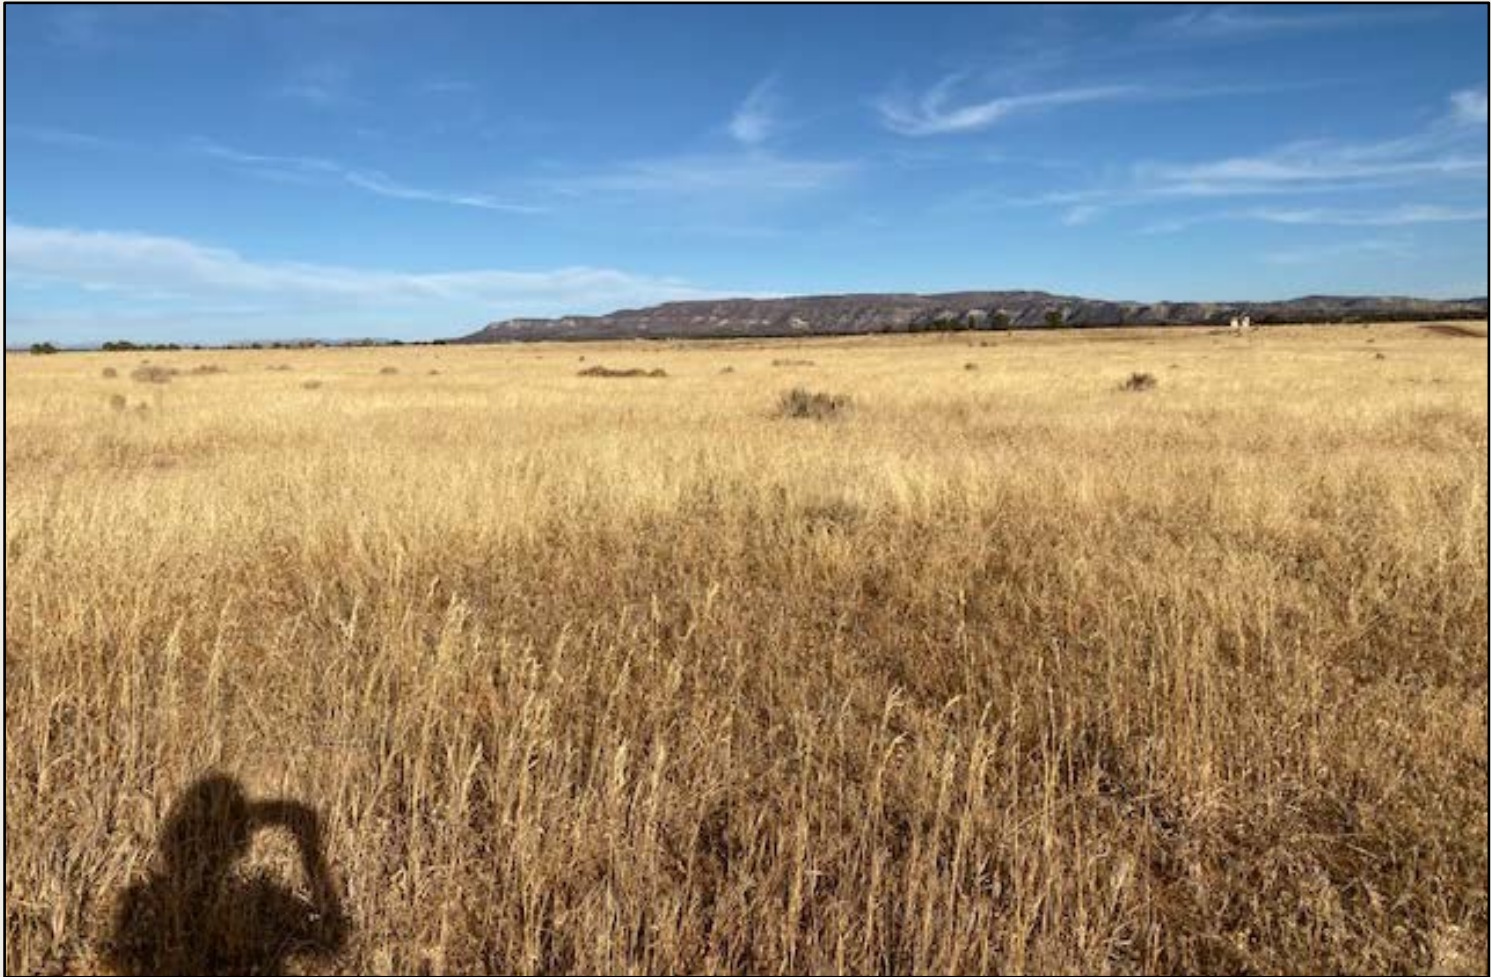
Photo 7. View of reference area, largely comprised of smooth brome, and scattered sagebrush plants.
