Inspection Photos  
Operator: BP America  
Location/API #: 067-09886  
Date: 12-10-2019

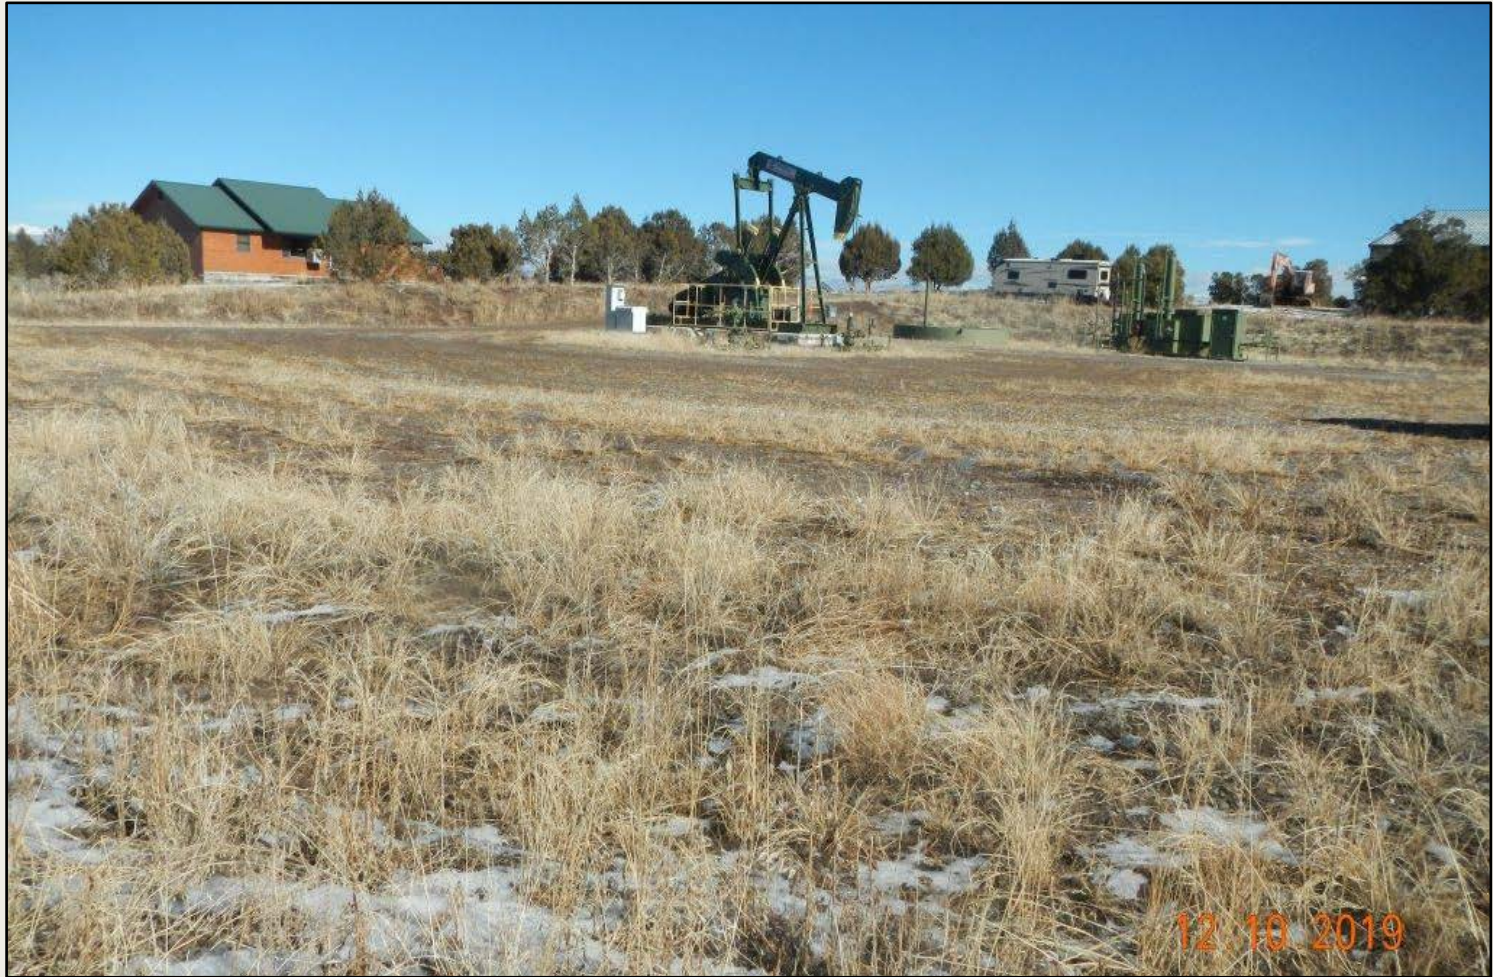
Photo 1. View of the project area from the southwestern corner facing center.

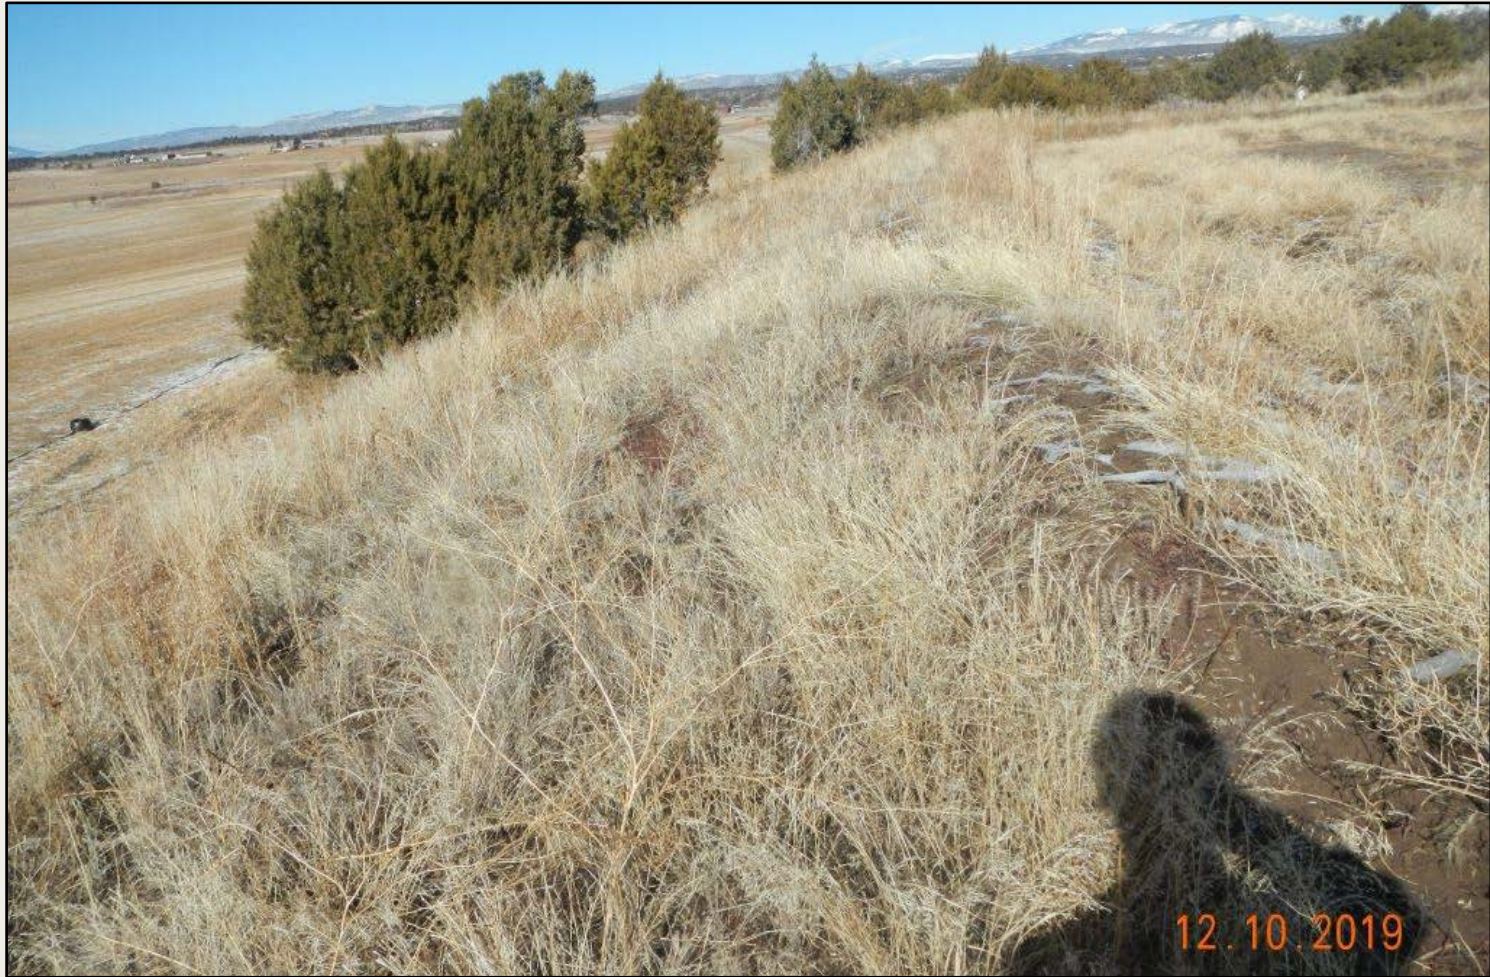
Photo 2. View of the western project area from the southwestern corner facing northward. Revegetation is progressing in portions of the reclamation area with grasses such as sand dropseed. However, a significant portion of the interim reclamation area is vegetated with the noxious weed jointed goatgrass.

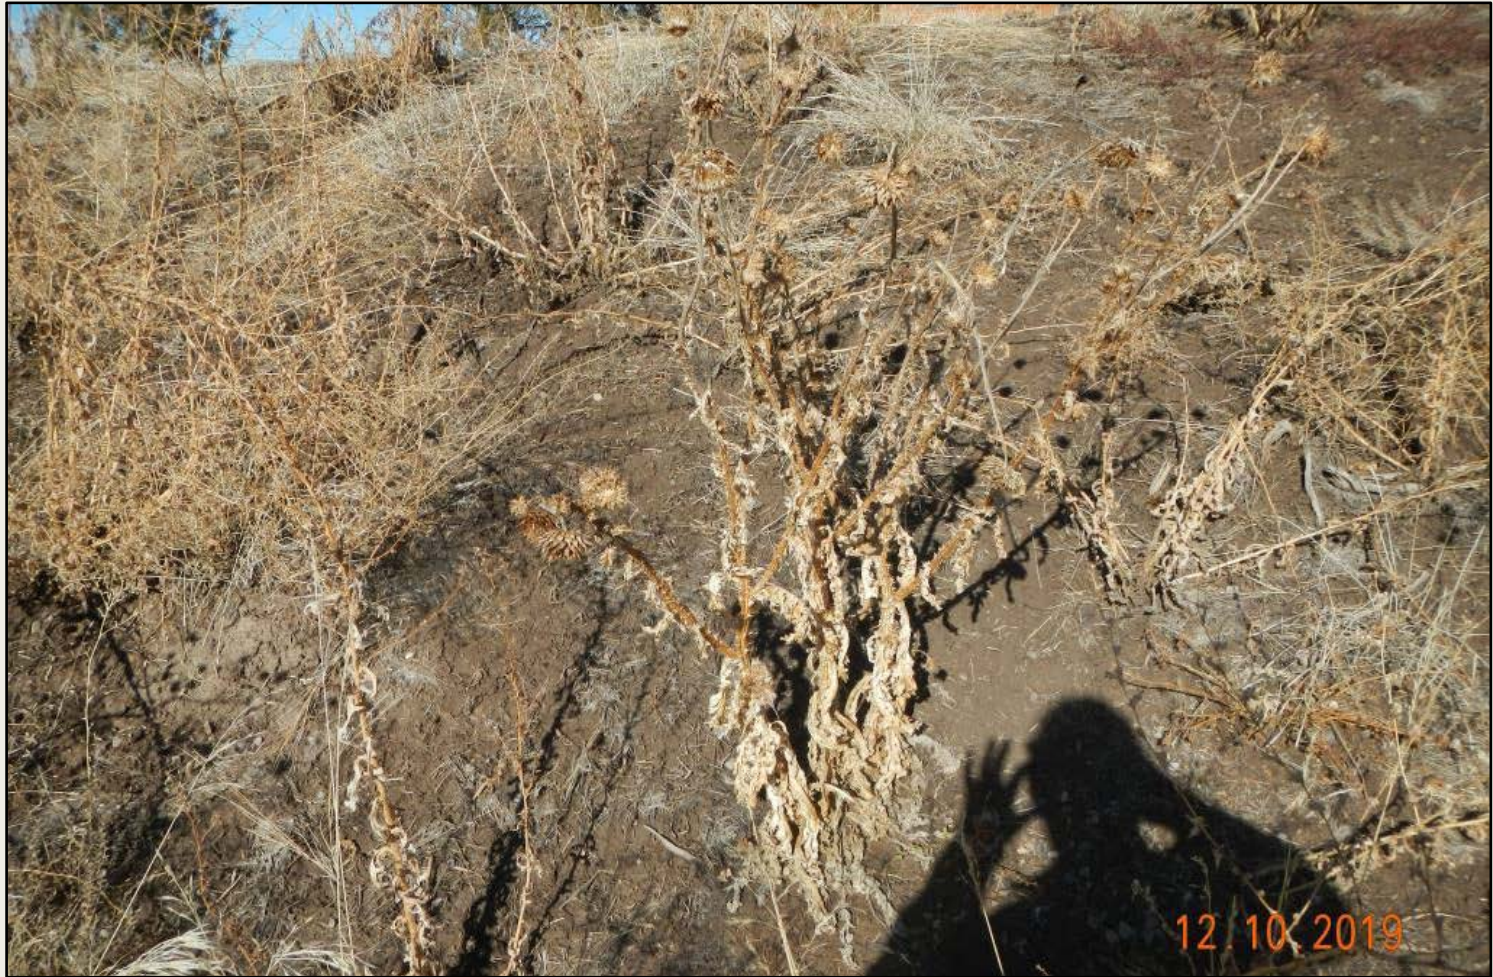
Photo 3. View of musk thistles within the northern project area. Approximately 50 individuals observed.

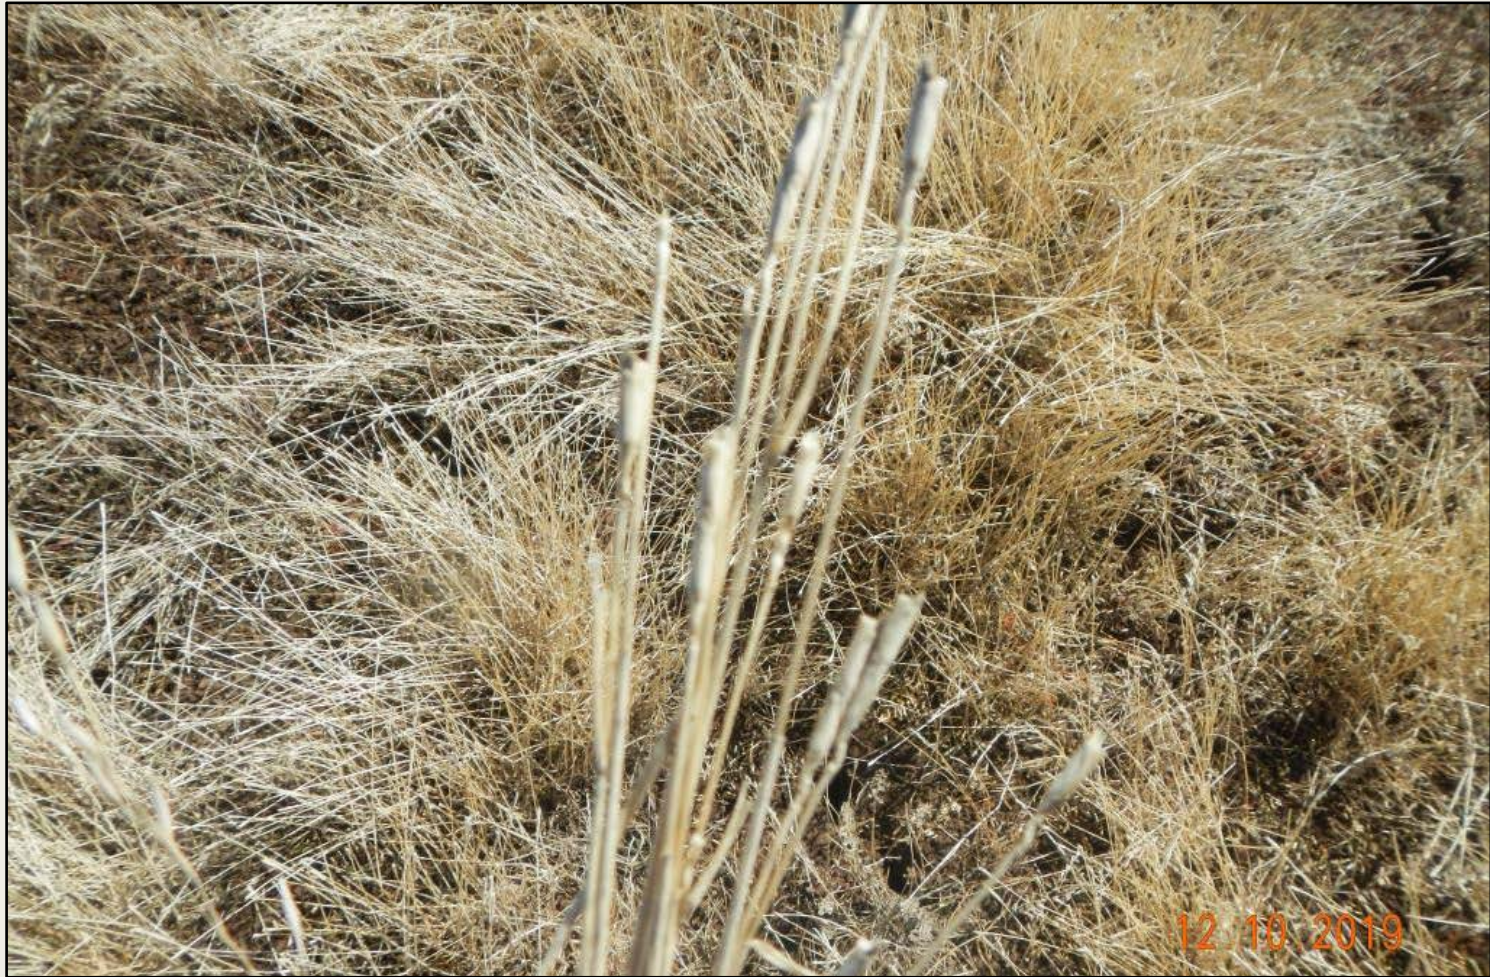
Photo 4. Closeup view of jointed goatgrass plants in foreground and densely populated in background. Photo taken on the southern fill slope.

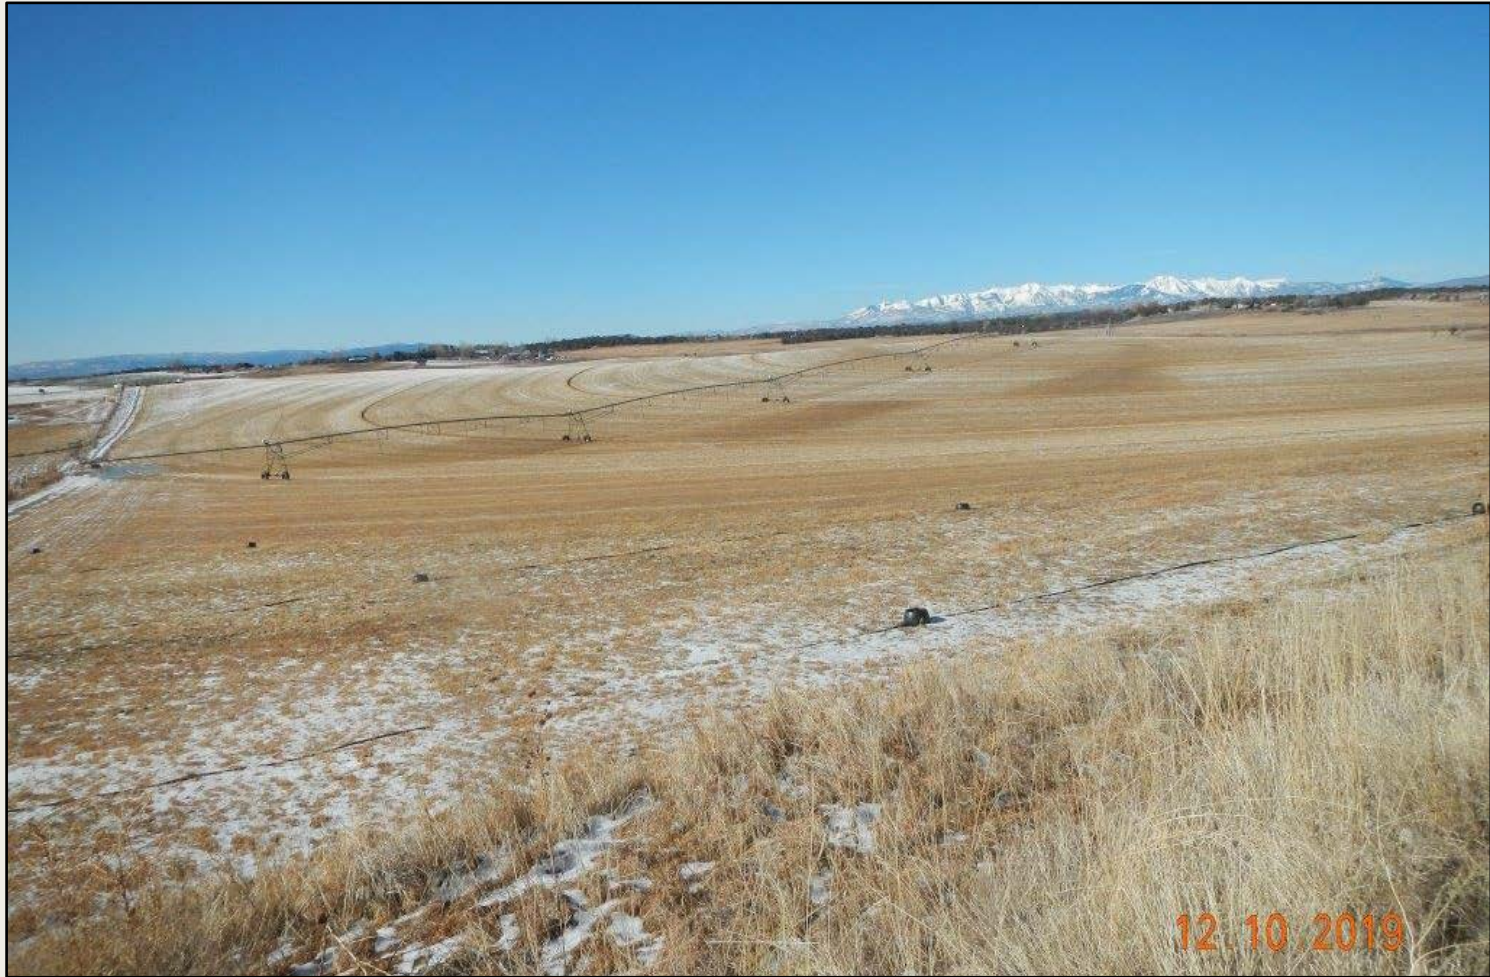
Photo 5. View of reference area in background, comprised of irrigated grass field. Residential housing present north and east of the well pad.
