Inspection Photos
Operator: BP America
Location/API #: 067-07916
Date: 12-10-2019

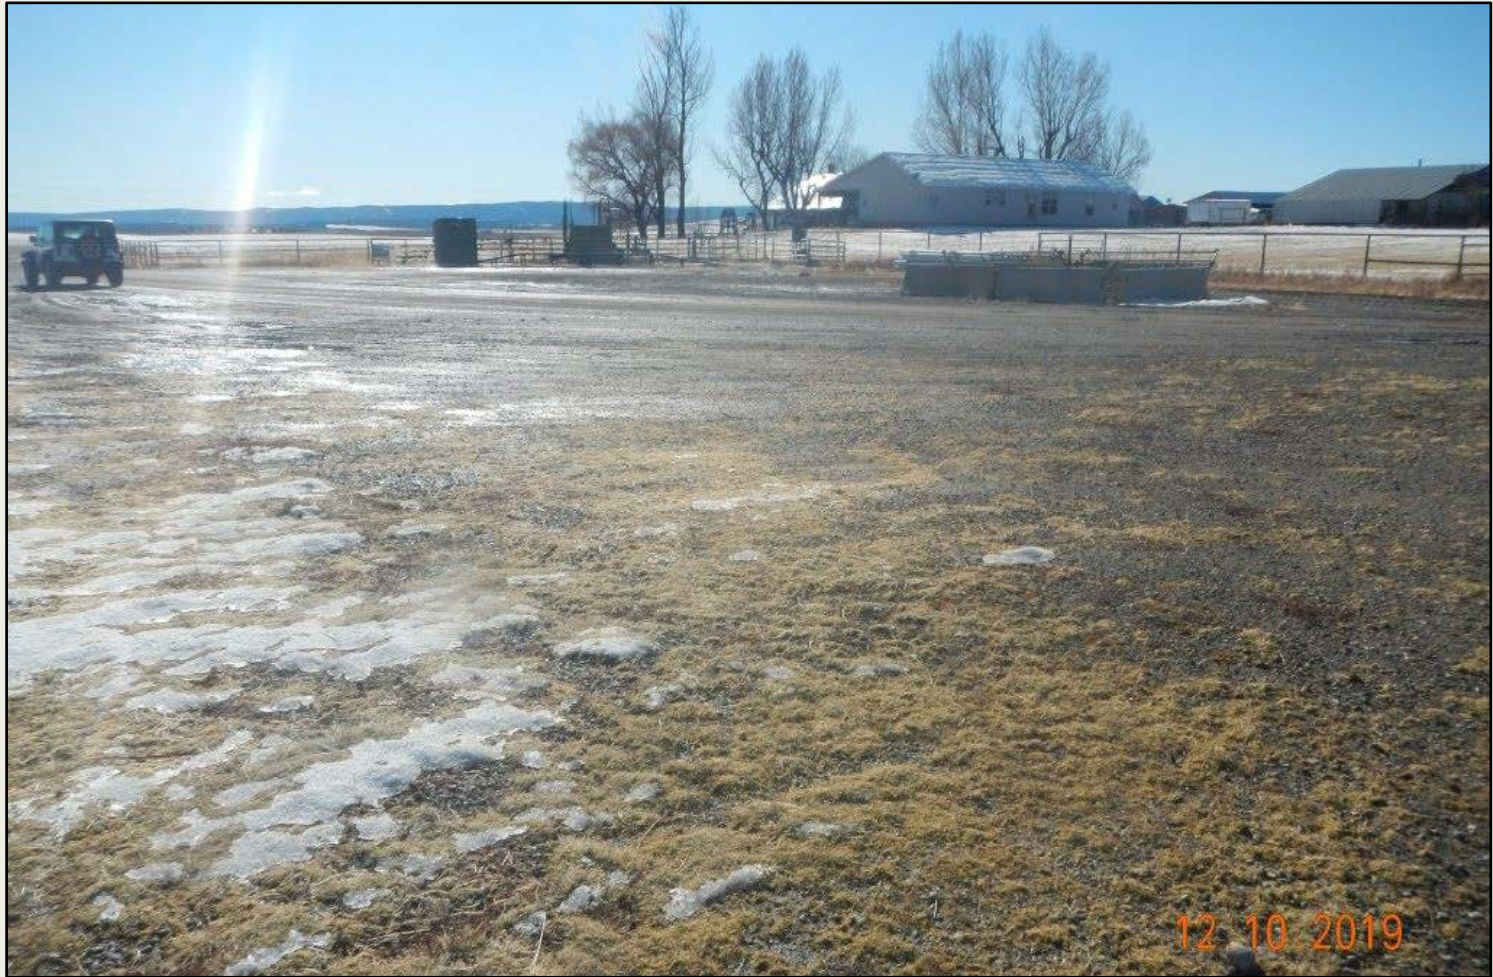
Photo 1. View of the project area from the northeastern corner facing center.

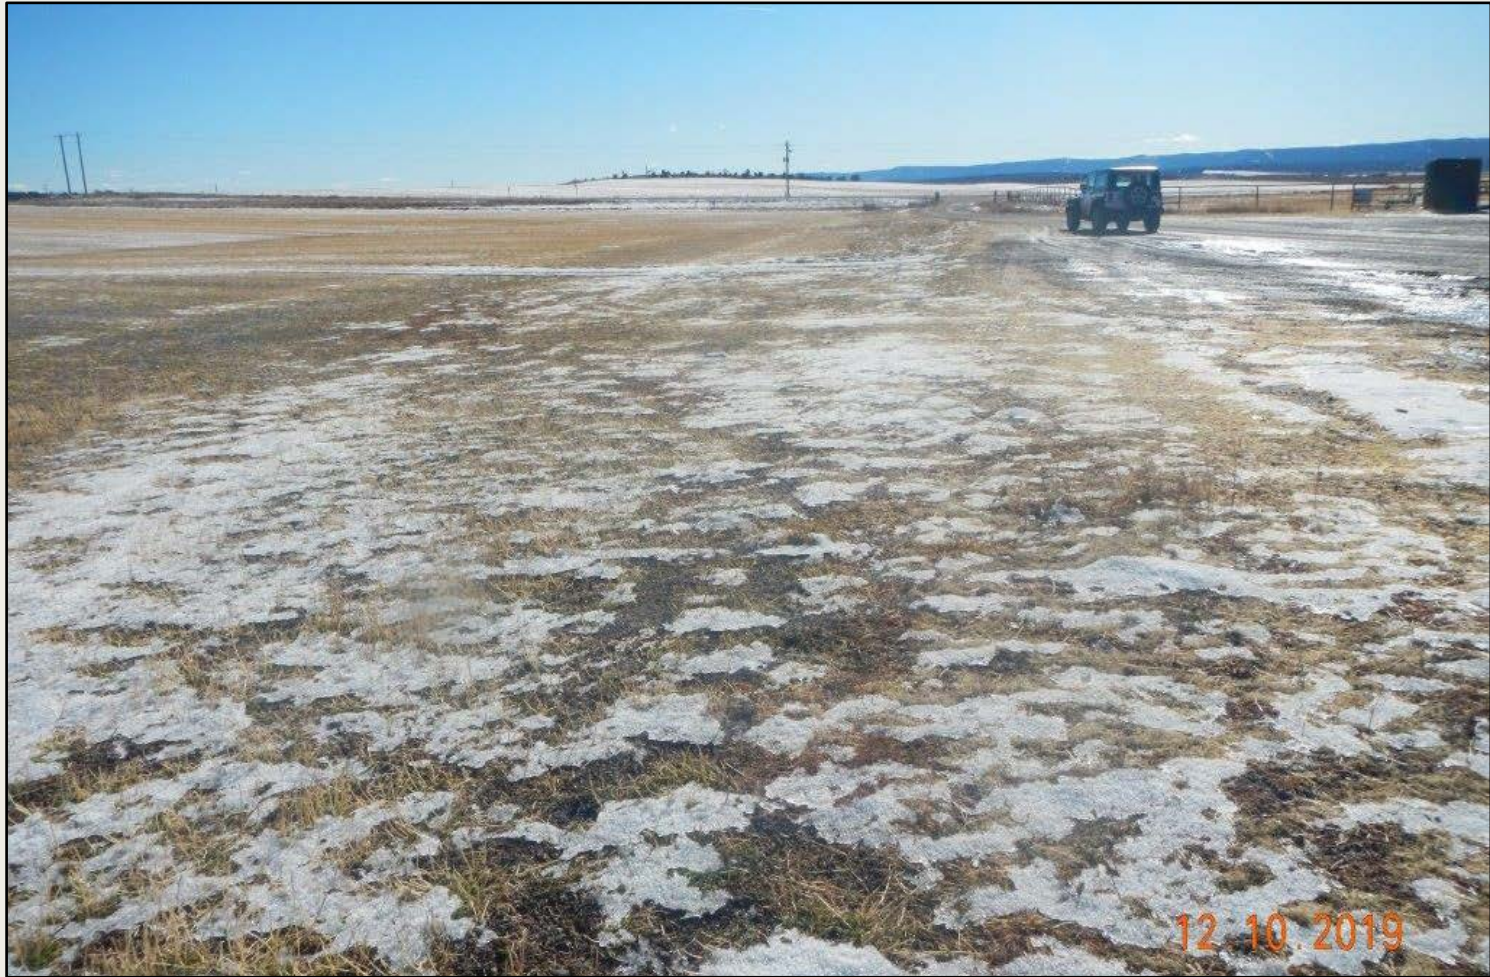
Photo 2. View of the eastern project area from the northeastern corner facing southward. Revegetation is in a dormant vegetative condition, and appears to be progressing similar to surrounding crop field.

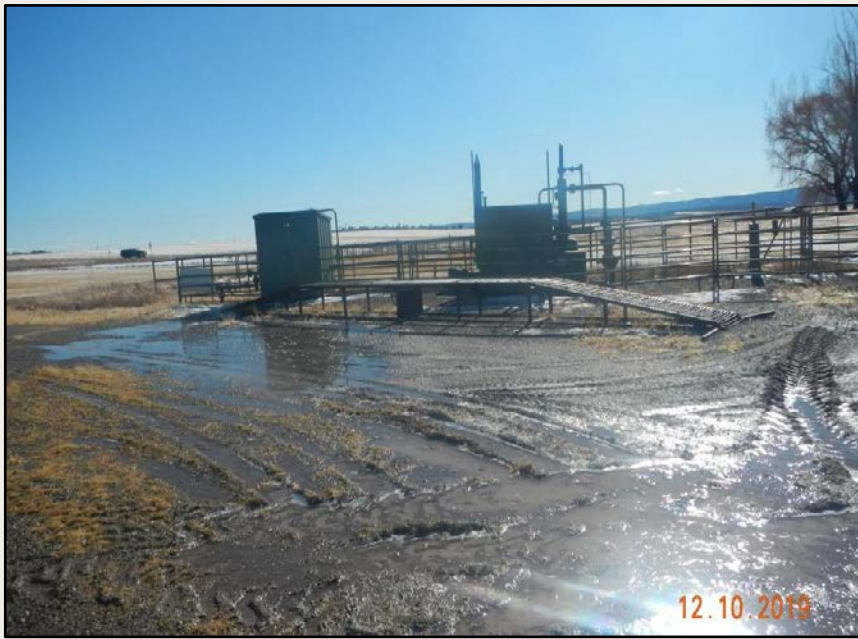
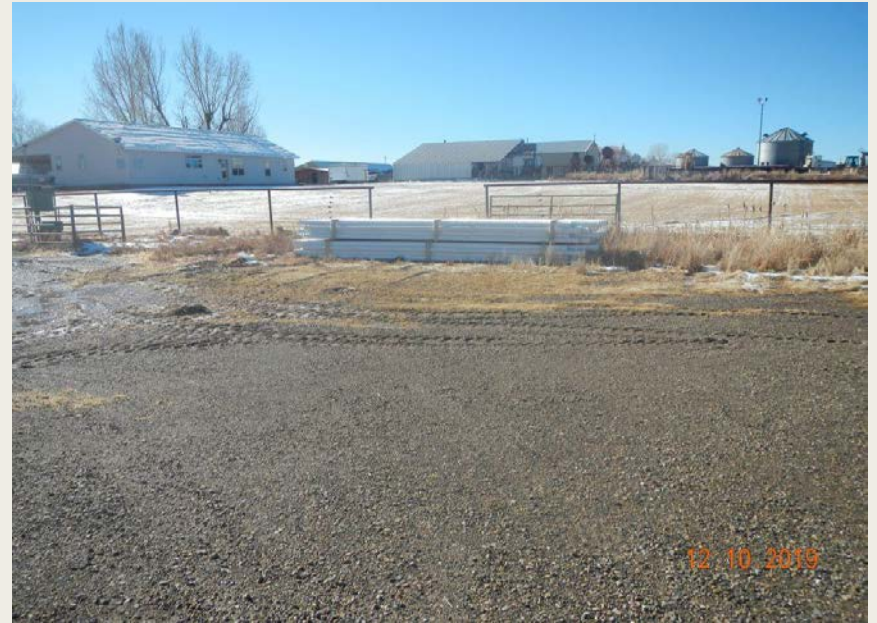
Photos 3/4. View of unused equipment stored in the project area.

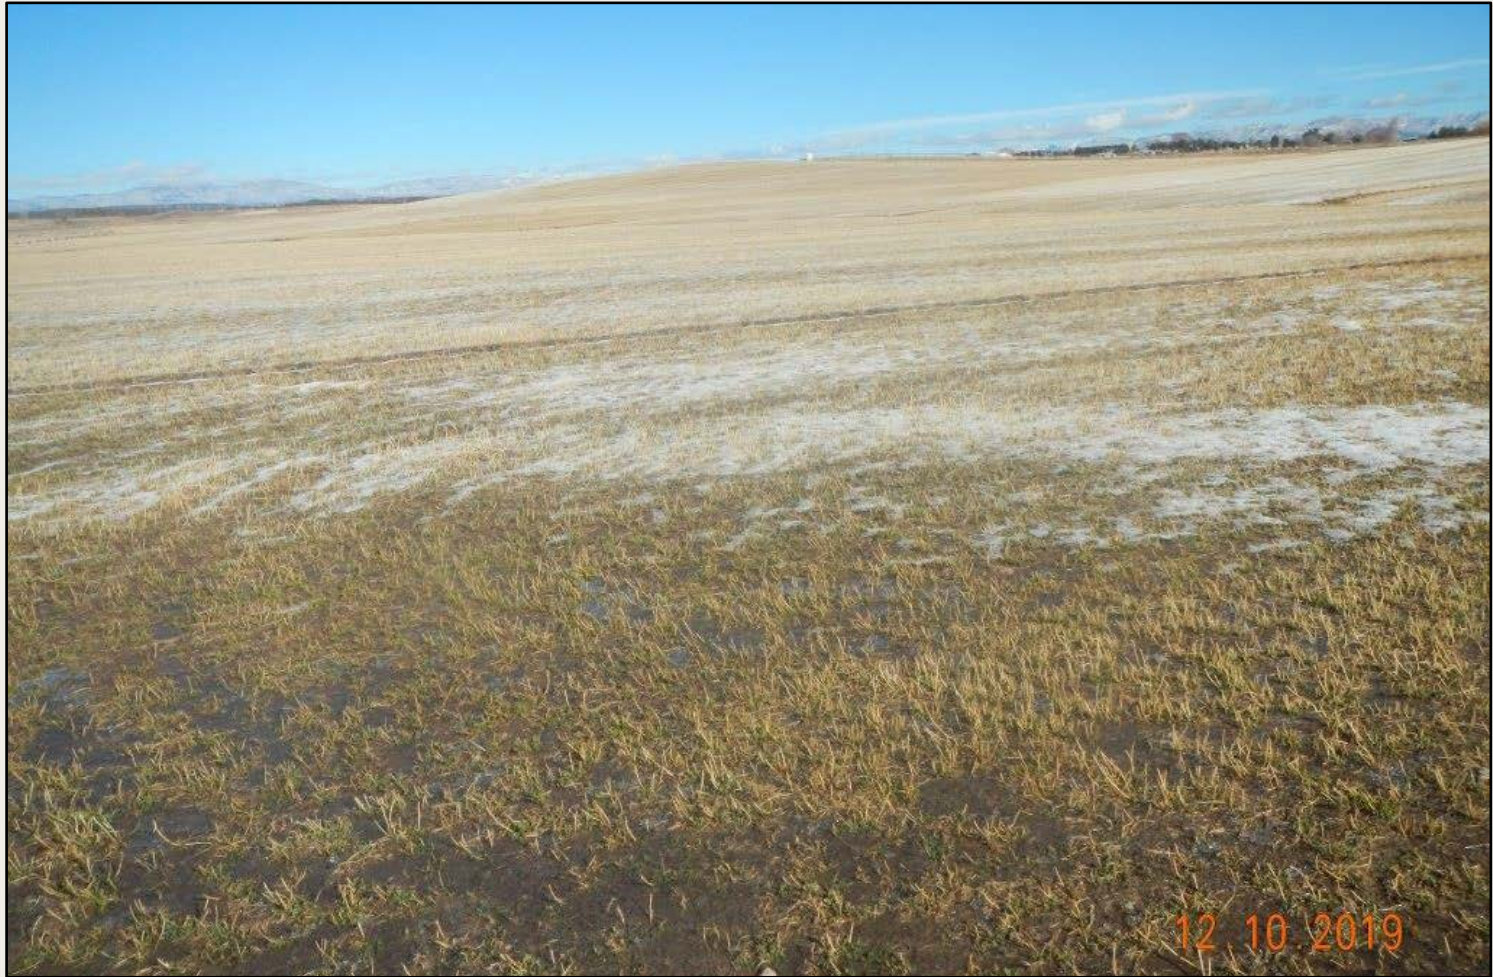
Photo 4. View of reference area, comprised of irrigated crop field.
