**Inspection Photos**  
**Operator: BP America**  
**Location/API #: 067-08215**  
**Date: 12-10-2019**

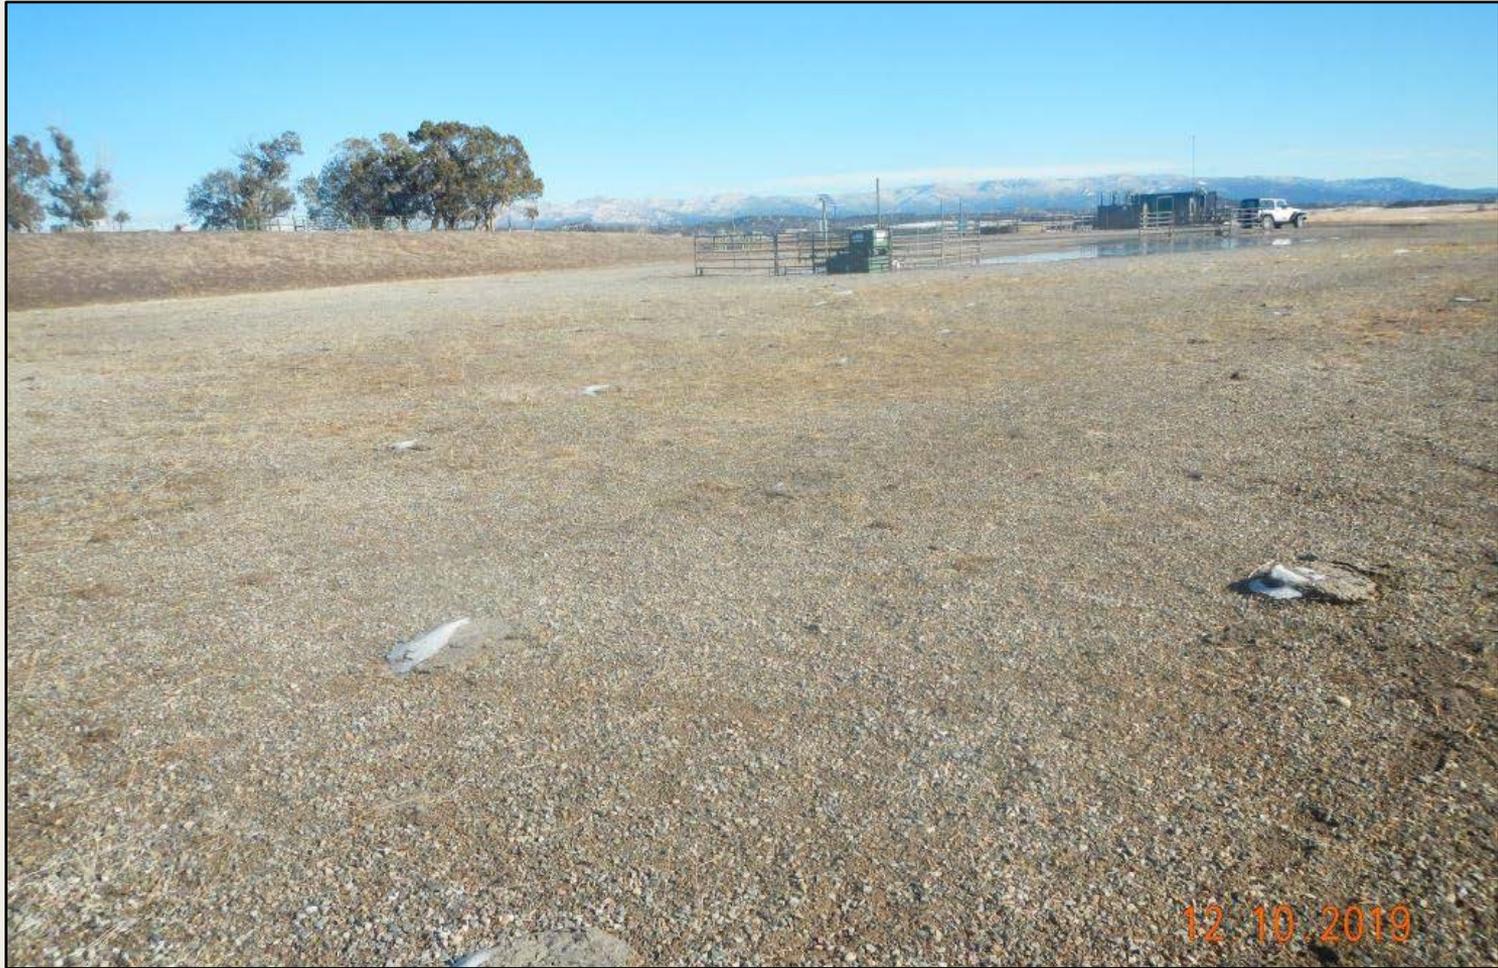
Photo 1. View of the project area from the western corner facing center.

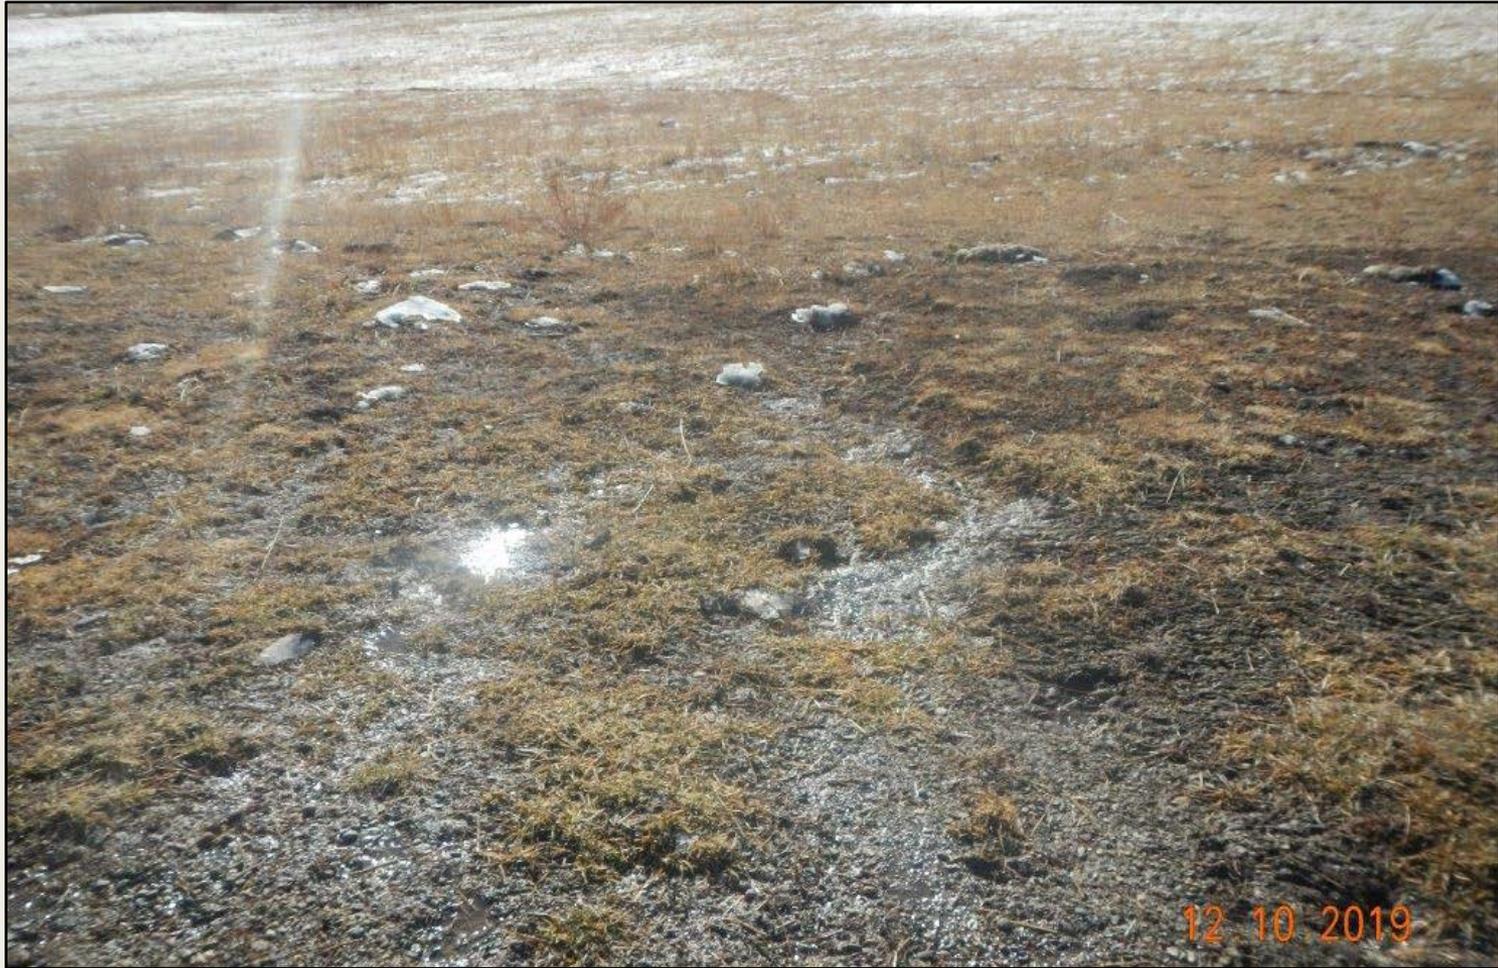
Photo 2. View of erosional rilling within the southwestern project area.

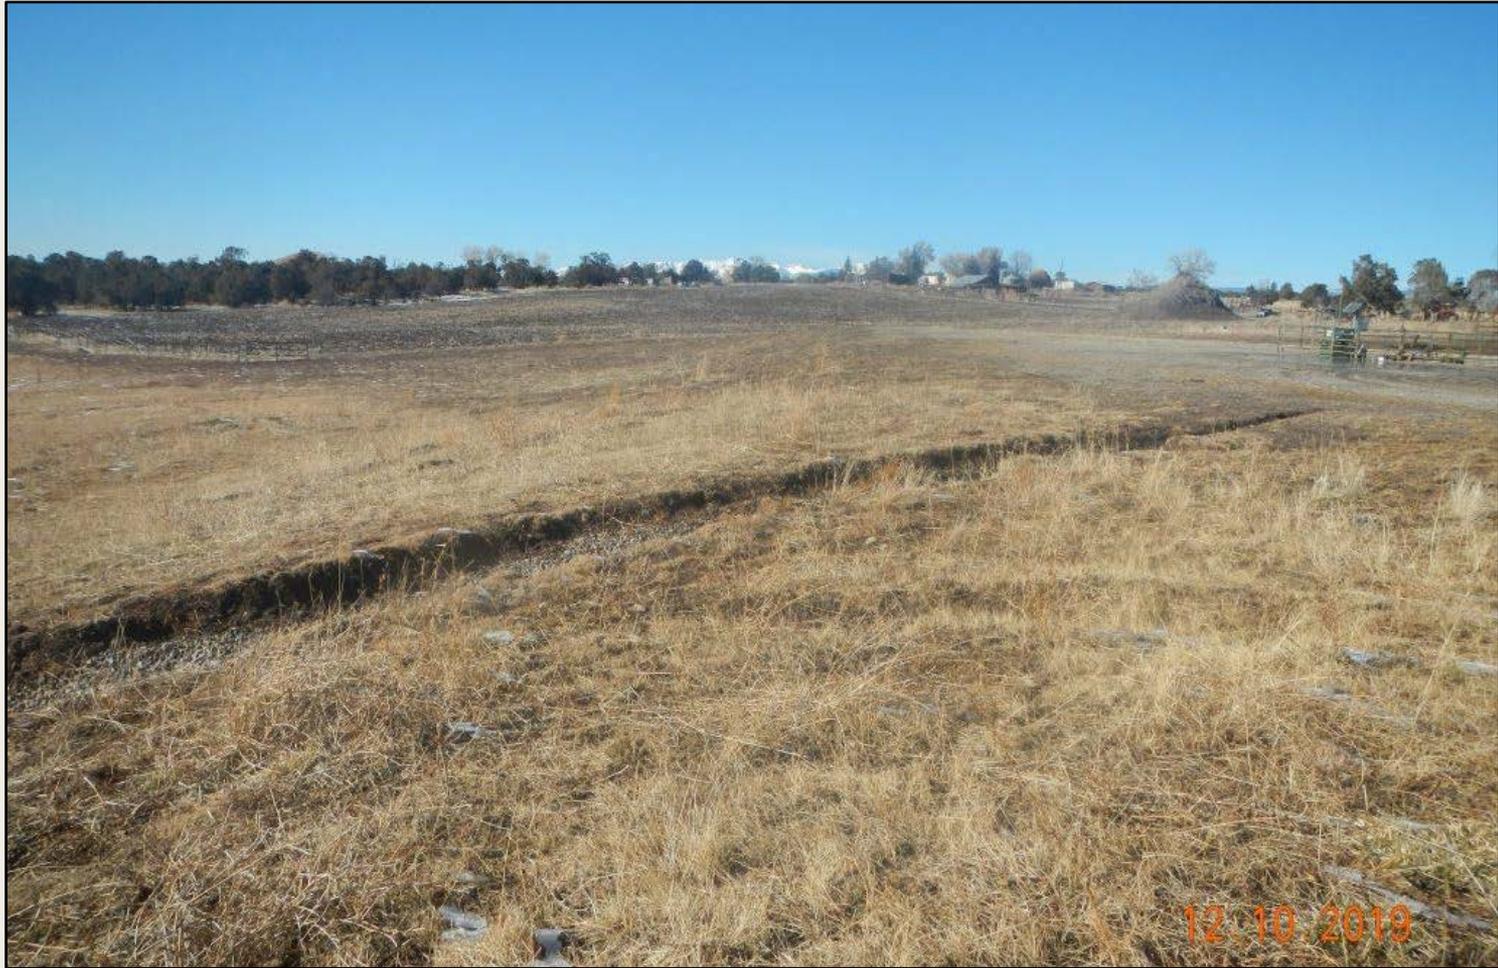
Photo 3. View of the southwestern fill slope from the southern corner facing northwestward. Revegetation appears to be progressing, in a dormant and grazed condition with grasses such as western wheat grass and sand dropseed.

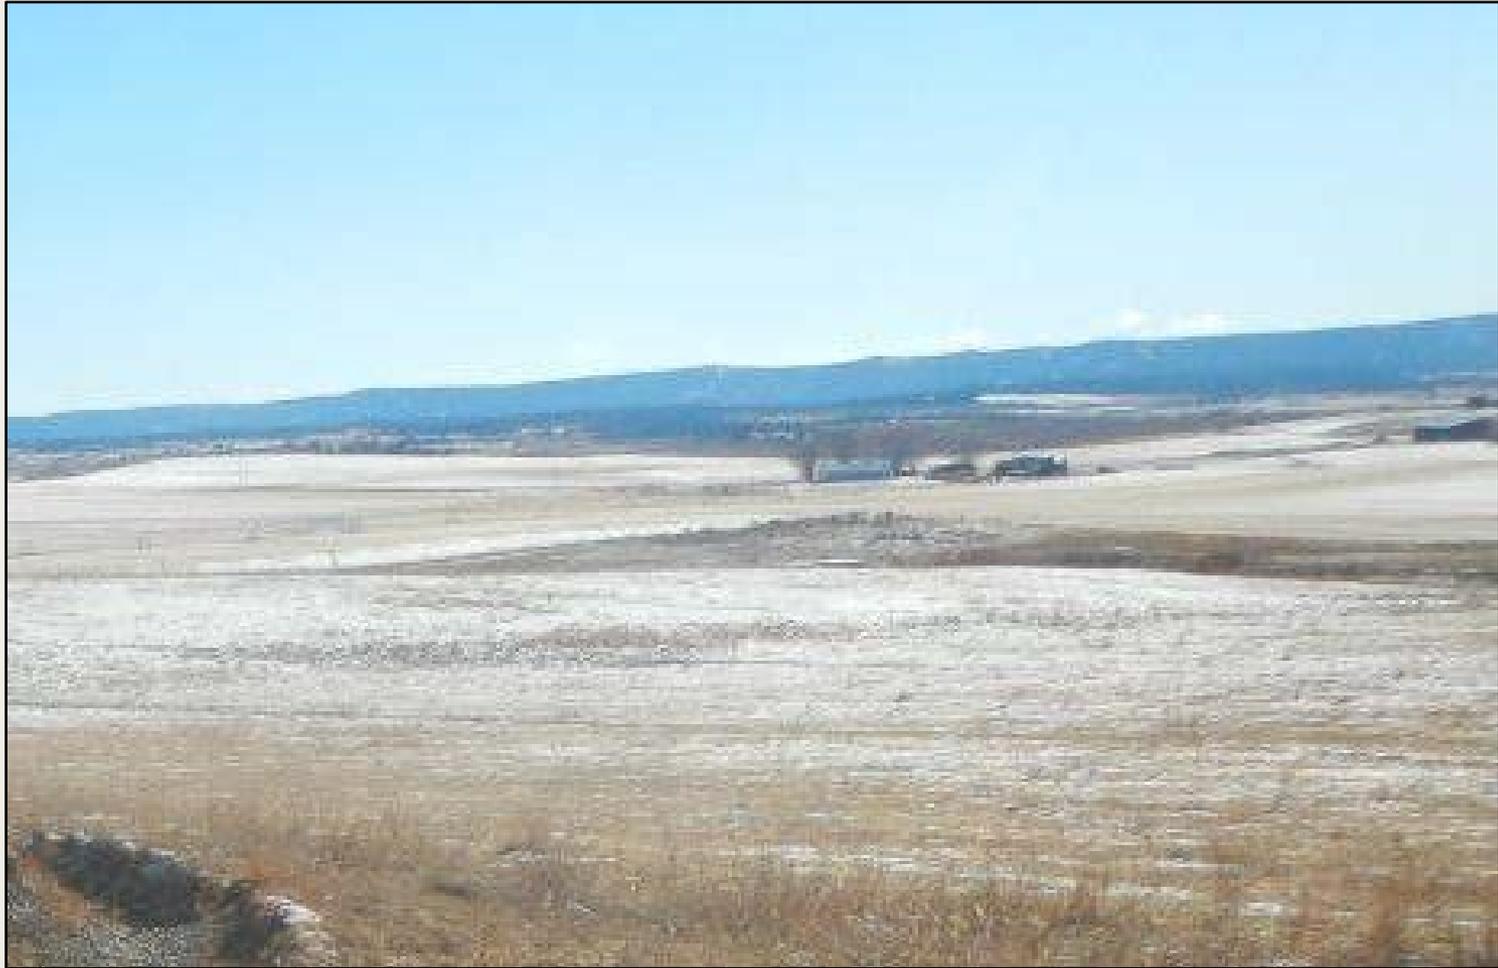
Photo 4. View of reference area, comprised of irrigated crop field.
