## Inspection Photos

Location Name: Jones-67S94W 17 SENW Pad & 17F Spills

Location ID: #335023 & Spill/Release IDs: #467054 & #469248

Inspection Date: November 25, 2019

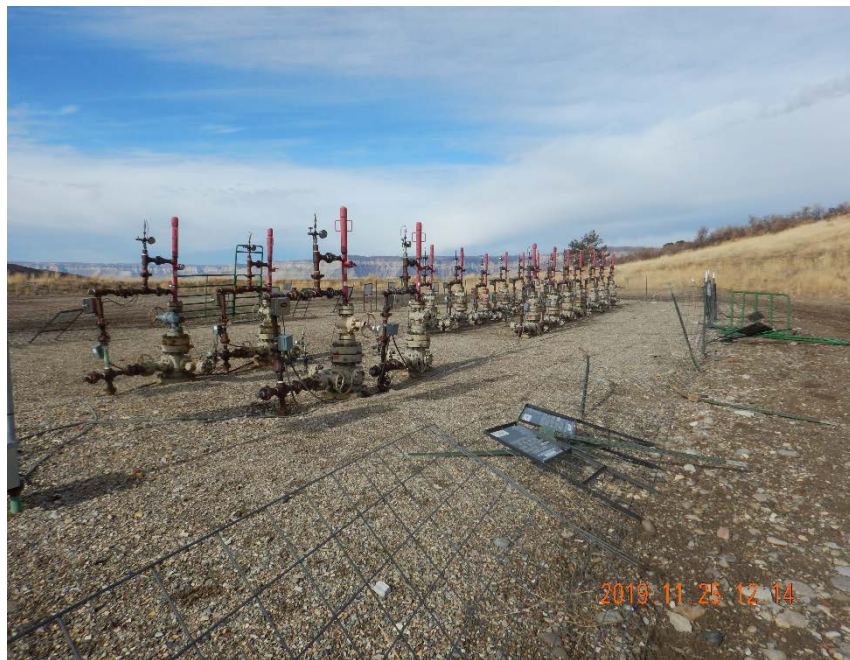
**Photo #1 – Wellhead fence is damaged.**

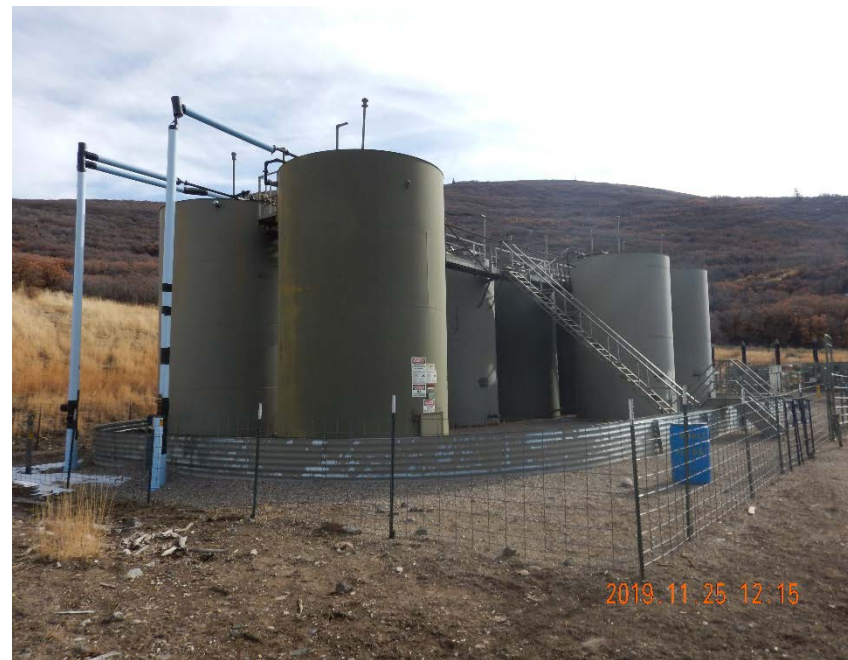
**Photo #2 – View of tank battery from northwest corner.**

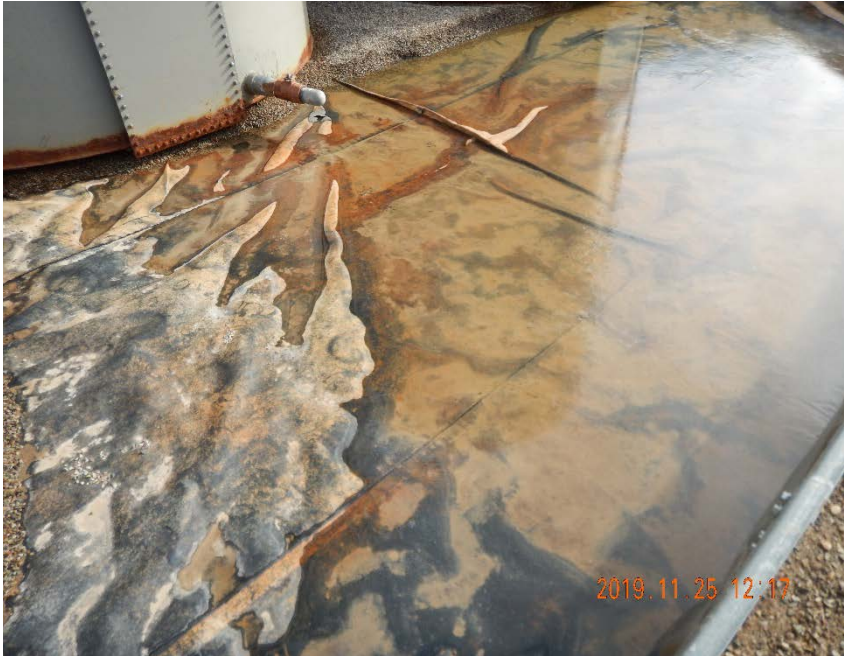
**Photo #3 – Gravel base has been removed from southwest corner of tank battery in response to Spill/Release ID #467054.**

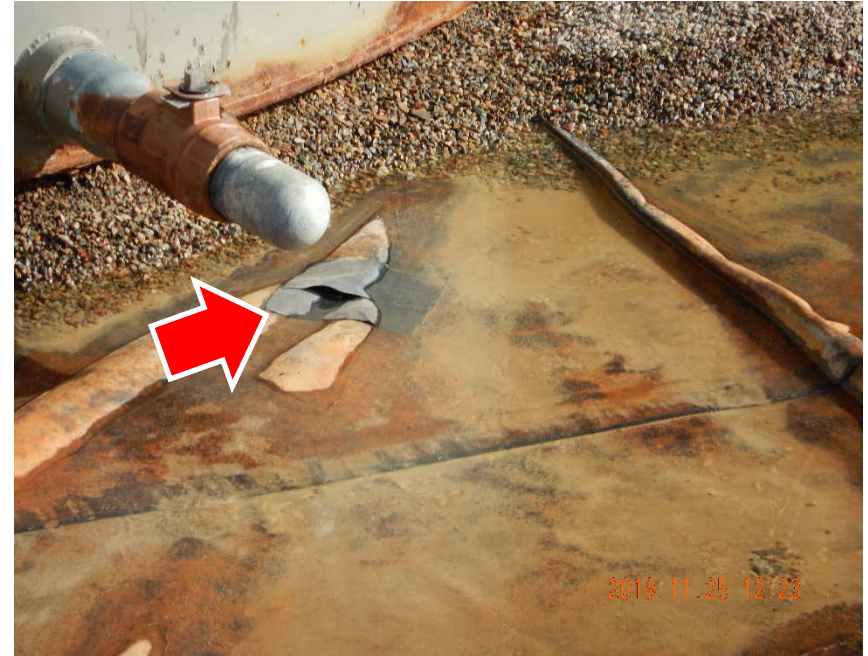
**Photo #4 – Patched area of tank battery liner had an apparent gap during inspection. Operator was notified of issue via phone on 11/26/2019.**

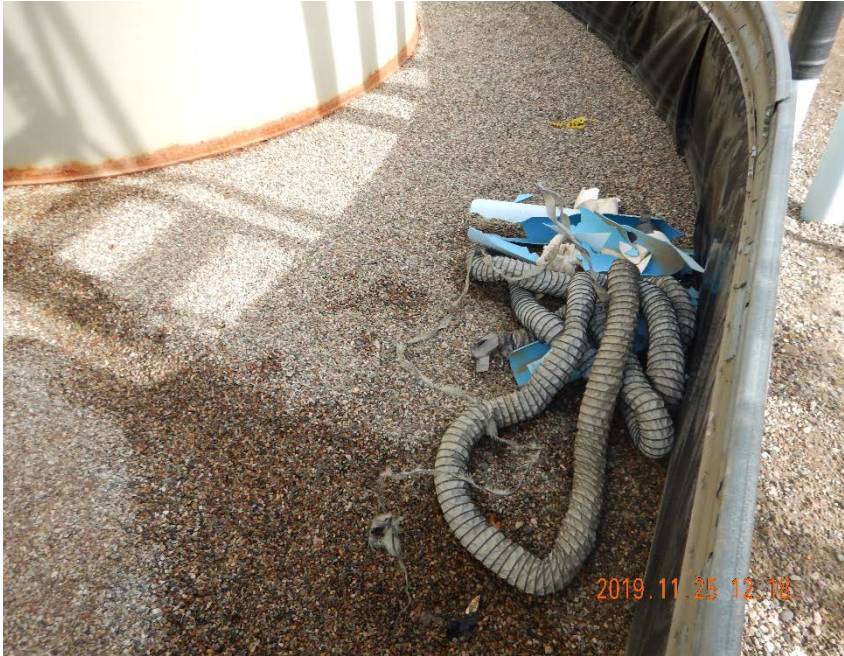
**Photo #5 – Unused equipment and junk stored inside of south end of tank battery secondary containment area.**

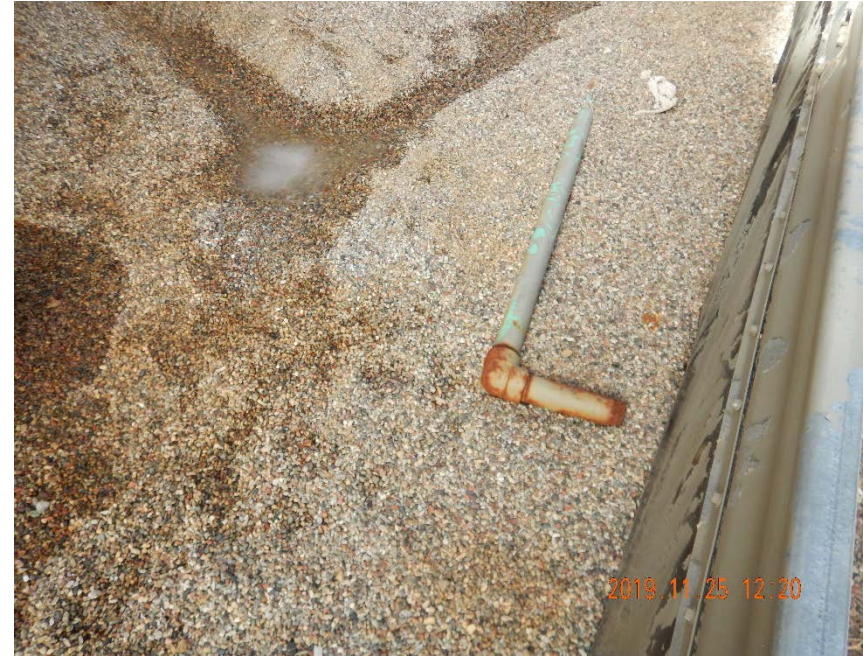
**Photo #6 – Unused equipment stored inside of secondary containment area on east side.**

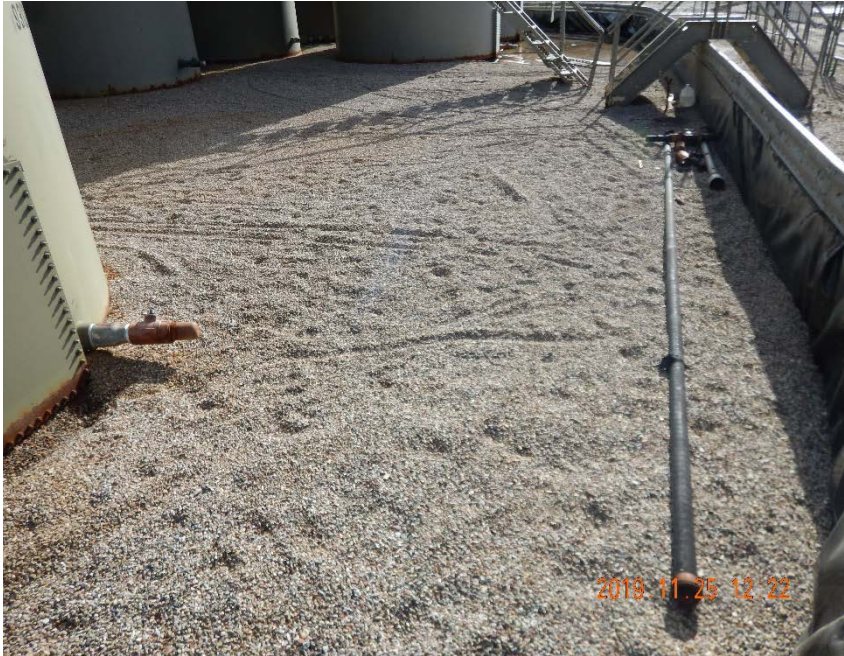
**Photo #7 – Unused equipment stored inside of secondary containment area on west side.**

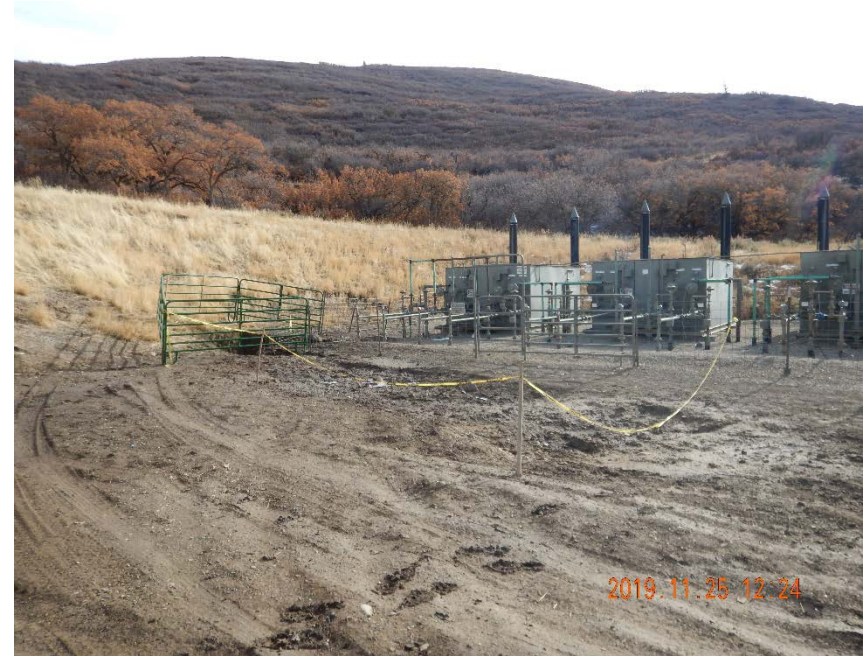
**Photo #8 – Overview of fenced separator area and flow path for fluids released by Spill/Release ID #469248, from north.**

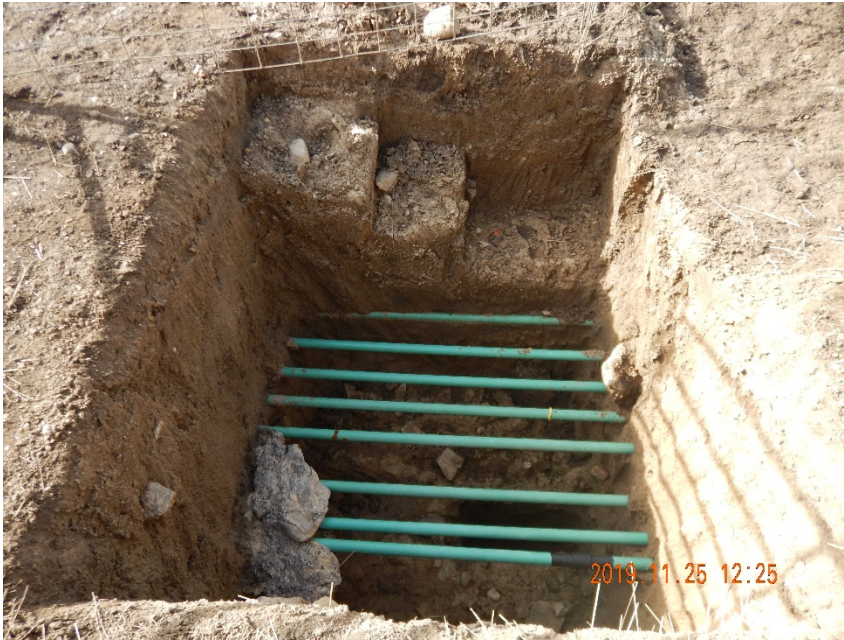
Photo #9 – View into flowline excavation, from east side.

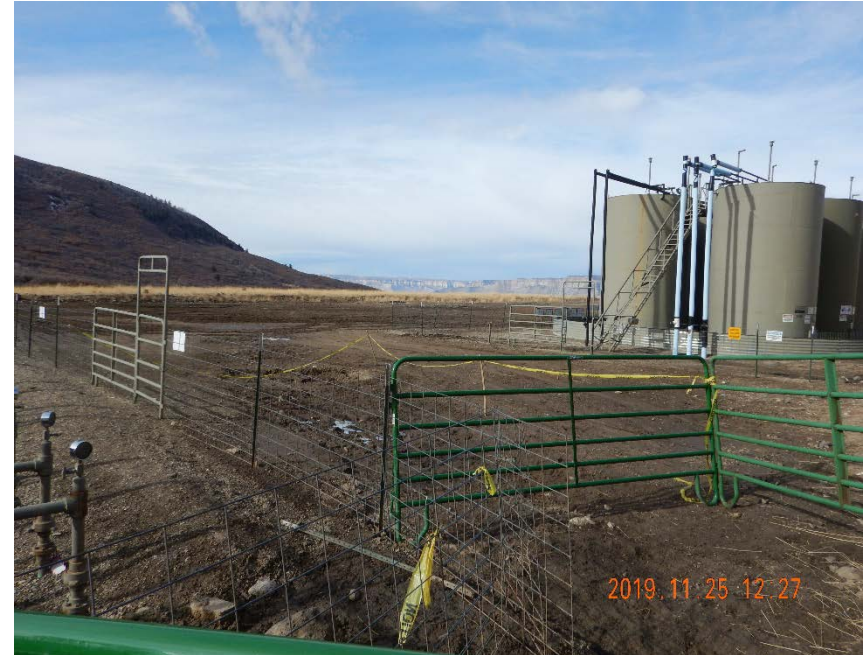
Photo #10 – View of fenced flow path area from south side of flowline excavation.

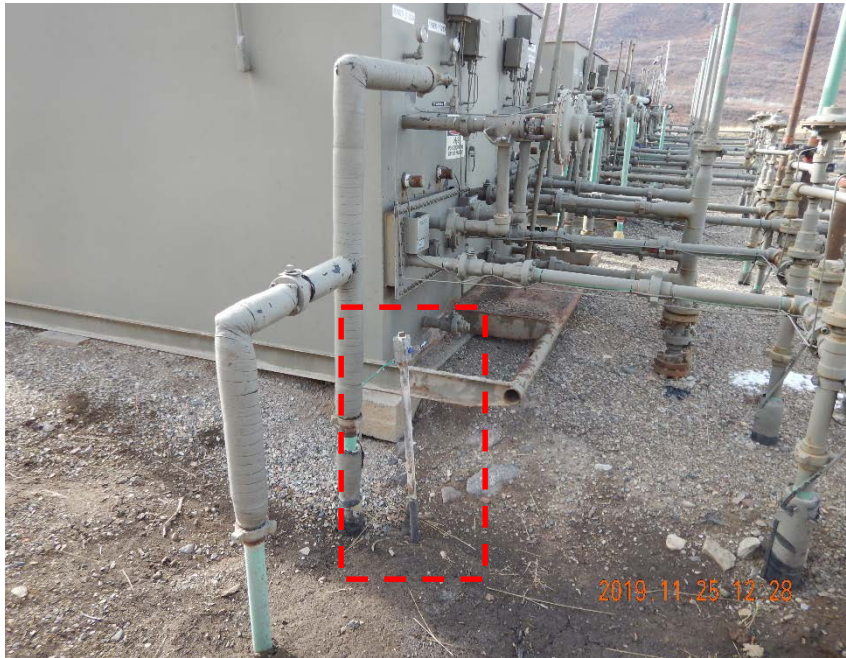
**Photo #11 – Capped, unmarked 1" flowline riser located east of separators.**

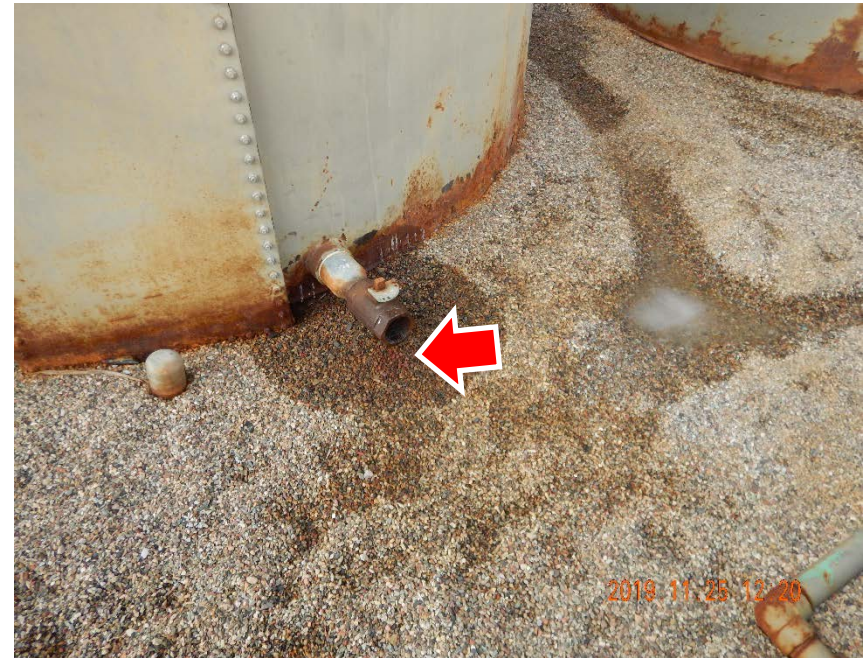
**Photo #12 – Unidentified fluids observed in threads and rust-stained gravel beneath ball valve attached to tank in NE corner of containment area (1).**

**Note bull plug was not installed during inspection.**

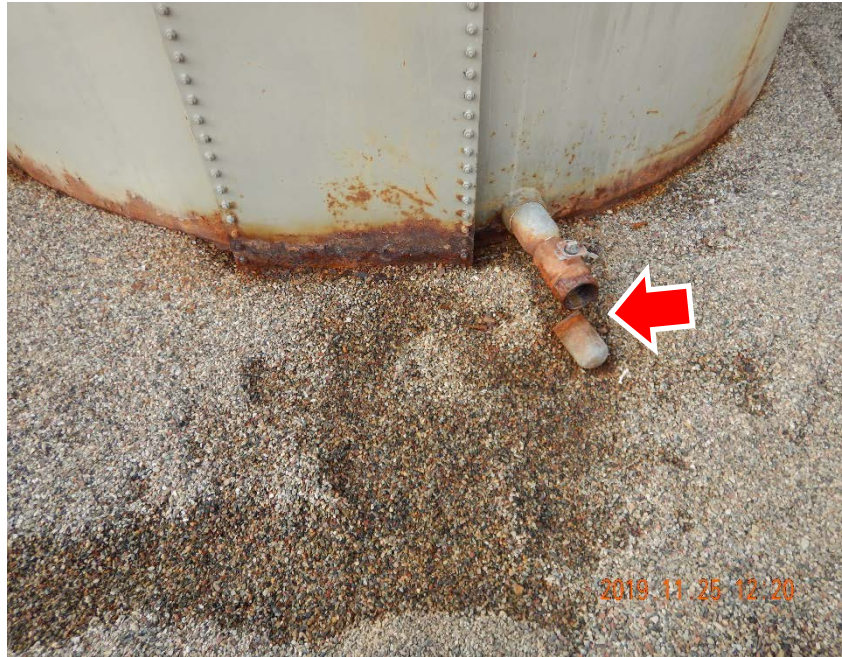
**Photo #13 - Unidentified fluids observed in threads and rust-stained gravel beneath ball valve attached to tank in NE corner of containment area (2).**

**Note bull plug was not installed during inspection.**
