Inspection Photos
Operator: Hilcorp Energy
Location/API #: 067-09564
Date: 12-13-2019

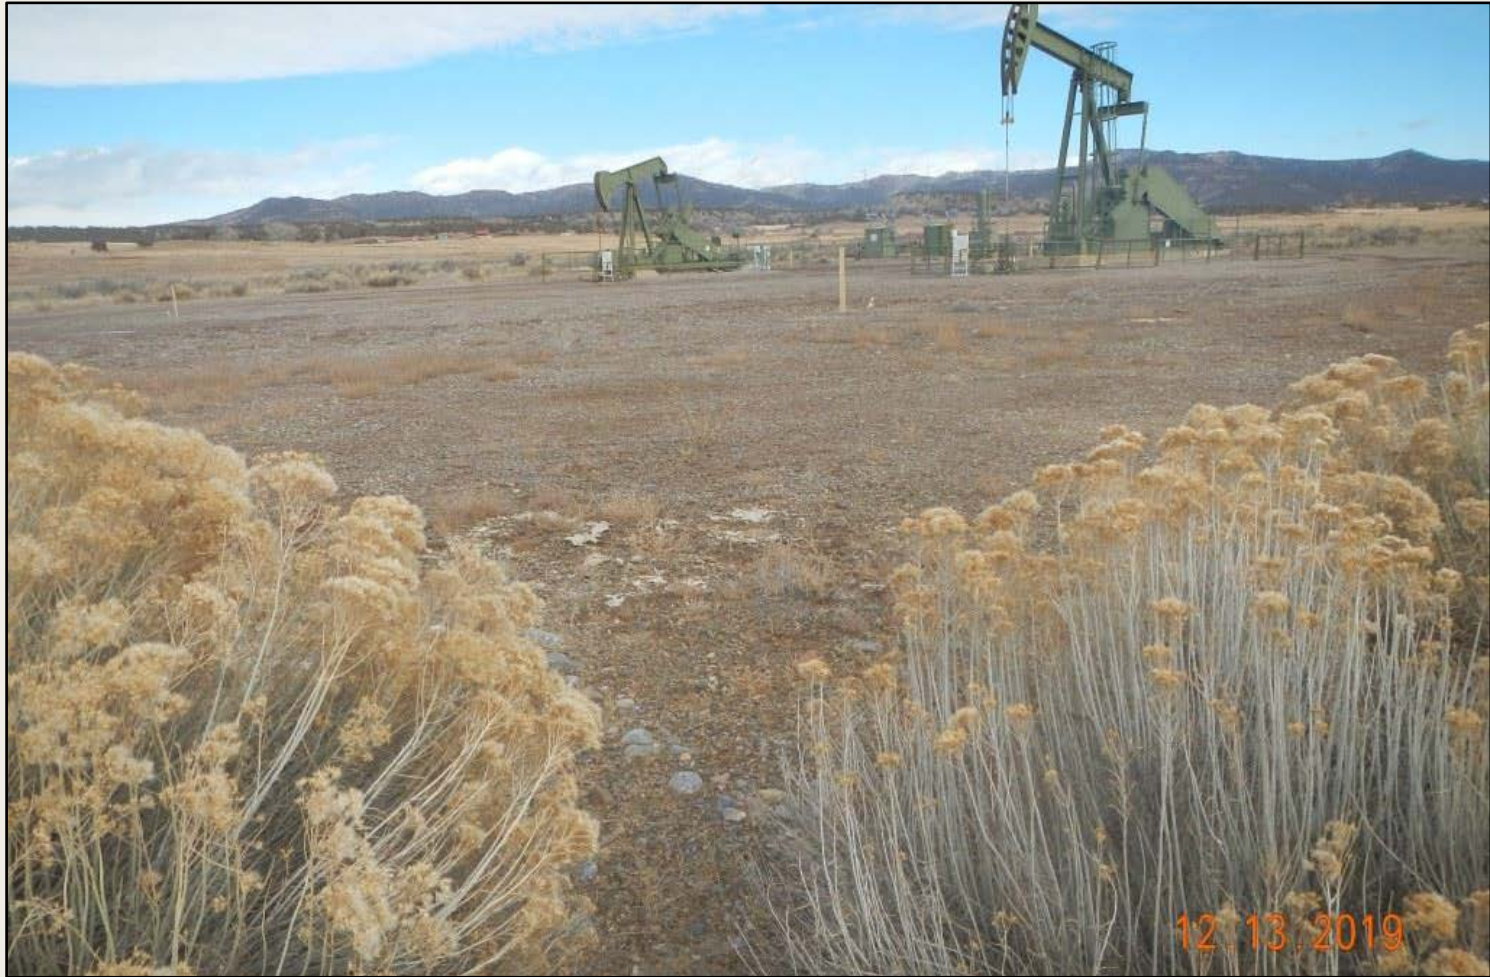
Photo 1. View of the project area from the southwestern corner facing center.

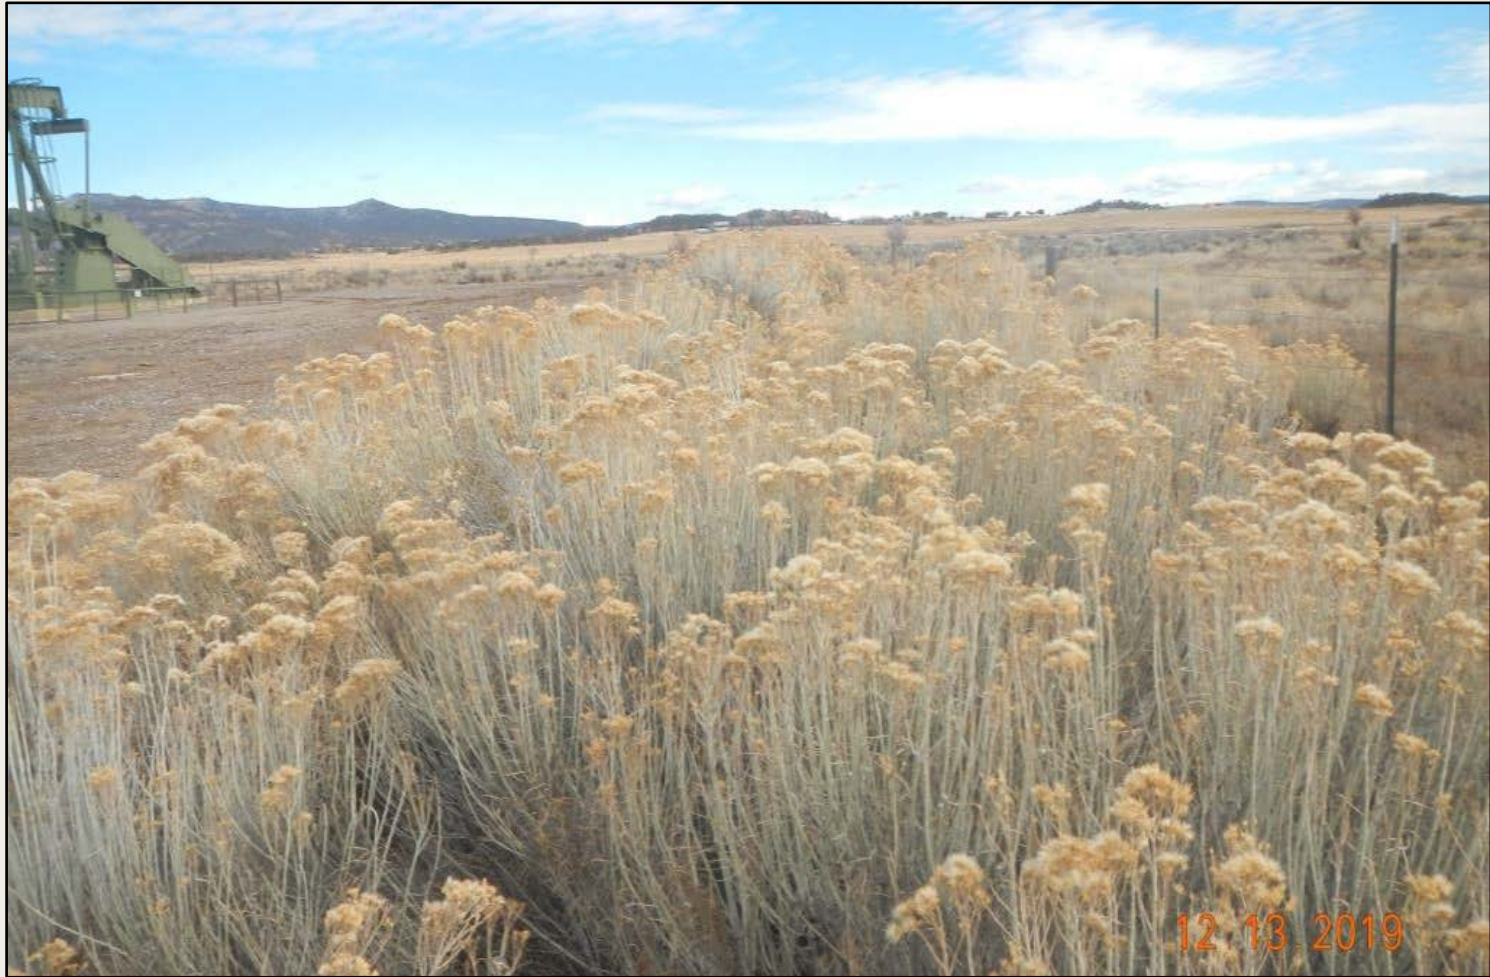
Photo 2. View of the southern project area from the southwestern corner facing eastward. Revegetation is progressing, largely with rubber rabbitbrush.

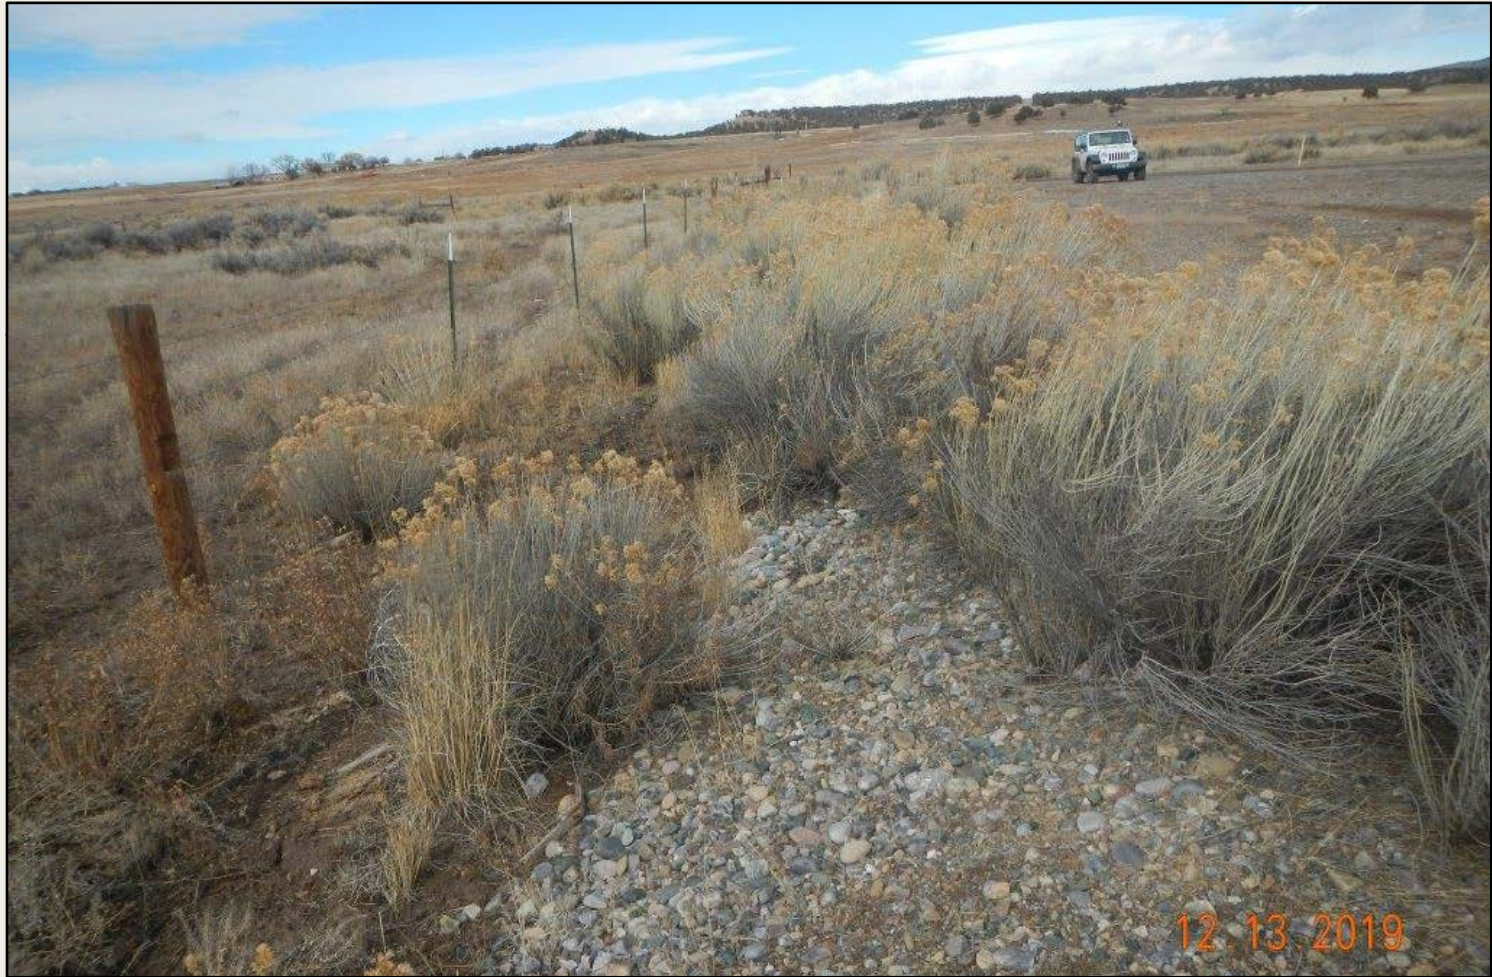
Photo 3. View of the western project area from the southwestern corner facing northward.

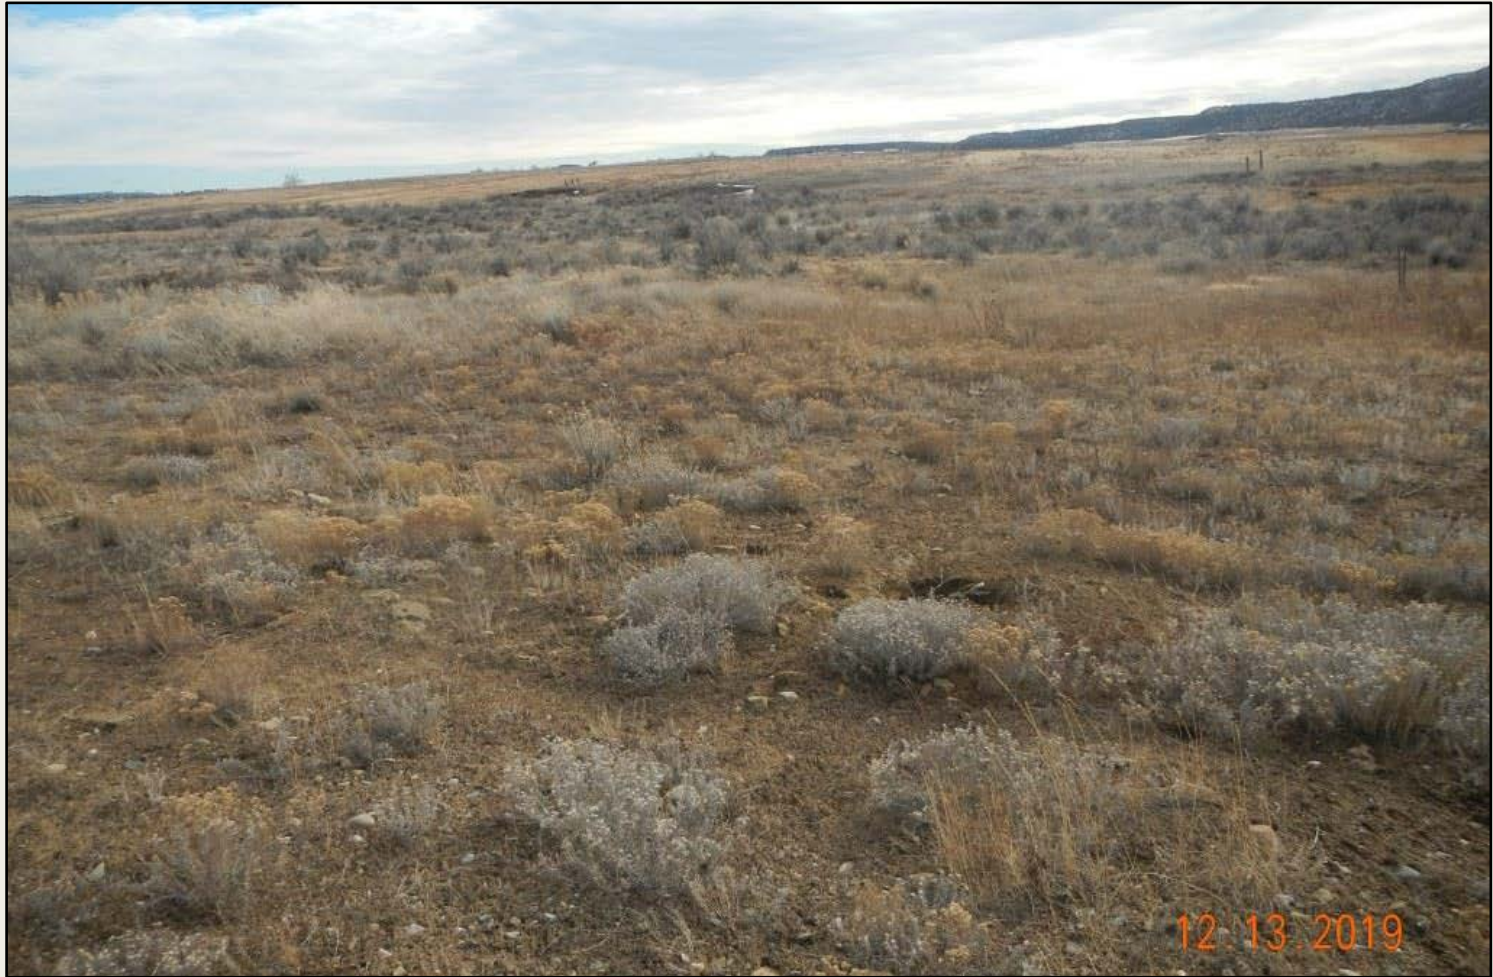
Photo 4. View of reference area, comprised of greasewood, snakeweed, and sand dropseed.
