## Inspection Photos Location #420972

**COLORADO**  
Oil & Gas Conservation  
Commission  
Department of Natural Resources

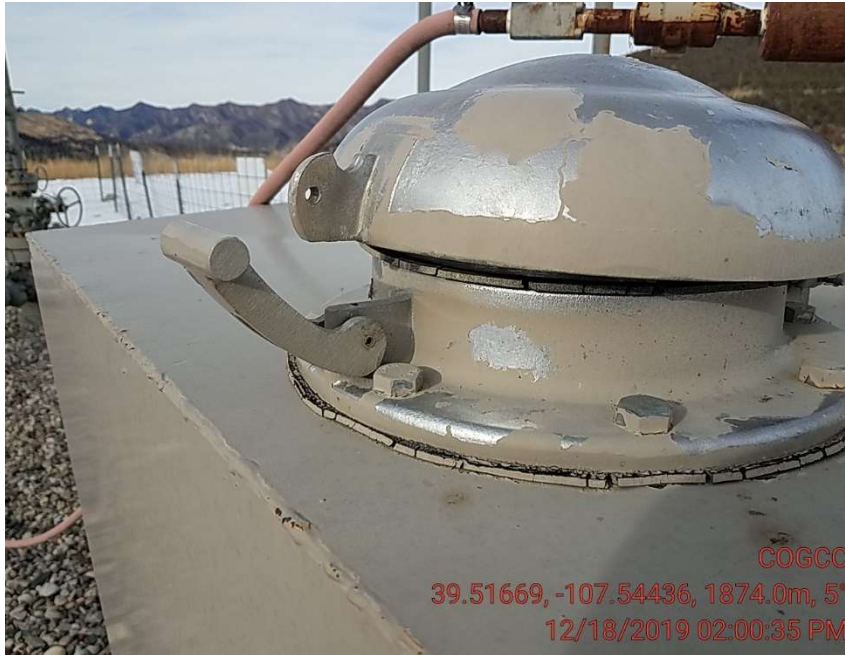
**Thief hatch not secured**

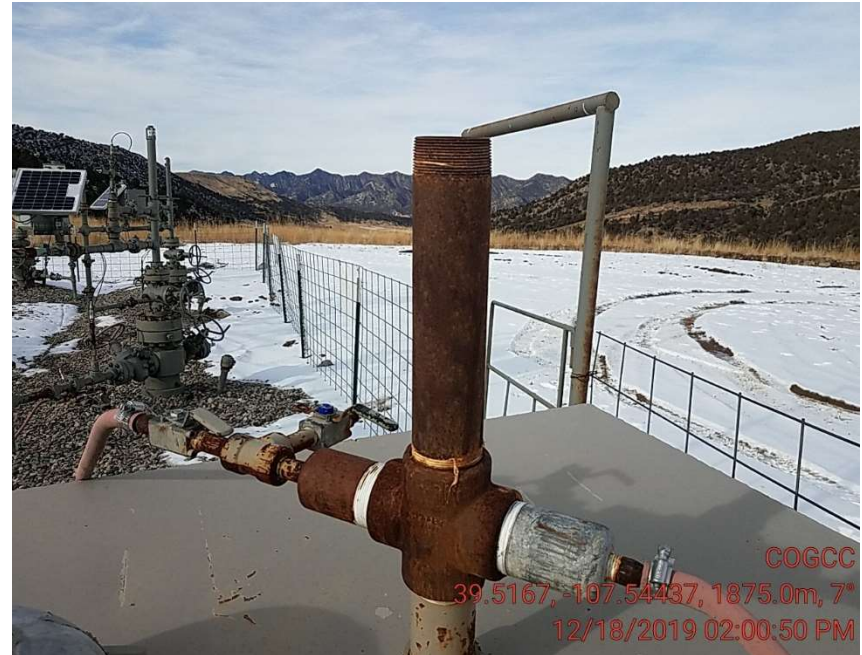
**Pipe is open to atmosphere**

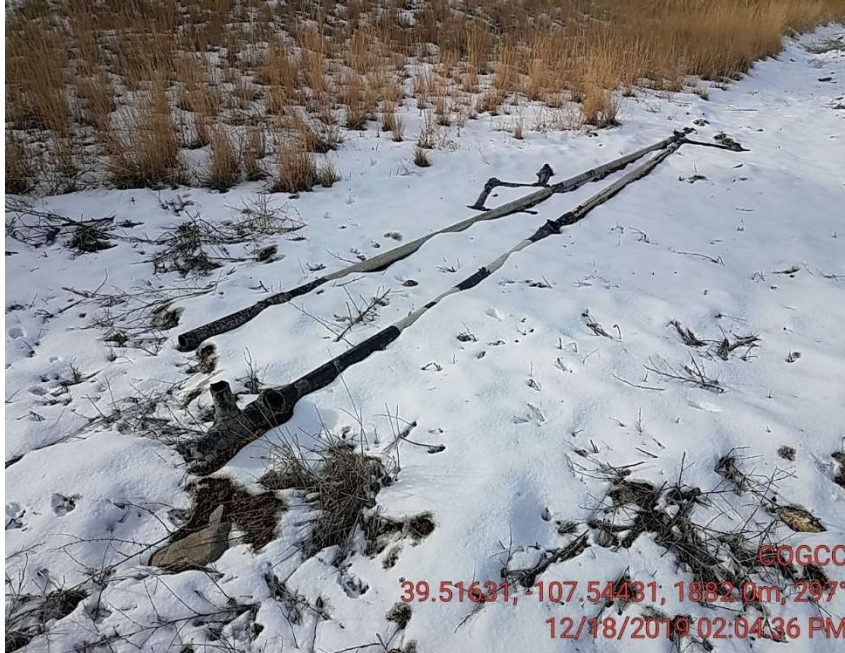
Piping on edge of location

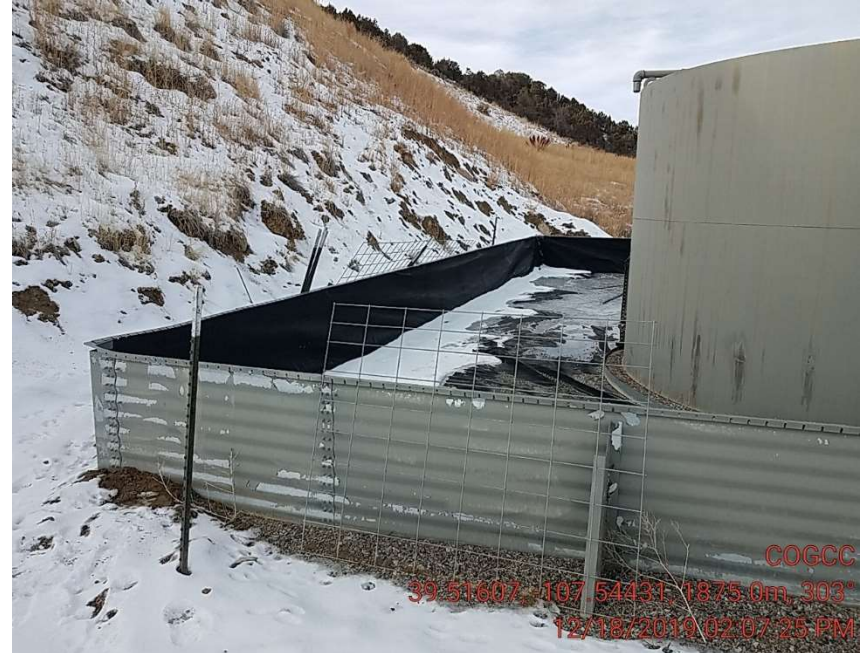
Fencing not installed

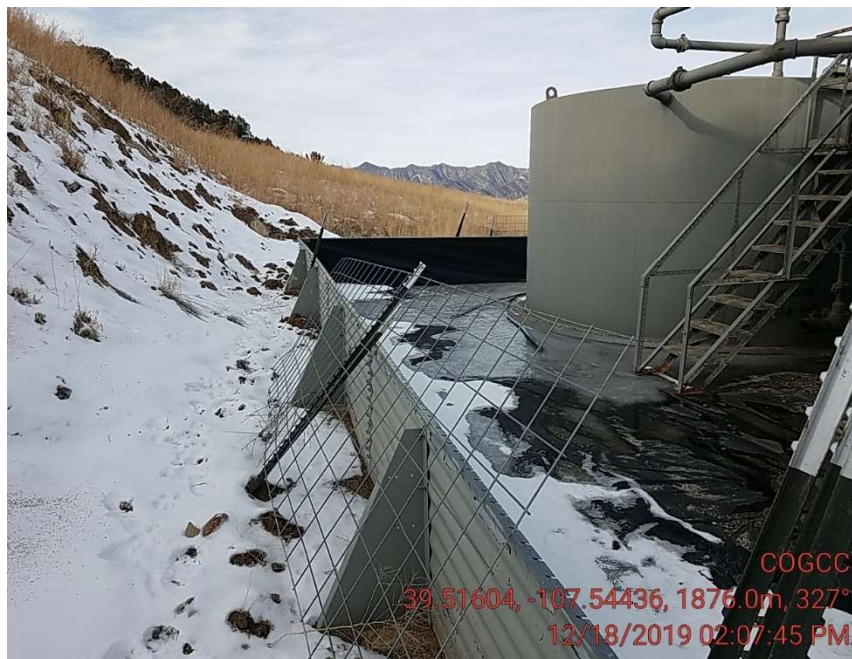
Fencing not installed

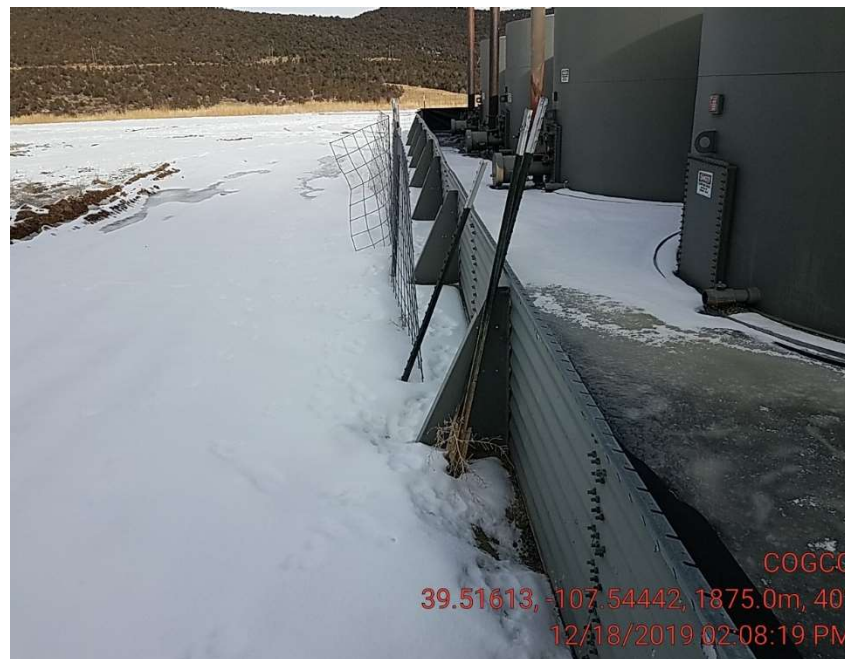
Fencing not installed
