Inspection Photos

Operator: Hilcorp Energy
Location/API #: 067-08148
Date: 12-18-2019

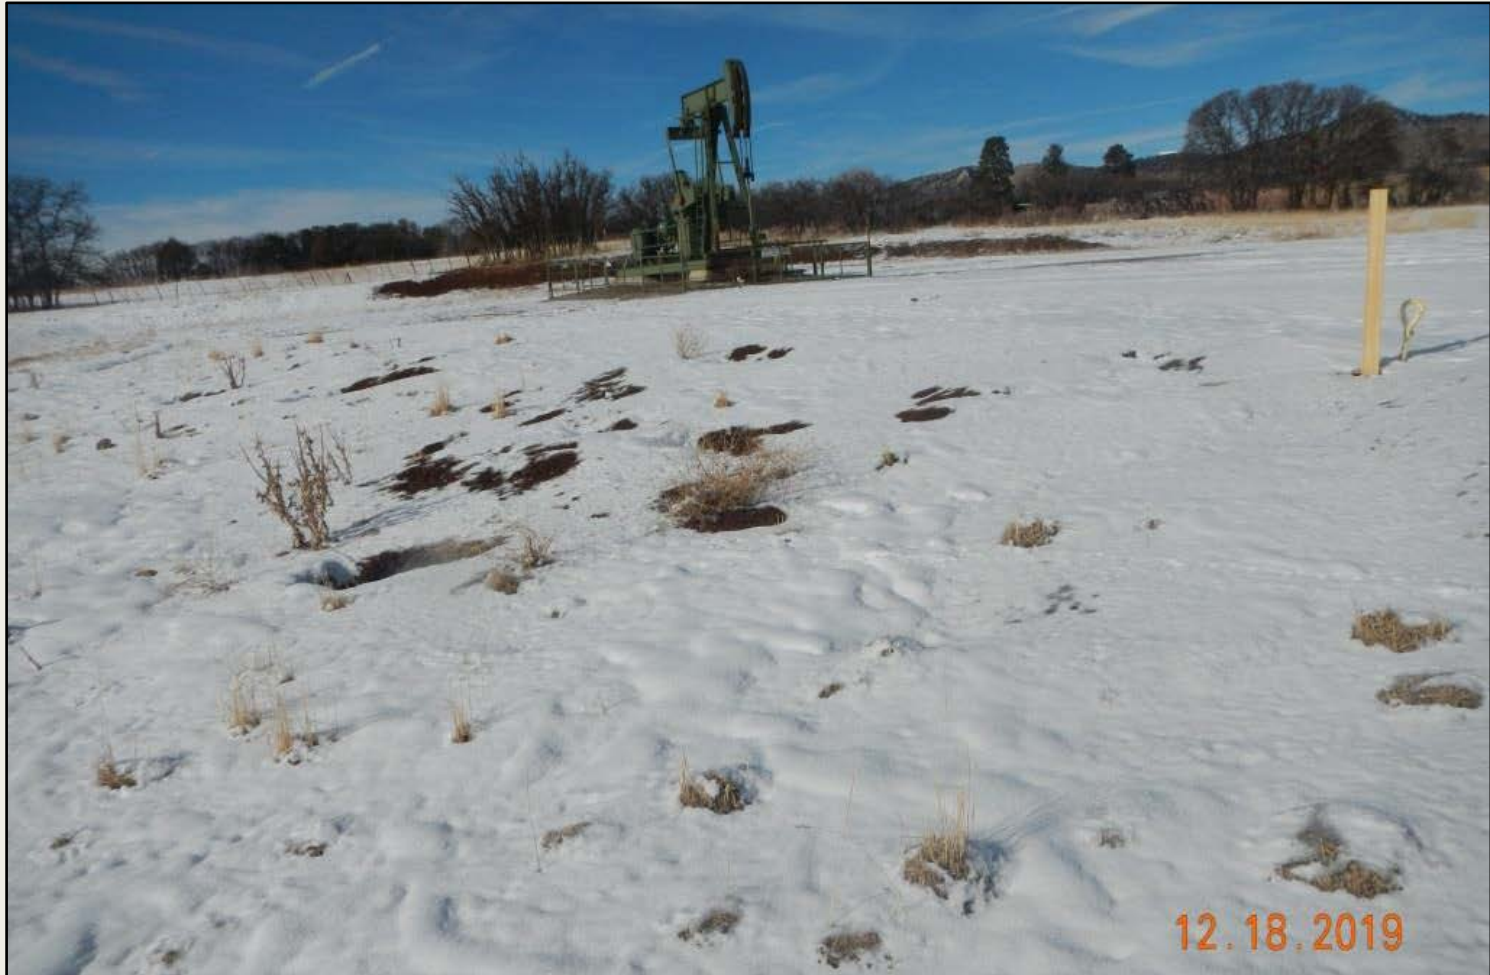
Photo 1. View of the project area from the southeastern corner facing center.

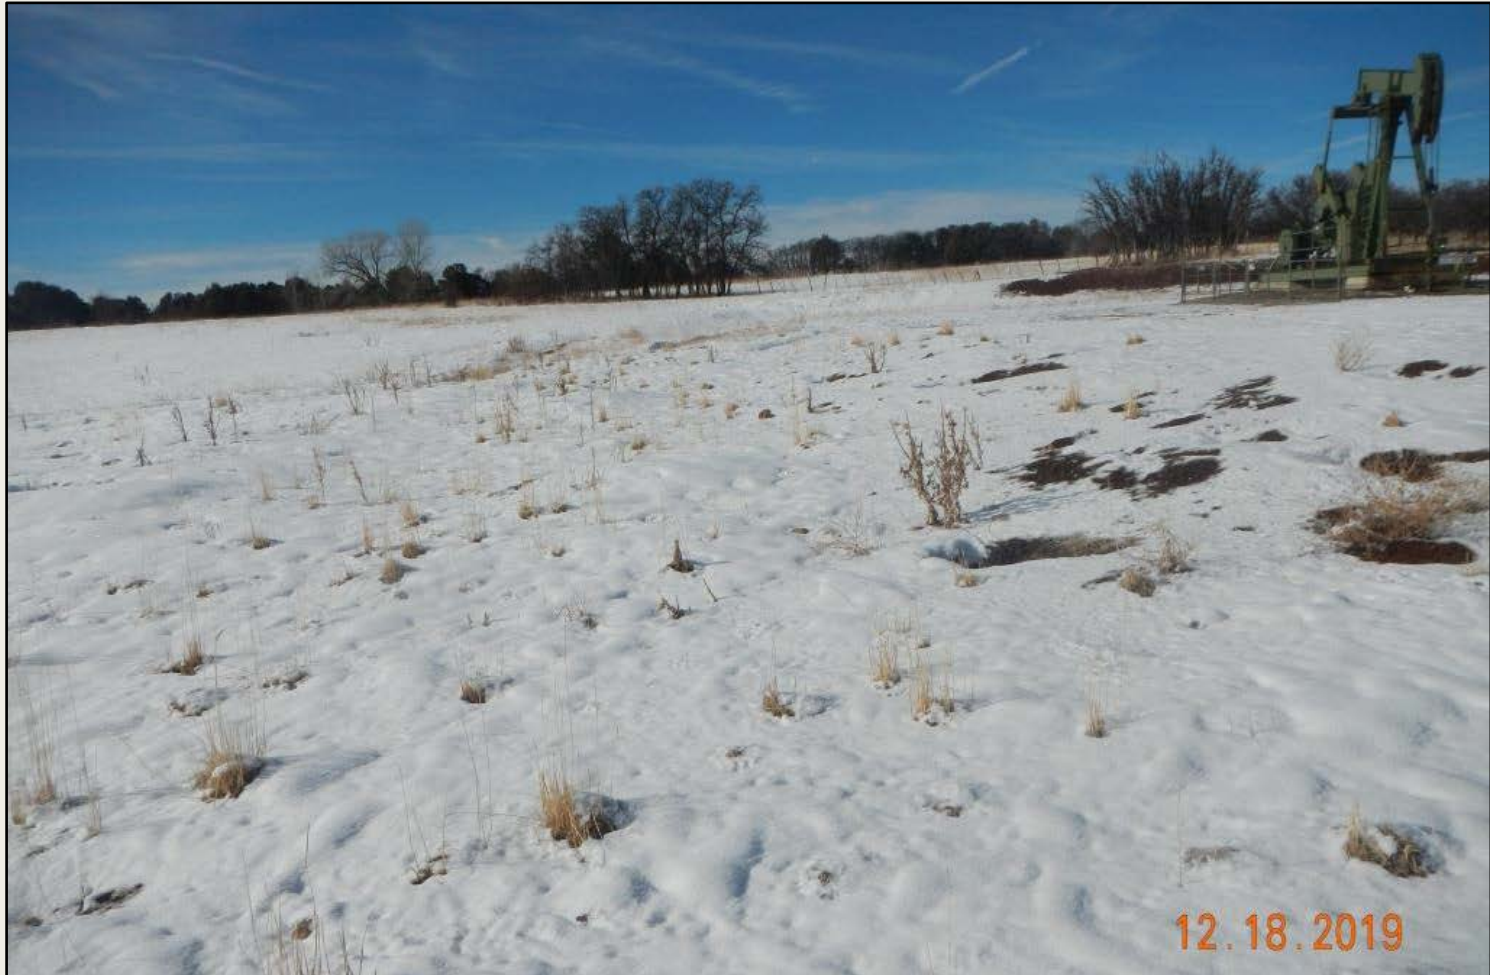
Photo 2. View of the southern fill slope from the southeastern corner facing westward. Location is partially snow covered at this time. Revegetation is in a dormant vegetative condition, and largely comprised of intermediate wheatgrass.

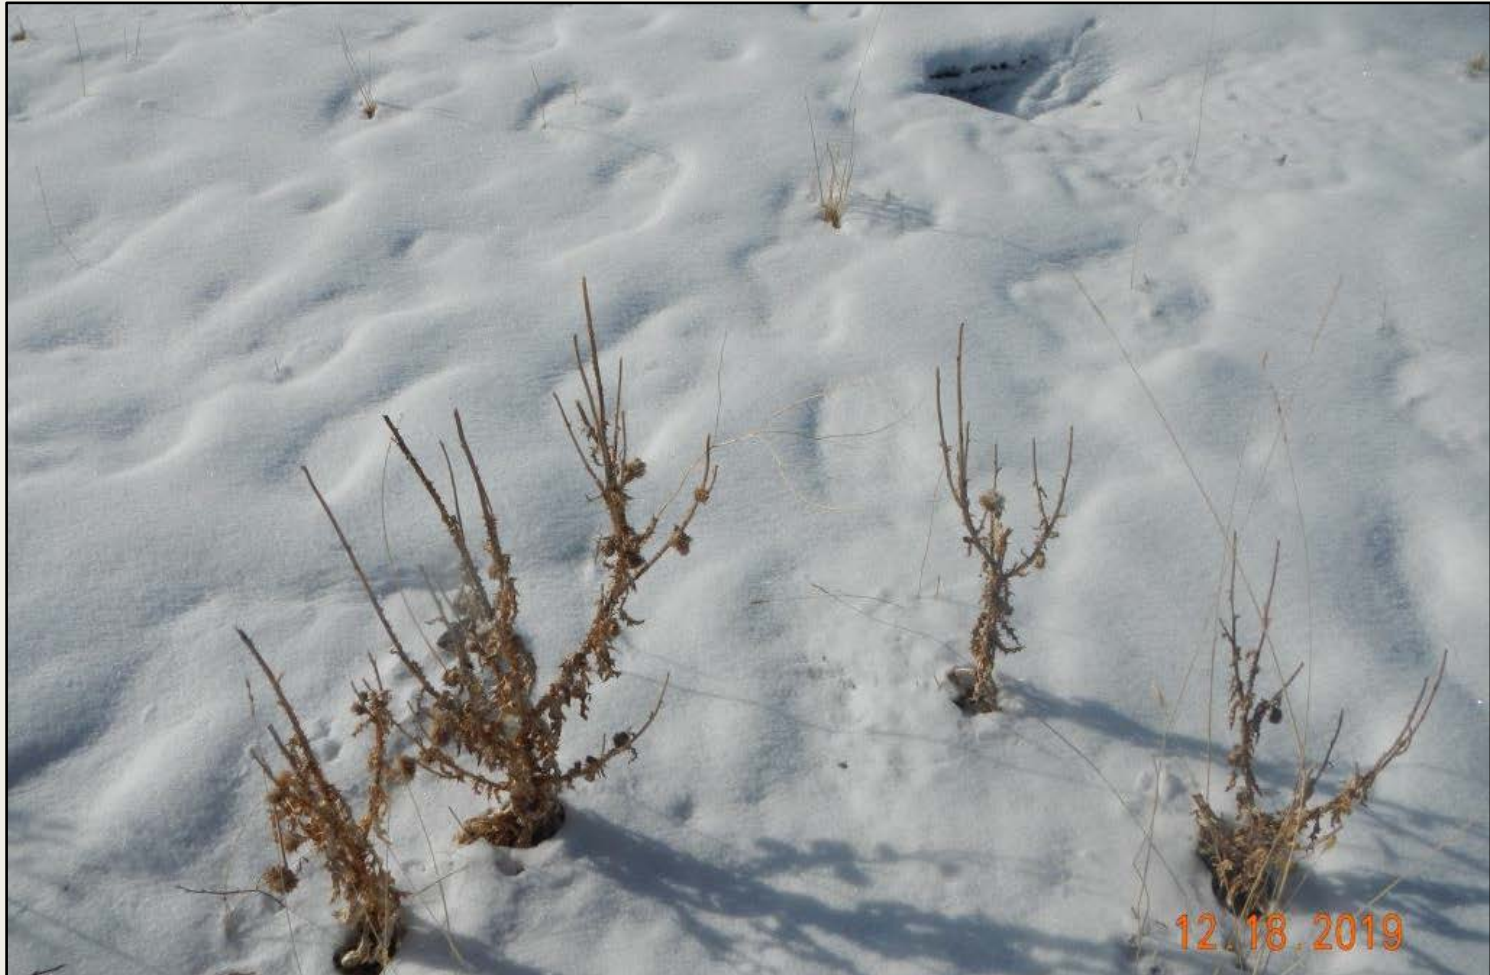
Photo 3. View of musk thistles in a post-flowering condition within the interim reclamation area.

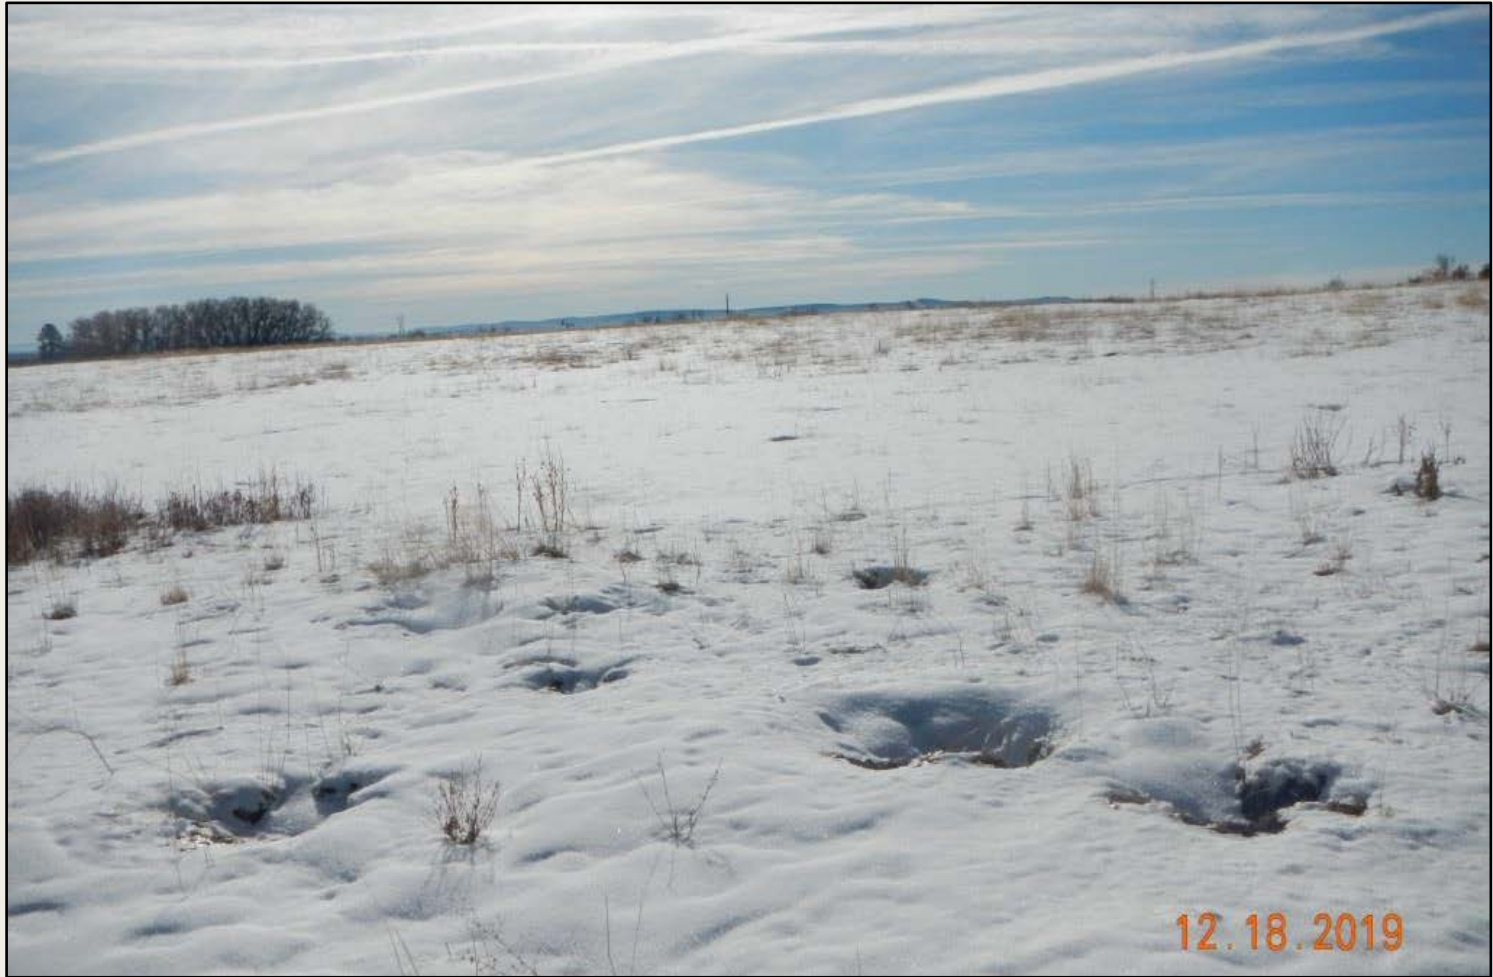
Photo 4. View of reference area, comprised of a grass field in dormant vegetative condition.
