Inspection Photos  
Operator: Enduring Resources  
Location/API #: 067-08391  
Date: 12-18-2019

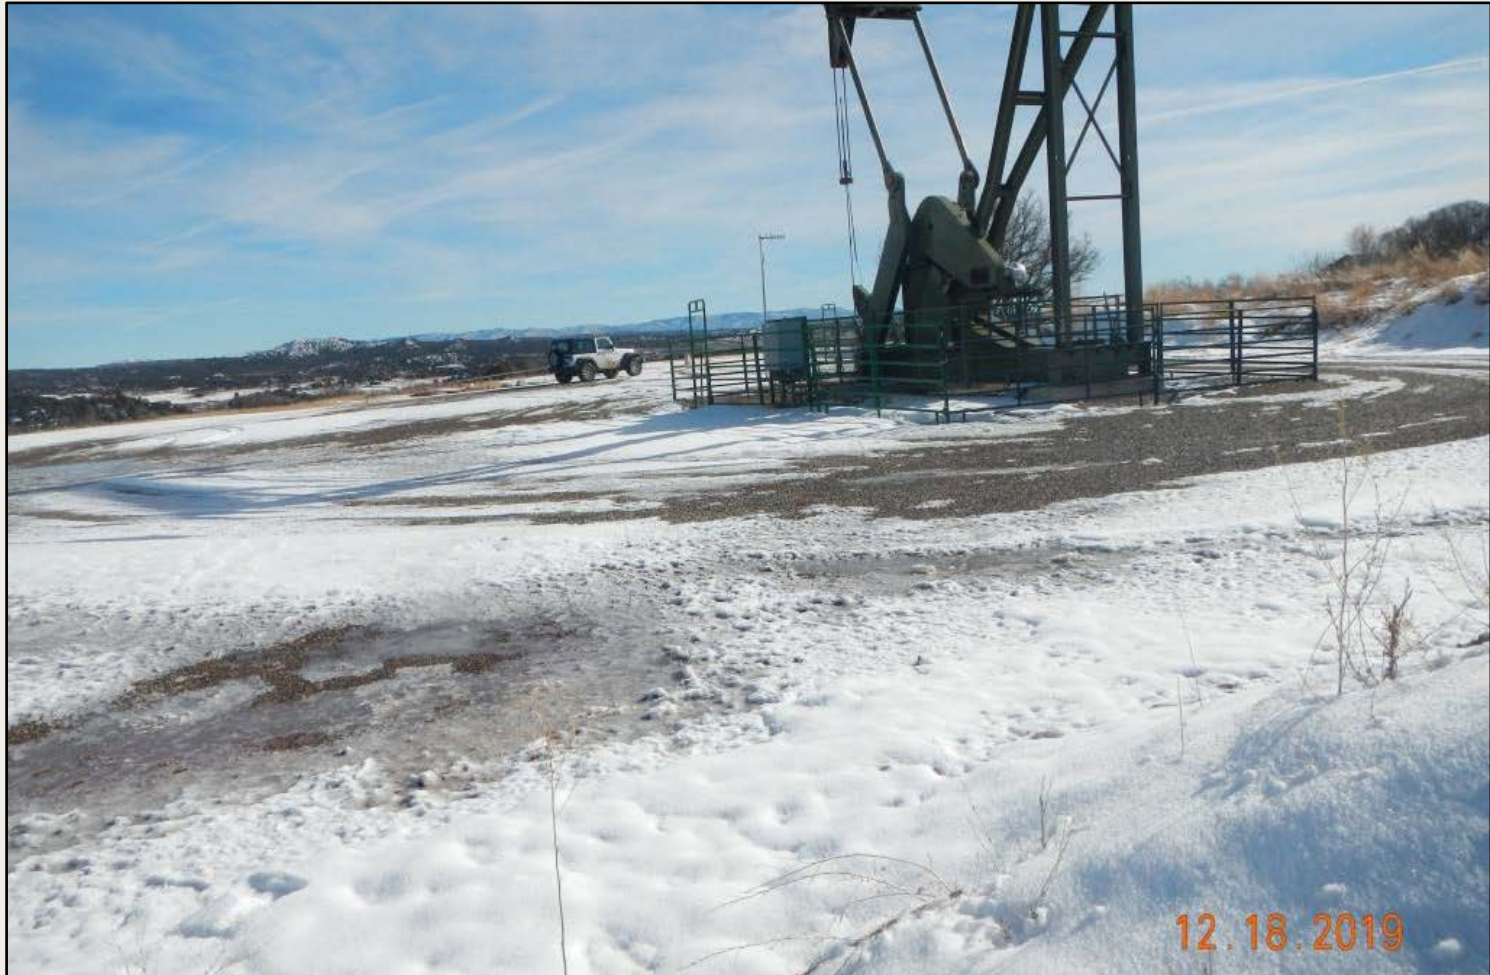
Photo 1. View of the project area from the western edge of the working area facing center.

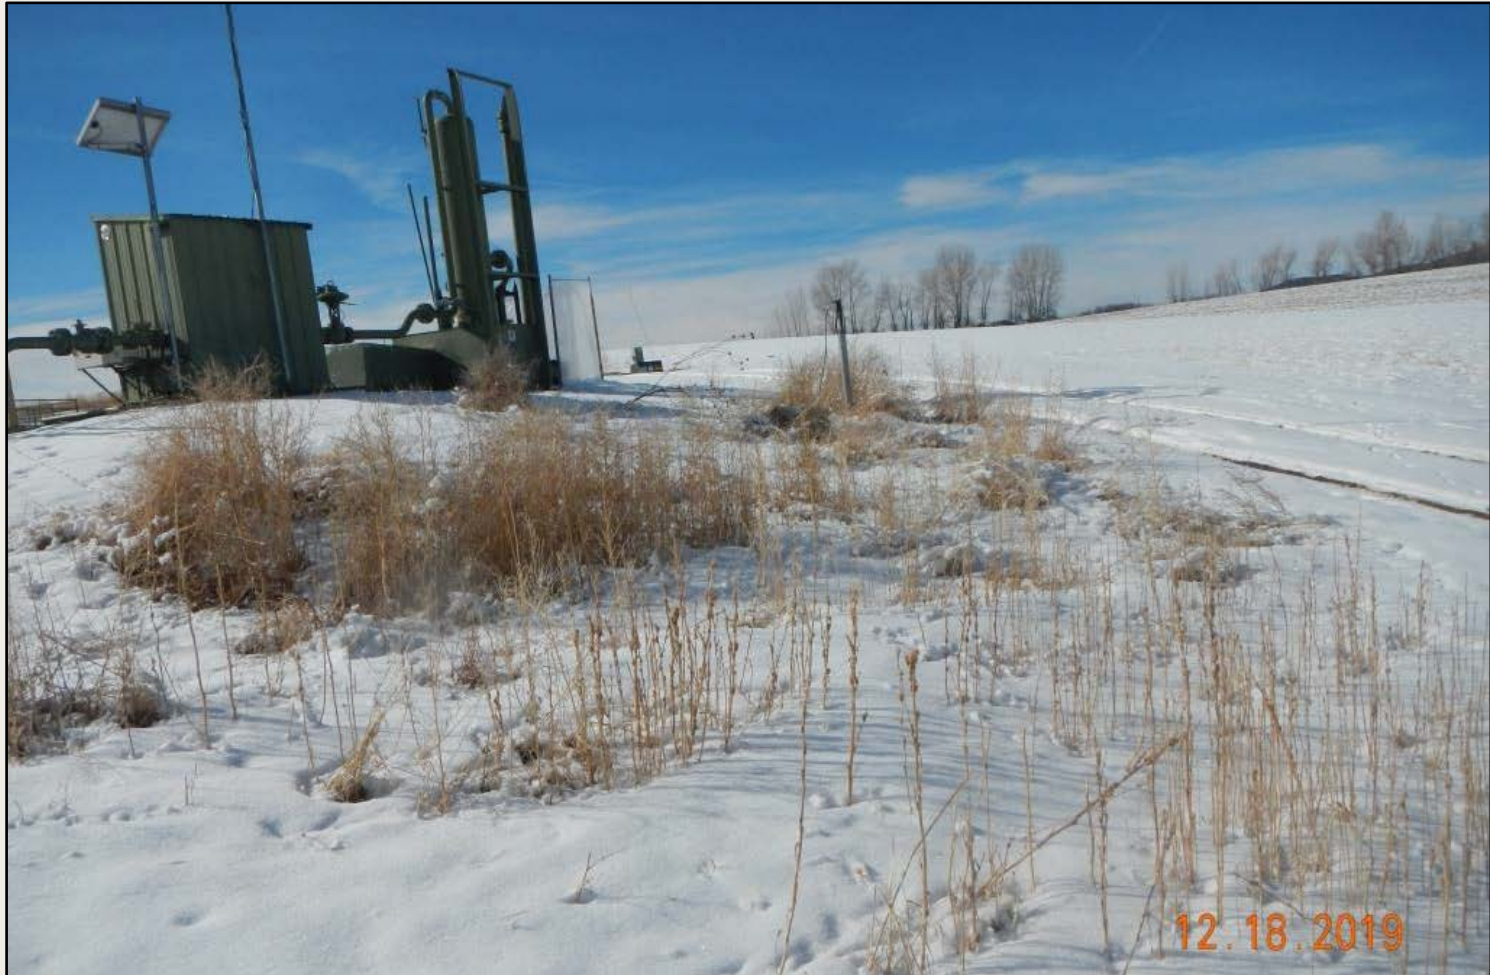
Photo 2. View of the northern fill slope from the northeastern corner facing westward. Tall vegetation is comprised of weeds such as kochia and Russian thistle. Smooth brome observed beneath weeds. Weeds need to be managed to encourage desirable vegetation.

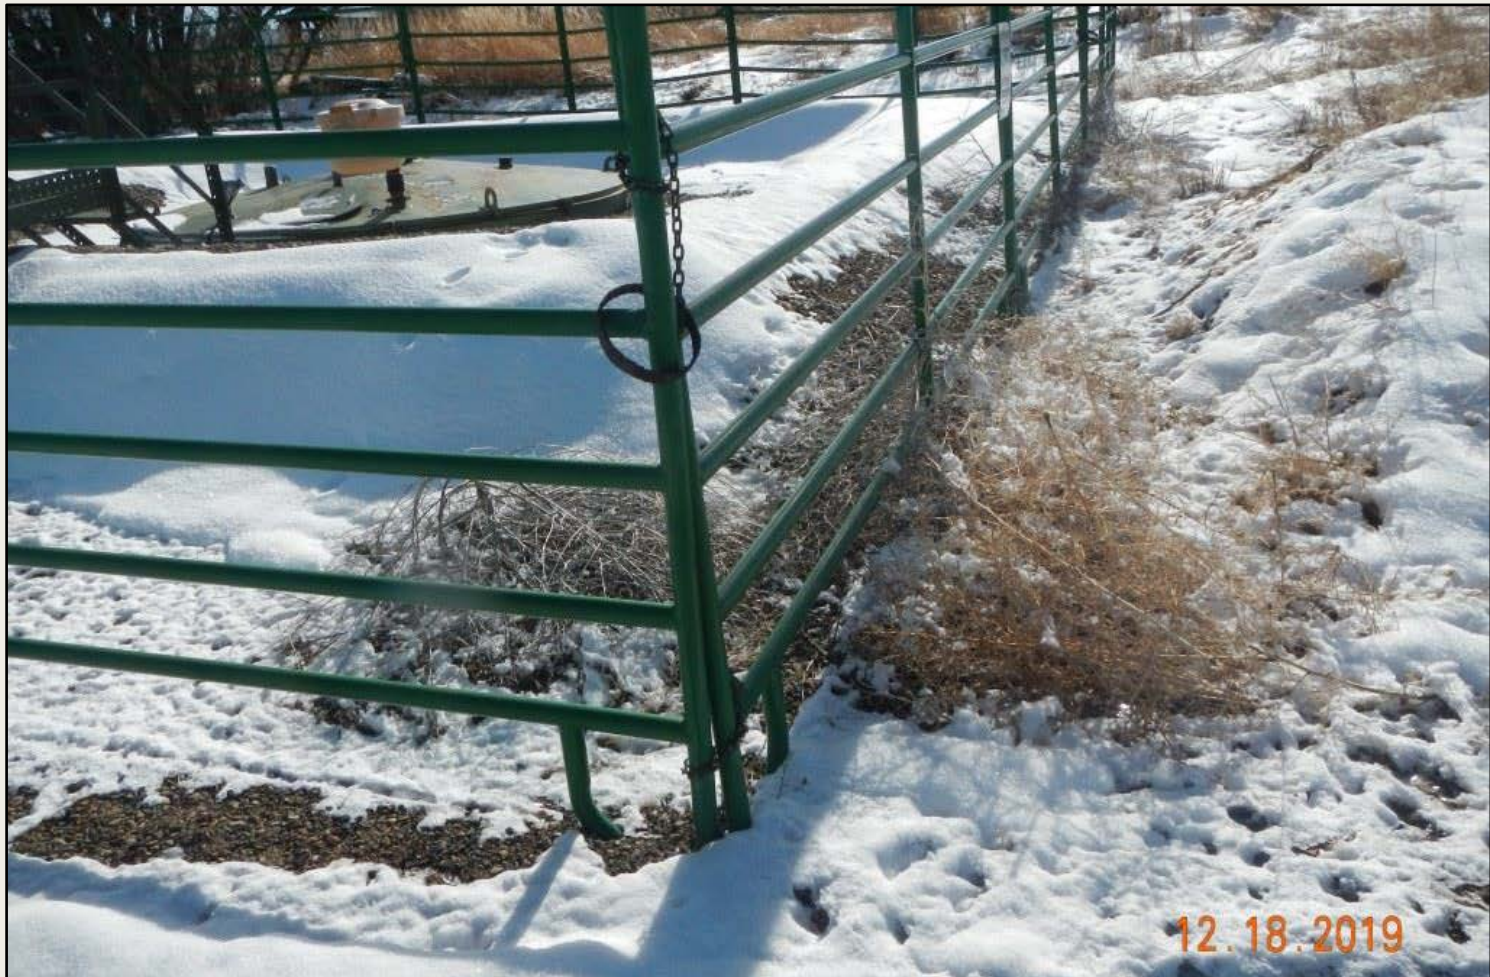
Photo 3. View of weed debris within the project area.

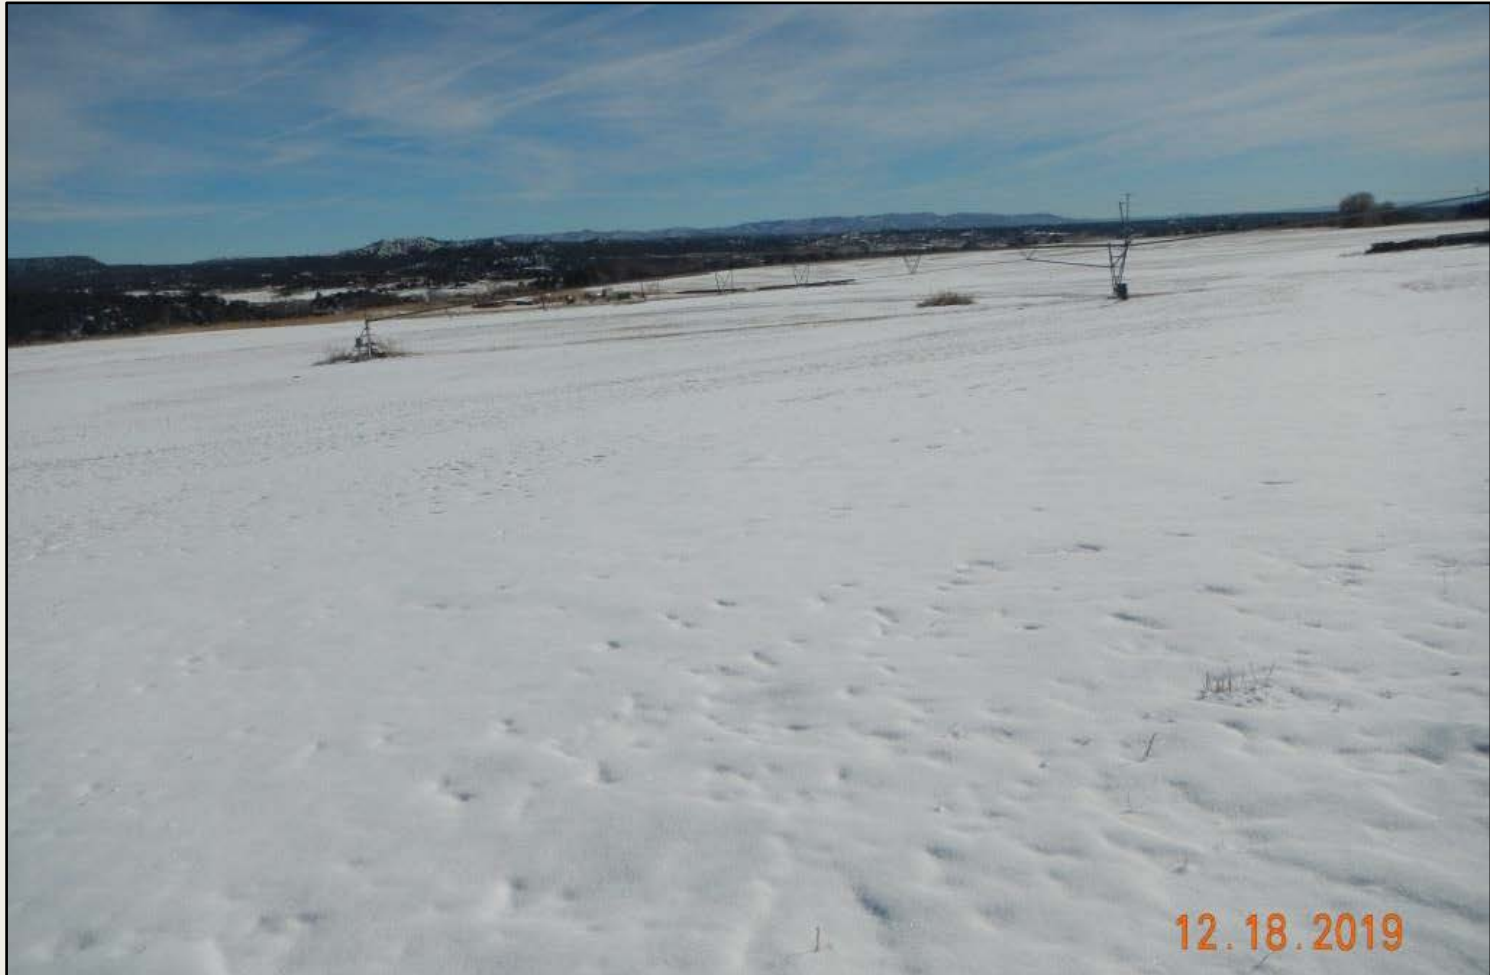
Photo 4. View of reference area comprised of irrigation grass field that is largely snow covered at this time.
