Inspection Photos

API: 05-073-06324

Operator: NIGHTHAWK PRODUCTION

Inspection Date: 12/18/2019

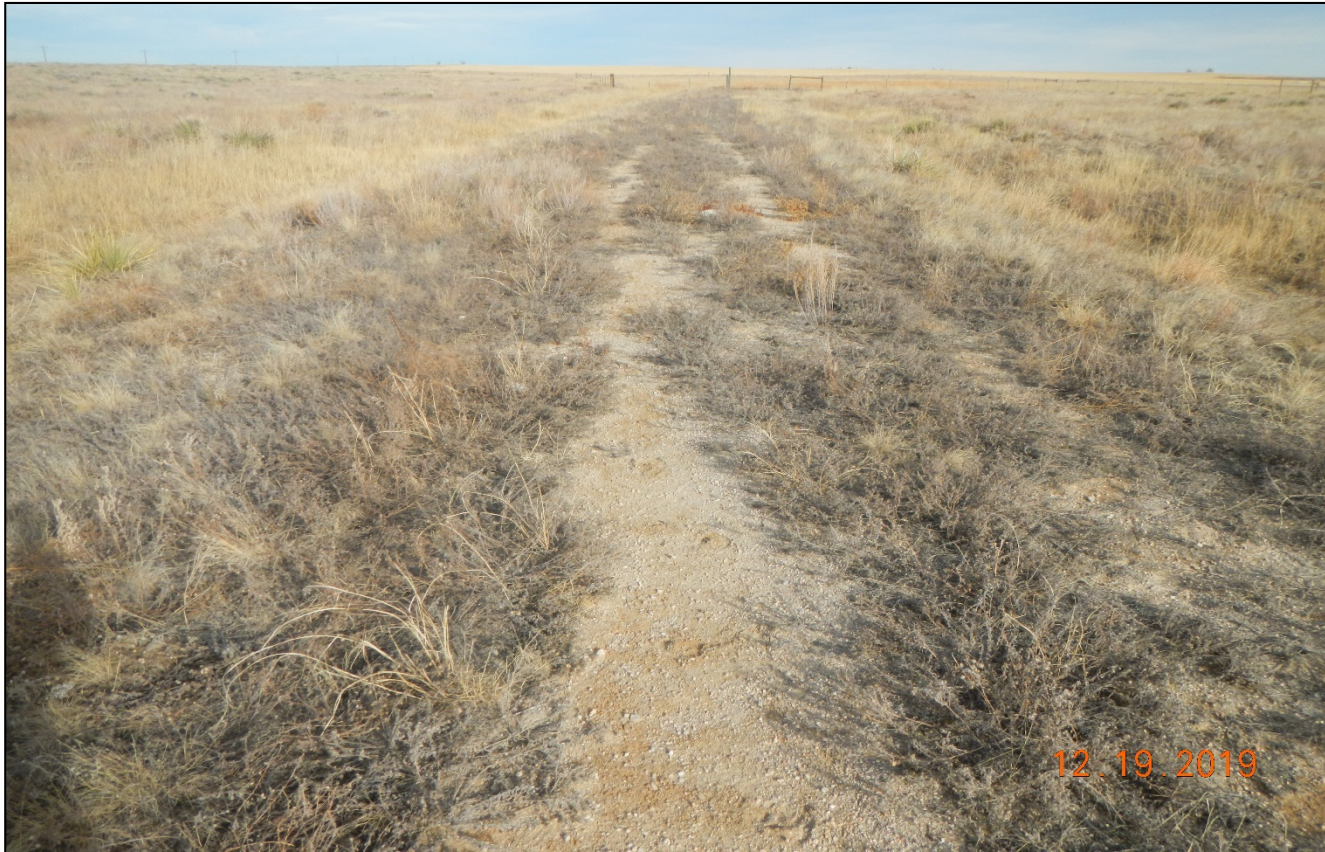
Photo 1. Facing northeast along the former access road standing at Lat/Long:39.00830,-103.62582. This portion of the road has not been recontoured and decompacted. Approximately 325 ft. to the location.

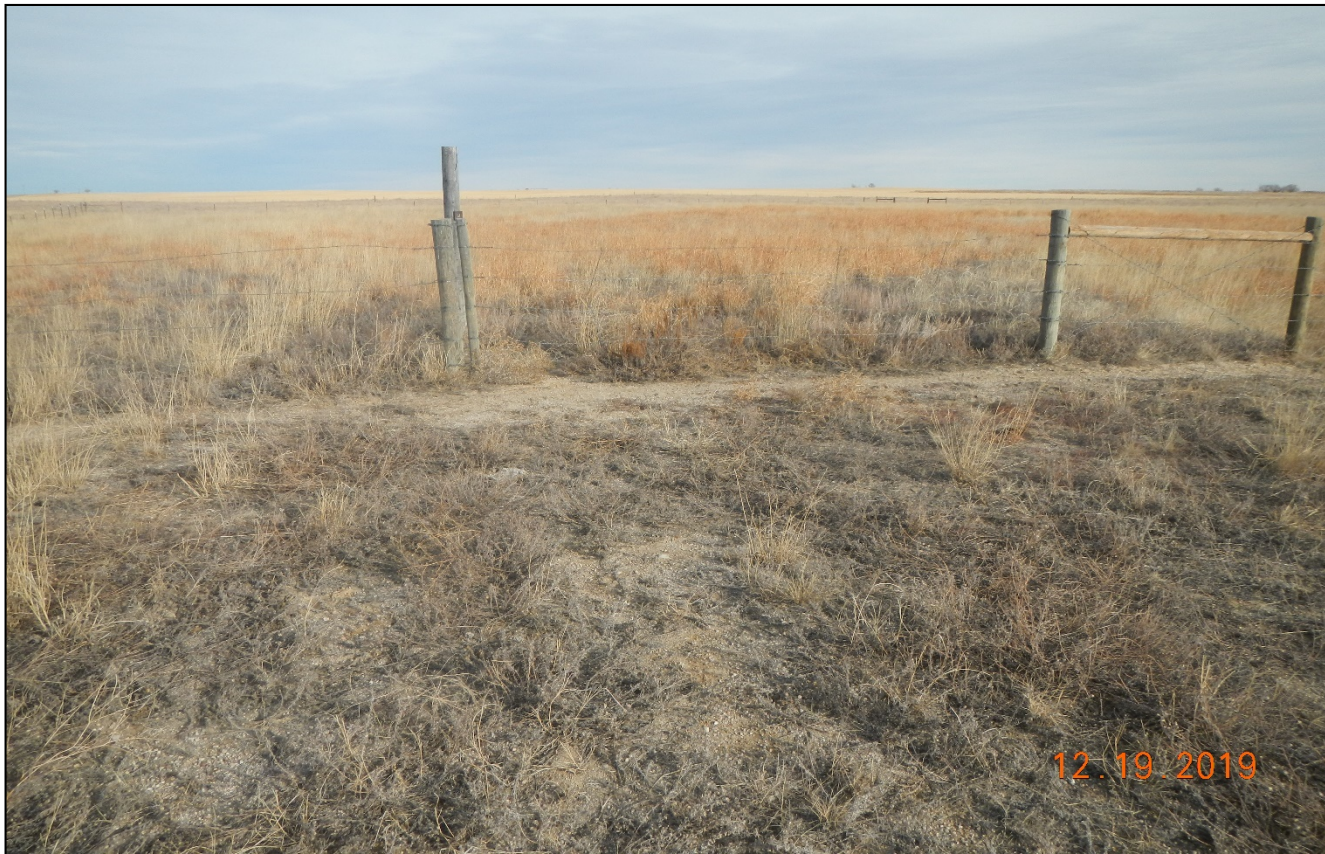
Photo 2. Facing northeast toward the location. A perimeter fence remains around the location.

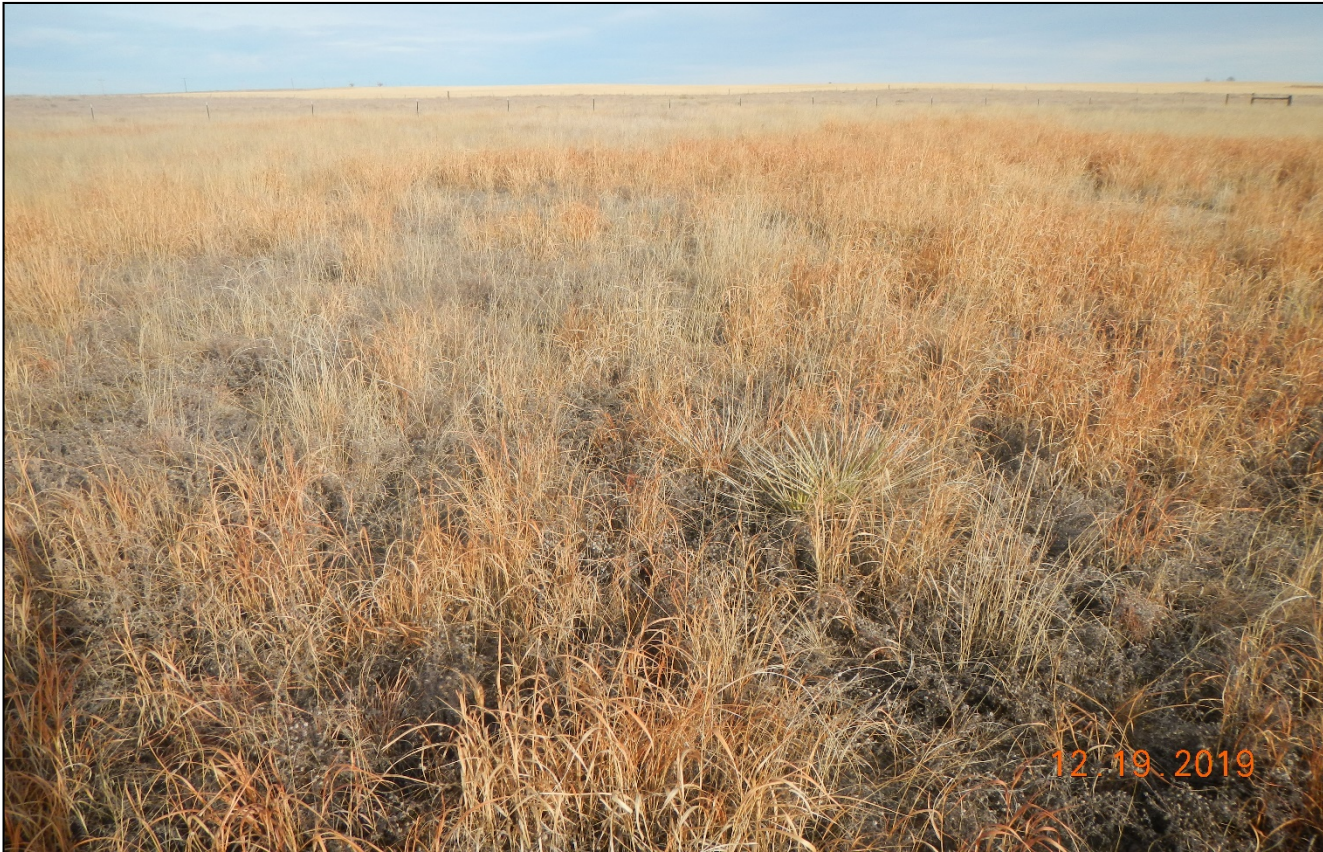
Photo 3. Center of the location facing north. Vegetation is well established at the location.

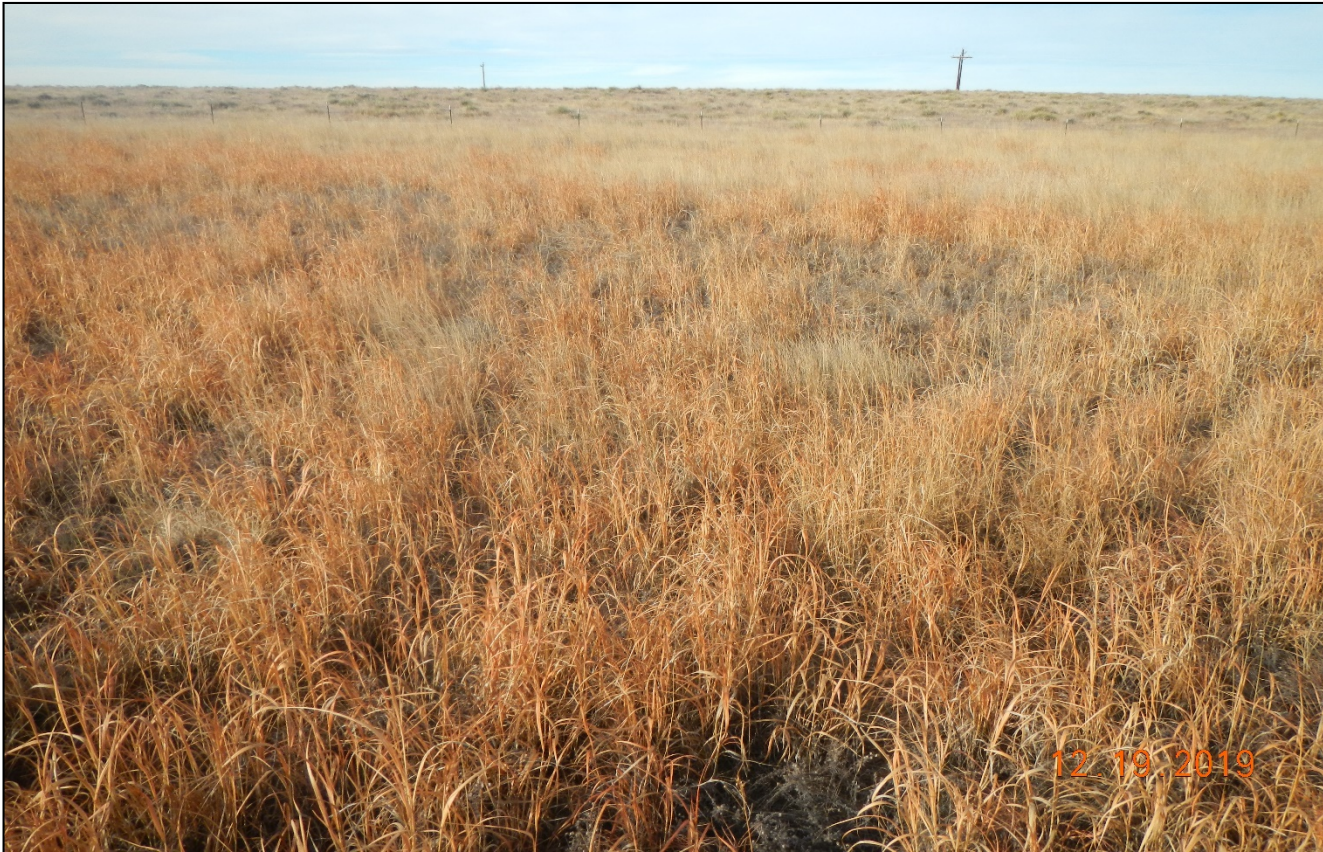
Photo 4. Center of the location facing east. Vegetation is well established at the location.

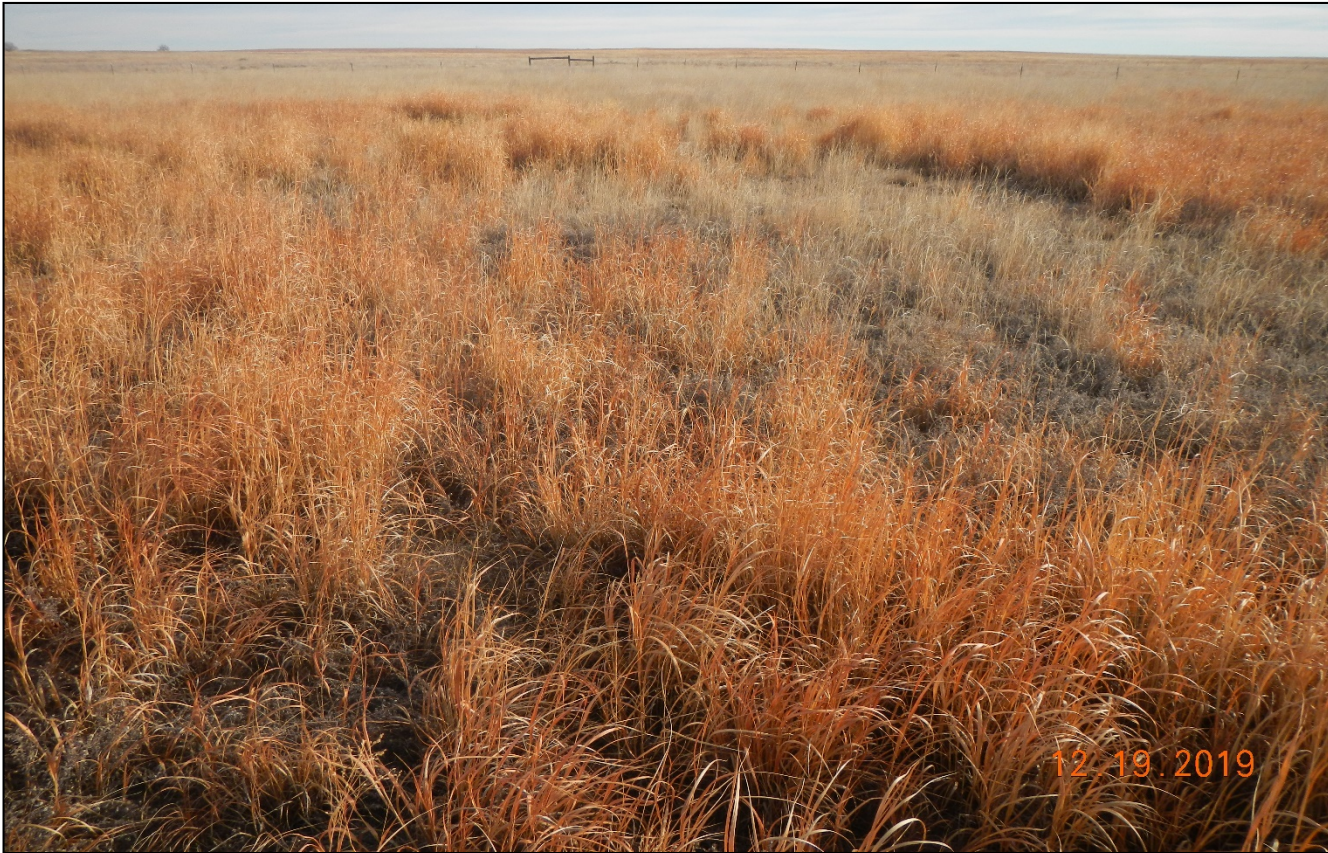
Photo 5. Center of the location facing west. Vegetation is well established at the location.

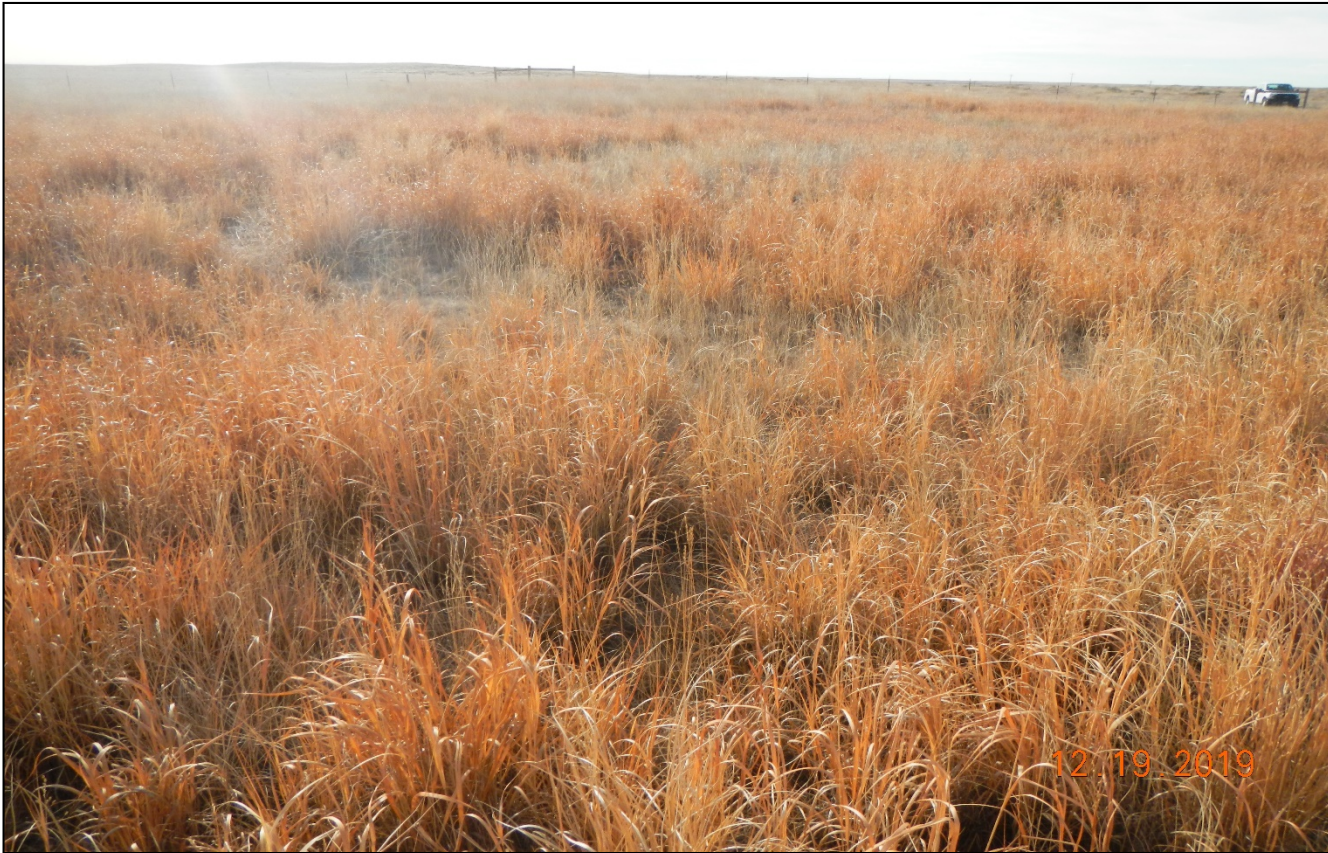
Photo 6. Center of the location facing south. Vegetation is well established at the location.

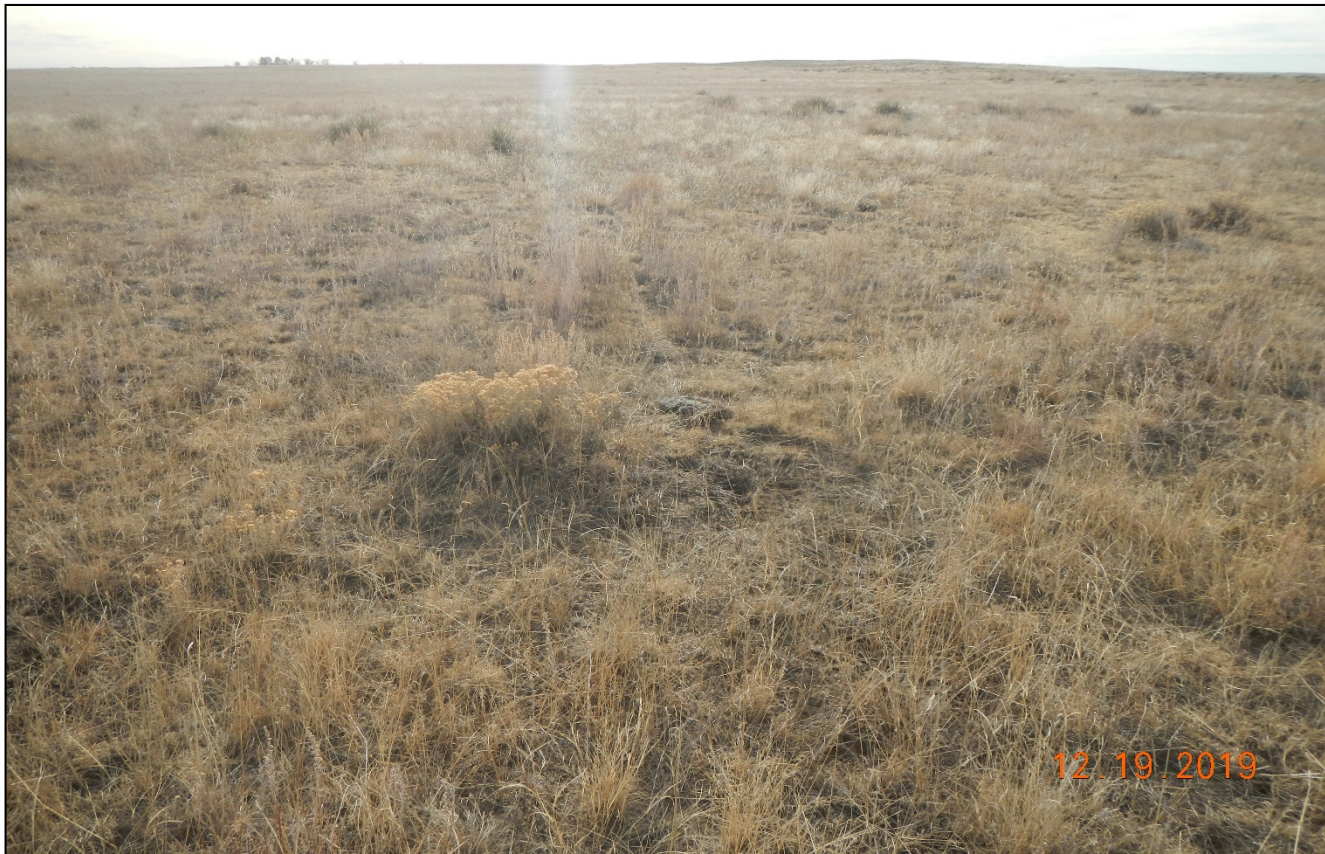
Photo 7. Facing east toward the surrounding reference area.
