COGCC Follow Up Inspection Photos FIR DOC # 690101612 dated 12/20/2019
Location: KP Kauffman - Charter Schneider Tank Battery
Facility ID #444630
REM #9522

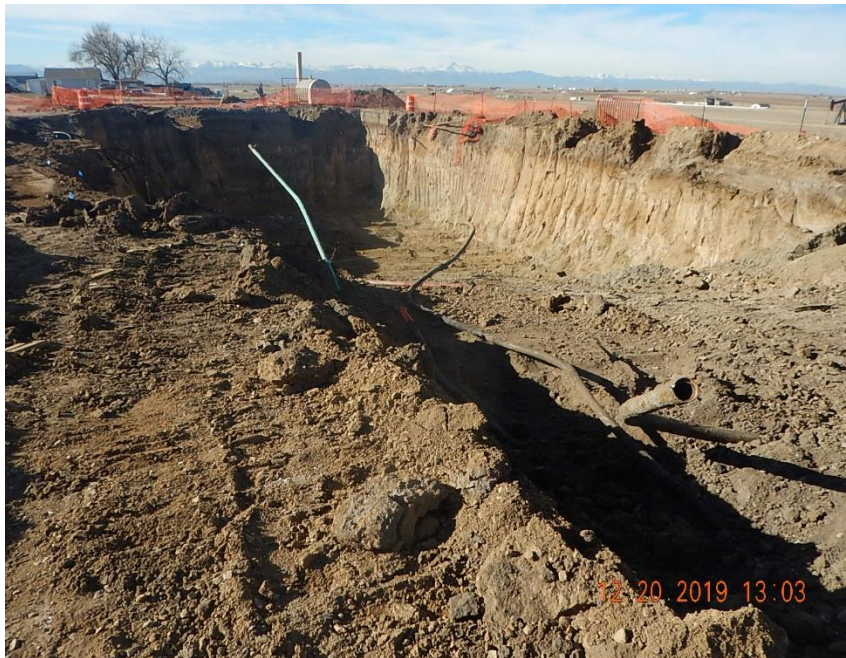
**View of excavation; flowlines exposed in ground and walls
(view west).**

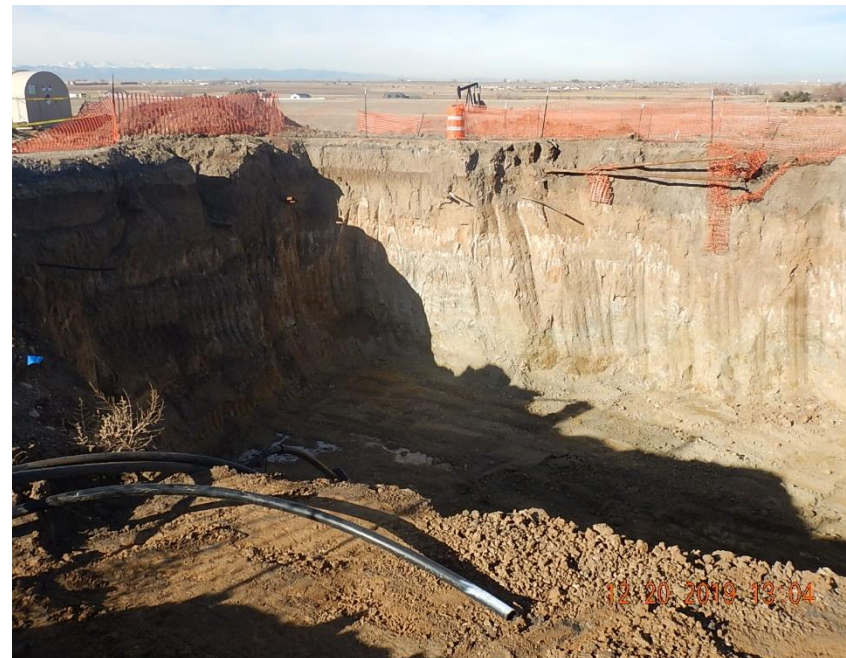
Cut ends of flowlines exposed in excavation (view to NW).

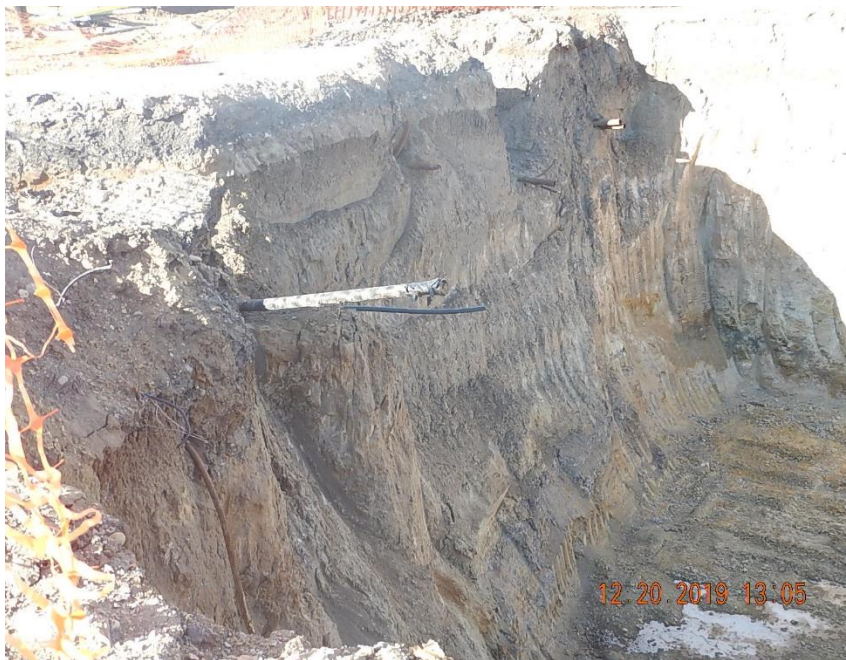
Cut ends of flowlines exposed in excavation (in west wall).

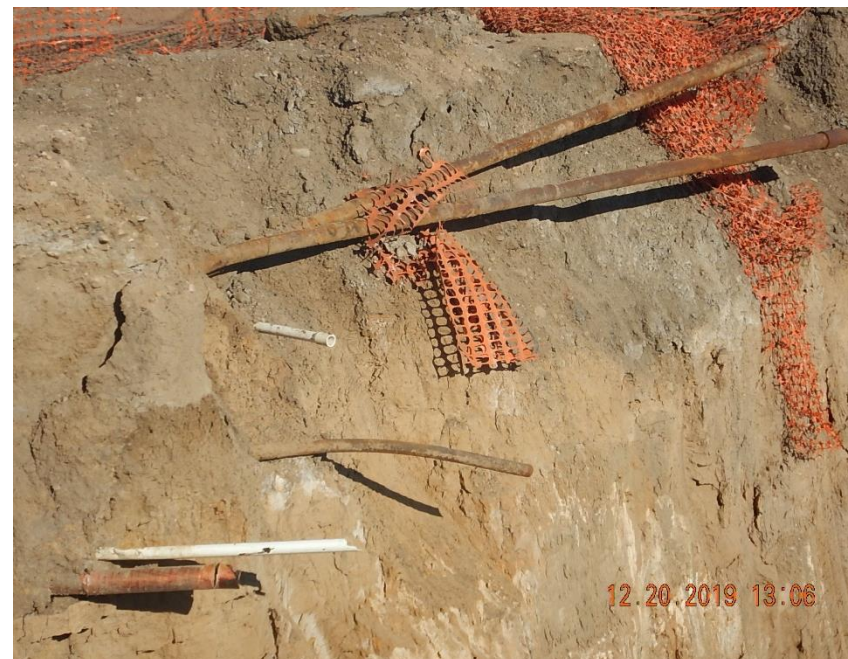
Cut ends of flowlines exposed in excavation (in north wall).

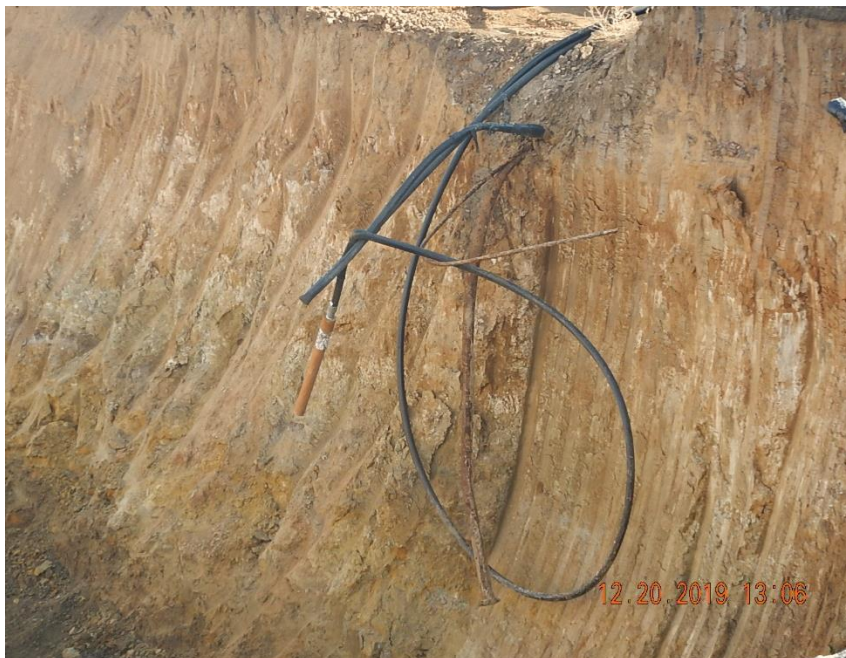
Cut ends of flowlines exposed in excavation (in south wall).

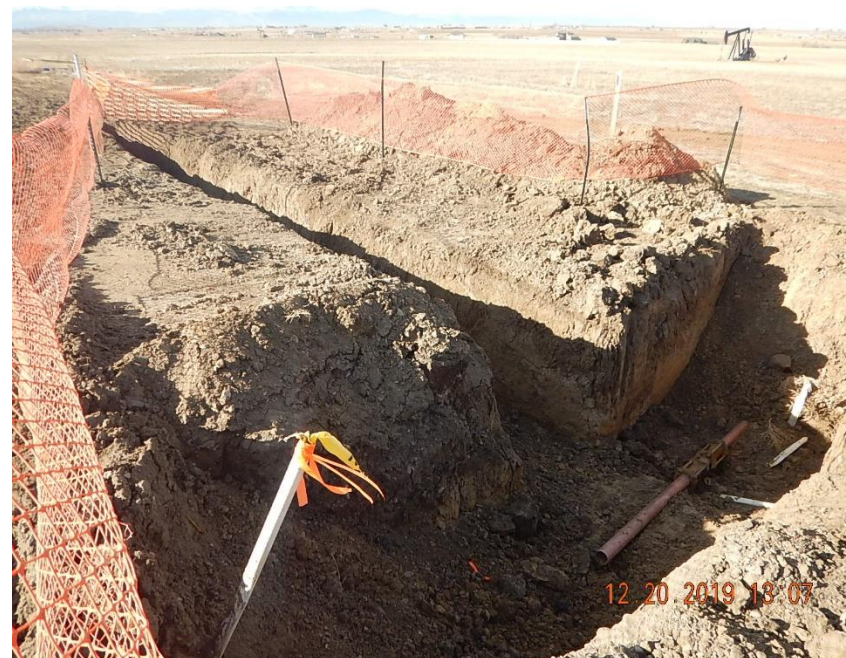
Cut ends of flowlines exposed in trenching/ excavation recently completed approximately 30' north of the north wall of the primary excavation; ends open to atmosphere.
