Inspection Photos
Operator: Hilcorp Energy
Location/API #: 067-08228
Date: 12-20-2019

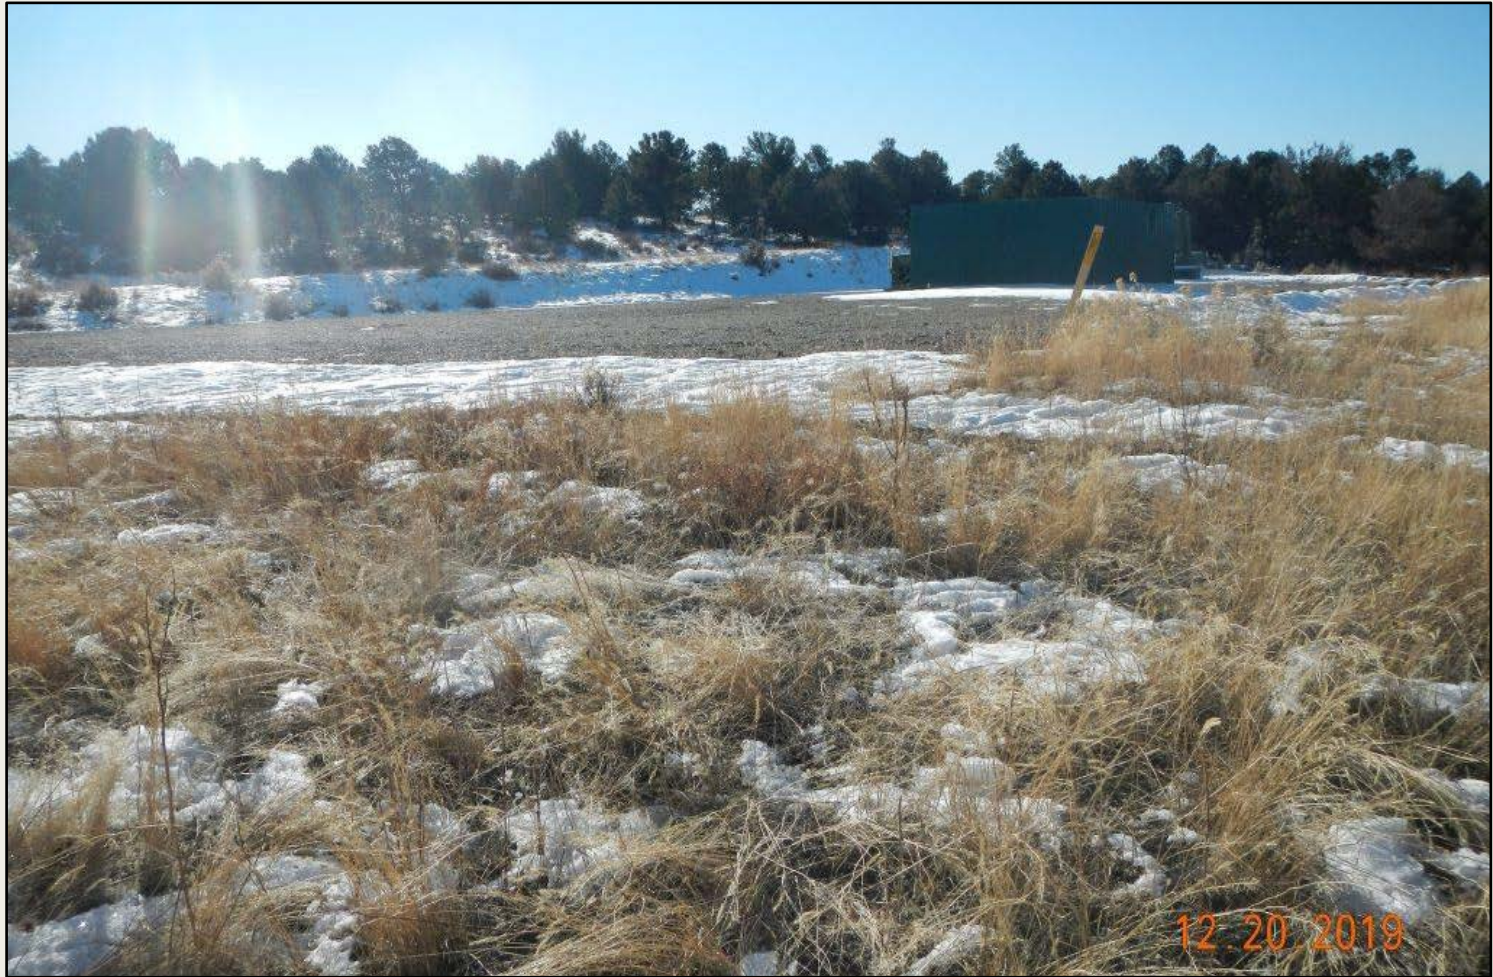
Photo 1. View of the project area from the northwestern corner facing center.

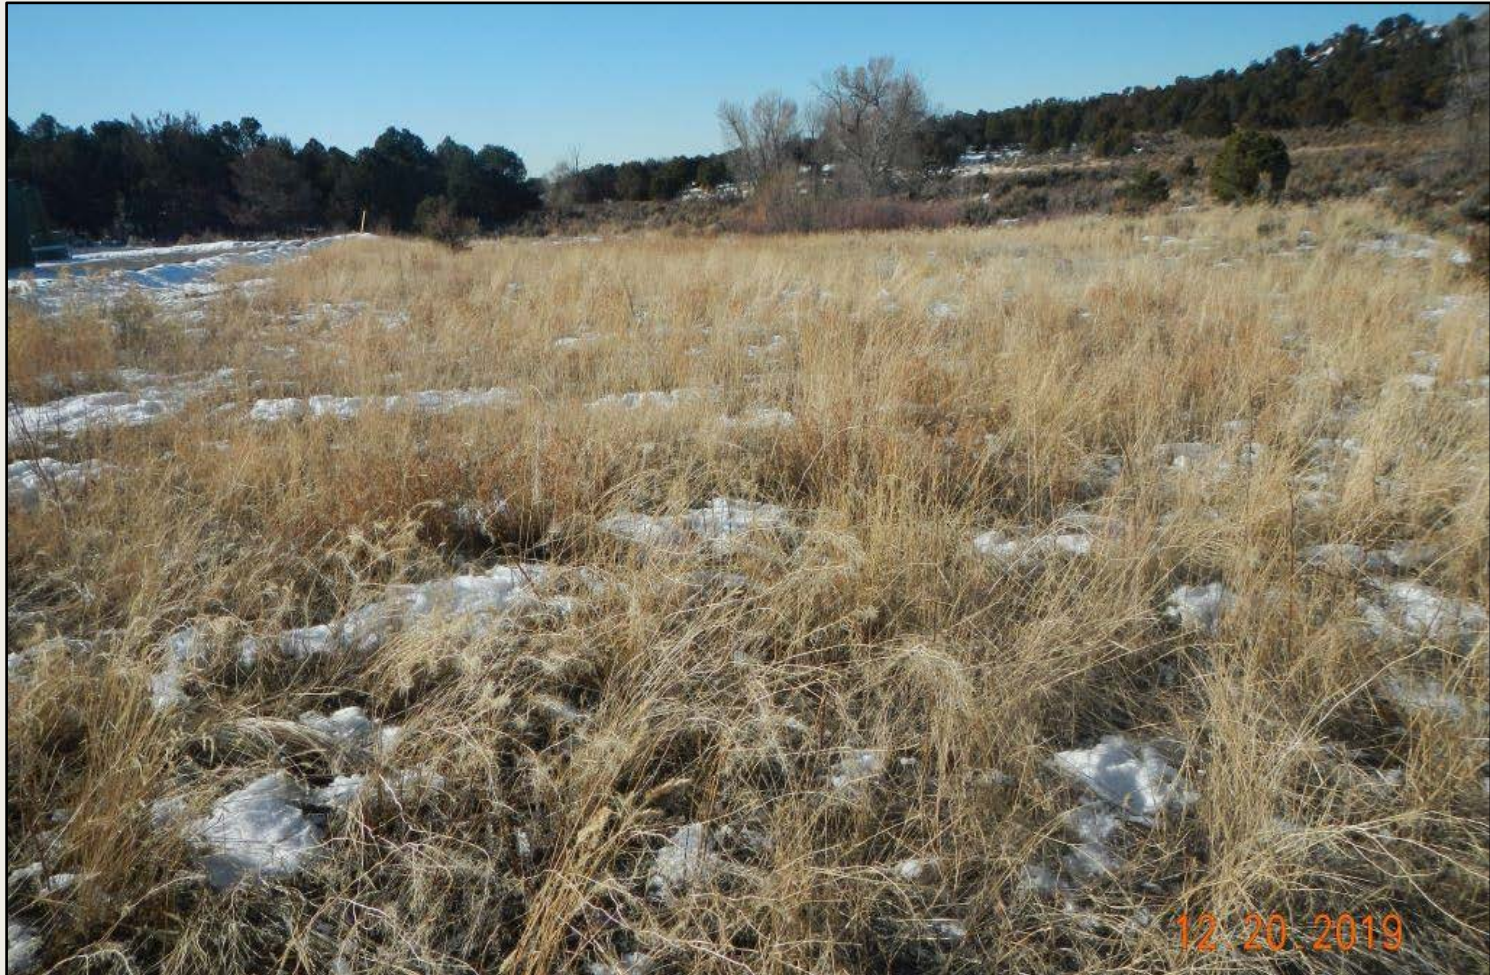
Photo 2. View of the western project area from the northwestern corner facing southward. Revegetation is progressing with perennial grasses such as smooth brome, crested wheatgrass, and sand dropseed.

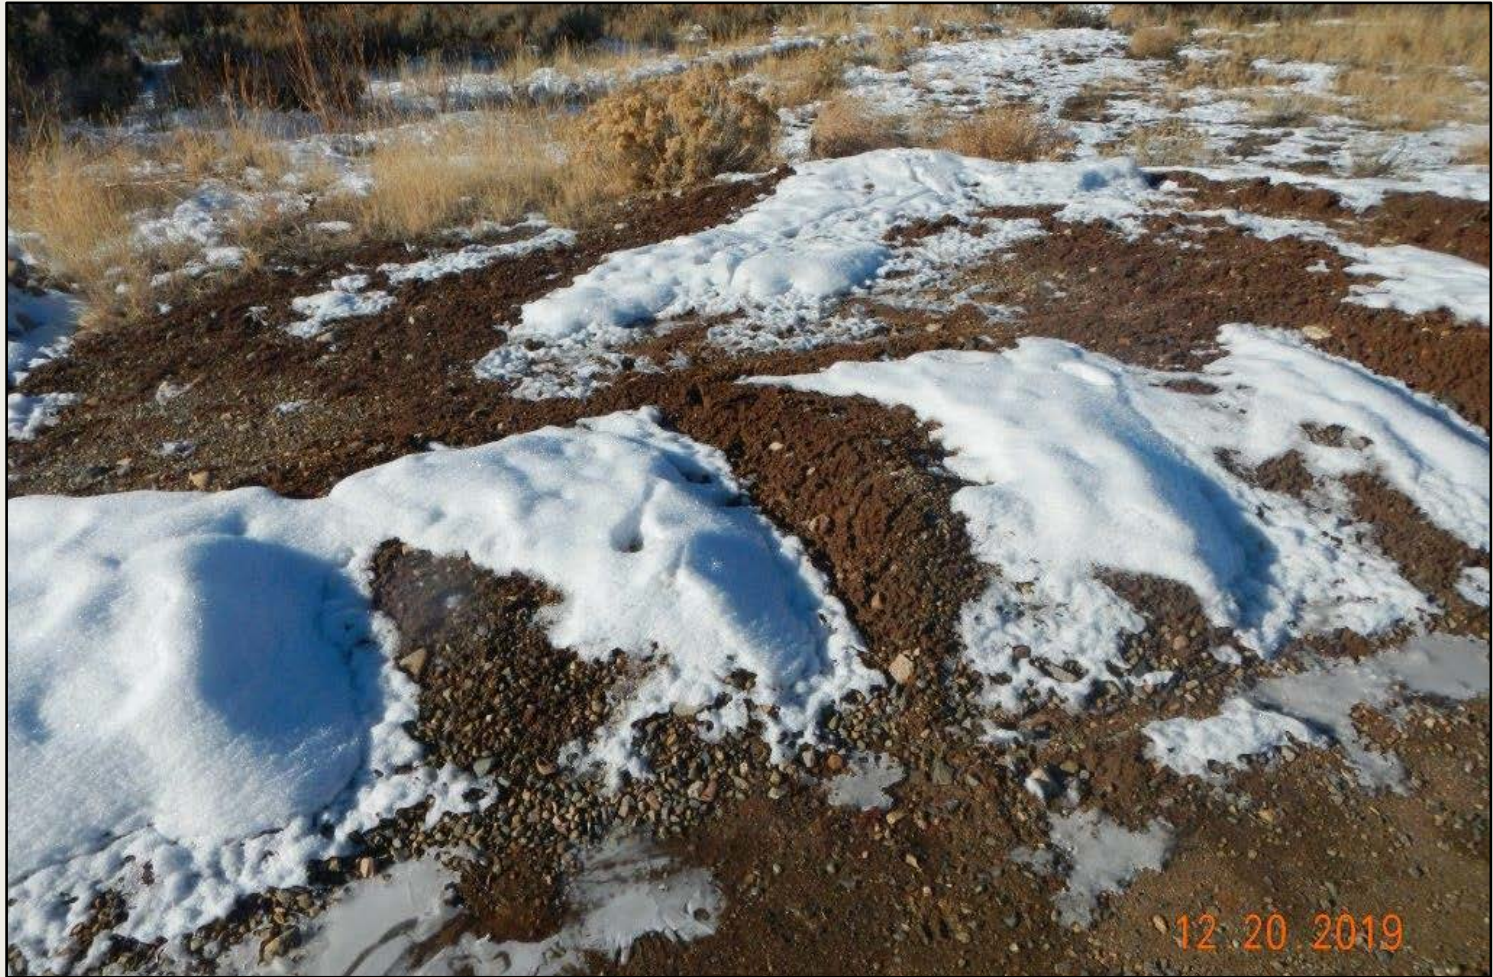
Photo 3. View of area (approximately 15 to 20 feet wide and long) in the southwestern reclamation area where vegetation is not present and deep truck tracks marked in soil. Area needs reclamation.

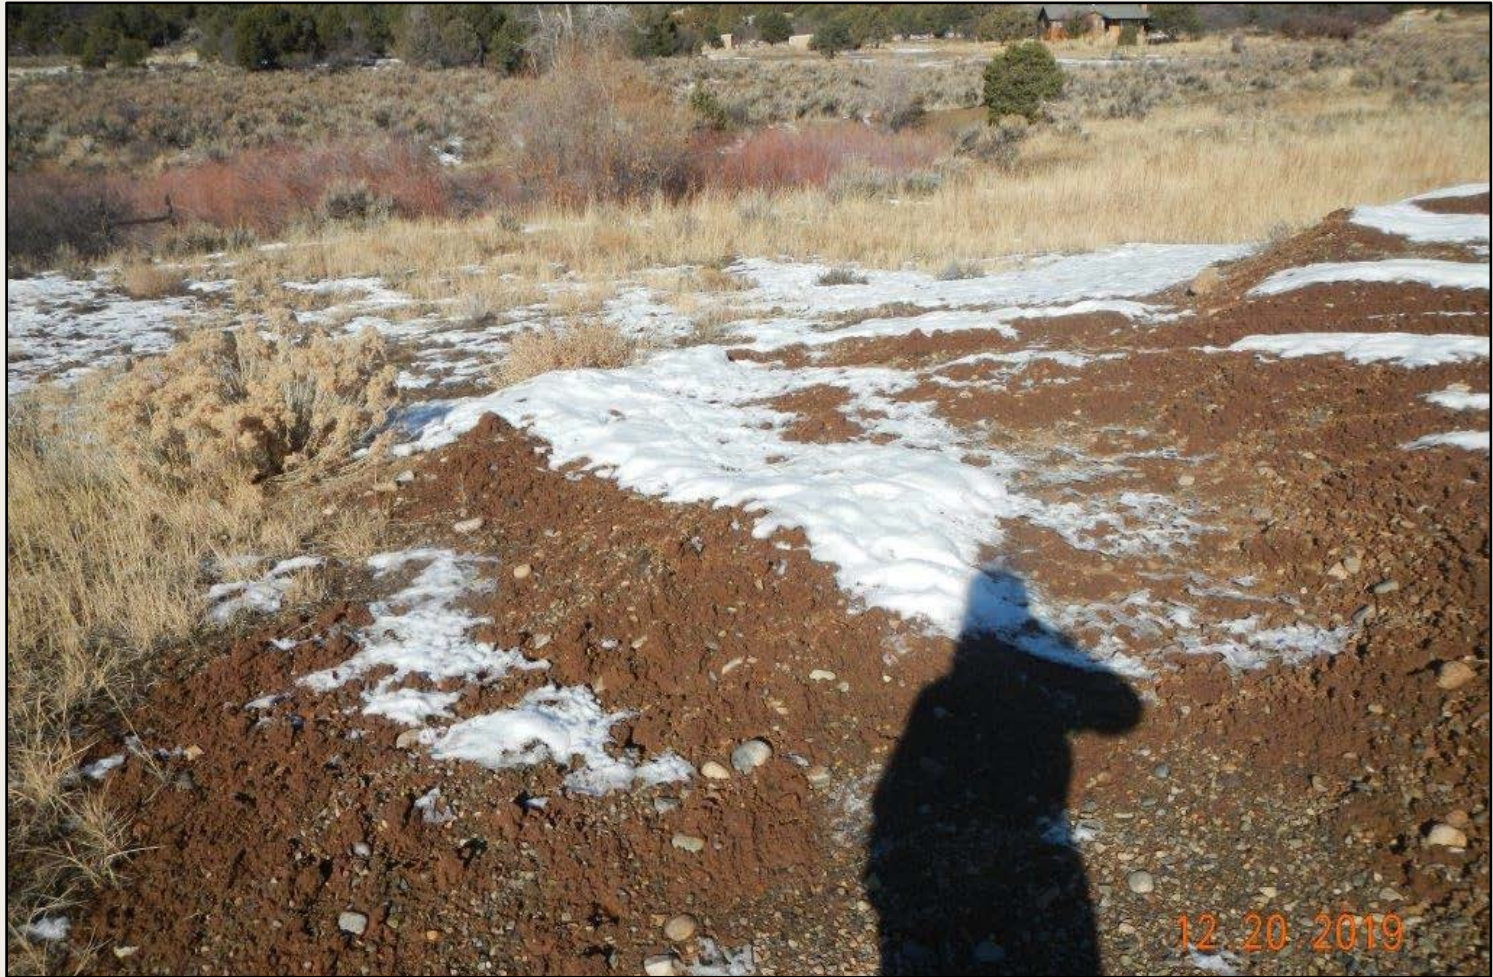
Photo 4. Another view of area in the southwestern project area where there is bare soils and truck tracks in the interim reclamation area.

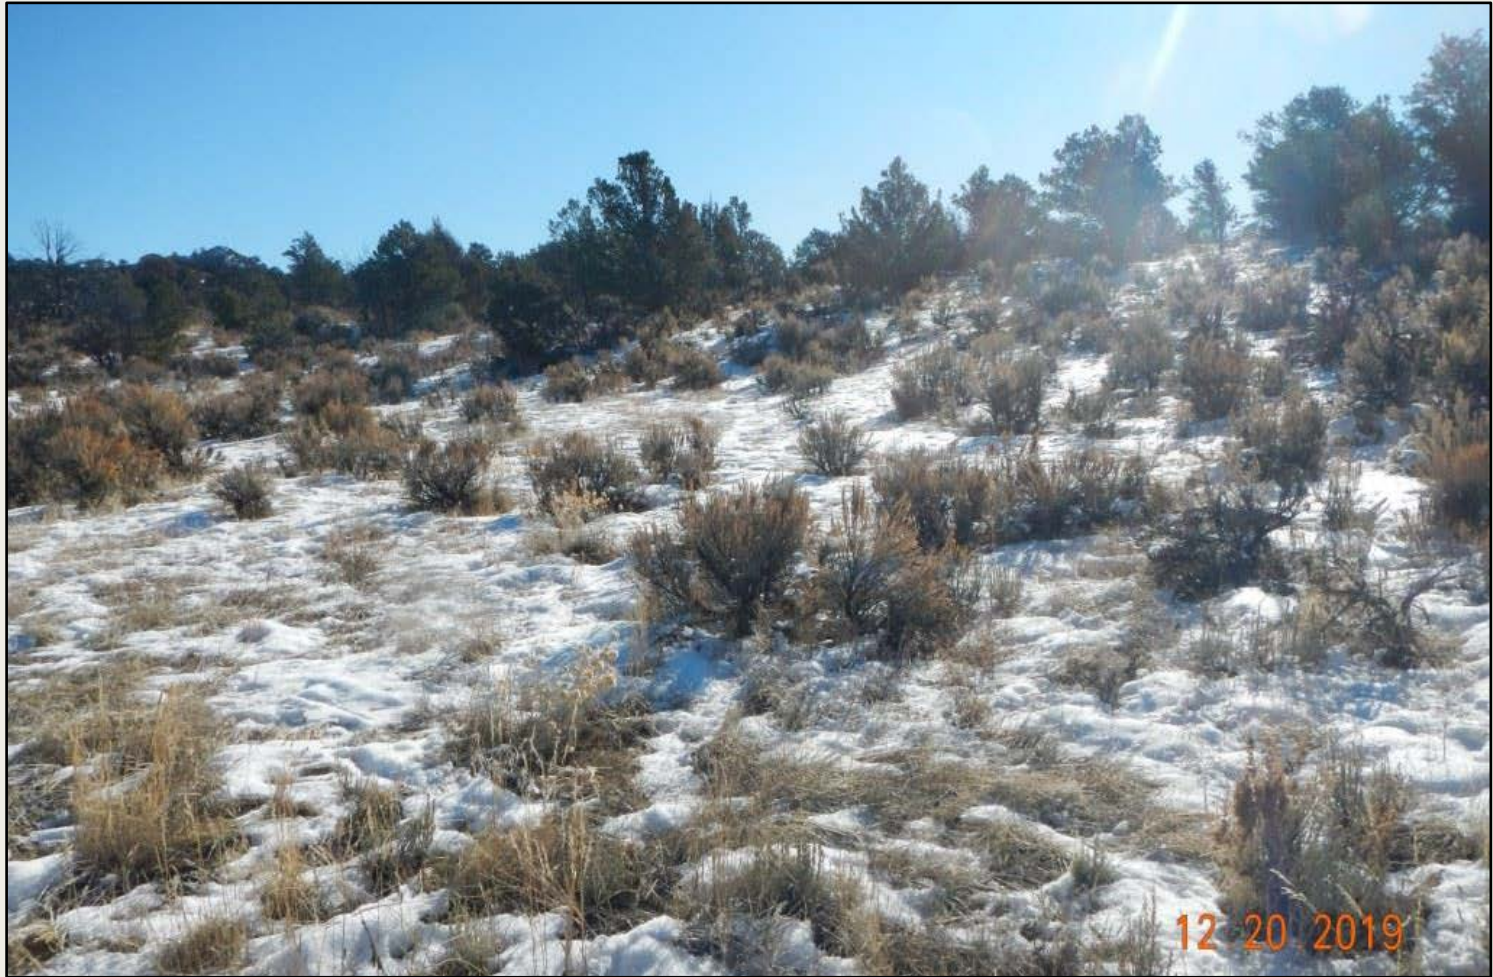
Photo 5. View of reference area vegetation comprised of mosaic of sagebrush shrubland and pinyon and juniper woodland.
