Standley\* Robert K DBA Otis Energy, Geoglein 5  
121-10574  
Inspection #688306571  
12/19/2019  
Engineering Inspection

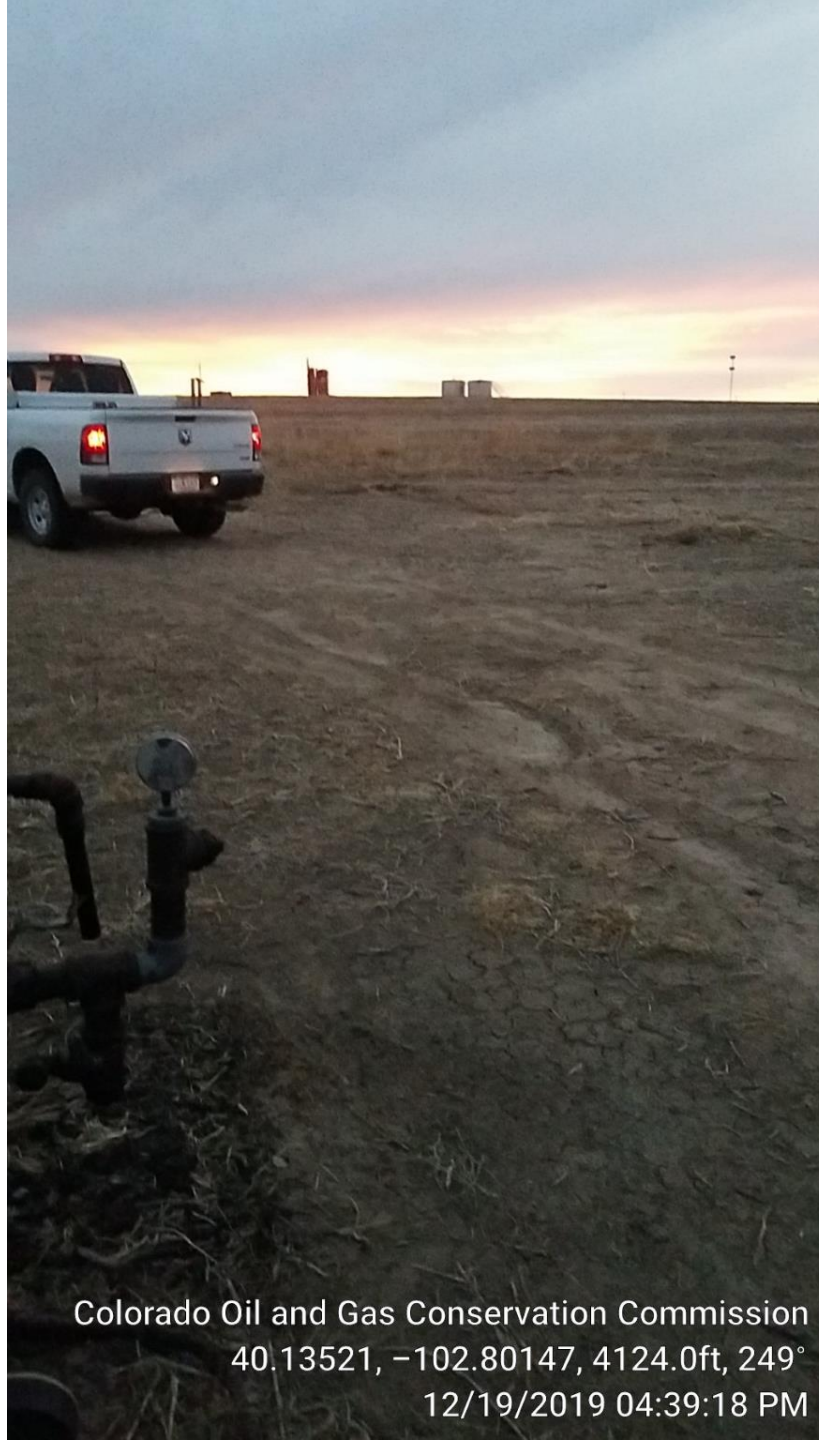
Flowline GPS at  
wellhead.

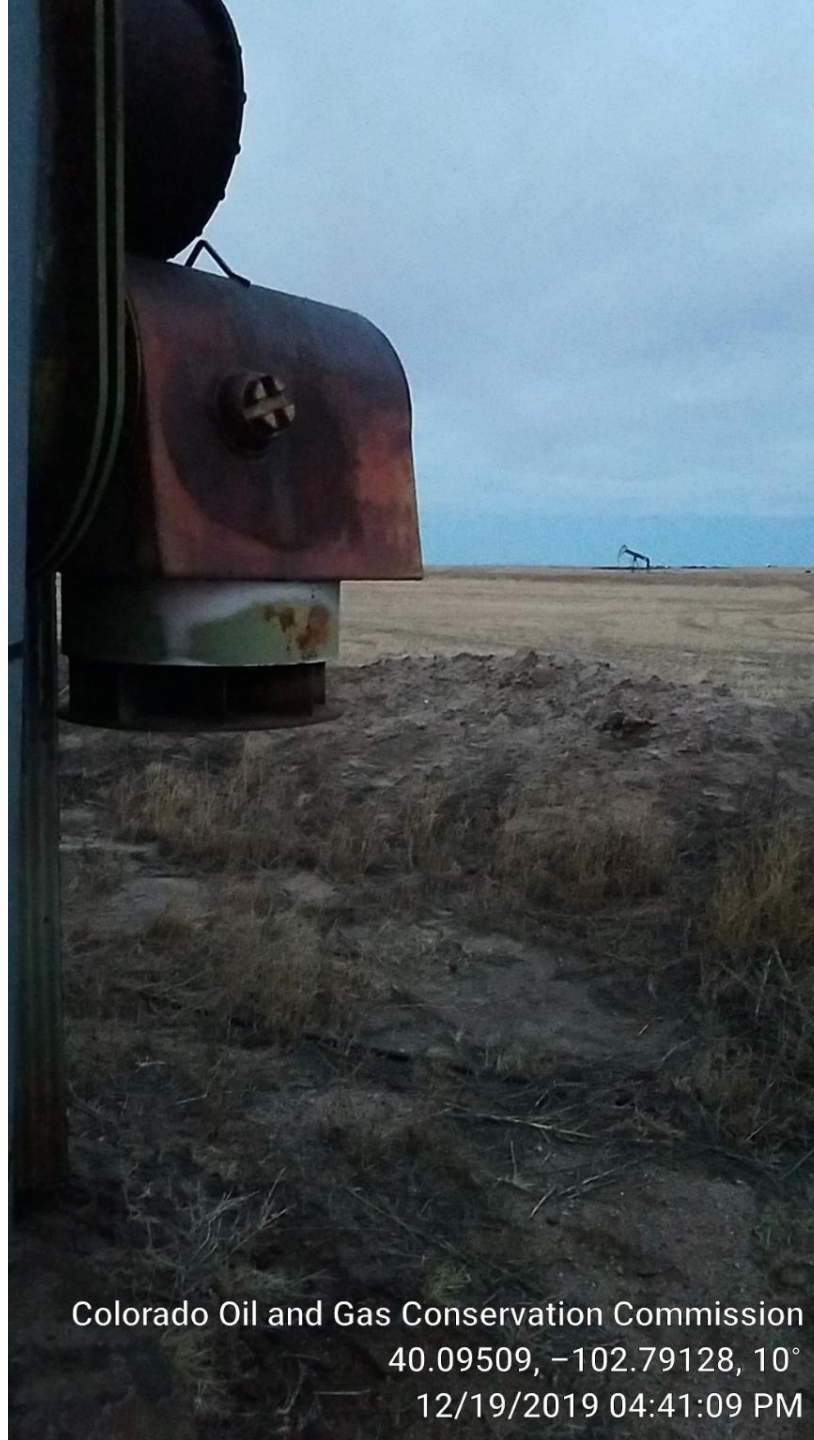
Flowline GPS at  
treater.
