Inspection Photos

Operator: Enduring Resources
Location/API #: 067-08501
Date: 12-23-2019

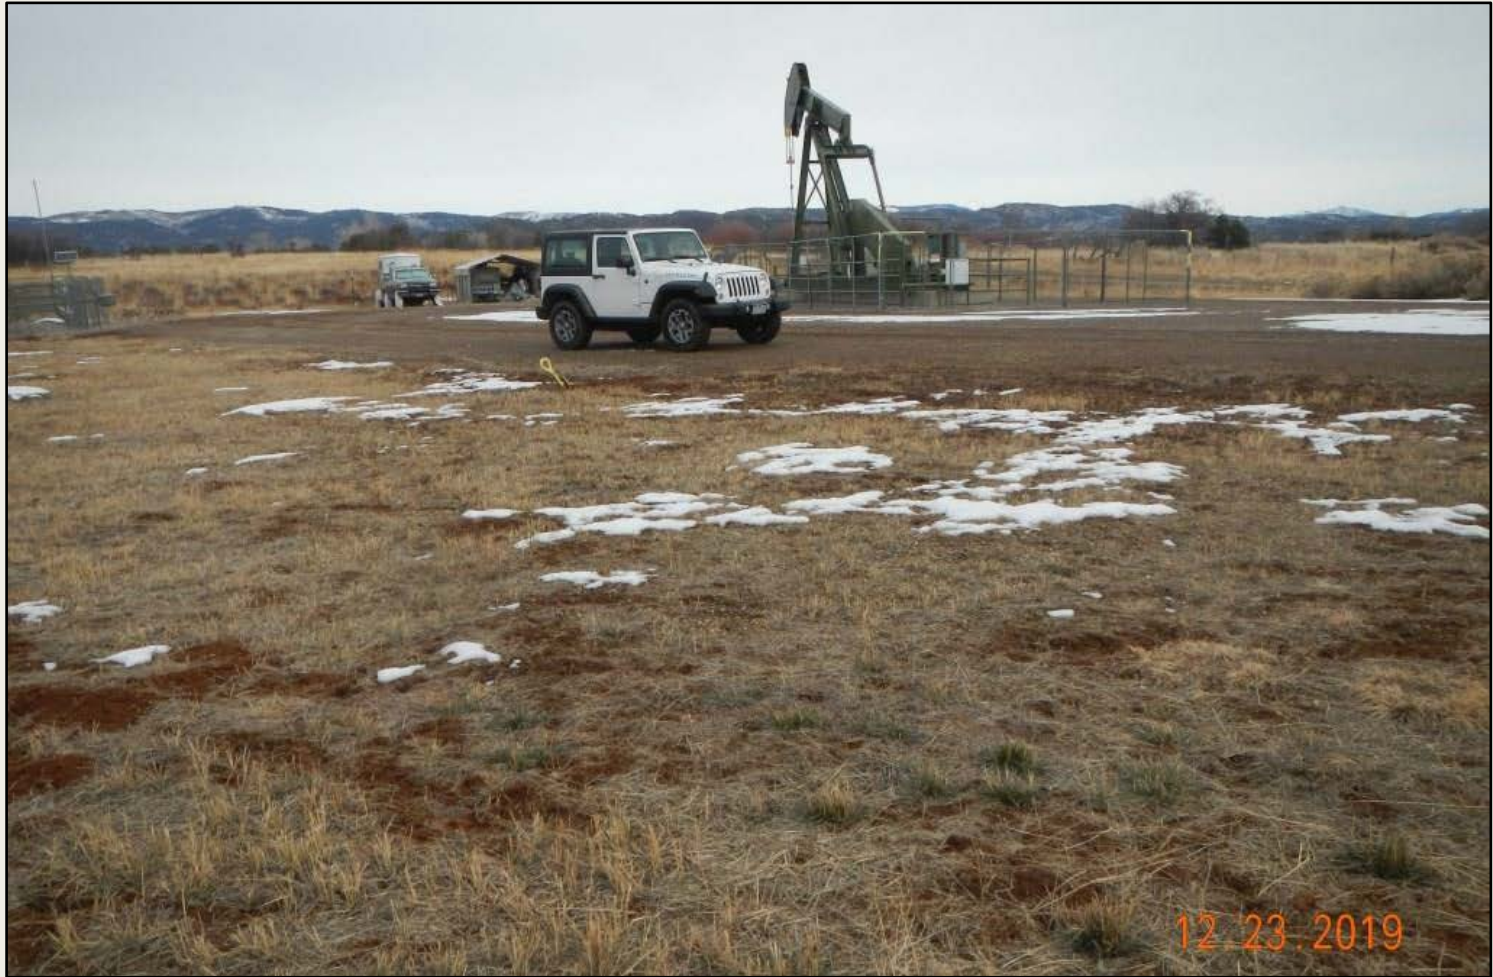
Photo 1. View of the project area from the southwestern corner facing center.

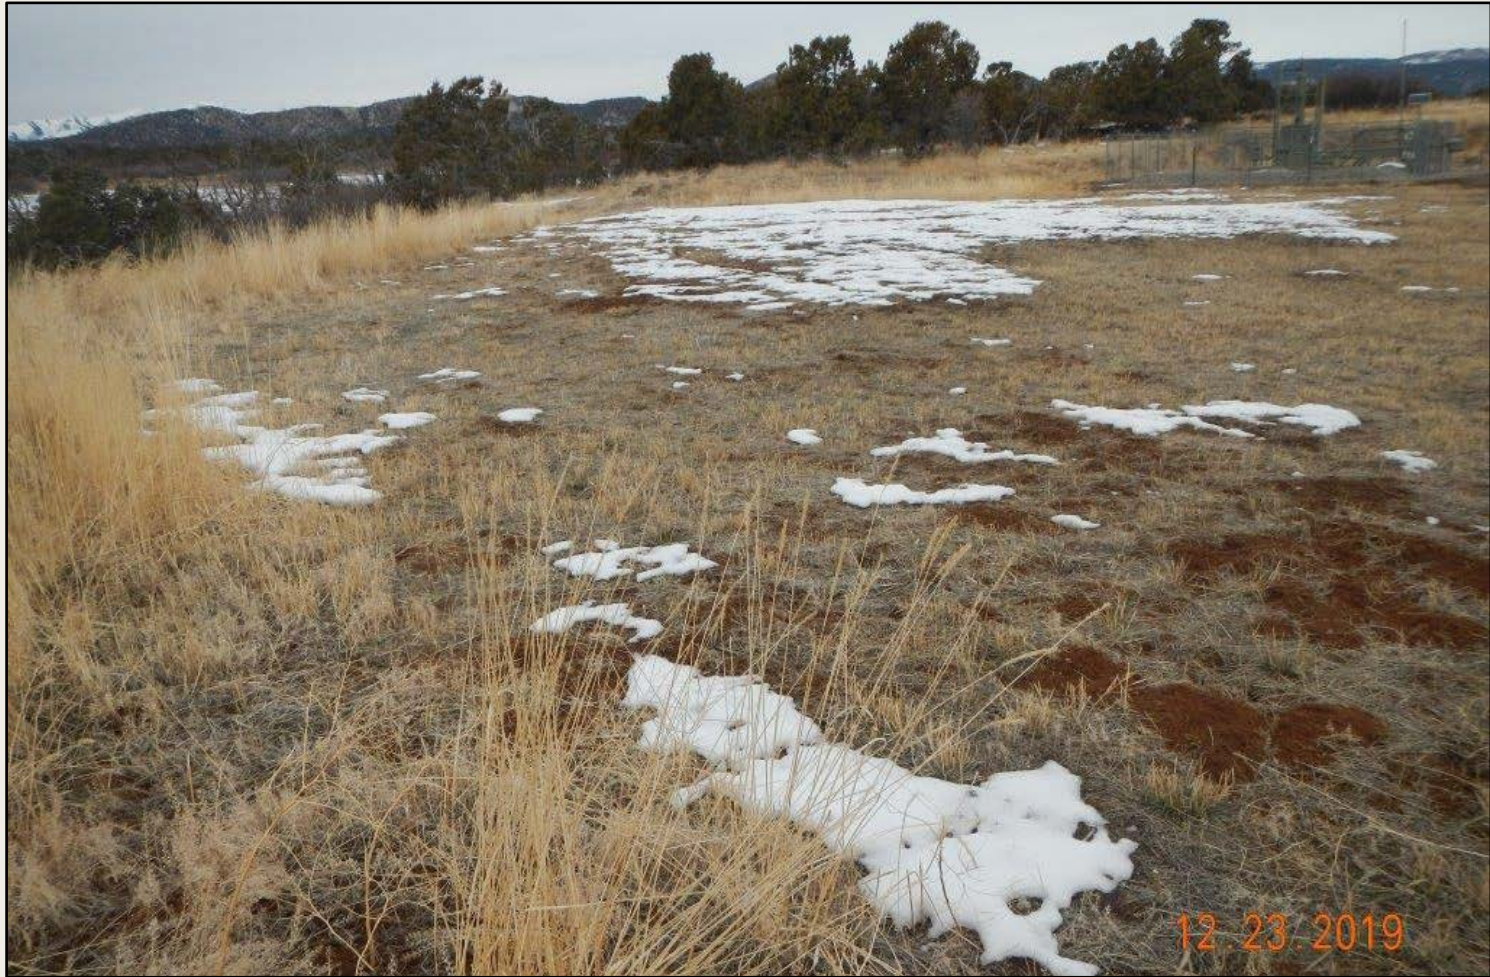
Photo 2. View of the western project area from the southwestern corner facing northward. Revegetation is mowed and appears to be progressing with grasses such as smooth brome and crested wheatgrass.

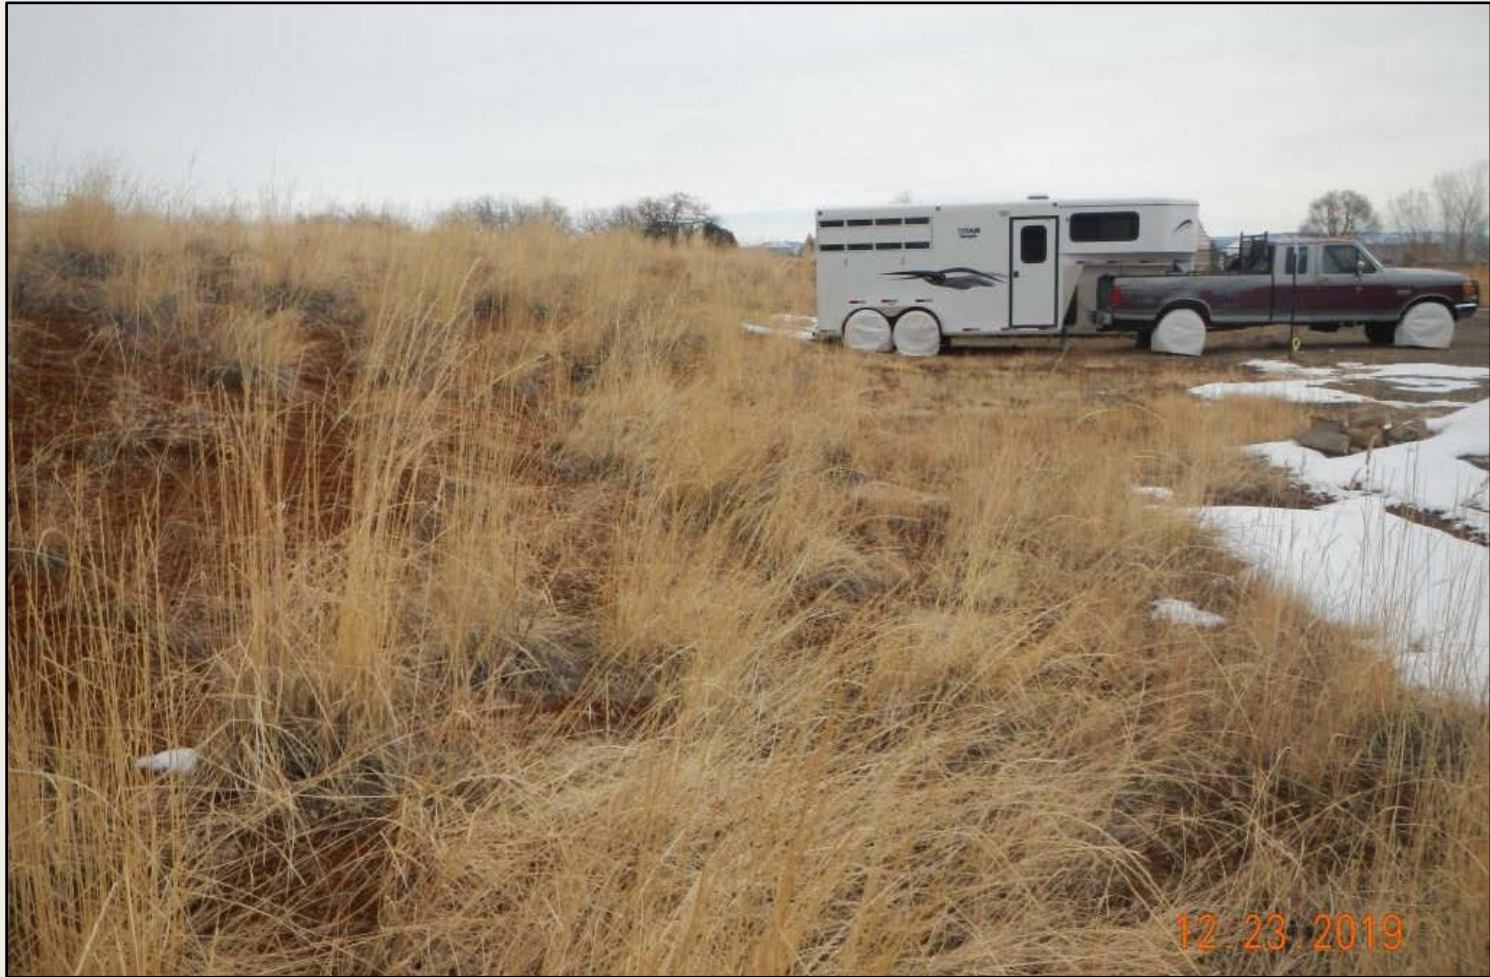
Photo 3. View of the northern project area from the northwestern corner facing eastward. What appears to be surface owner equipment and materials is stored in the northern project area.

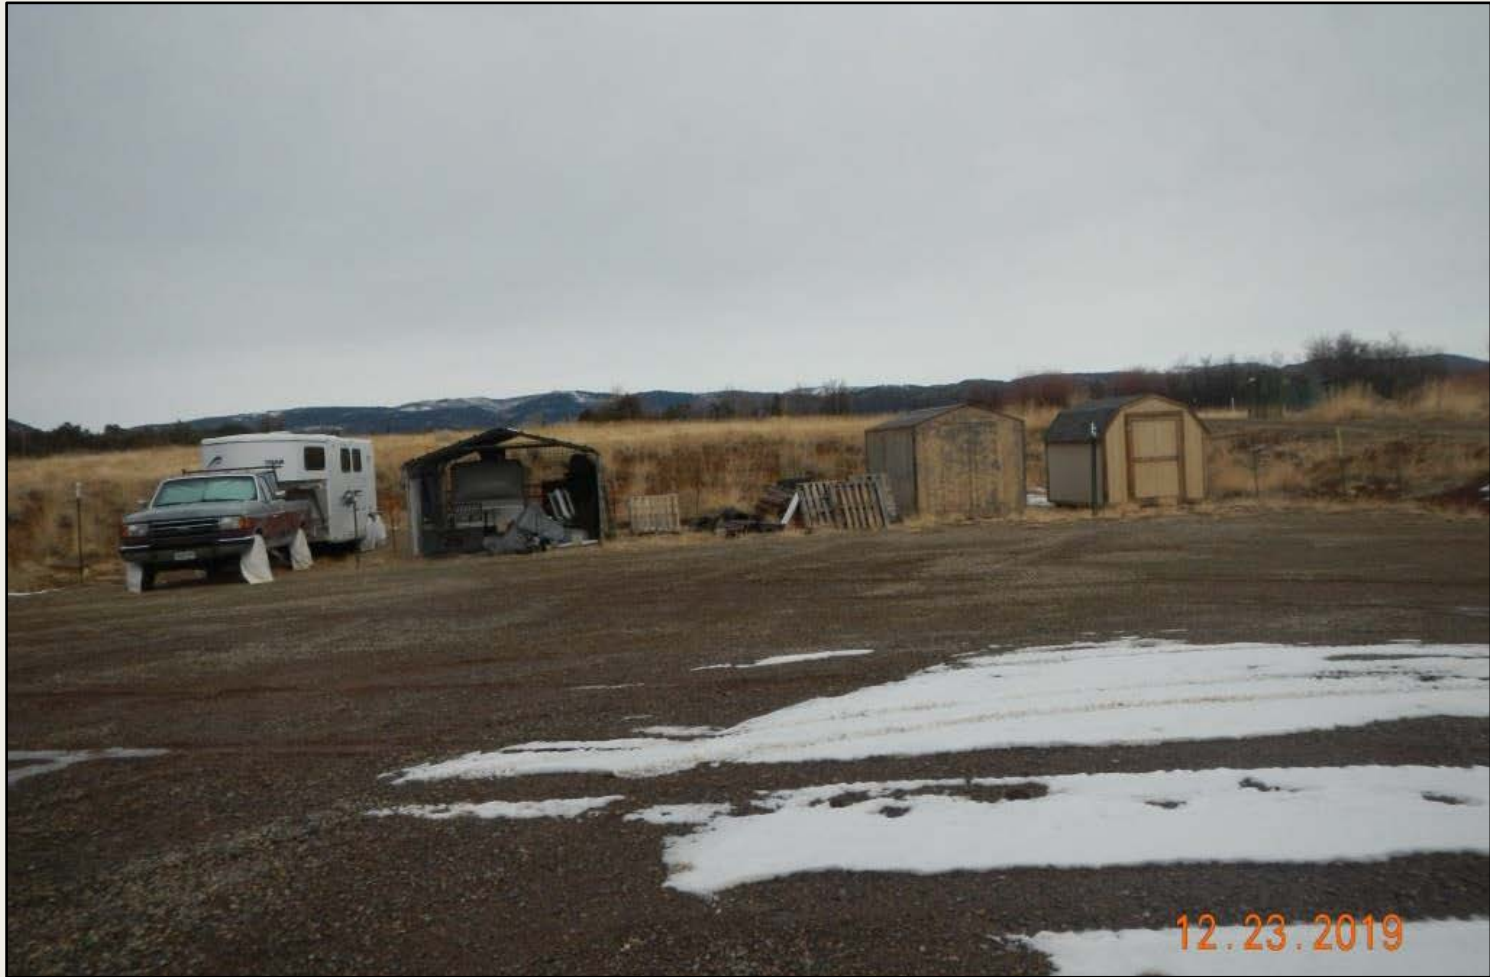
Photo 4. Another view of surface owner equipment and materials stored within the northern project area.

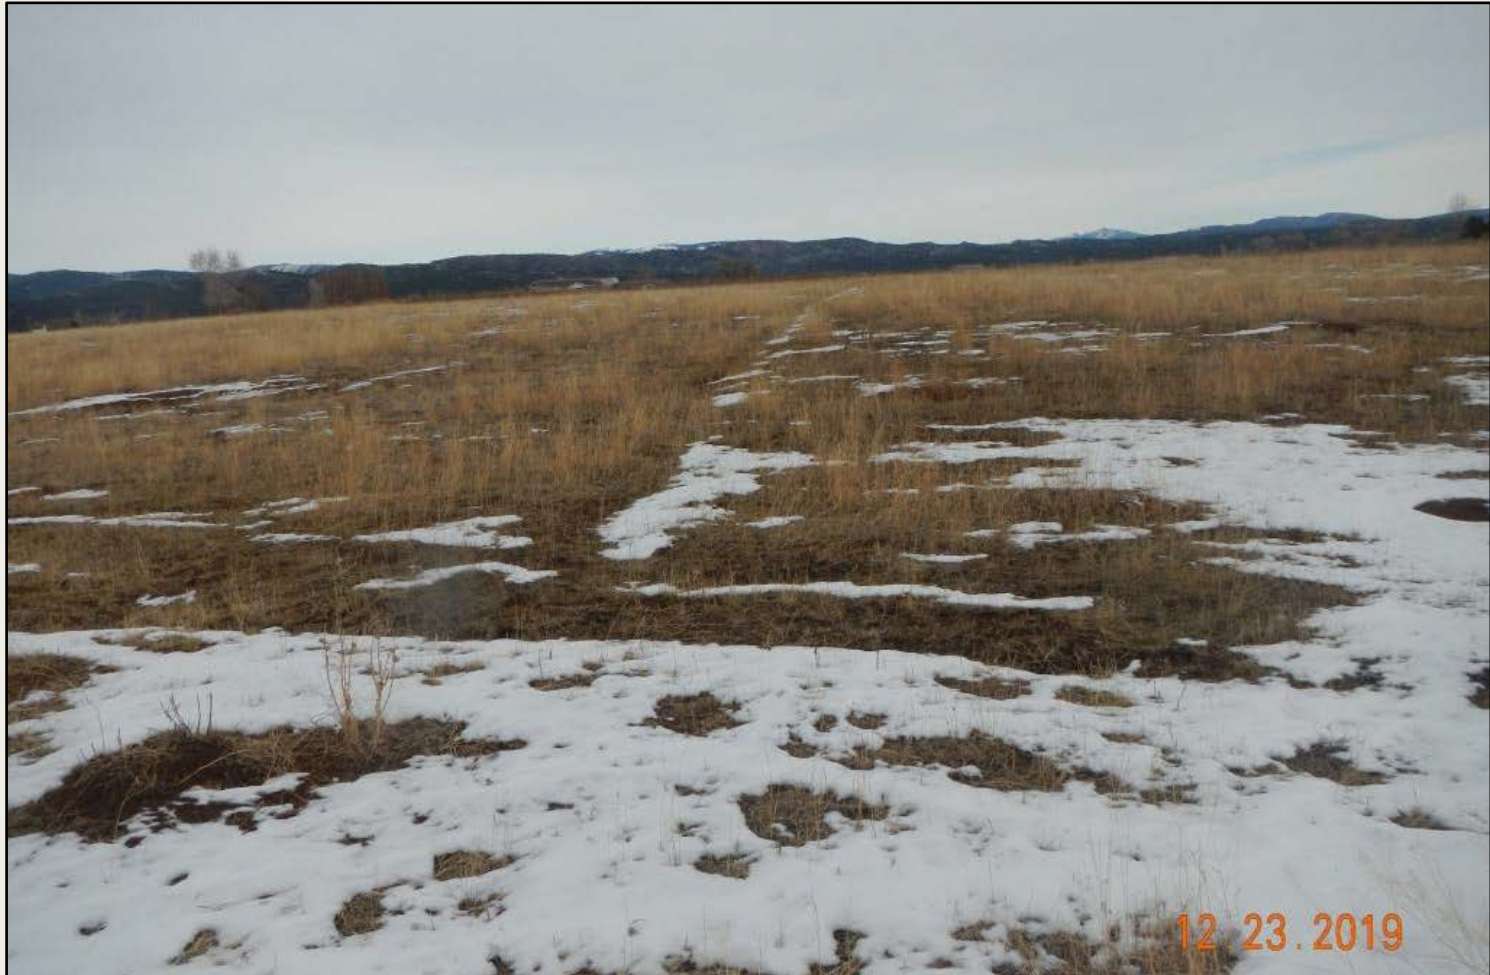
Photo 5. View of reference area vegetation comprised of open grass field with both native and introduced grasses in dormant vegetative condition.
