**Inspection Photos**  
**Location Name:** NHF-65N63W /9NWSW  
**Location #:** 331573

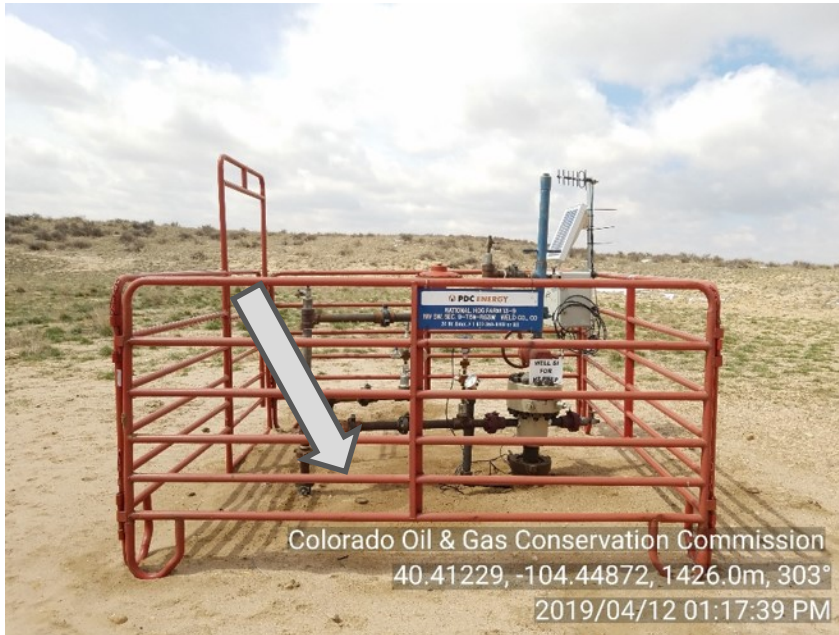
**Photo #1**  
**NHF 13-9 (05-123-20921) Wellsite**  
**Temporarily Abandoned | TA**  
**Stained soil at wellhead perimeter**  
*prior insp.*

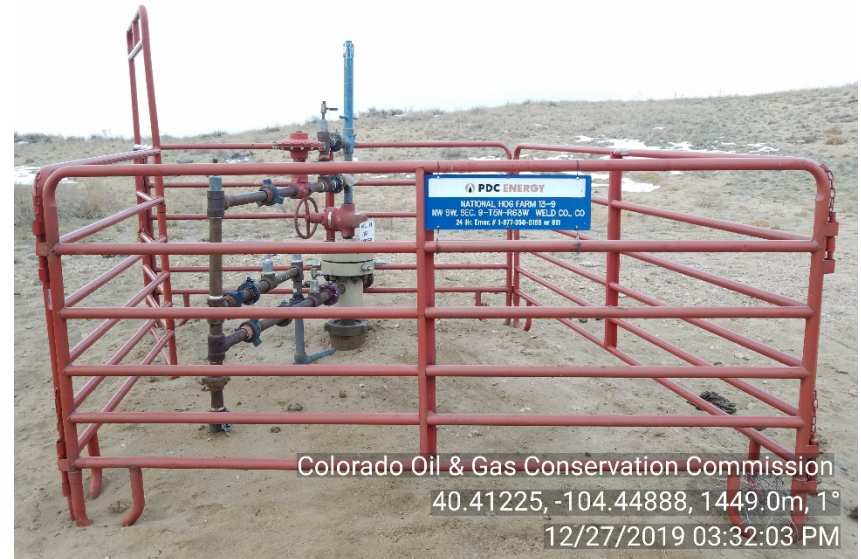
**Photo #2**  
**NHF 13-9 Wellsite**  
**Temporarily Abandoned | TA**  
*Stained soil at wellhead perimeter: Mitigated*

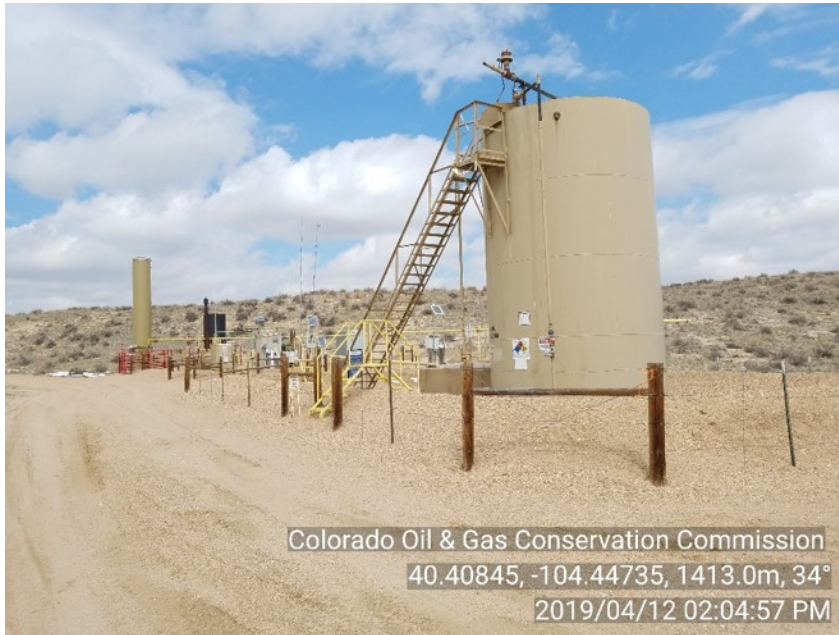
**Photo #3**  
**NHF 13-9, 24-9 Battery site**  
**Shut-down | Inactive**  
*prior insp.*

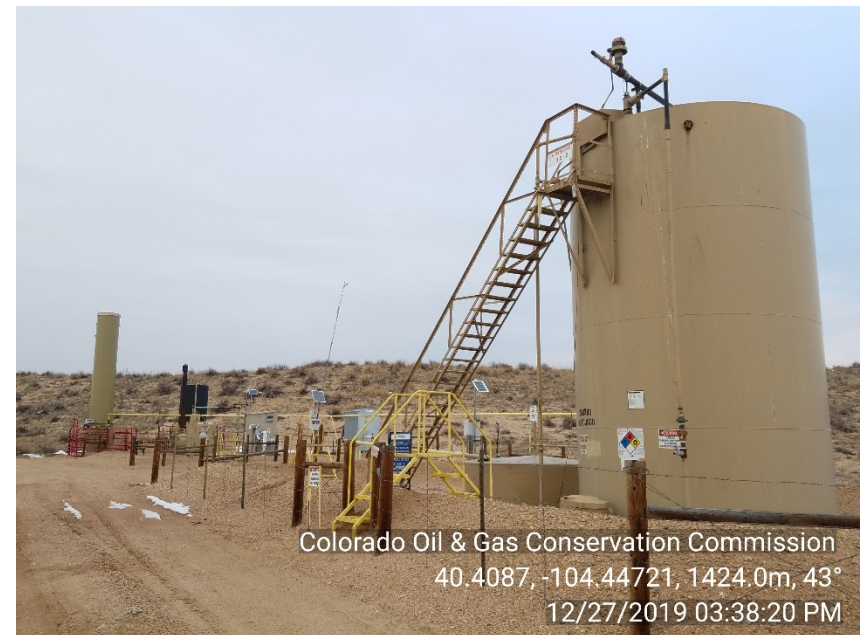
**Photo #4**  
**NHF 13-9, 24-9 Battery site**  
**Shut-down | Inactive**

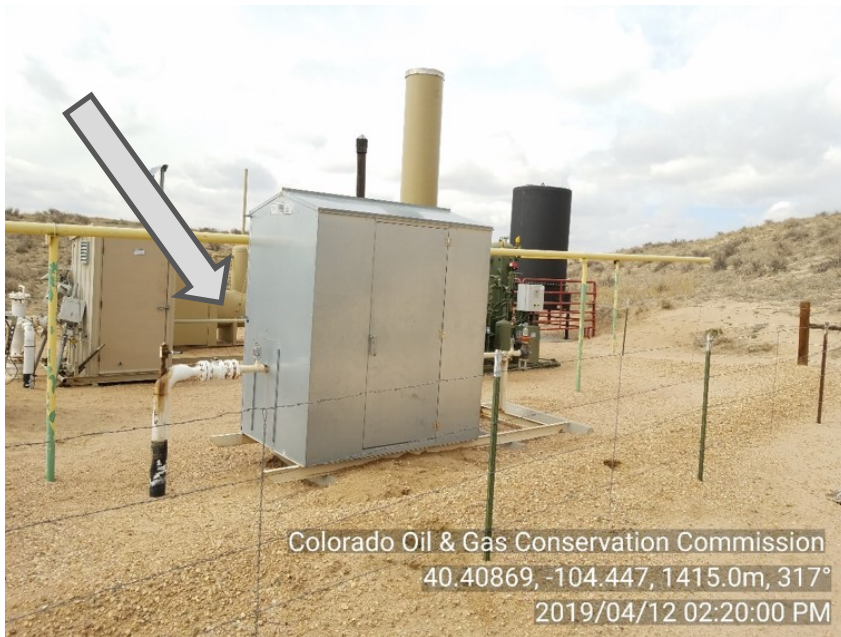
**Photo #5**  
**NHF 13-9, 24-9 Battery site**  
**Unused Equipment**  
*Gas meter run, riser  
prior insp.*

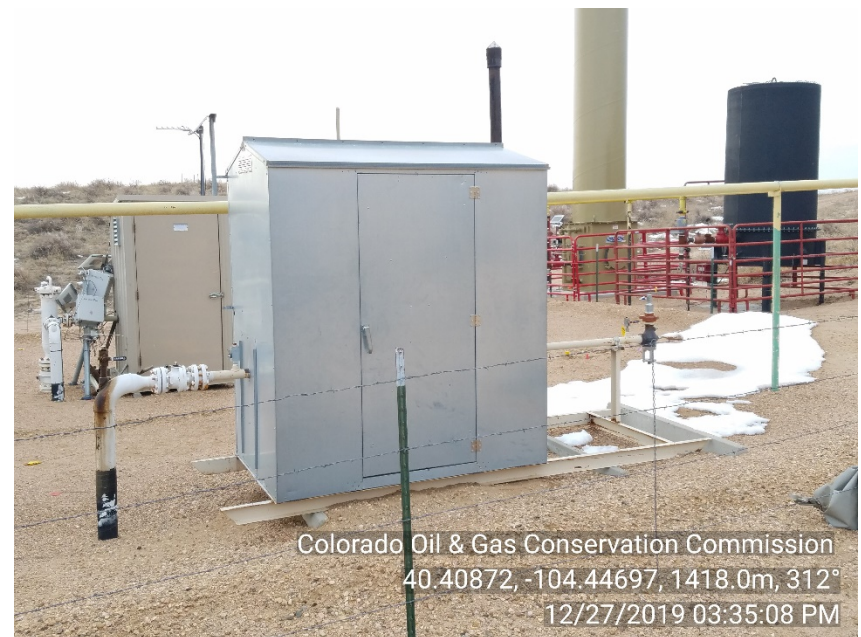
**Photo #6**  
**NHF 13-9, 24-9 Battery site**  
**Unused Equipment**  
*Gas meter run, riser: **Company states plans to re-use***
