Interim Reclamation and Stormwater Inspection

Operator: PETRO OPERATING COMPANY LLC- #10583

Location ID: 458074

Inspection Document #: 697500959

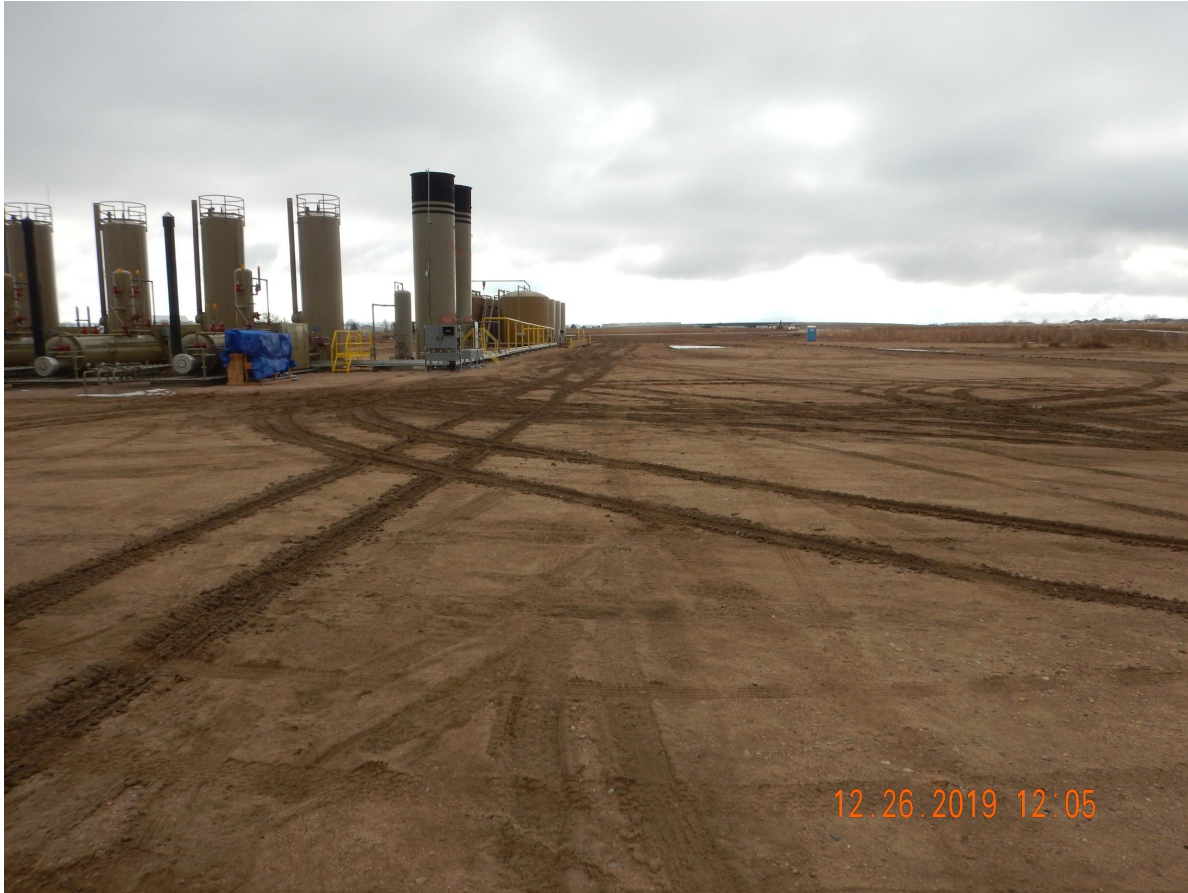
Photo 1. Photo taken from the central location, facing South. Photo illustrates the production facility. At the time of this inspection, soil conditions were frozen. Note: Per Rule 1002.f.(2).F., locations shall control potential sediment discharges from operational roads, well pads, and other unpaved surfaces. Practices should include minimizing rutting.

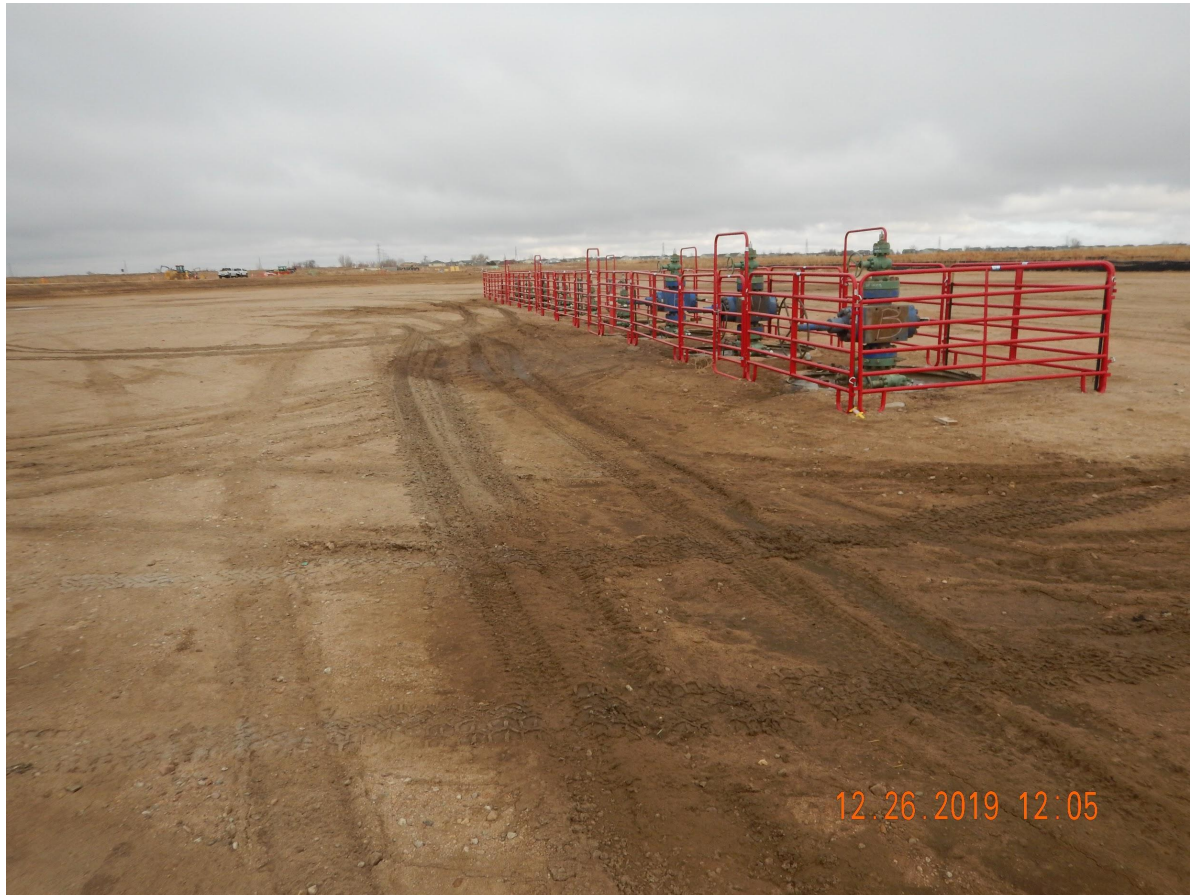
Photo 2. Photo taken from the central location, facing North. Photo illustrates the current wells. See comments under Photo 1 regarding rutting.

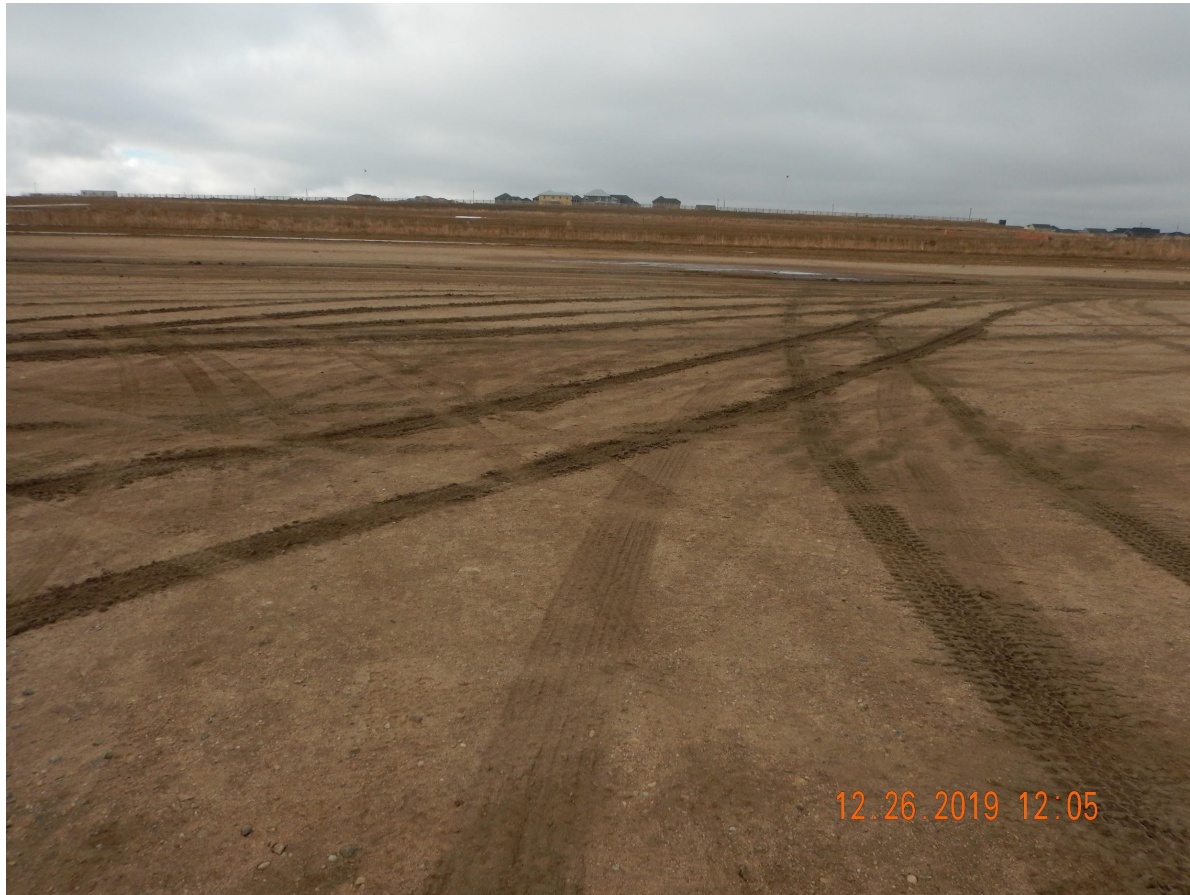
Photo 3. Photo taken from the central location, facing West. See comments under Photo 1 regarding rutting.

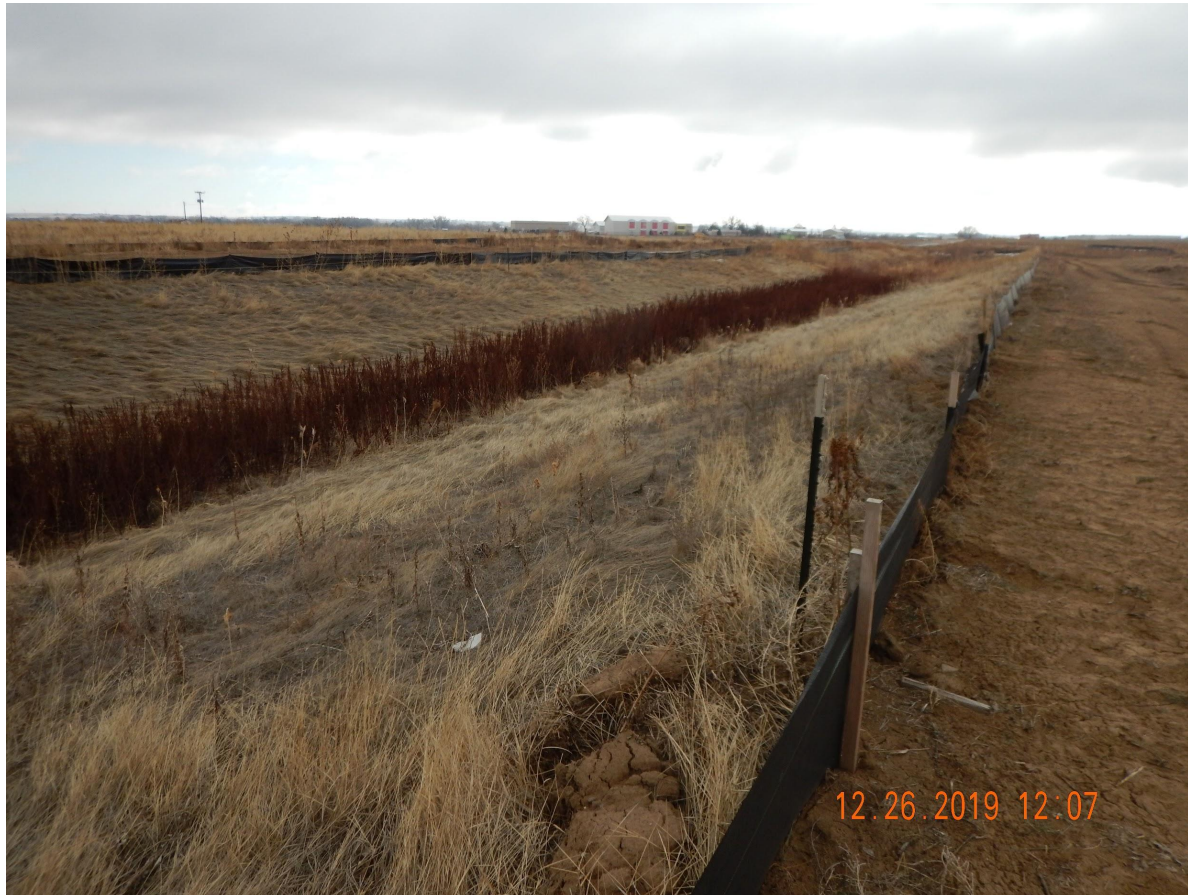
Photo 4. Photo taken from the eastern location, facing South. Photo illustrates silt fence BMP installed along the eastern down-gradient portion of the location. This ditch will be used as part of the housing development stormwater plan.

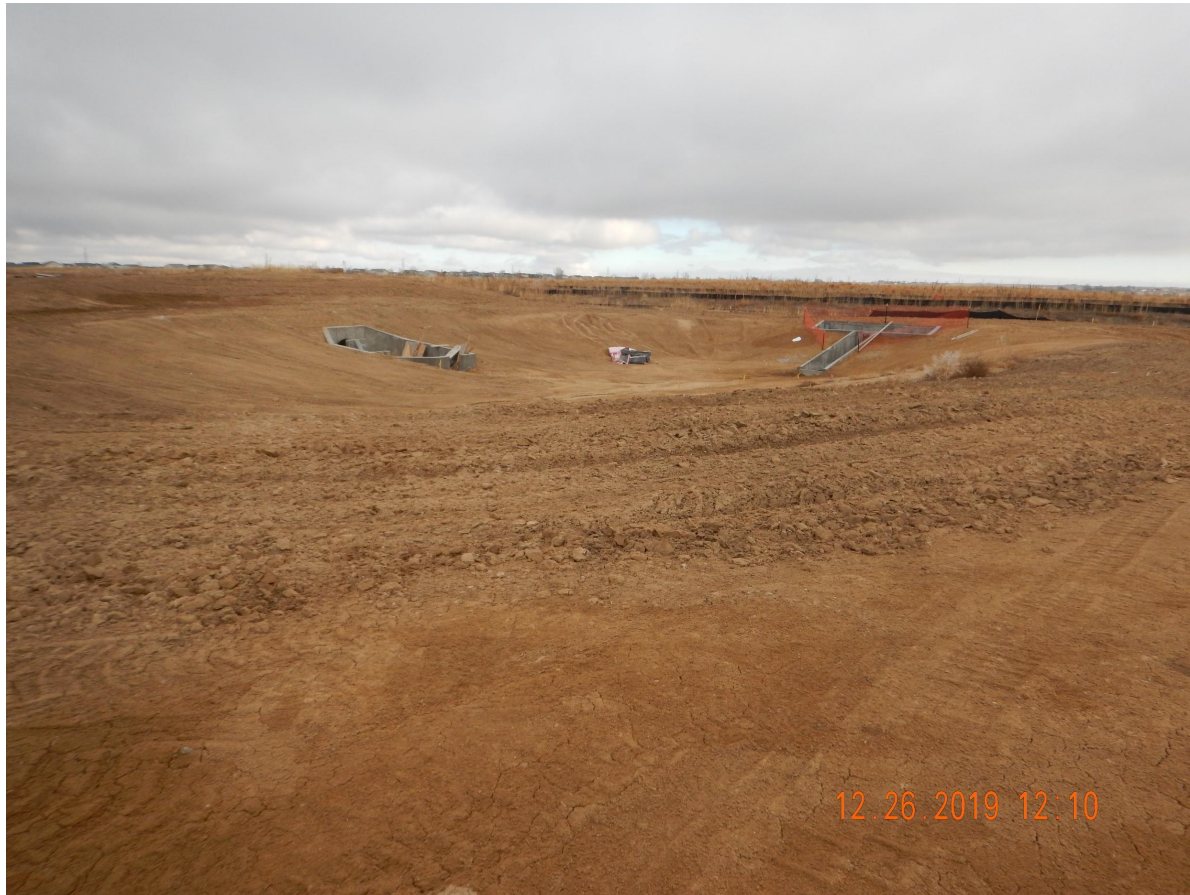
Photo 5. Photo taken from the northeastern location, facing North. Photo illustrates housing development stormwater construction underway. Note: this is not part of the location.

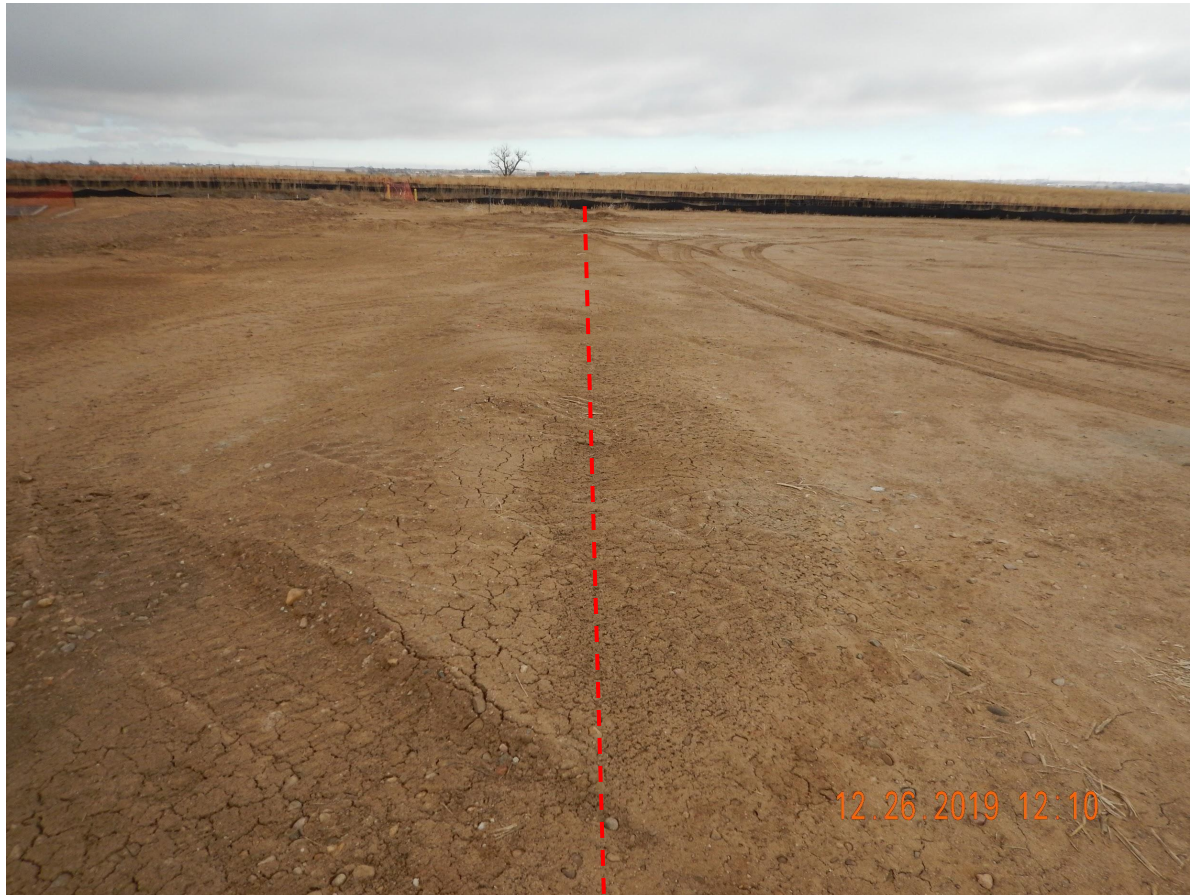
Photo 6. Photo taken from the northeastern location, facing East. Photo illustrates the housing development area to the left of the red-dashed line, and the BEF pad to the right.

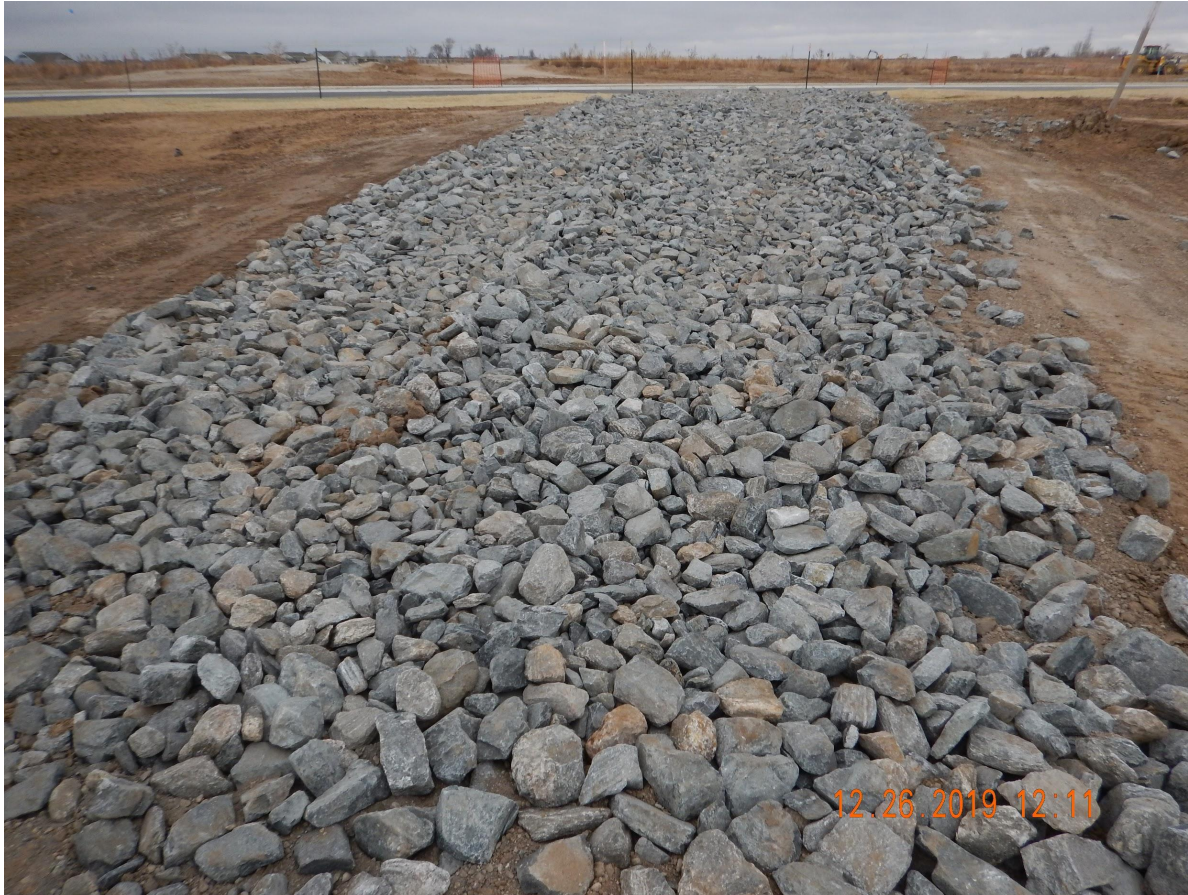
Photo 7. Photo taken from the northwestern location entrance, facing North. Photo illustrates what appears to be the temporary access point, as this is not included in the location file.

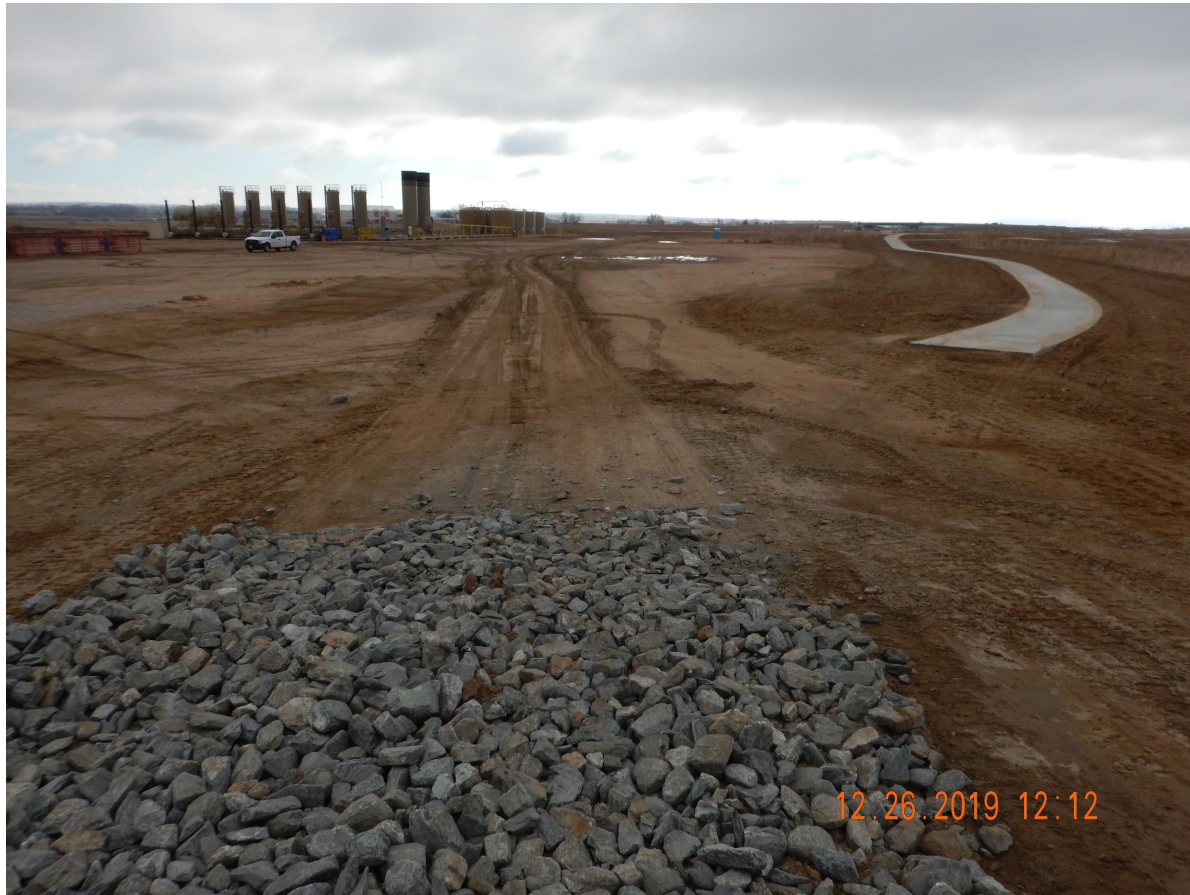
Photo 8. Photo taken from the northwestern location entrance, facing South. Photo illustrates what appears to be a sidewalk along the western portion of the location.

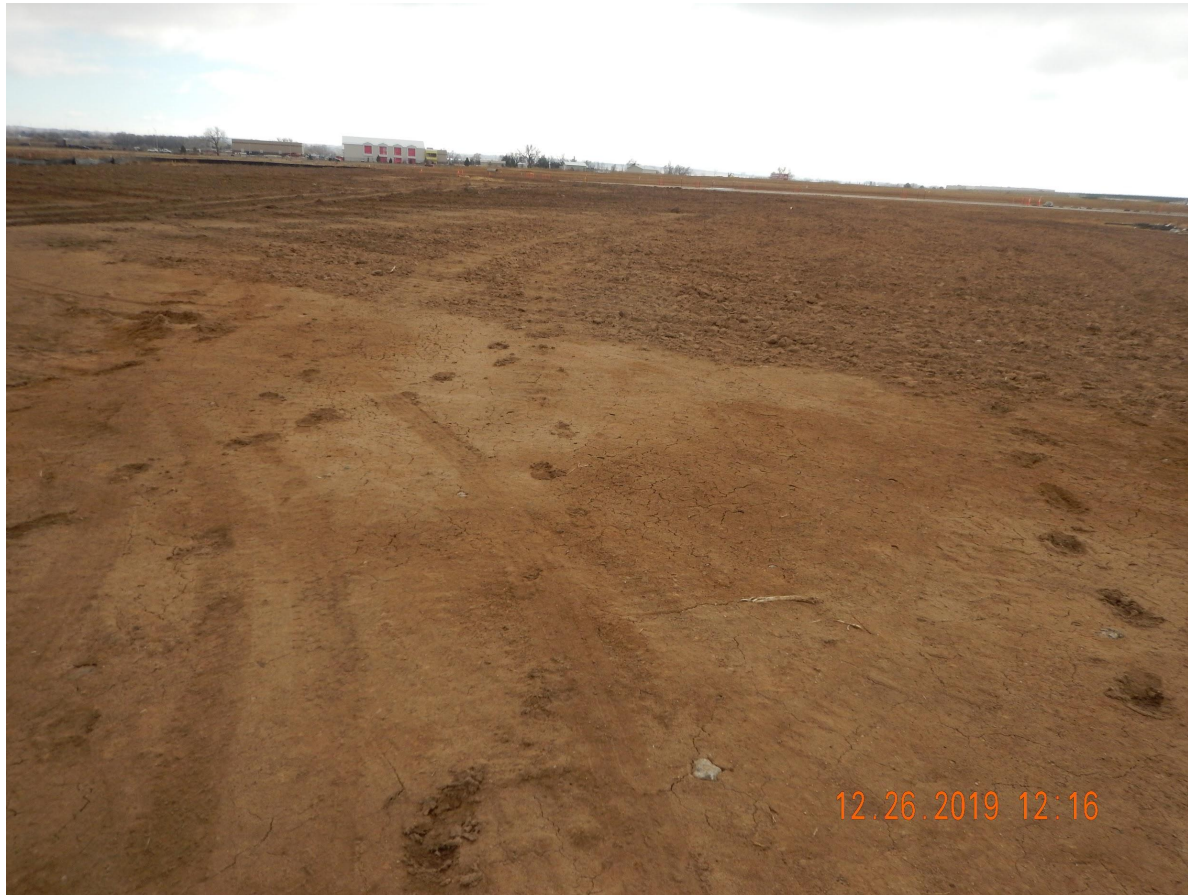
Photo 9. Photo taken from the southern location, facing South. Operator indicated this is where topsoil was stored; however, there is no indication that additional soil is present (e.g., no stockpile and southern area appears to be similar in contour as its surrounding area).
