Well Name: Ford Olson 2 API # 05-067-08789
IGE 128 API # 05-067-09568
IGE 129 API # 05-067-09908
IGE 130 API # 05-067-09909

Inspection Number: 687903685

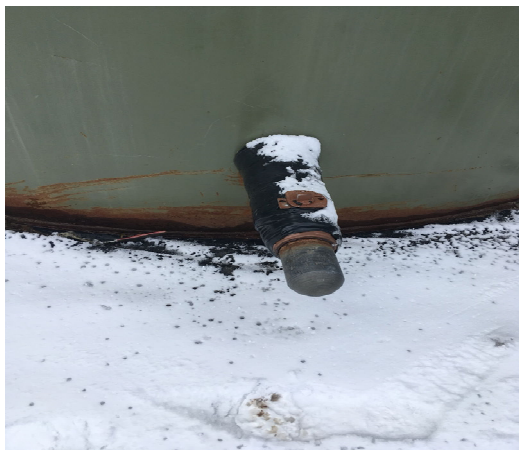
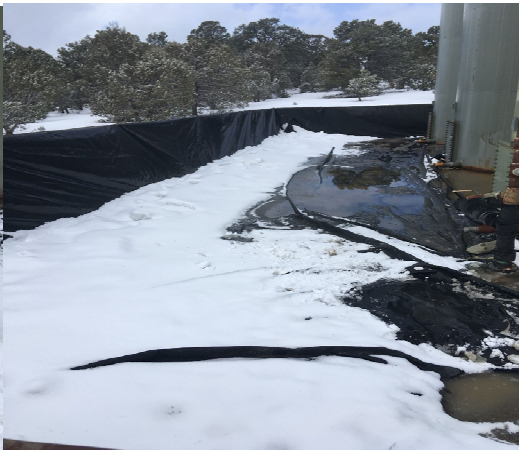
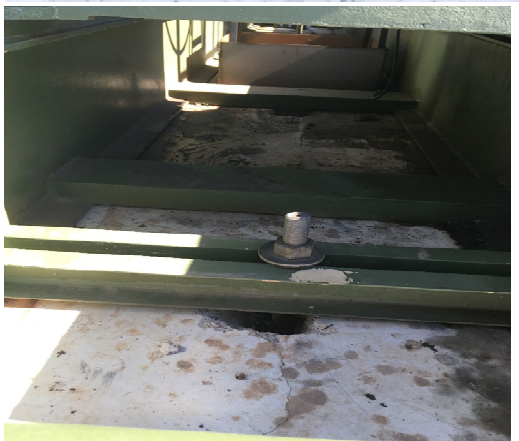
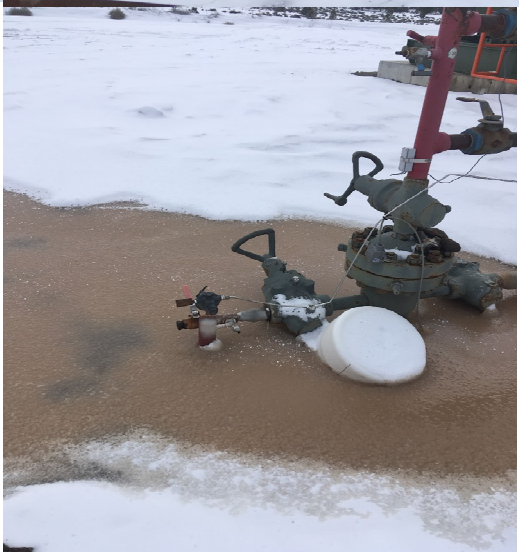
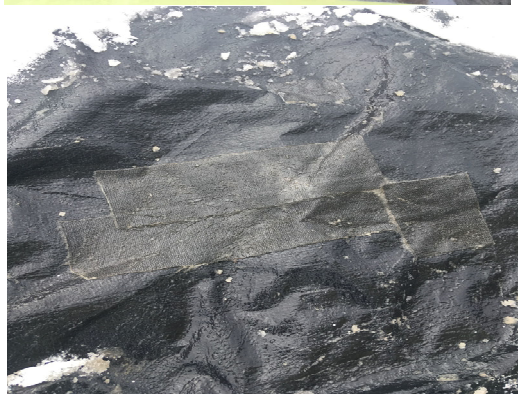
Corrective Action: Leaking valves on production tanks

Corrective Action: Oily rags on pumping unit

Corrective Action: Unused hose on Ford Olson 2 well head

Corrective Action: Rubber tires in secondary containment, tear in secondary containment

Action Taken: Replaced leaking valves on production tanks

Action Taken: Pick up and clean oily rags and trash.

Action Taken: Removed unused equipment from location

Action Taken: Removed rubber tires from secondary containment, repaired tear in secondary containment.
