Well Name: Olson Smith GU 2, IGE 127 **API #** 05-067-07911 05-067-09545
Inspection Number: 687903691
Corrective Action: Stuffing box leak
Correction Action Due: 2/1/2019
Action Completed: 2/1/2019
Action Taken: Repair stuffing box.

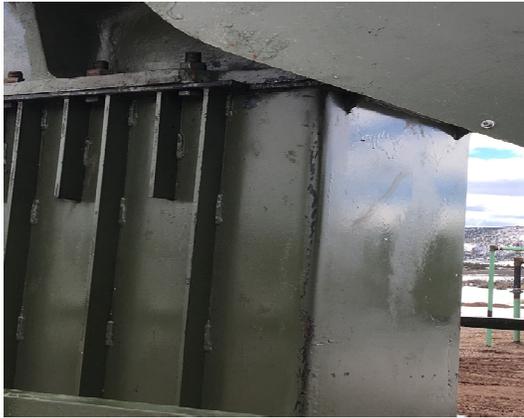
Corrective Action: Trash and rags on pumping unit skid
Correction Action Due: 2/11/2019
Action Completed: 2/4/2019
Action Taken: Clean up trash and rags.

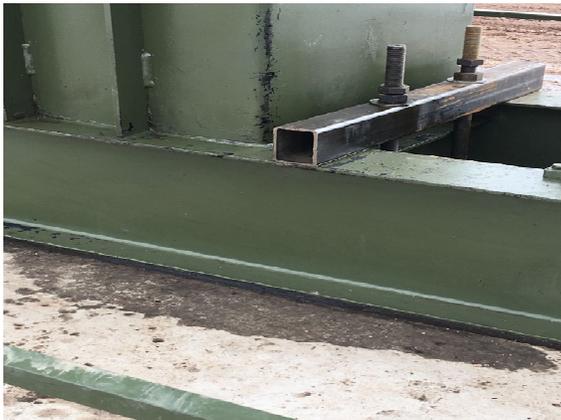
Corrective Action: Pumping unit gearbox leak
Correction Action Due: 2/8/2019
Action Completed: 2/4/2019
Action Taken: Repaired pumping unit gearbox leak, clean up oil from leak.

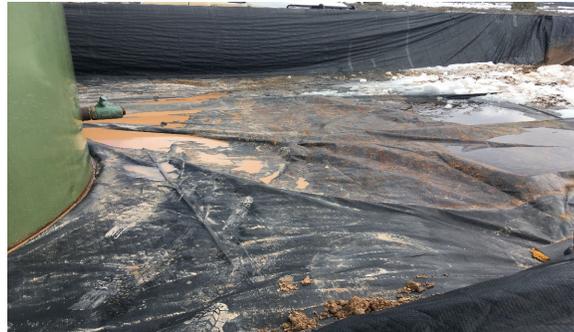
Corrective Action: Tear in southern wall of secondary containment
Tires inside secondary containment
Correction Action Due: 2/28/2019
Action Completed: 2/4/2019
Action Taken: Repaired tear in secondary containment.
Removed tires from secondary containment.
