Inspection Photos

API: 05-071-06753

Operator: EVERGREEN NATURAL RESOURCES

Inspection Date: 1/6/2020

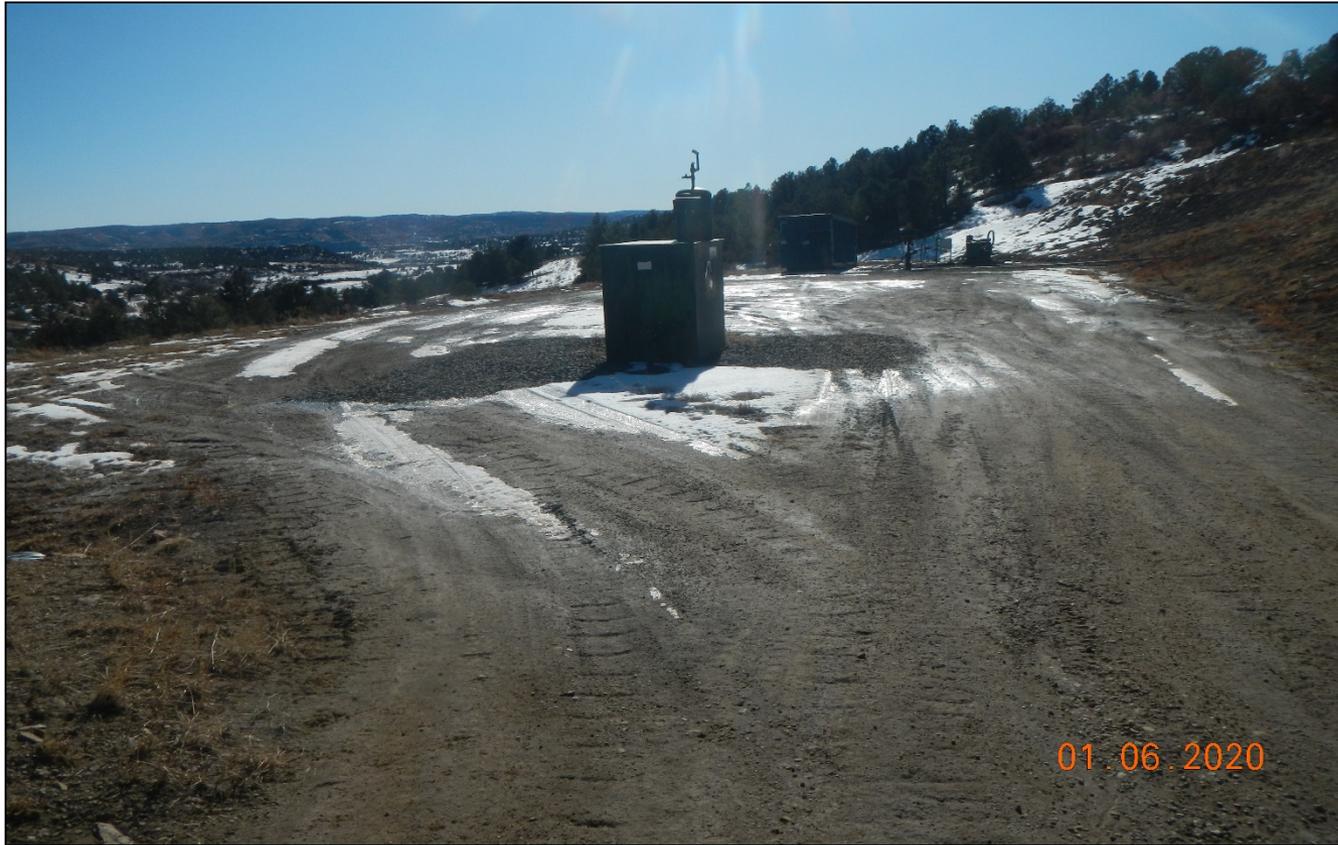
Photo 1. Facing south toward the location.

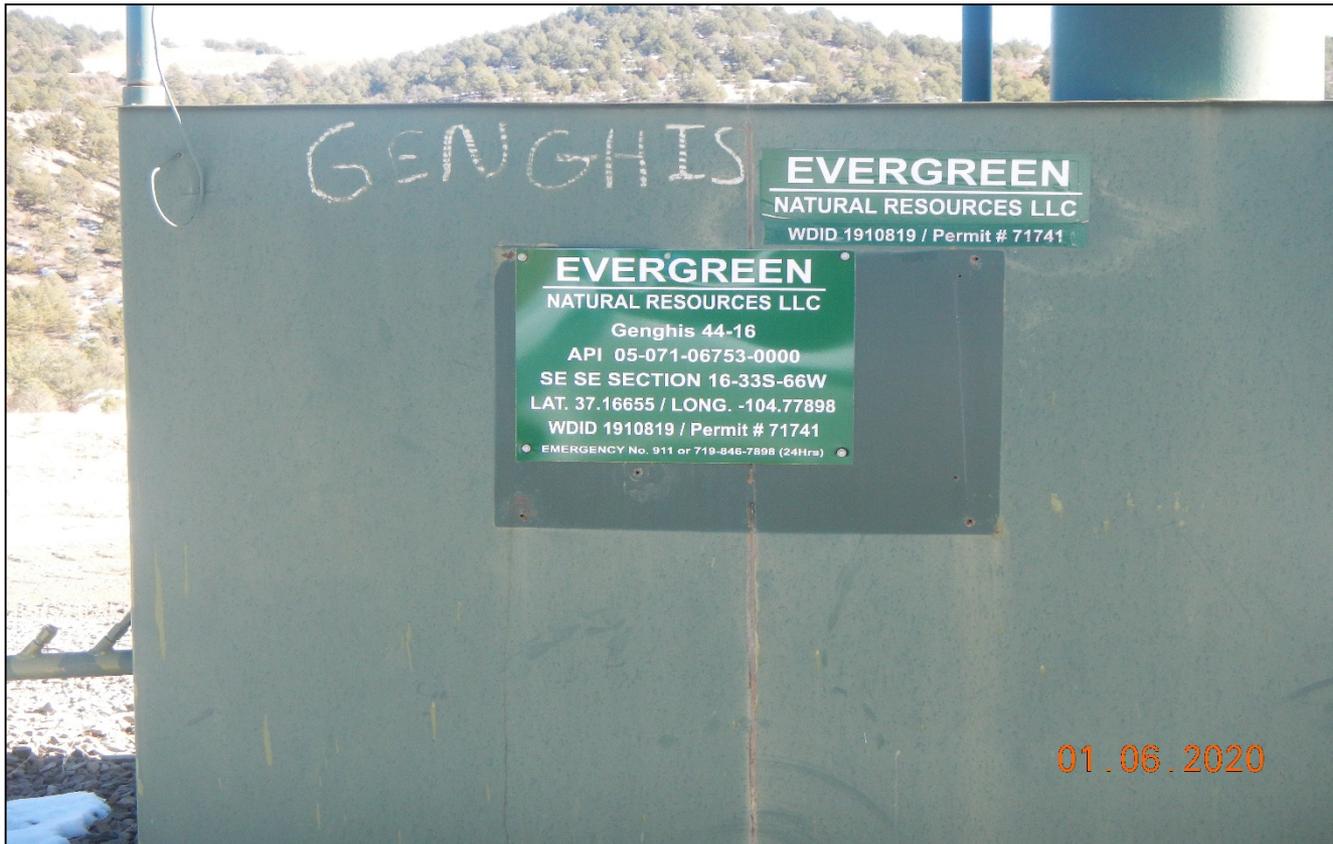
Photo 2. Well sign is posted at meter house.

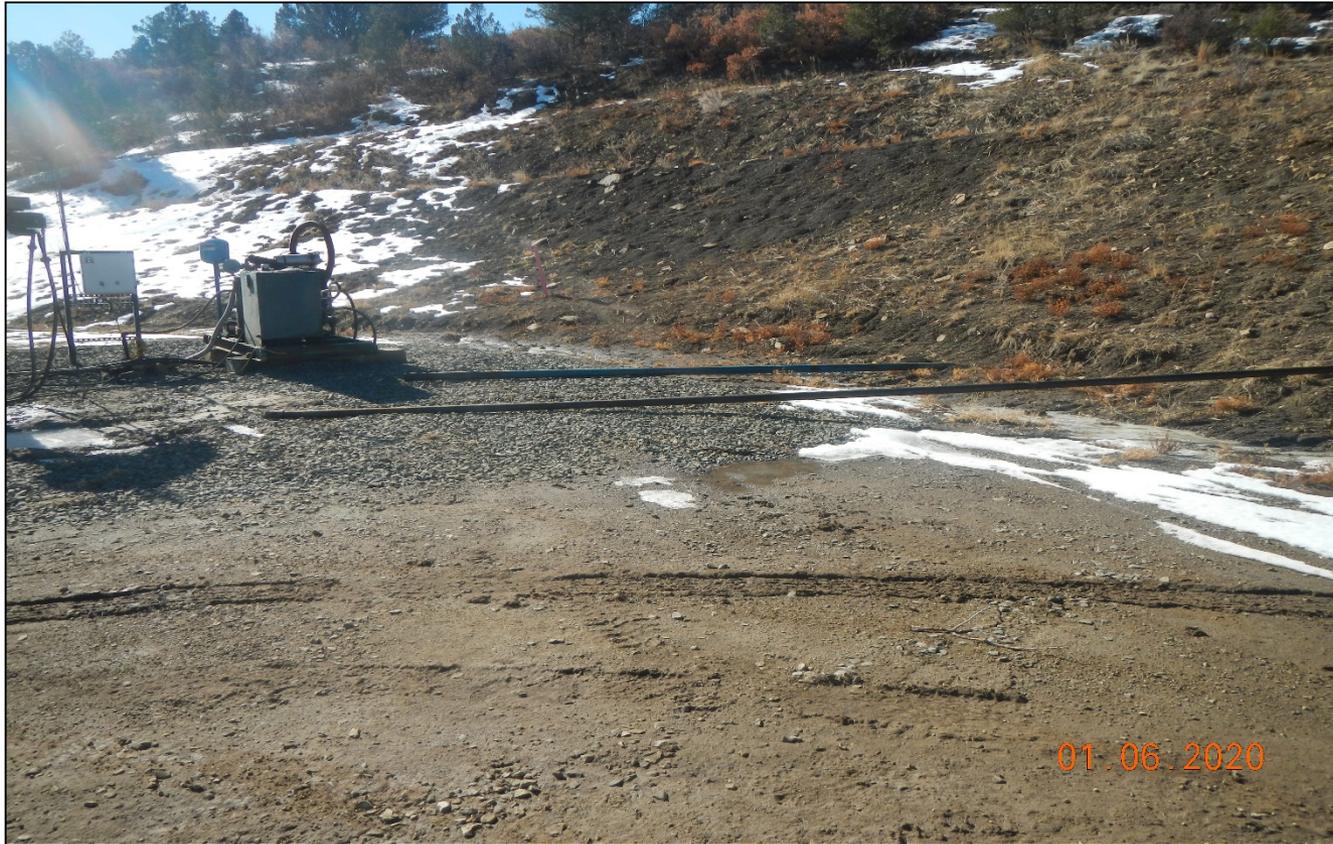
Photo 3. There are two pieces of unused pipe that will need to be removed.

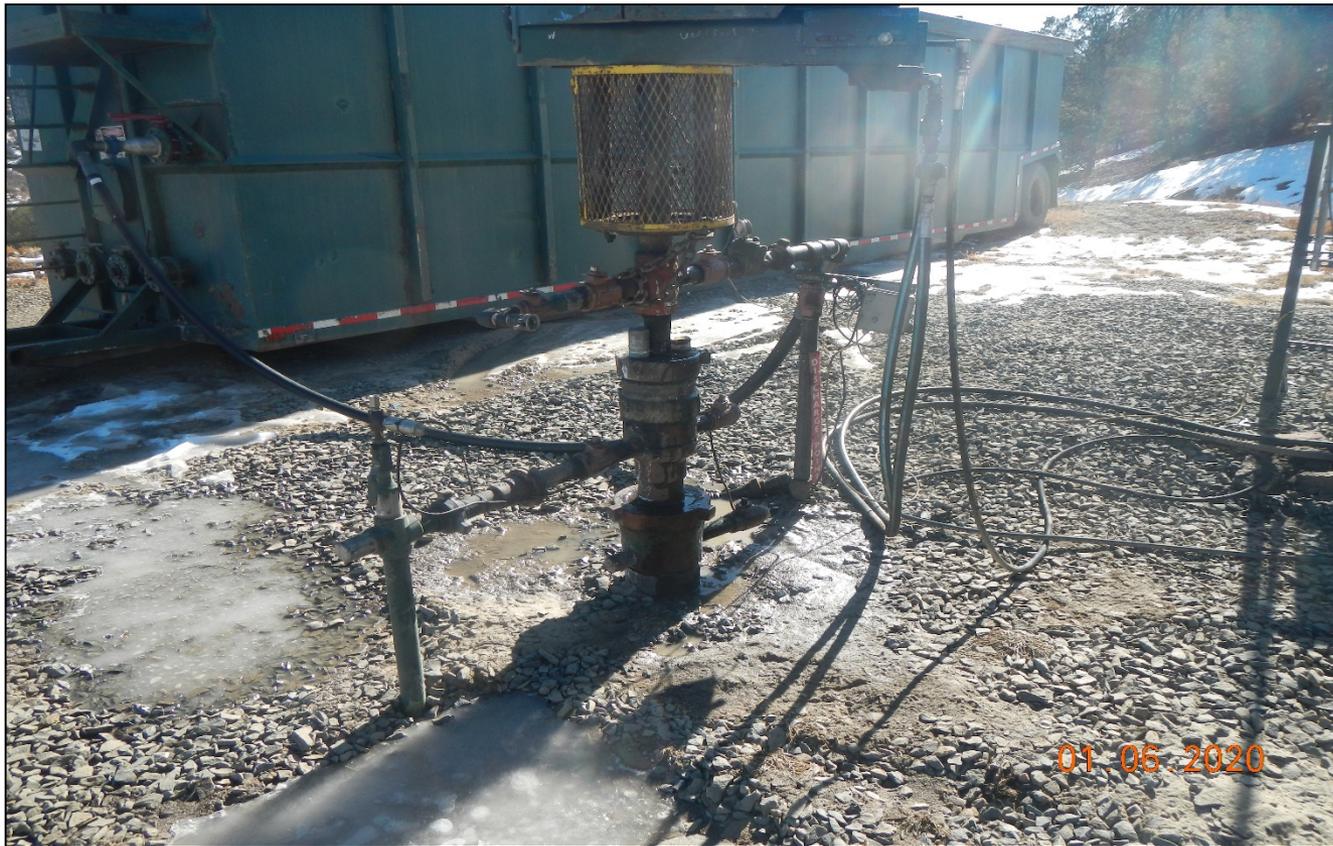
Photo 4. There is a dripping water leak at the wellhead.

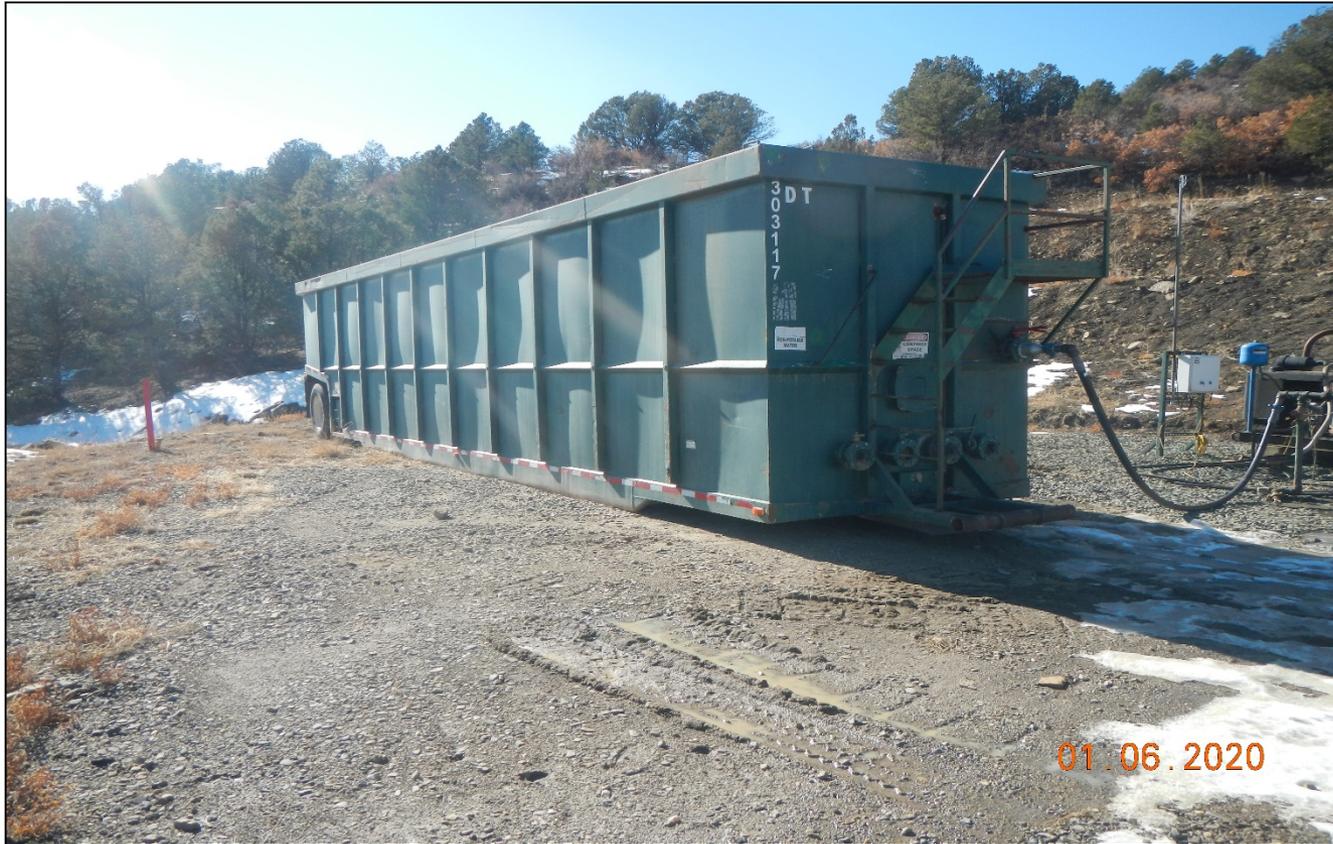
Photo 5. The tank at the location does not have secondary containment or proper labeling.

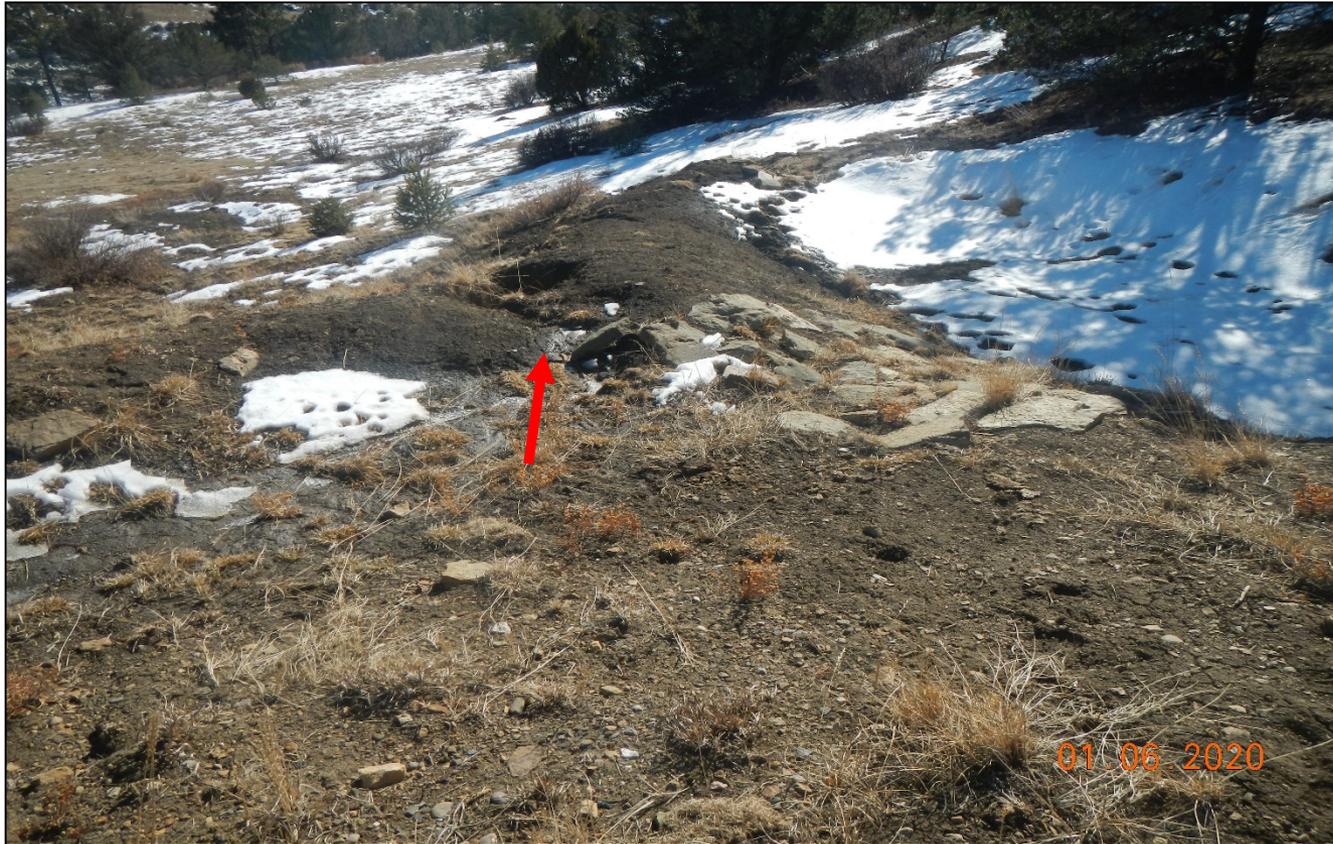
Photo 6. An erosion channel has developed which is preventing stormwater from entering the sediment trap. This is located at the south side of the location.

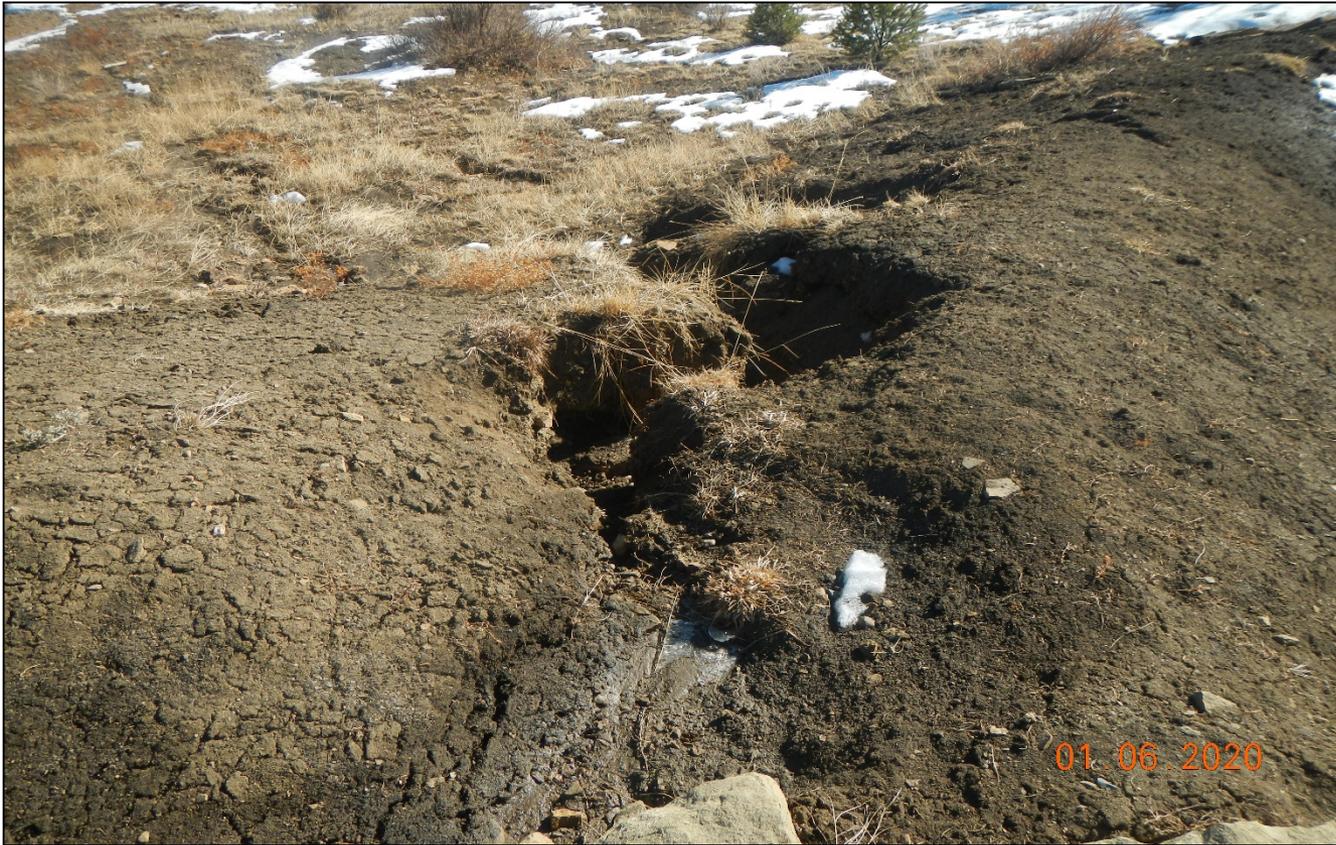
Photo 6. Erosion channel shown in previous photo.
