Inspection Photos
Operator: BP America
Location/API #: 067-08494
Date: 1-6-2020

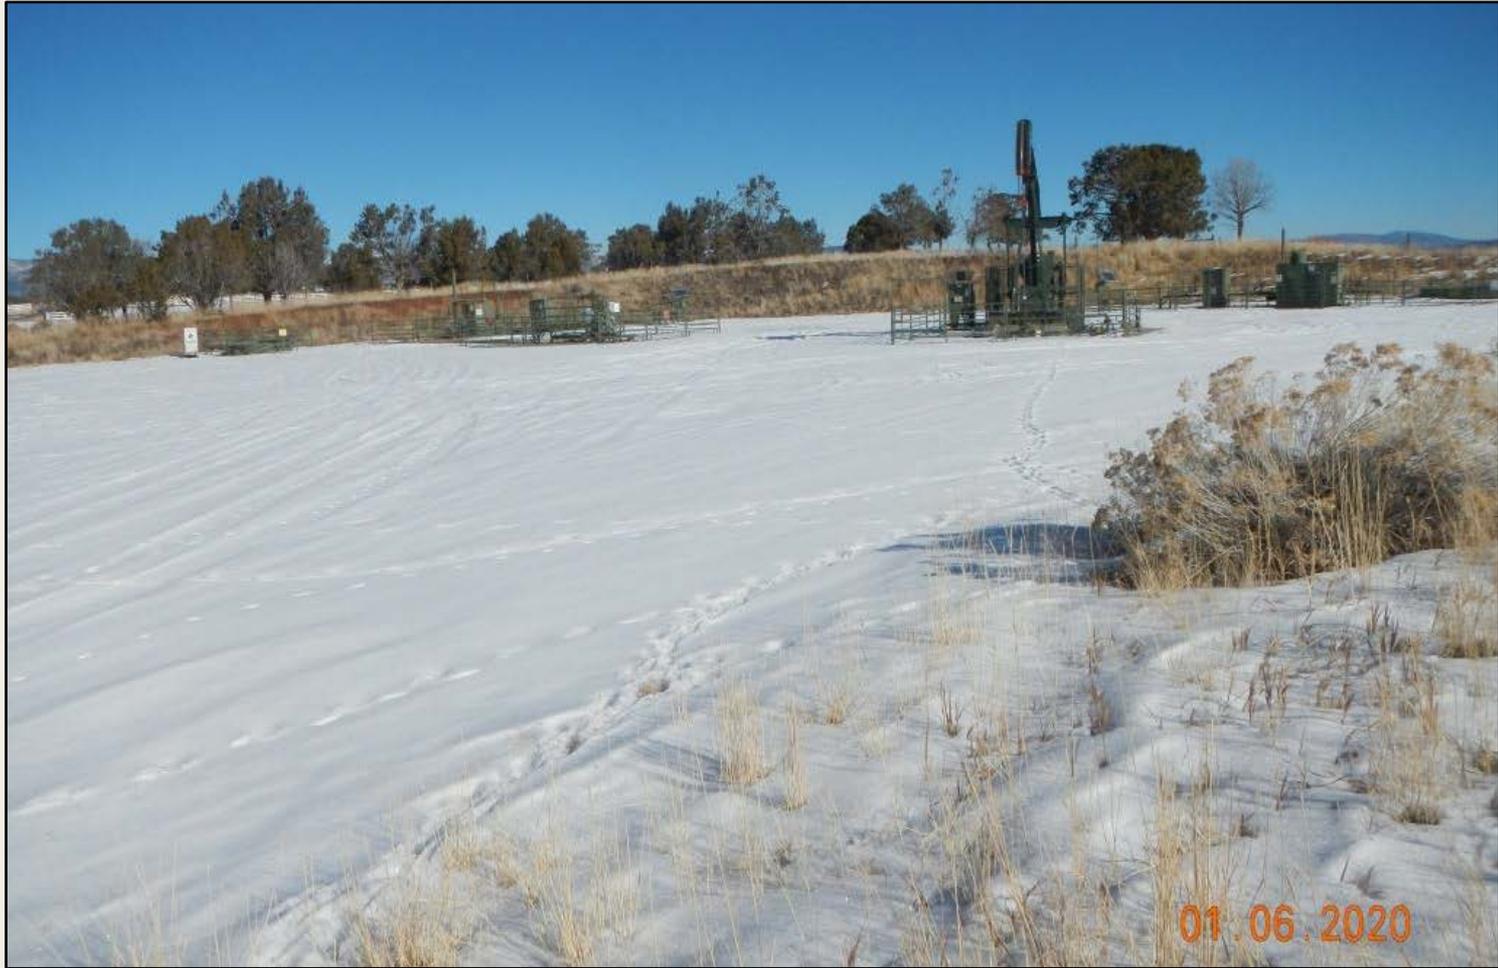
Photo 1. View of the project area from the southwestern corner facing center.

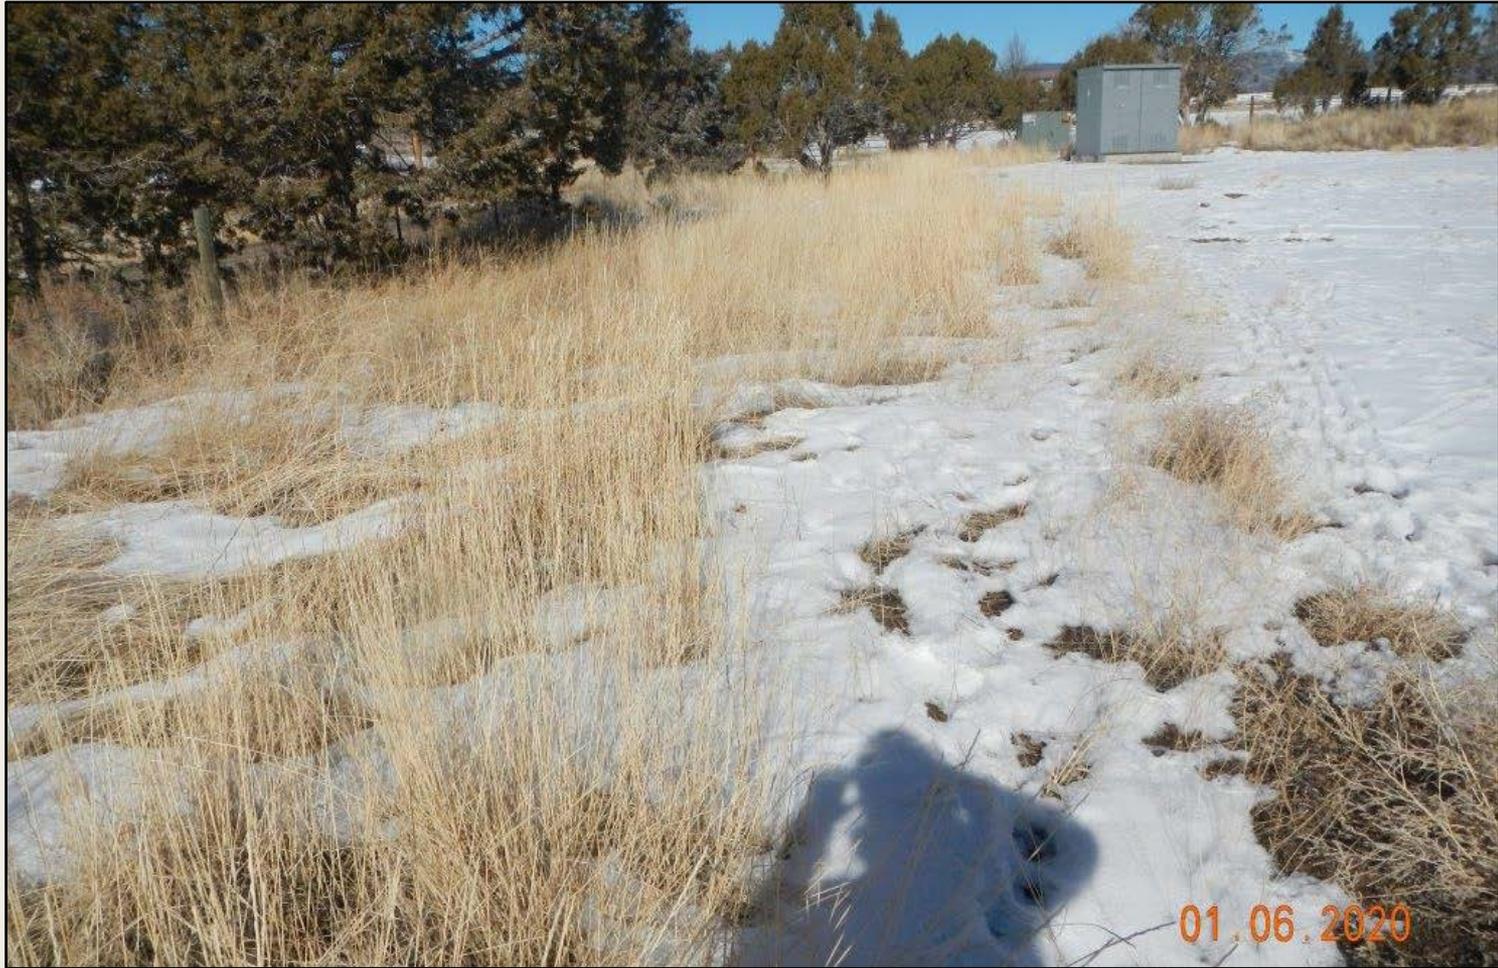
Photo 2. View of the western fill slope from the southwestern corner facing northward. Revegetation appears to be progressing with grasses such as intermediate wheatgrass and smooth brome.

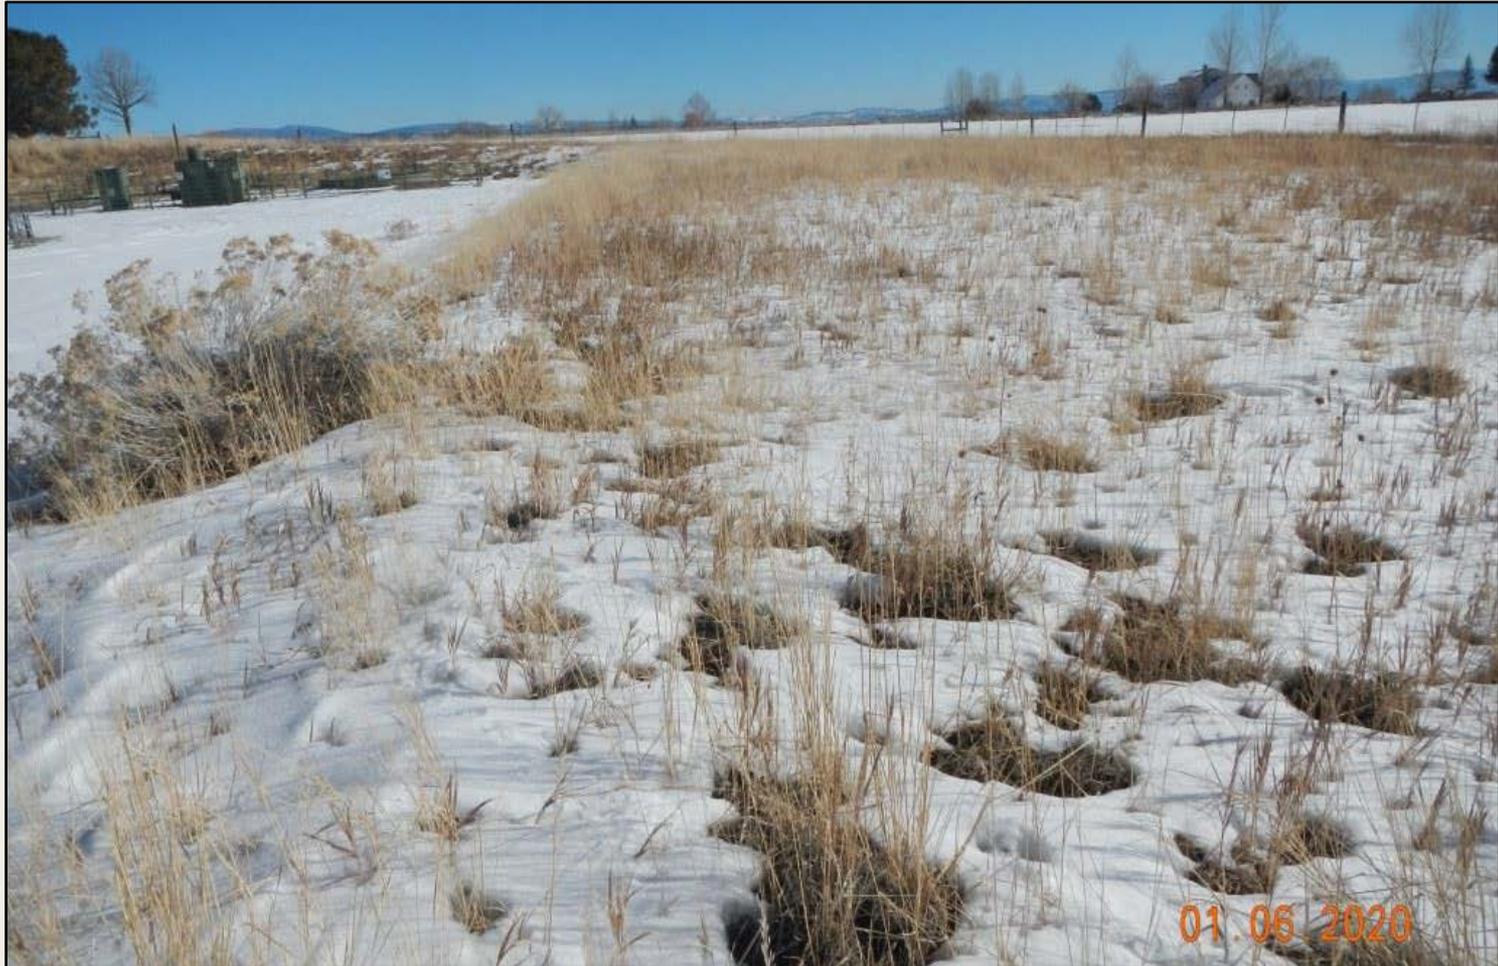
Photo 3. View of the southern project area from the southwestern corner facing eastward.

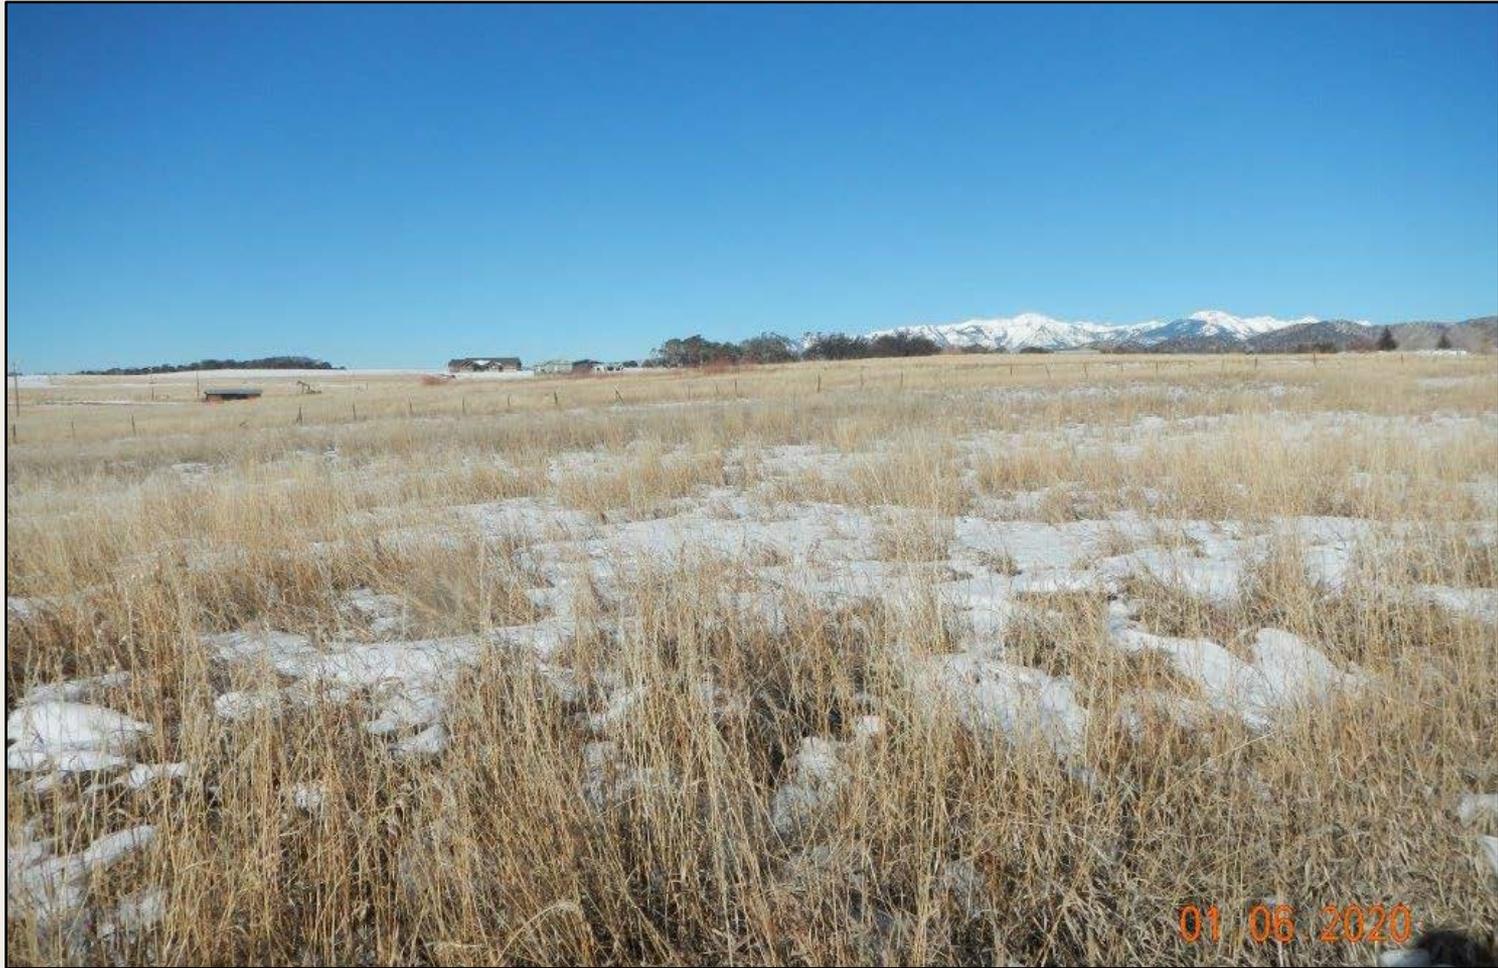
Photo 4. View of reference area, comprised of irrigated grass field largely with smooth brome.
