Inspection Photos
Location Name: Anderson 19-1-10
Location ID: 441824

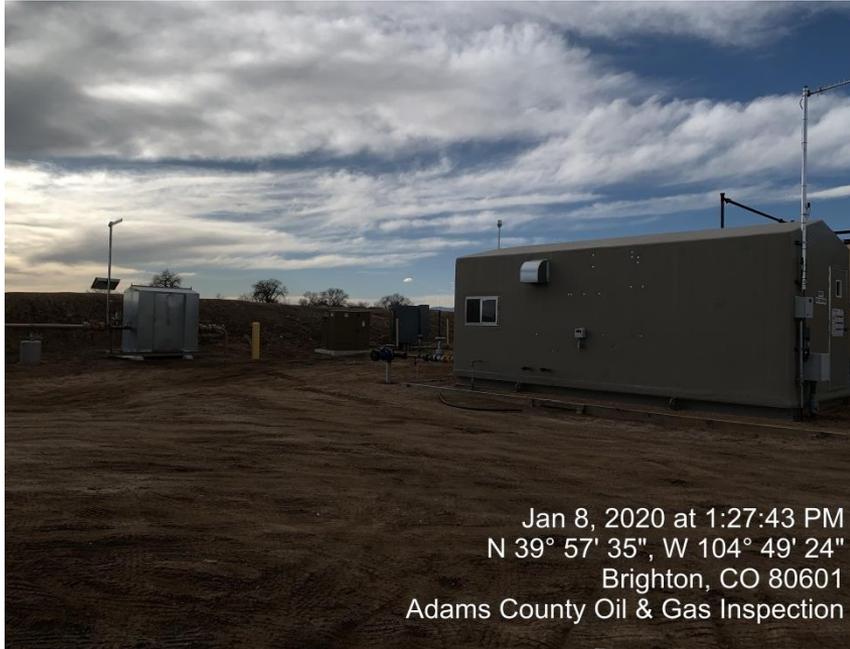
Photo#1 LACT Unit/Gas Meter/(2) Electrical Boxes

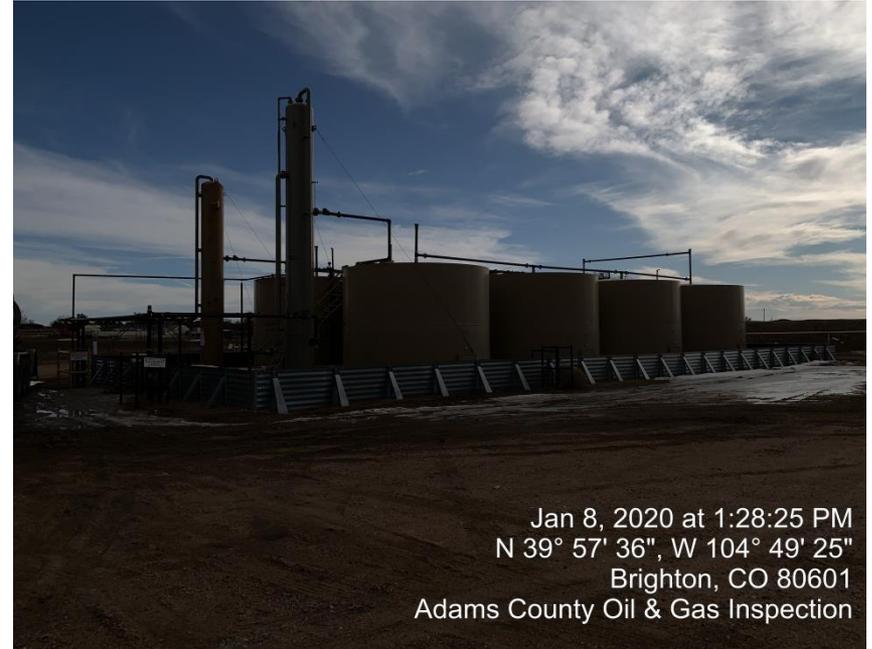
Photo#2 (6)Production Tanks/(2) Produced water tanks/(2)VRTs

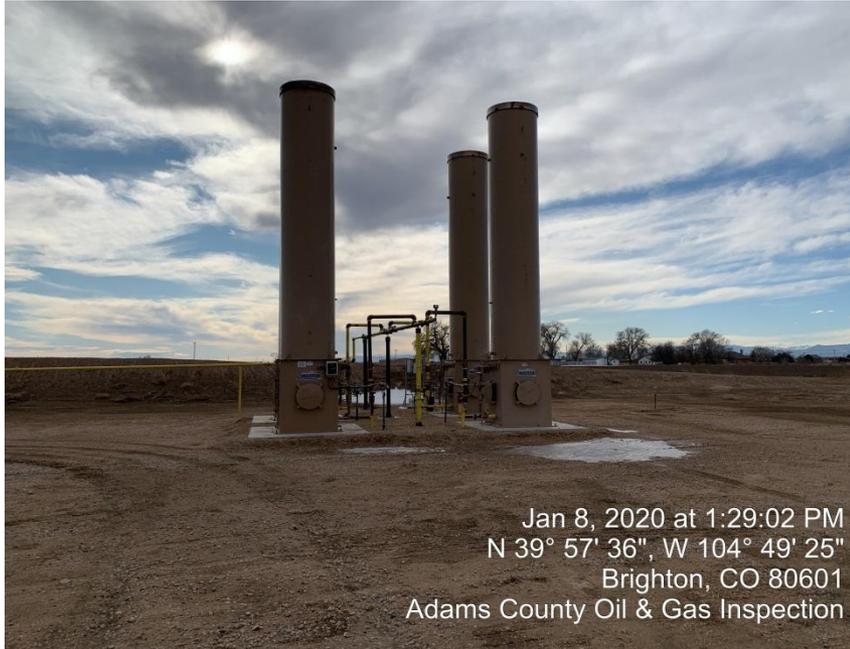
Photo#3 (4) ECDs

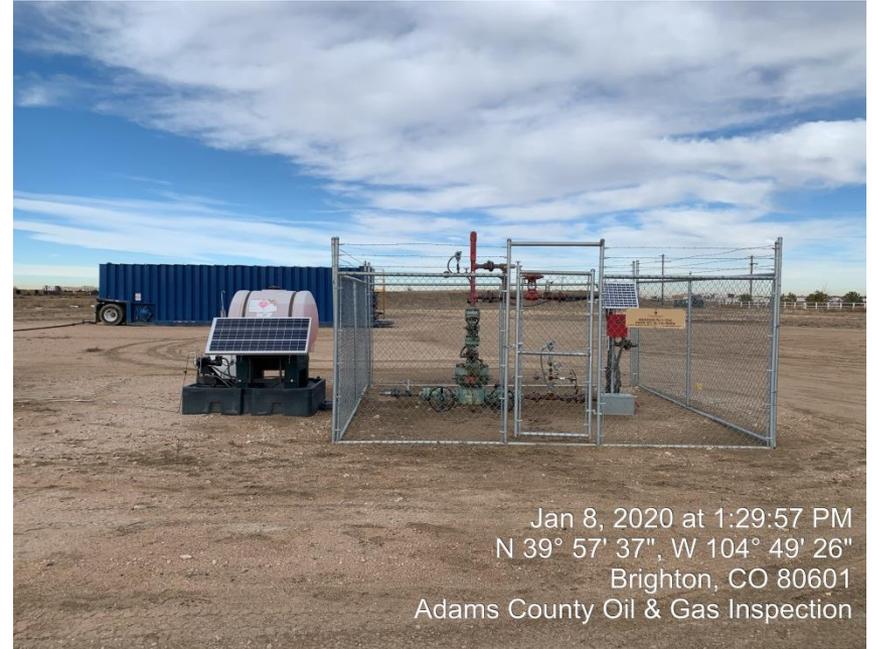
Photo#4 Wellhead/Chem tank OPS 2501V Oil soluble Paraffin Solvent

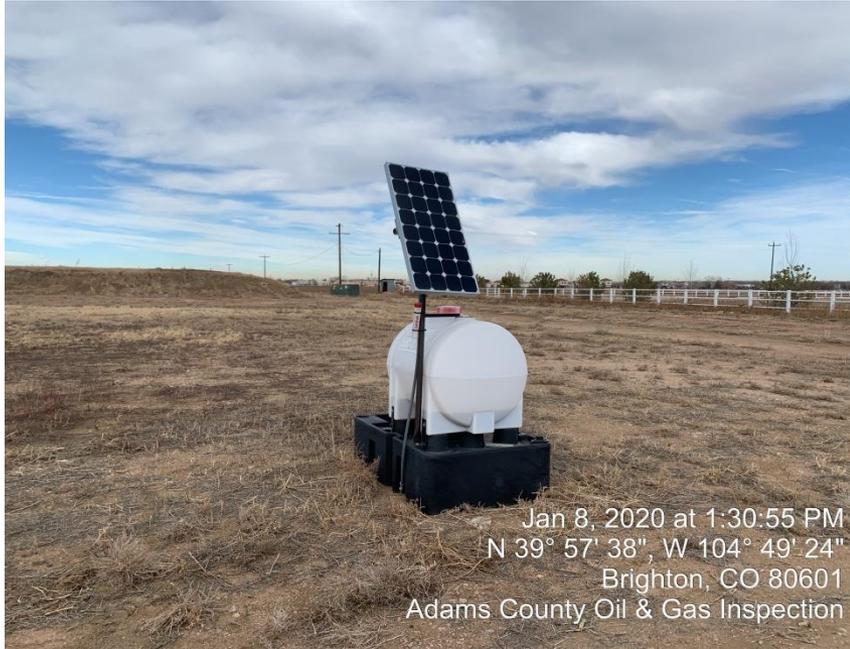
Photo#5 **Unused chemical tank**

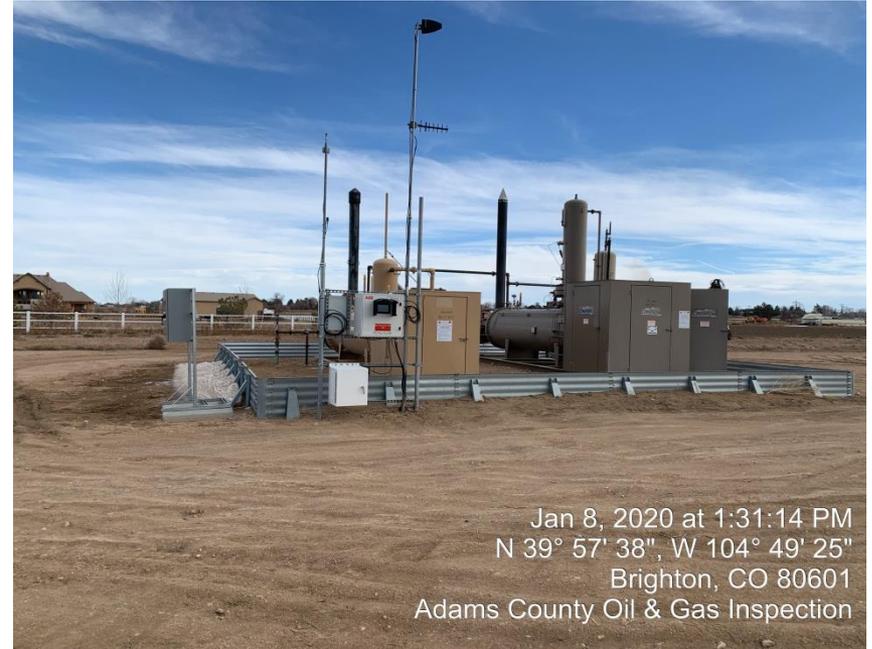
Photo#6 **Automation RTU/(2)Separators**

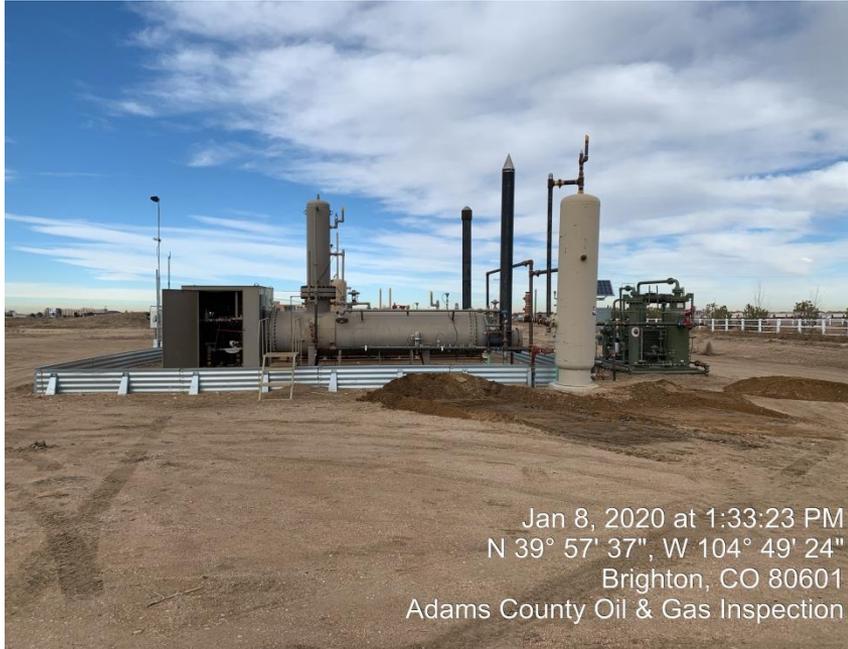
Photo#7 Buffer Tank/VRU

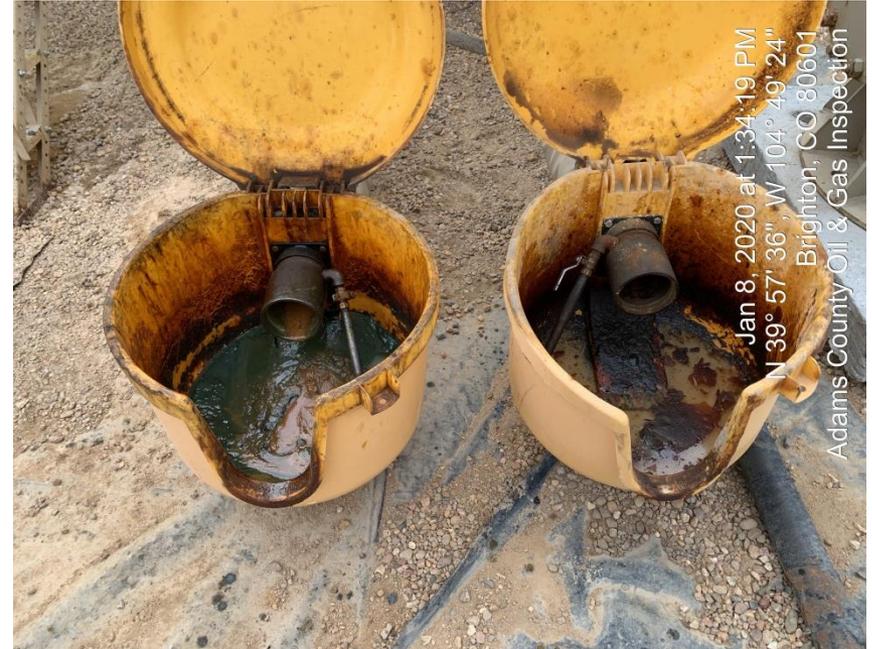
Photo#8 Bullplugs Missing

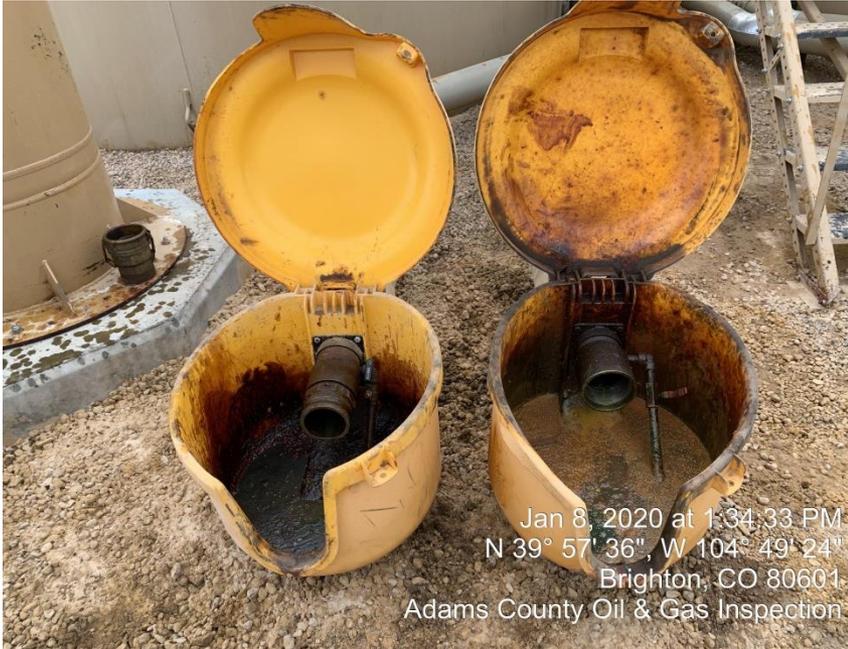
Photo#9 Bullplugs Missing/Right bucket needs emptied out

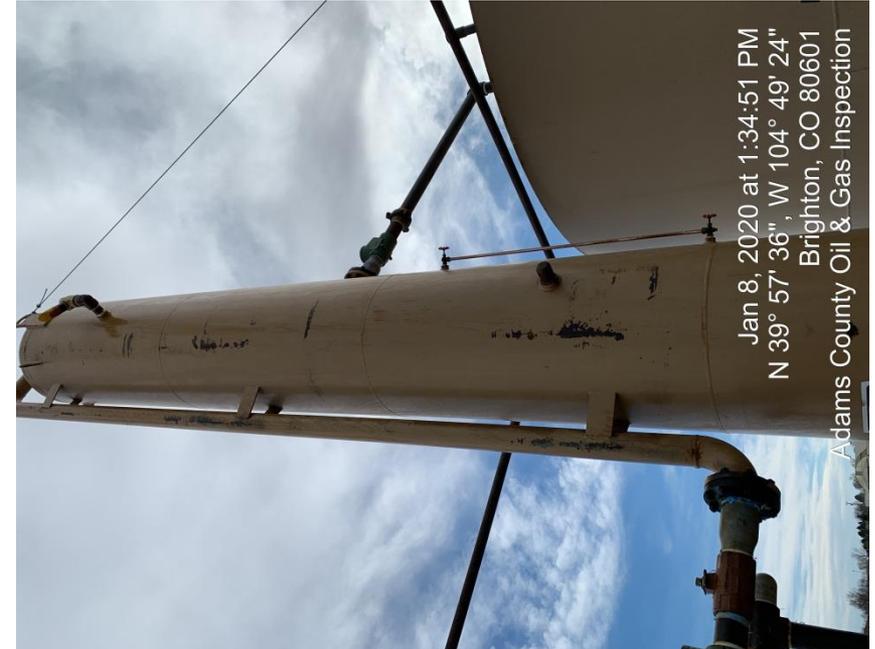
Photo#10 VRT, Leaking from PRV

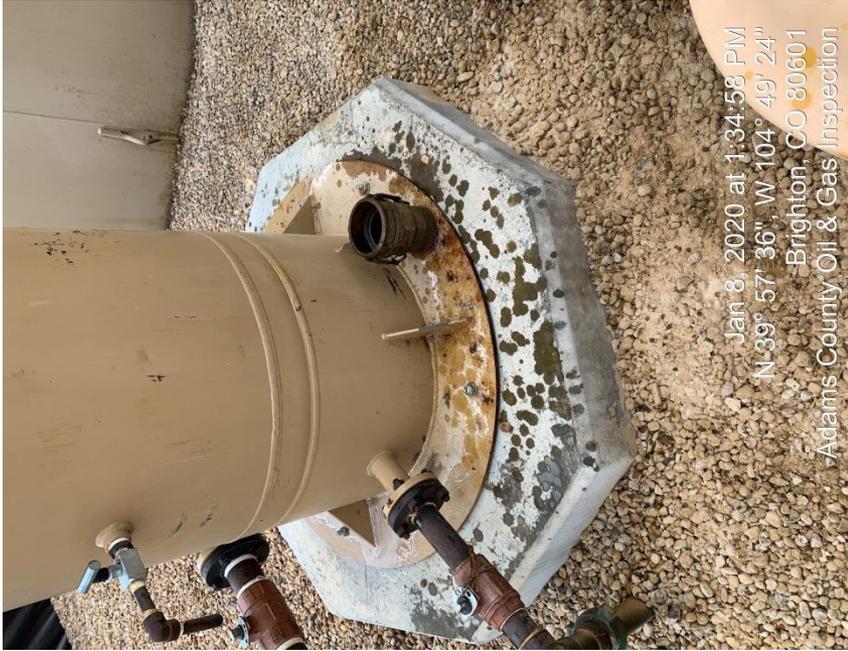
Photo#11 VRT leaking from PRV

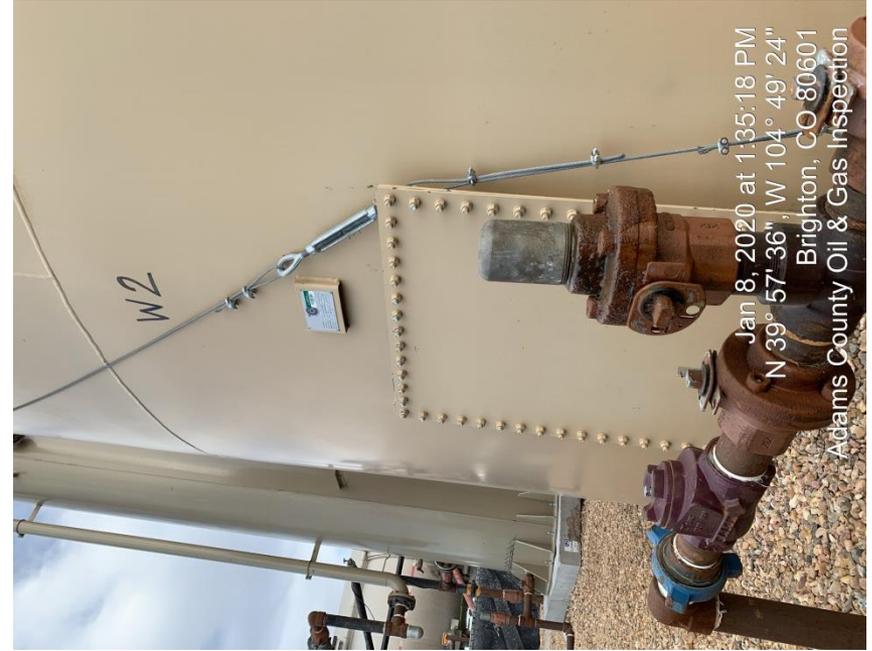
Photo#12 Balon valve leaking

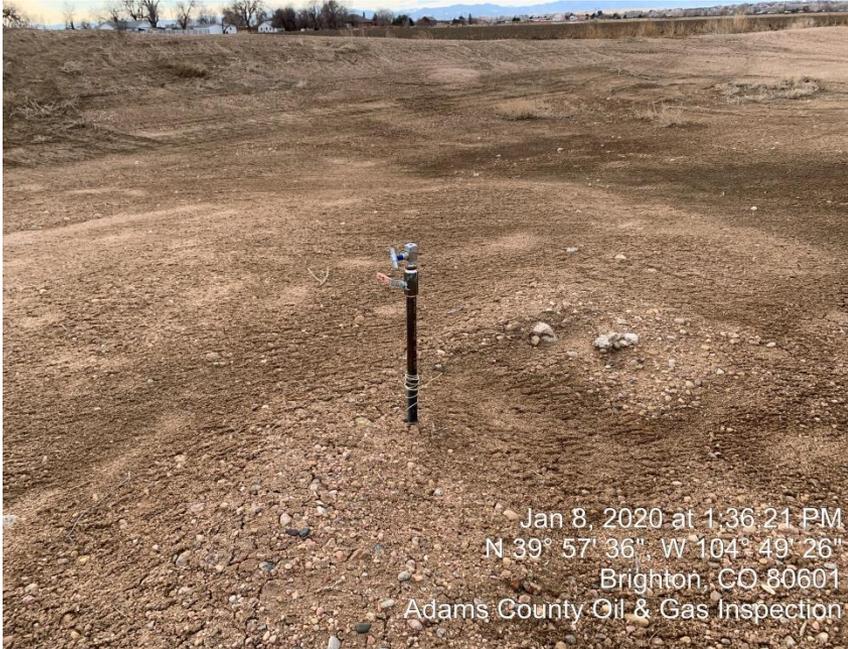
Photo#13 UNMARKED RISER

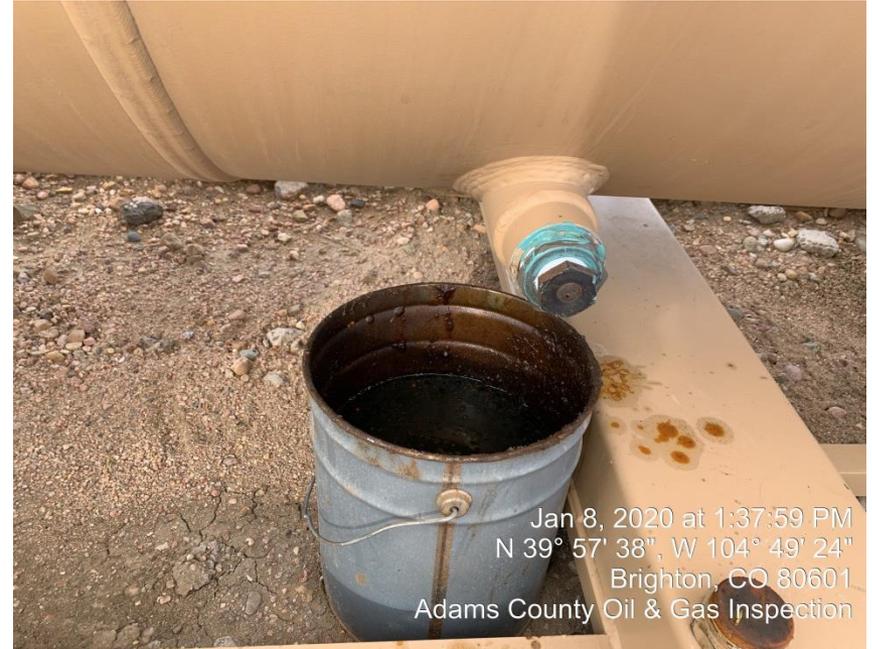
Photo#14 Full bucket sitting next to most north separator
