**Well Name:** EBC 9                      **API #** 05-067-06330  
**Well Name:** EBC 10                   **API #** 05-067-06331  
**Well Name:** Pargin Mtn. Unit 11      **API #** 05-067-06140

**Inspection Number:** 687905509  
**Inspection Number:** 693900926

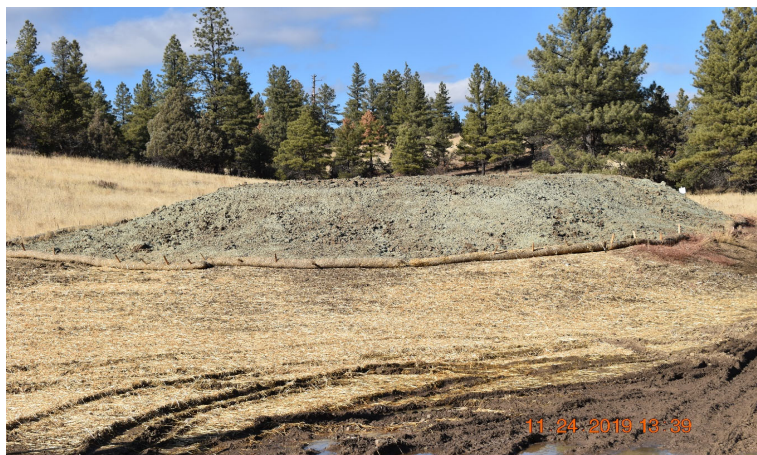
**Corrective Action:** Topsoil appears to be stored in a manner that does not promote microbes (Too Tall). Waddles at base and covered with weeds.

**Corrective Action:** Interim reclamation needs to be conducted during the fall 2019 seeding window. Topsoil that is retained for final reclamation shall be protected using short term and long term stabilization methods, such as use of straw mulch crimped into the soil, stormwater controls, and revegetation. Corrective action is backdated to start of construction date as topsoil protection should be initiated at that time.

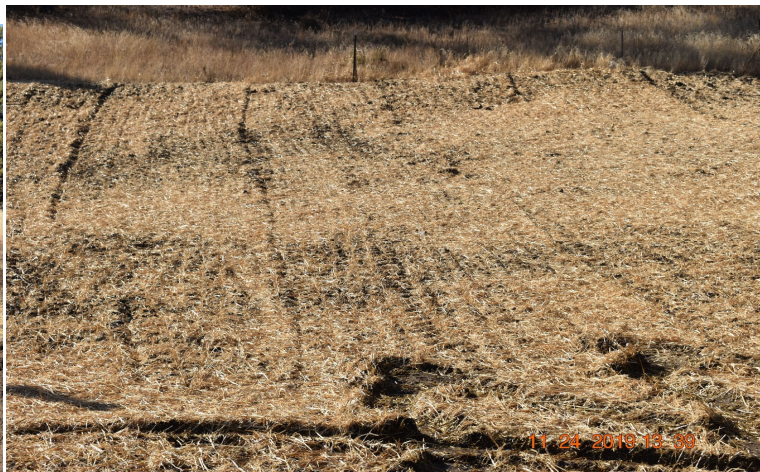
**Corrective Action:** Stormwater flooding is occurring at time of inspection on well pad and stormwater erosion is occurring on western slope of project area.

**Corrective Action:** Install erosion controls along western cut slope to comply with Rule 1002 and COA and best management practices.

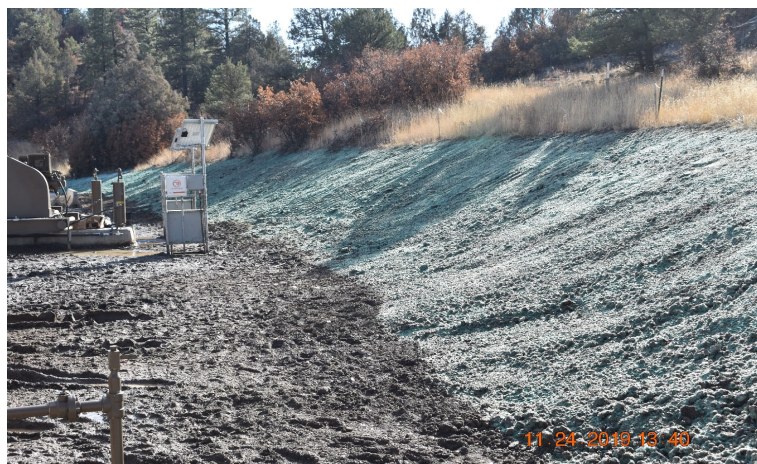
**Corrective Action:** Bare soils on well pad cut-slope need to be stabilized.
