Inspection Photos

Operator: Logos Operating
Location/API #: 067-08119
Date: 1-9-2020

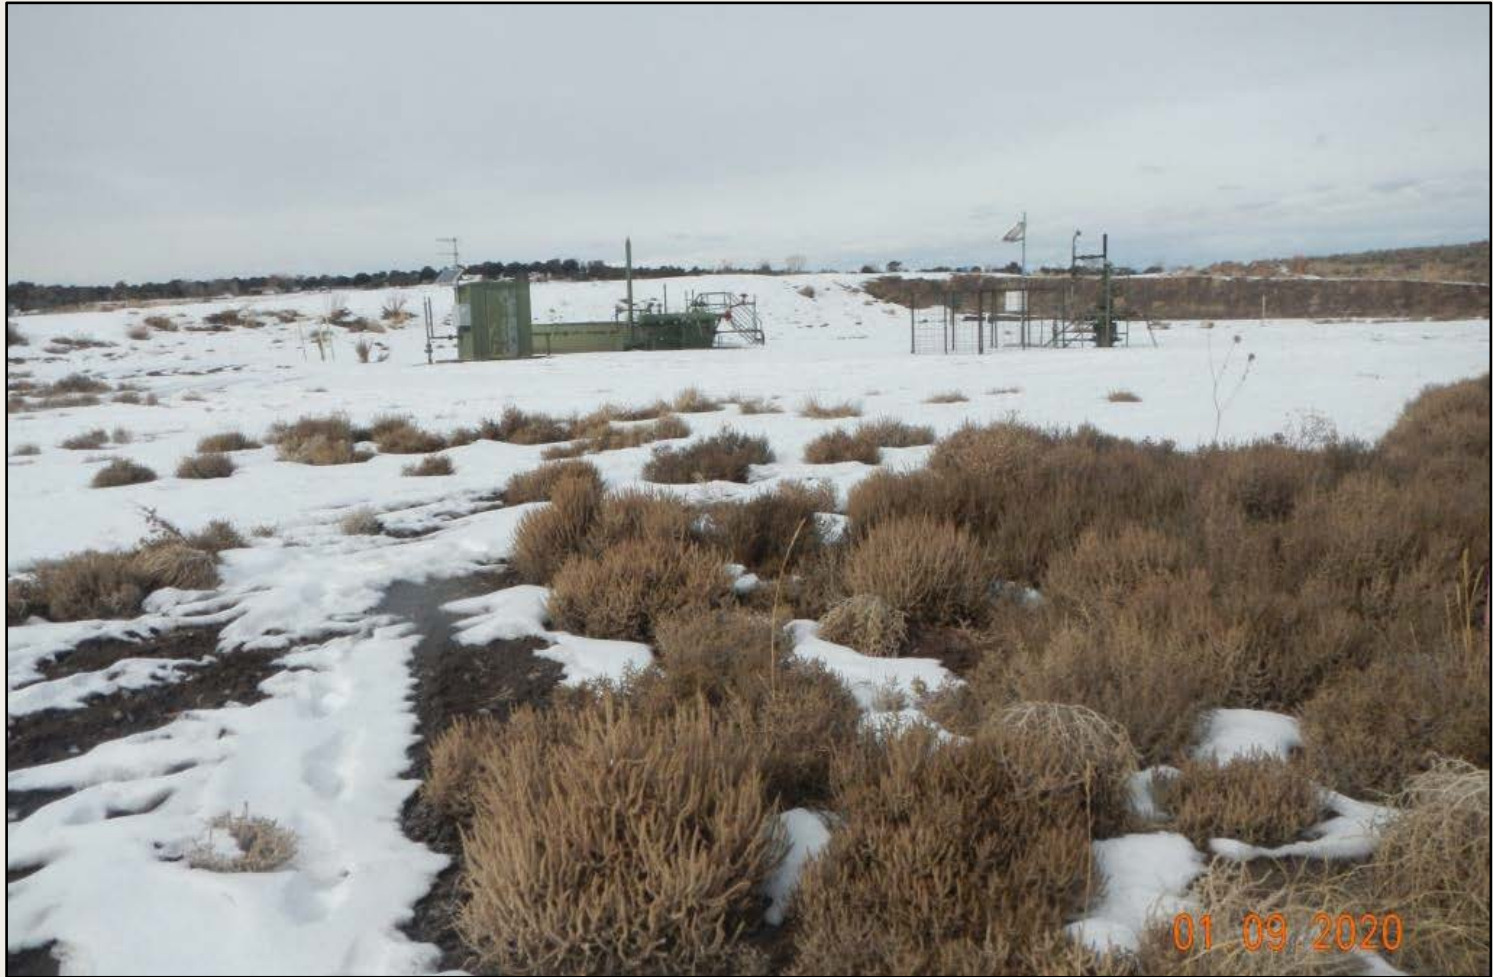
Photo 1. View of the project area from the southeastern corner facing center.

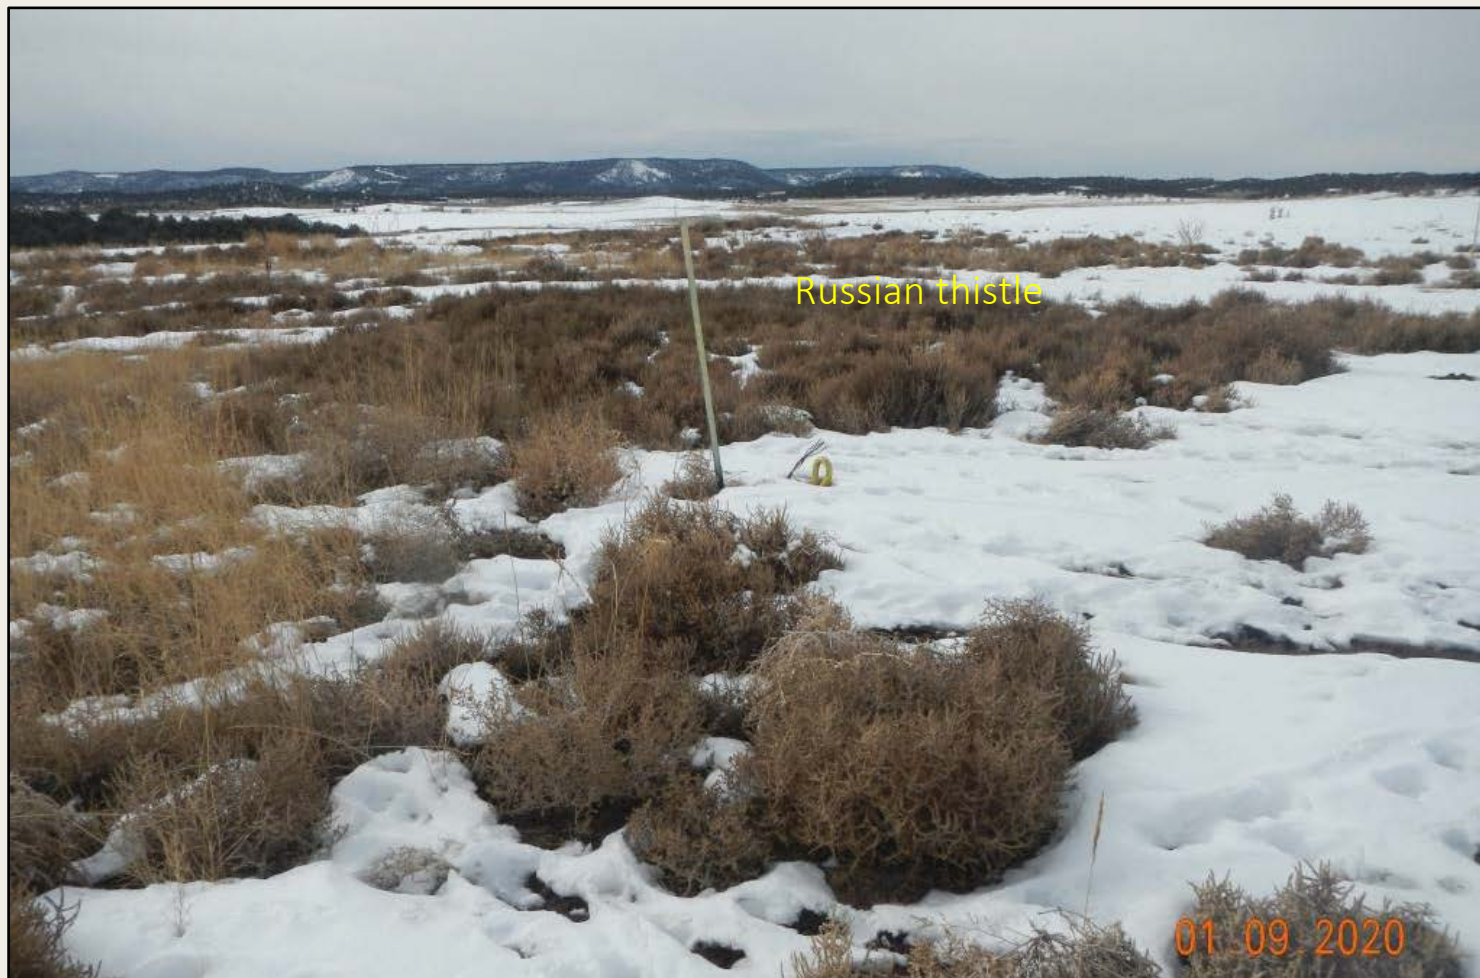
Photo 2. View of the southern project area from the southeastern well road facing westward. Dense Russian thistle debris observed throughout the project area. Perennial grasses such as sand dropseed is present in patches.

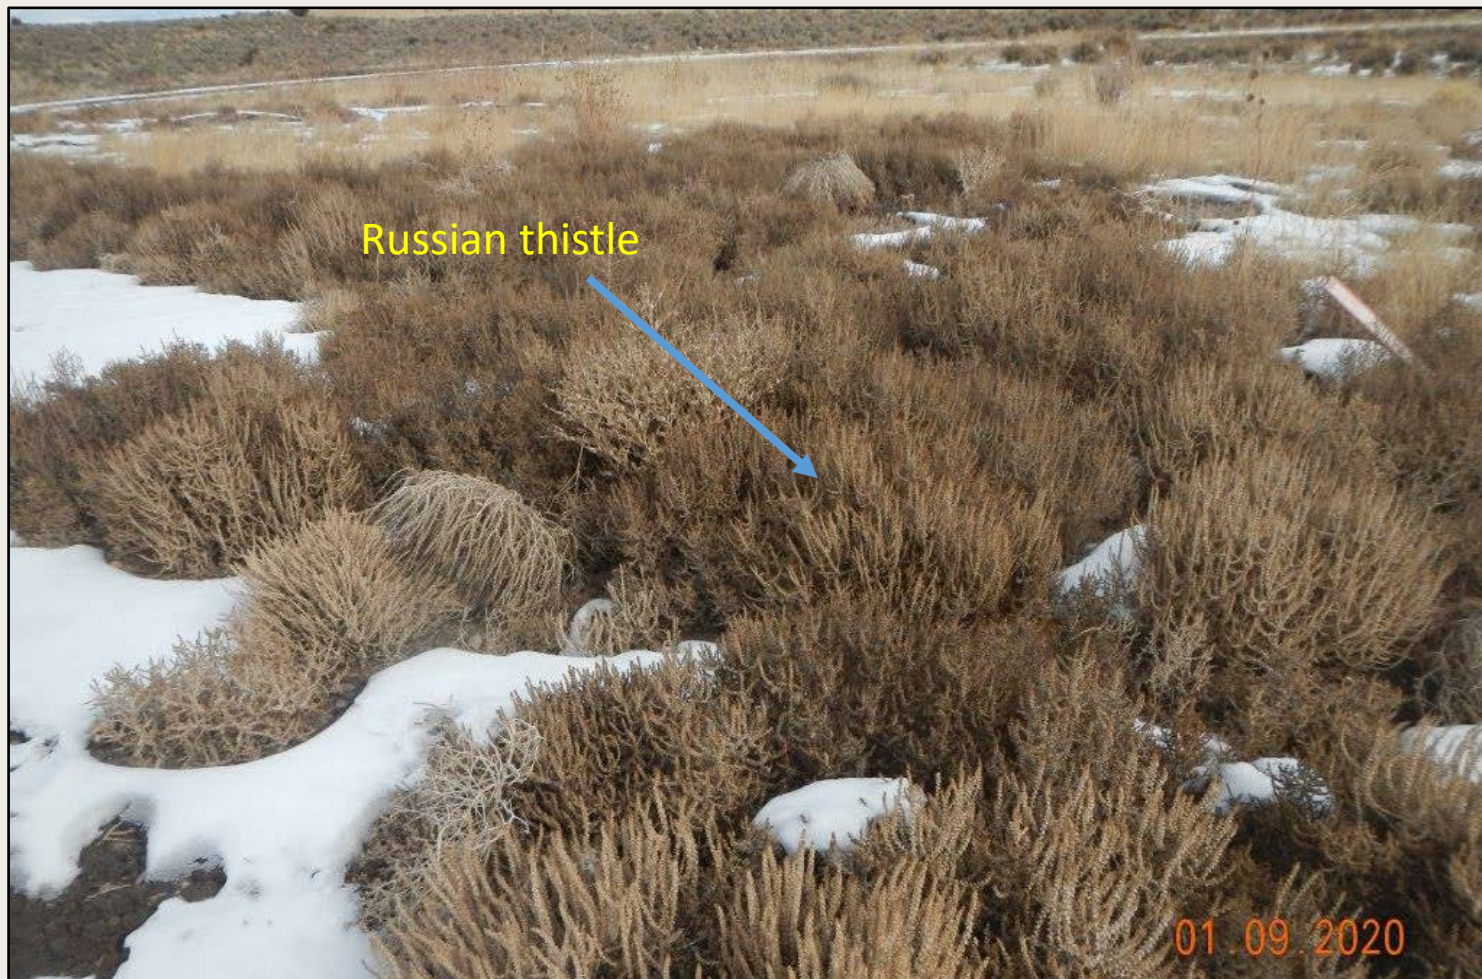
Photo 3. View of the eastern project area from the southeastern edge of the working area facing northward. Dense Russian thistle debris is present.

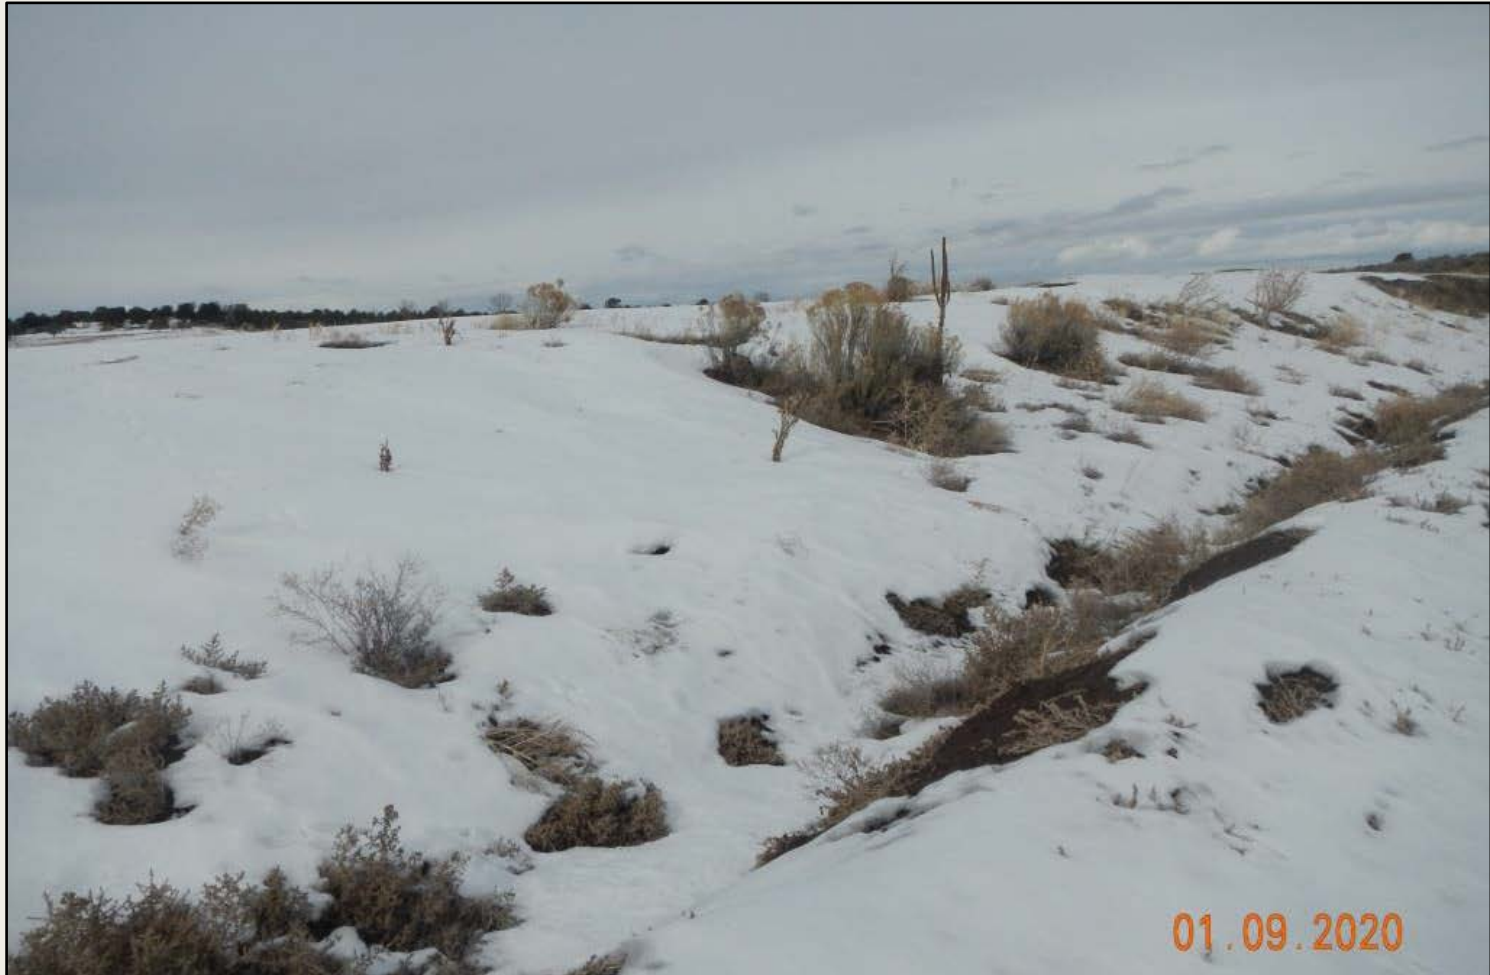
Photo 4. View of the western project area from the southwestern corner facing northward. Area is largely snow covered.

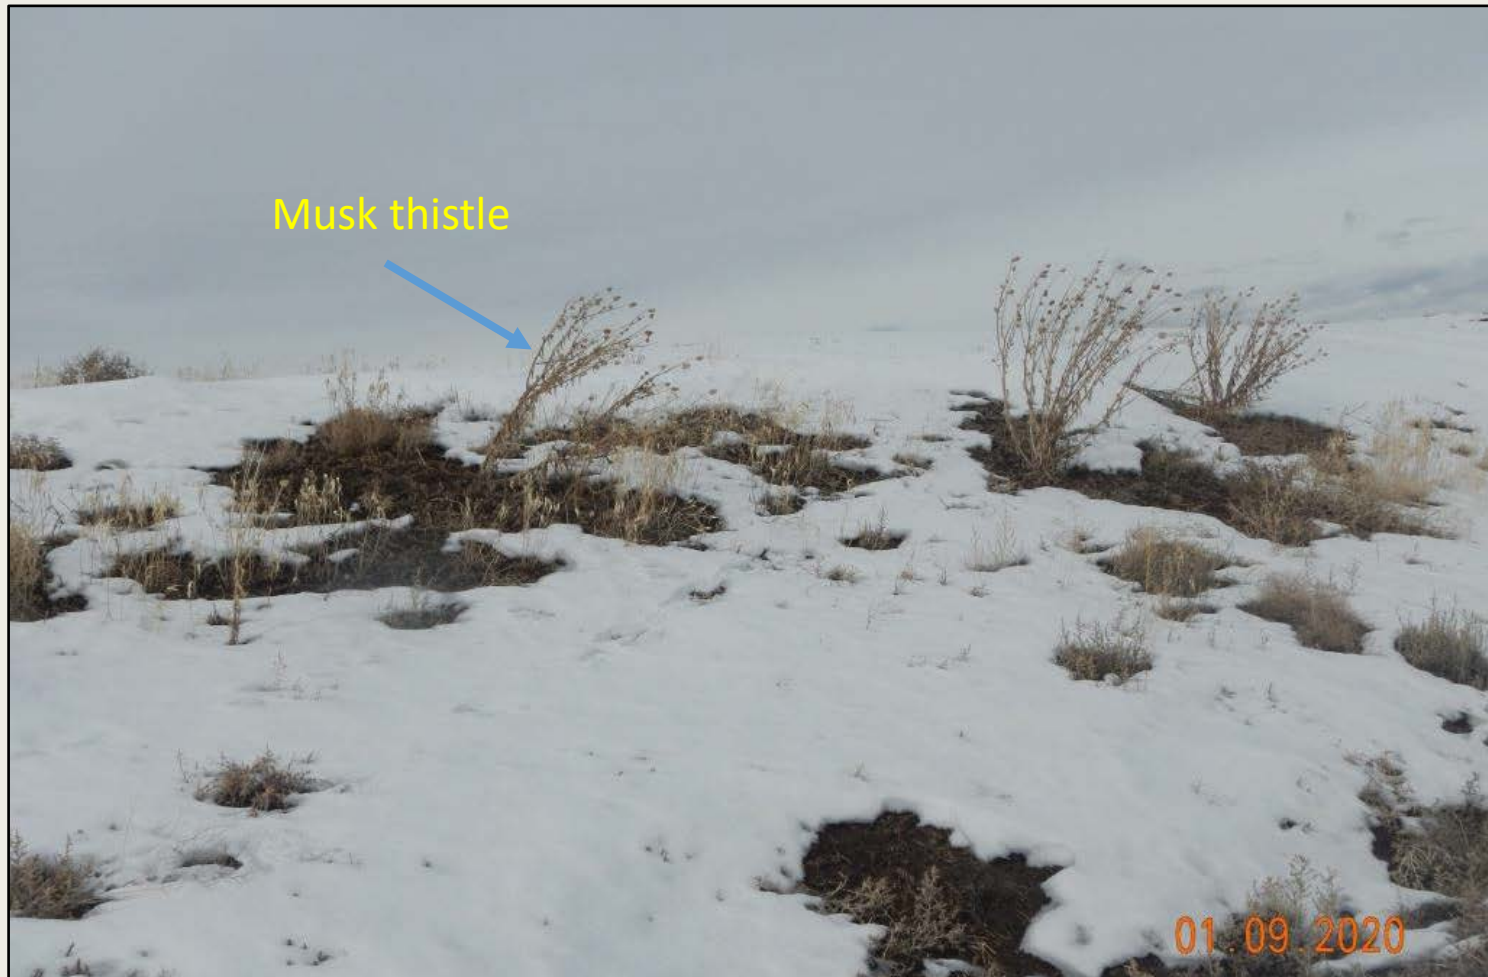
Photo 5. View of musk thistles within the western project area. Approximately 100 individuals observed.

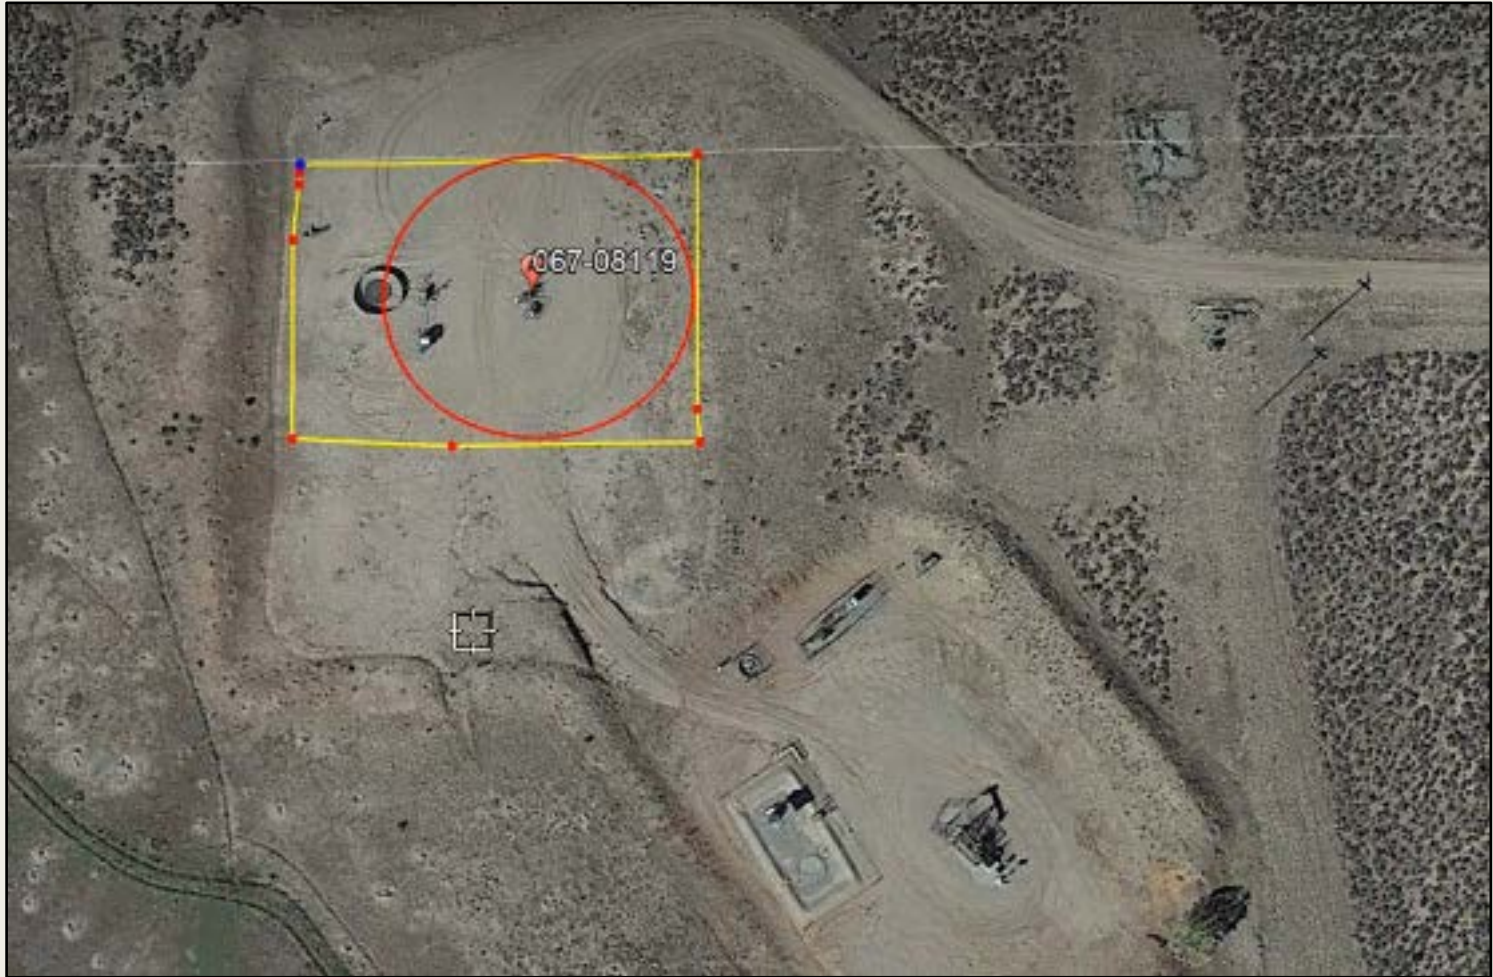
Photo 6. View of area (in yellow box) that appears needed for production operations. Disturbance areas outside of yellow box (other than active roads) need reclamation per the 1003 reclamation rules.

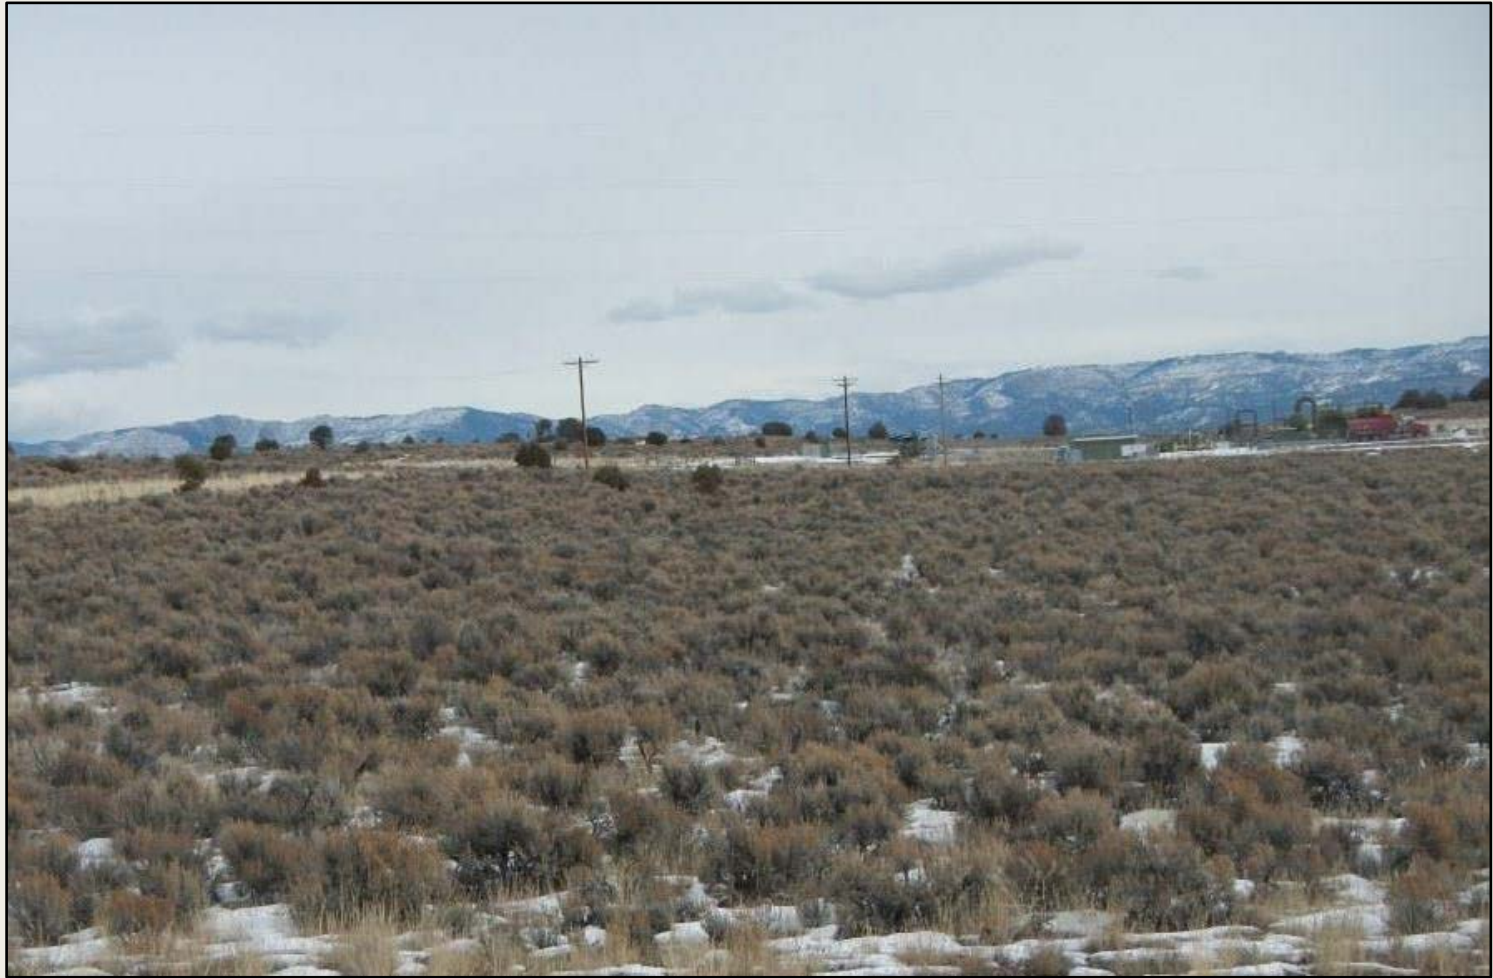
Photo 7. View of reference area, comprised of sagebrush shrubland.
