Inspection Photos

Location Name: CAERUS PICEANCE LLC Stewart /36-13H (PL36SW),

Location ID: 418660

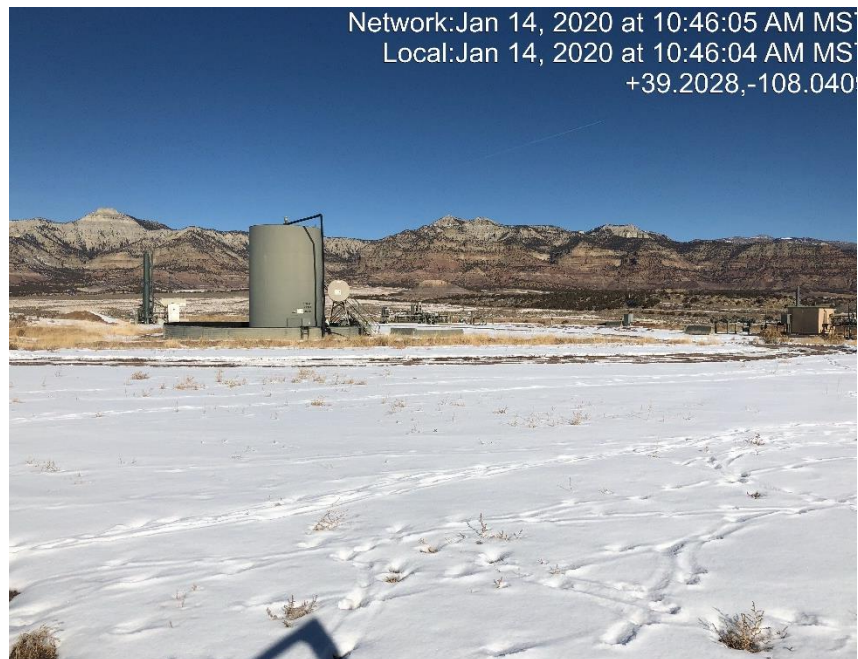
Photo #0395 photo from SW corner of location.

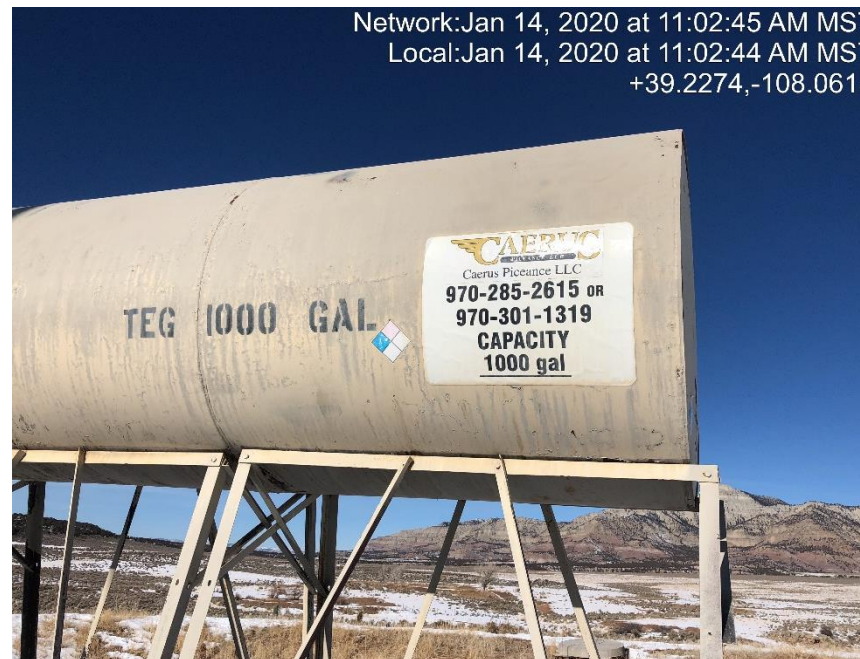
Photo #0396 NFPA label weathered and not legible.

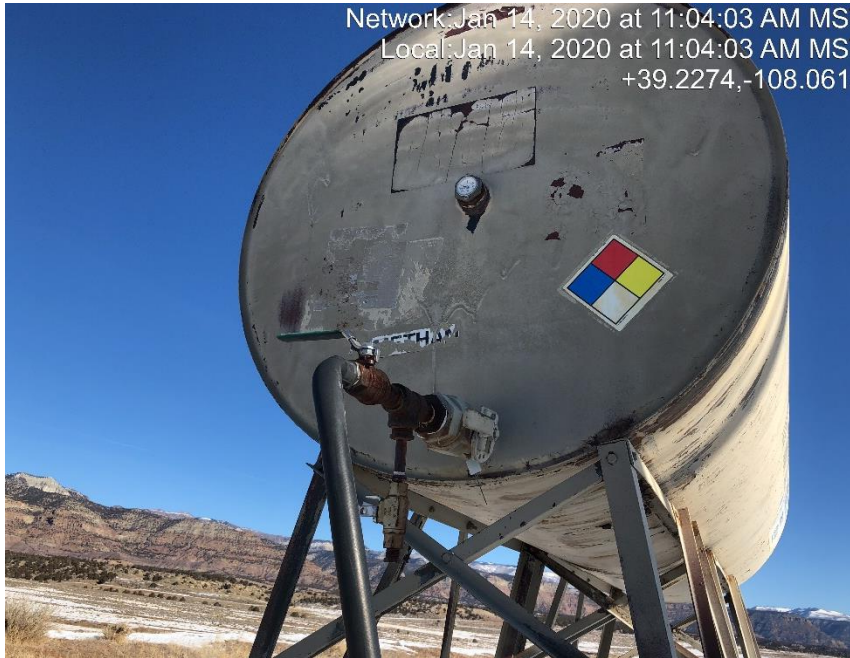
Photo #0398 contents label weathered and not legible

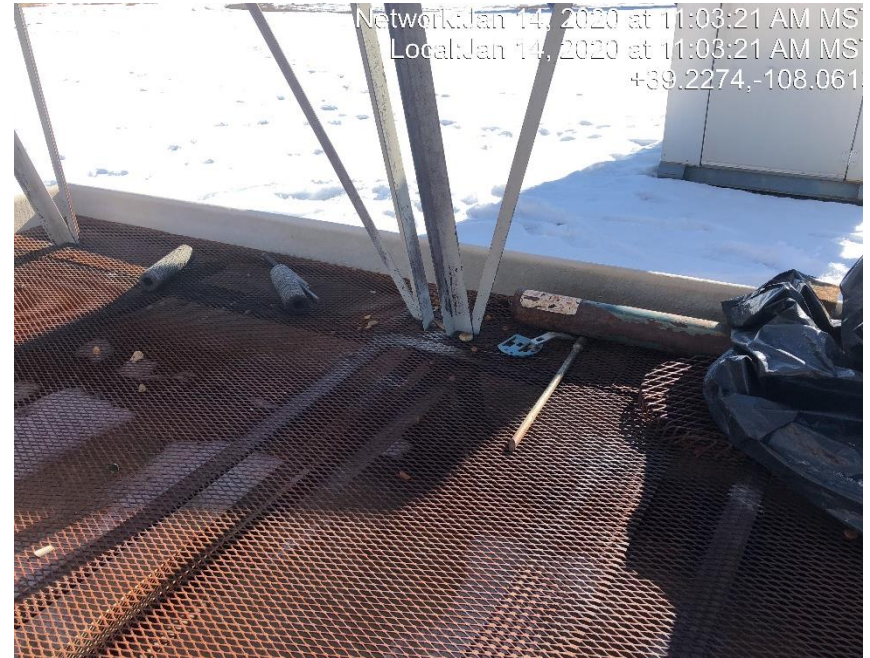
Photo #0397 Unused equipment and debris in 1000 gallon tank containment.

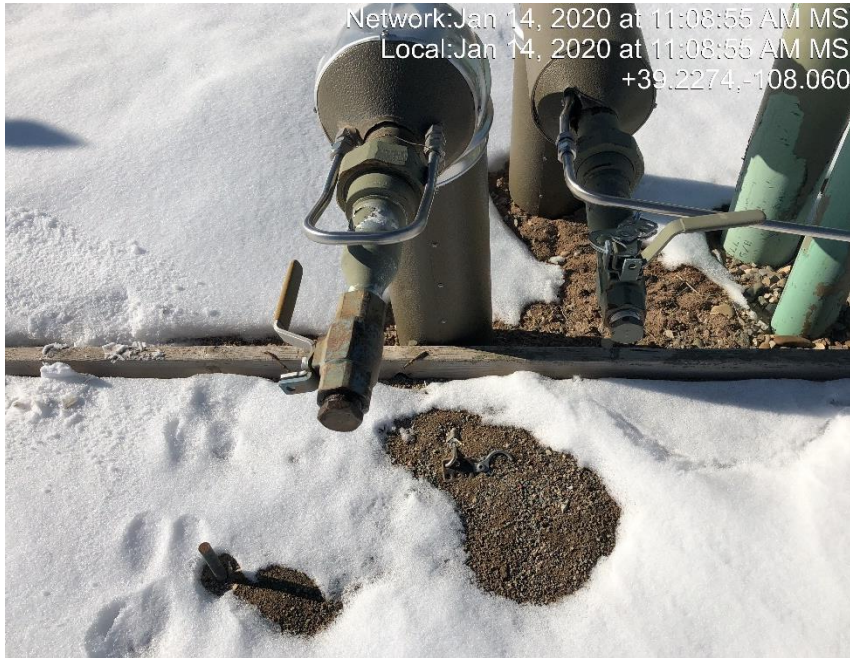
Photo #0399 Flowline riser not LO/TO.
