Construction and Stormwater Inspection

January 10, 2020

Operator: CONFLUENCE DJ LLC- #10518

Location ID: 458676

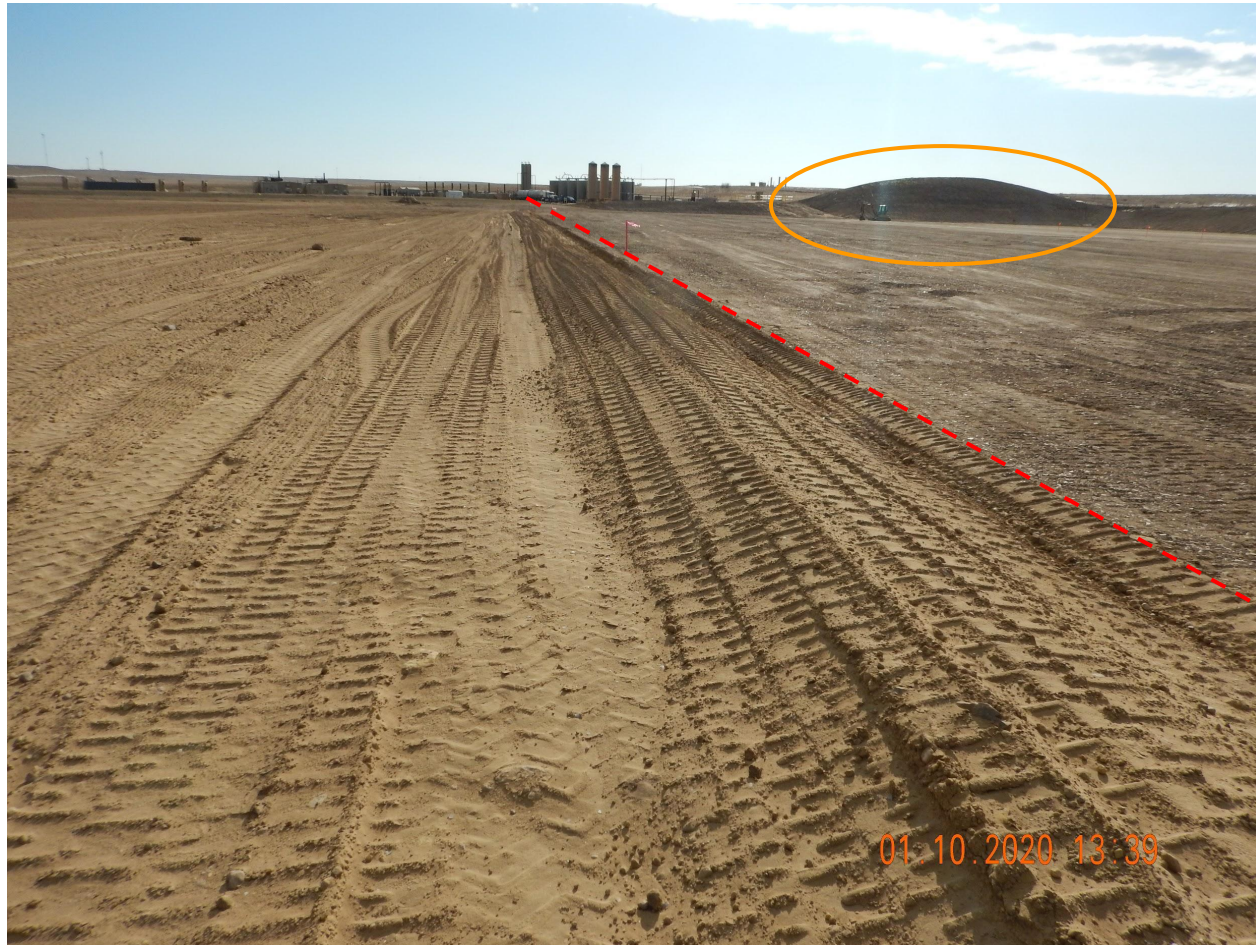
Photo 1. Photo taken from the north-central location, facing South. Photo illustrates the western portion of the location has been stabilized with gravel while the eastern portion has been left unconsolidated. Soil particle deposition from wind erosion is apparent. Also, topsoil has been salvaged and stored along the southwestern perimeter of location.

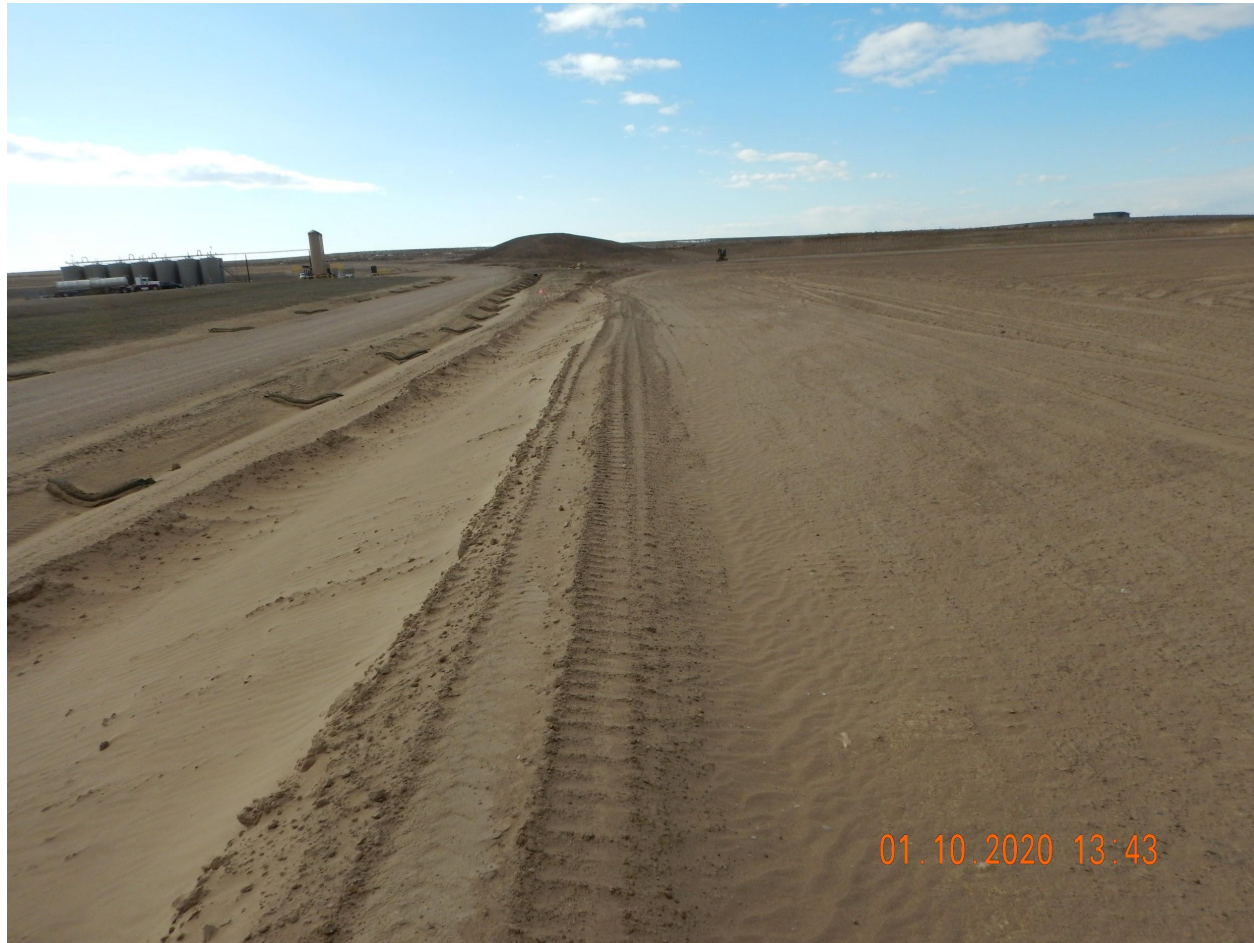
Photo 2. Photo taken from the southeastern location, facing West. Photo illustrates soil particle deposition from wind erosion along the fill slopes, filling up the ditch BMP, and off location.

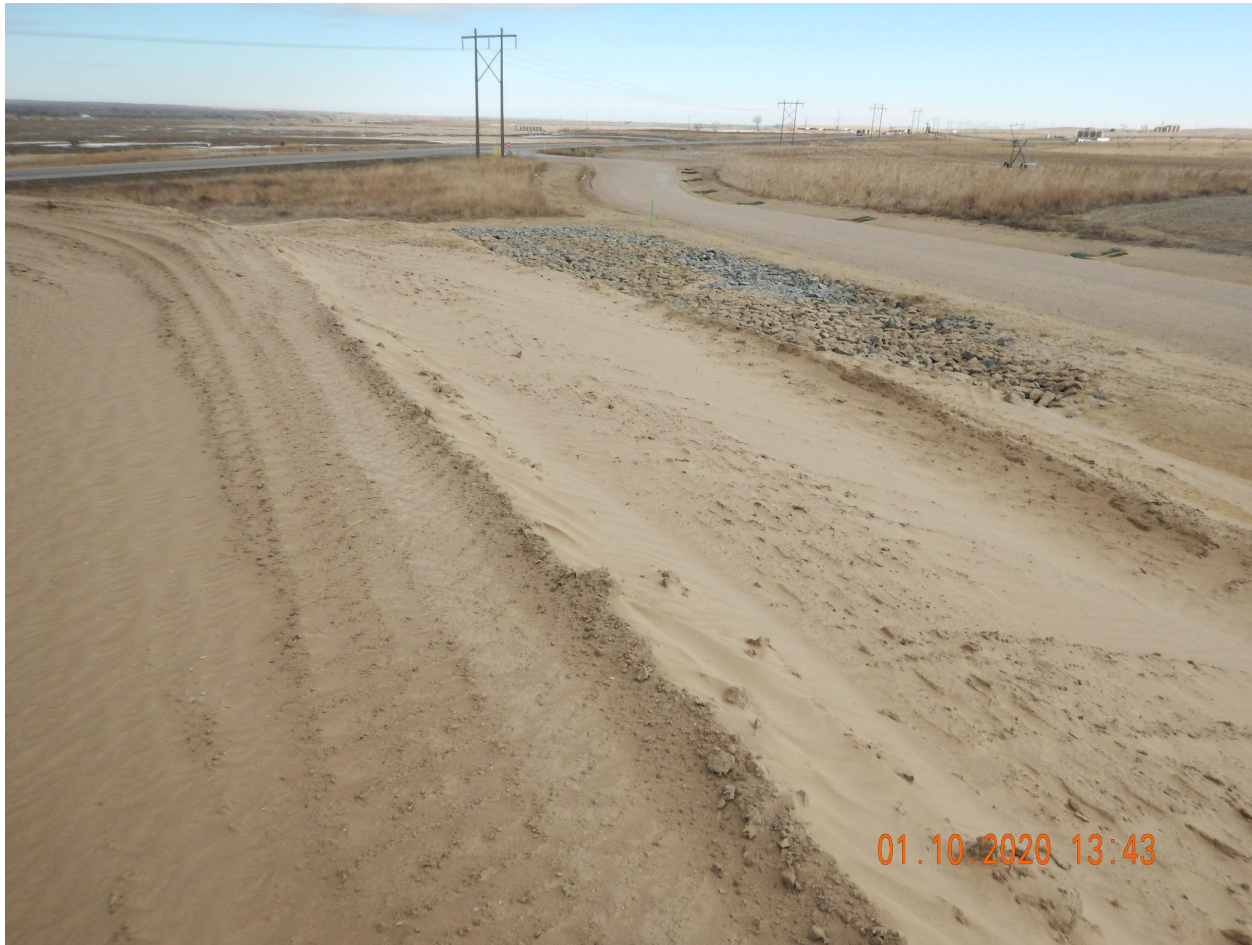
Photo 3. Photo taken from the southeastern location, facing East. See comments under Photo 2 regarding soil particle deposition from wind erosion.

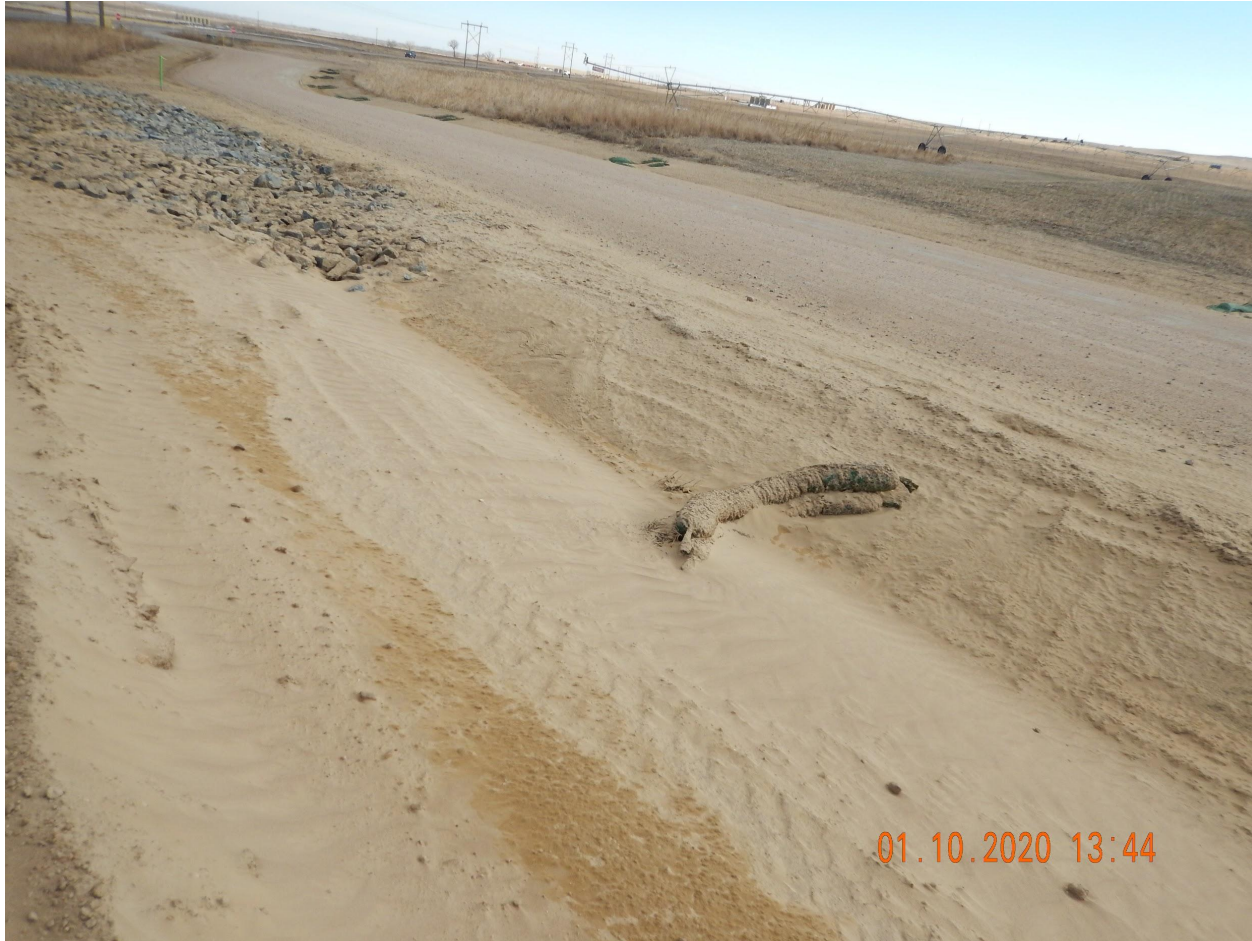
Photo 4. Photo taken from the southeastern location, facing East. See comments under Photo 2 regarding soil particle deposition from wind erosion. Note: Tackifier was observed along the southern fill slope but soil particle deposition has accumulated on top of that.

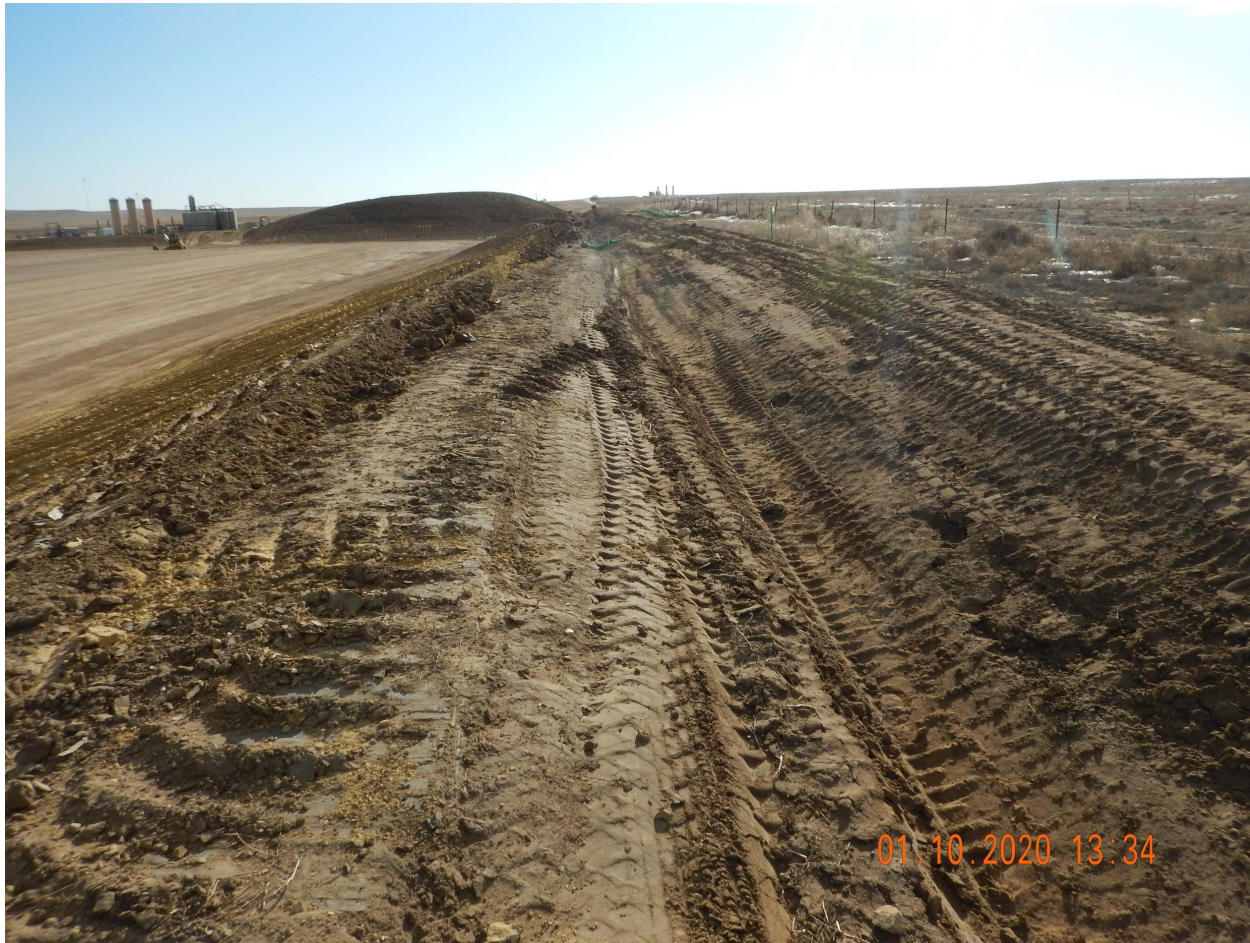
Photo 5. Photo taken from the western perimeter of location, facing South. Photo illustrates a ditch and berm BMP installed in conjunction with sediment traps and wattle check dams.

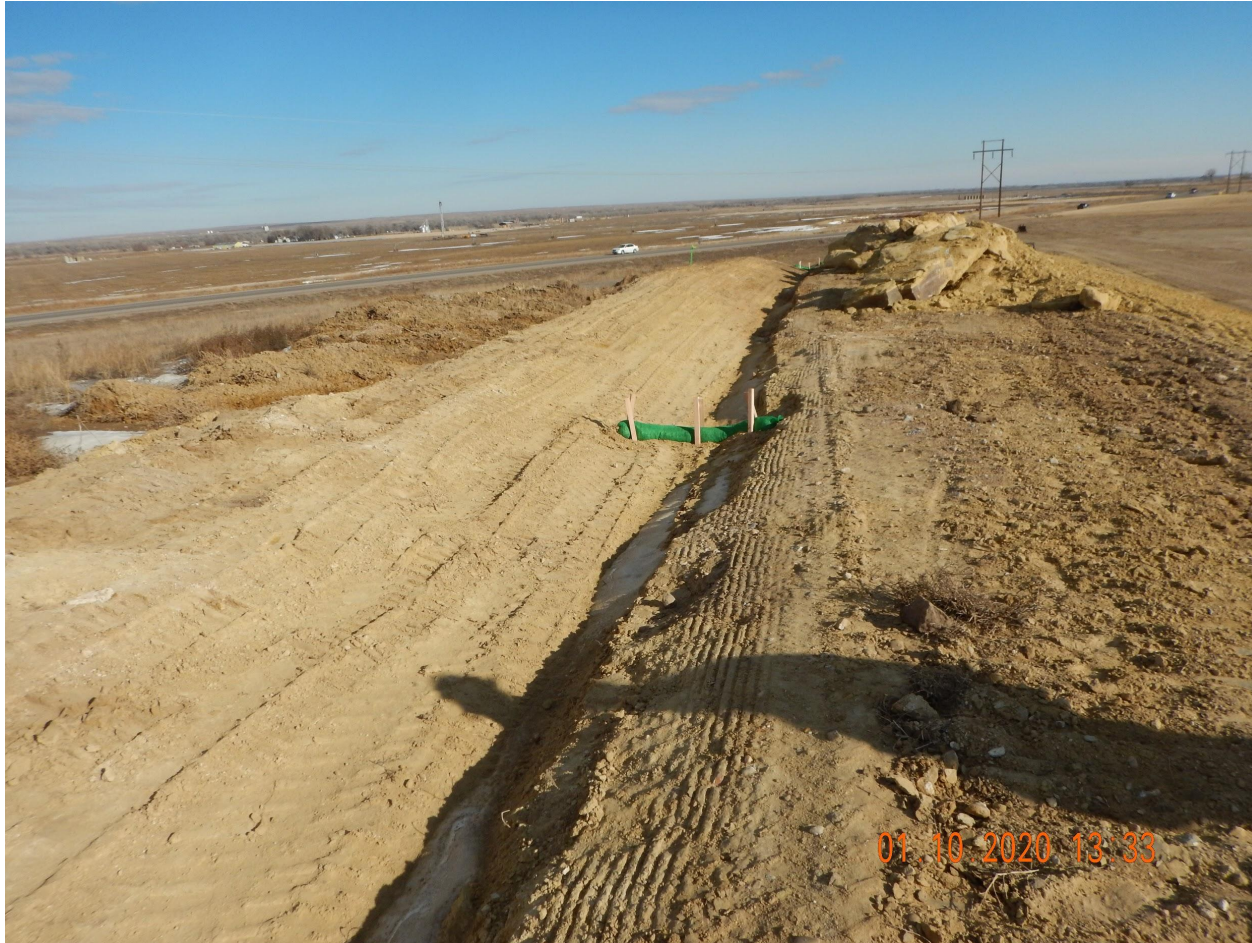
Photo 6. Photo taken from the northern perimeter of location, facing East. See comments under Photo 5.

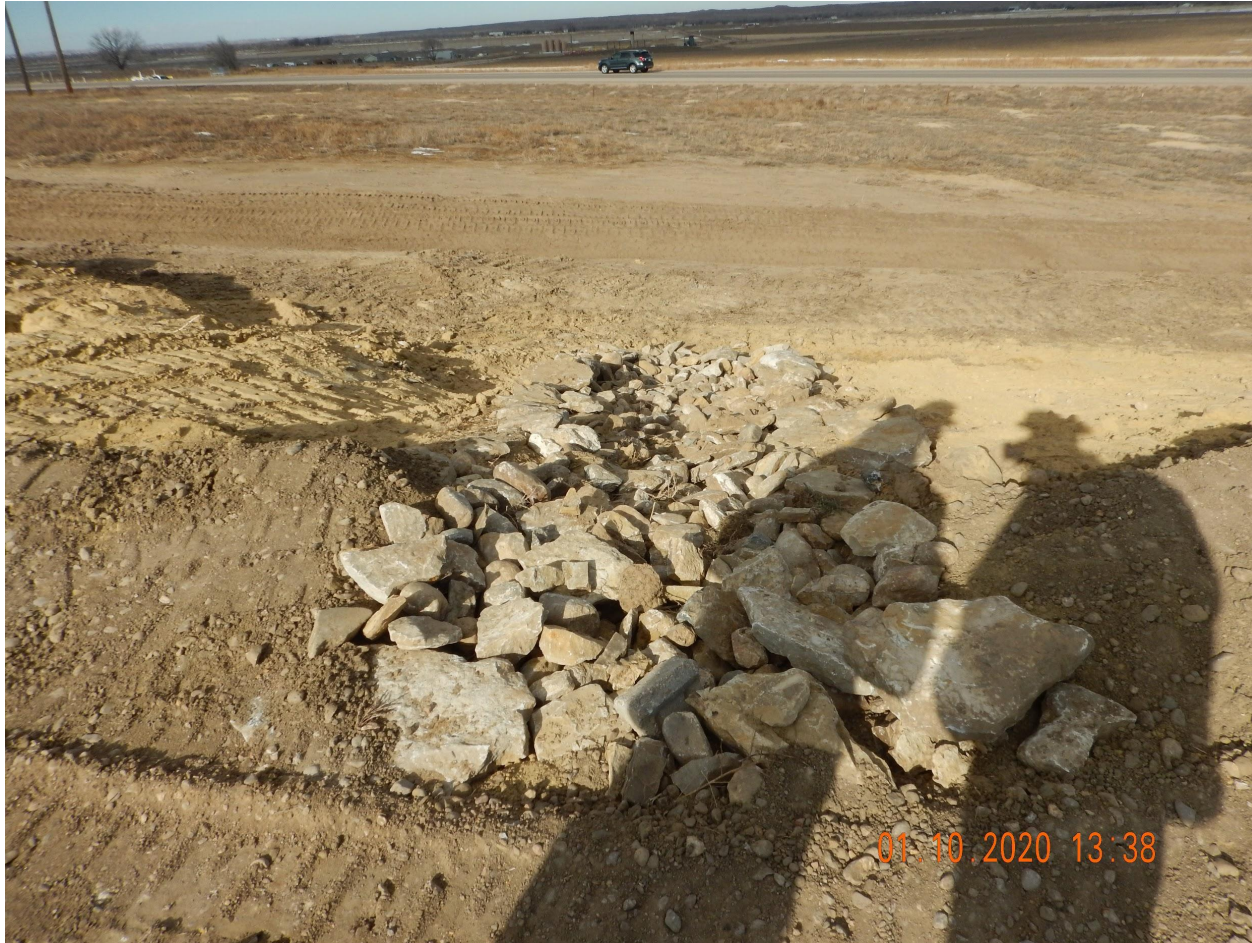
Photo 7. Photo taken from the northern location, facing North. Photo illustrates a stabilized ditch which is directed to the perimeter ditch and berm BMP and sediment trap.

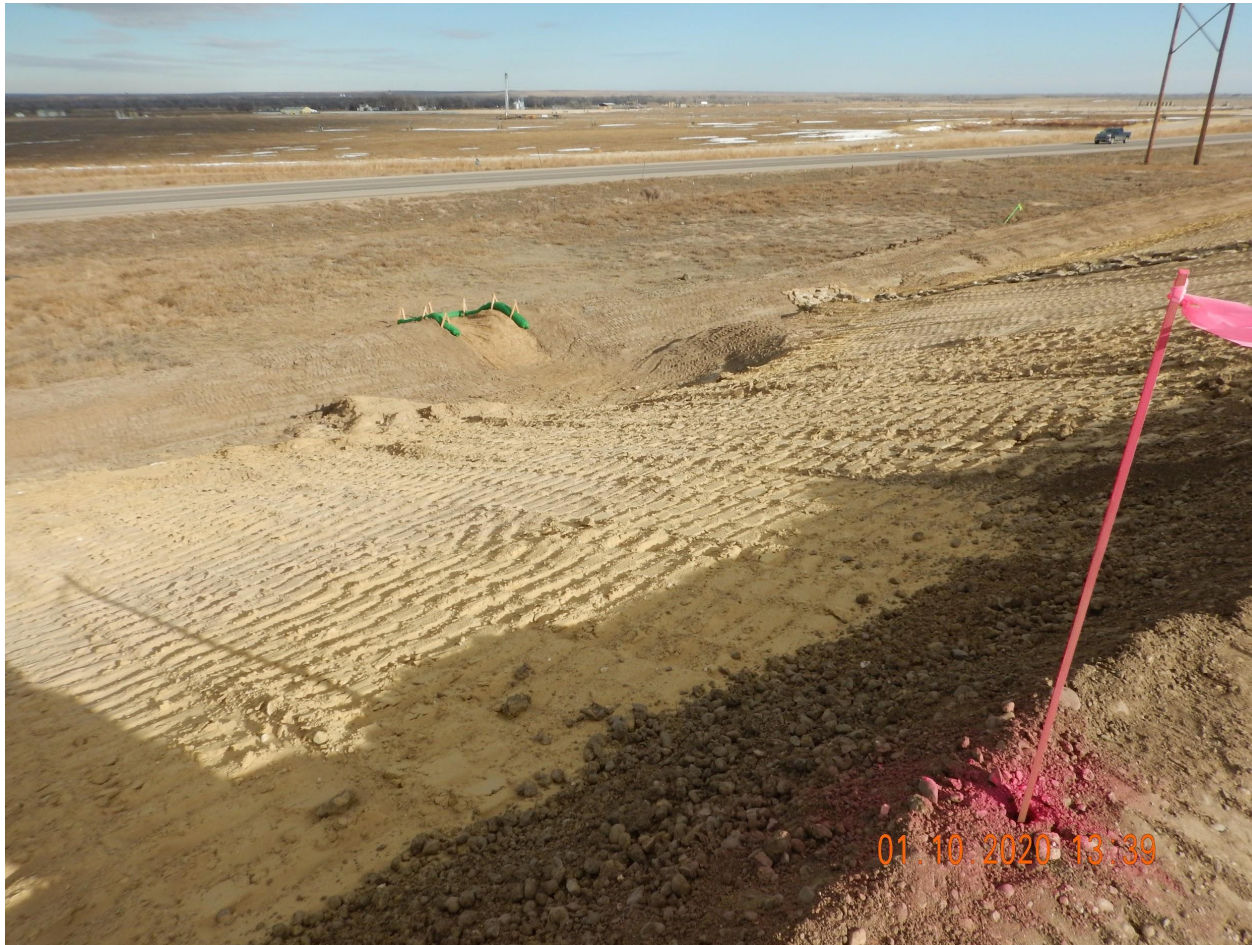
Photo 8. Photo taken from the northern location, facing Northeast. Photo illustrates one of the sediment traps with a temporarily stabilized outlet.

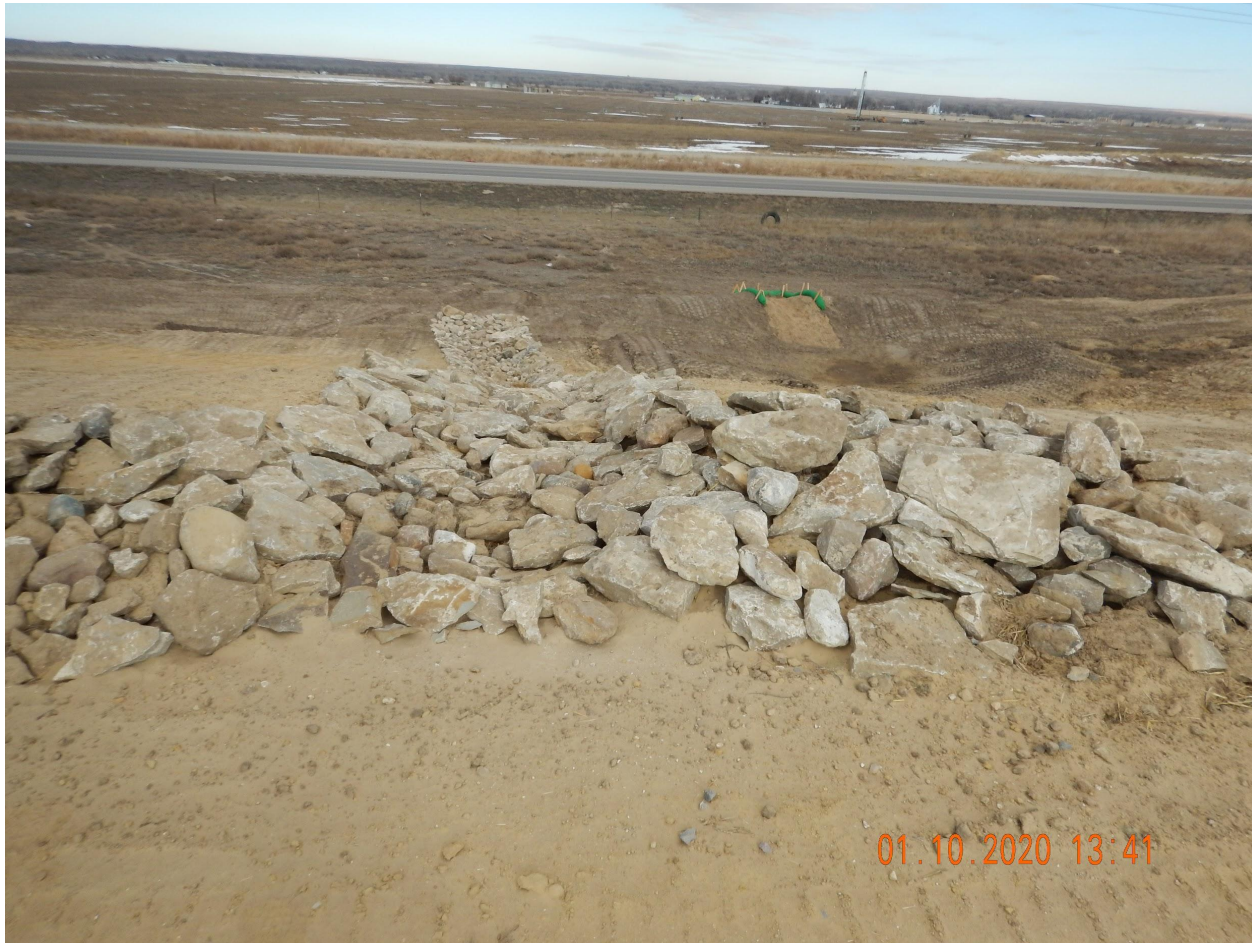
Photo 9. Photo taken from the northeastern location, facing North. Photo illustrates another sediment trap with a temporarily stabilized outlet and a stabilized ditch BMP.
