Construction and Stormwater Inspection

Operator: BONANZA CREEK ENERGY OPERATING COMPANY LLC - #8960

Location ID: 462951

Inspection Photos
Location Name: LATHAM /11-13 CPF
Location ID: 462951

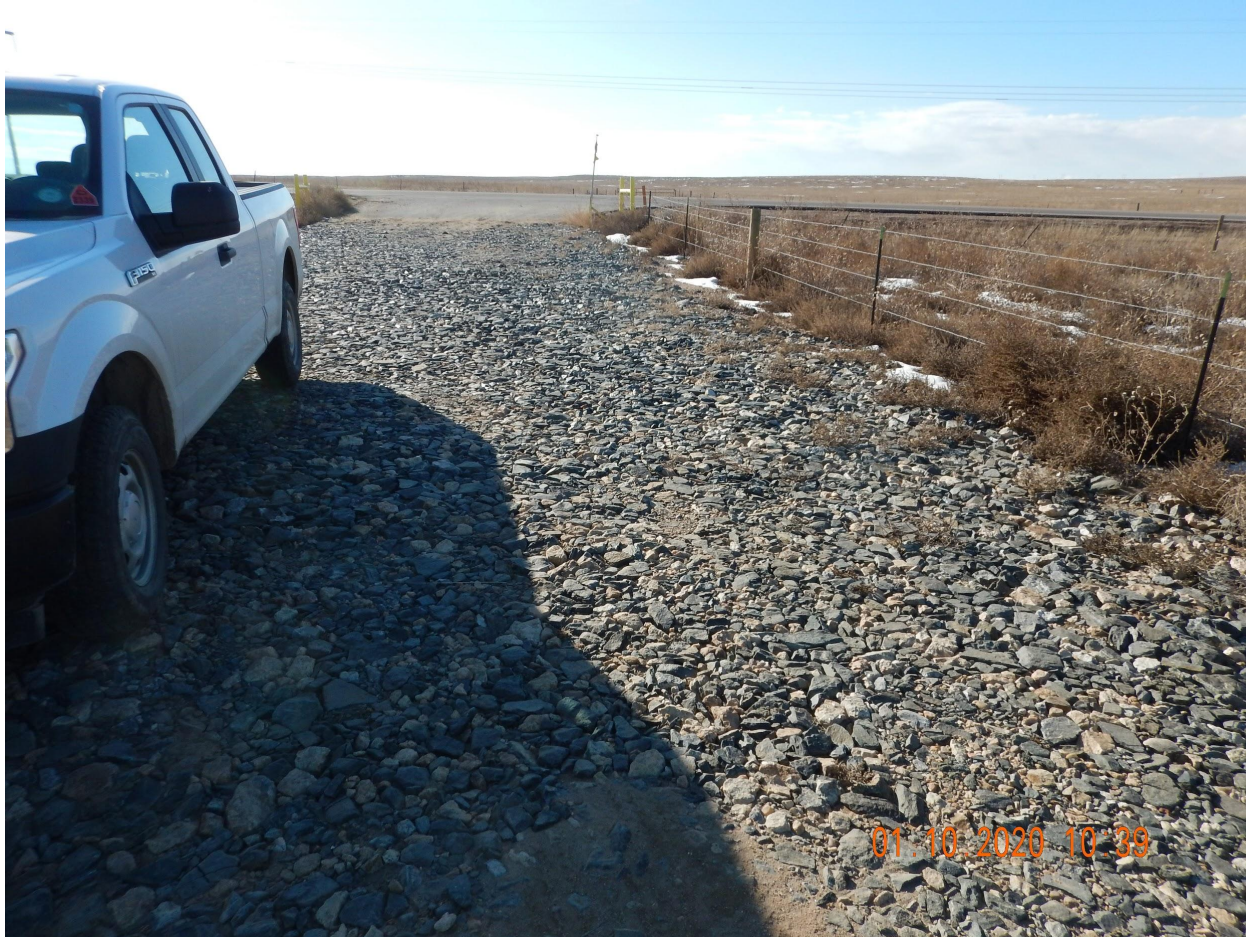
Photo 1. Photo taken from the entrance of the location off HWY 34, facing South.
Photo illustrates a portion of the vehicle tracking device BMP.

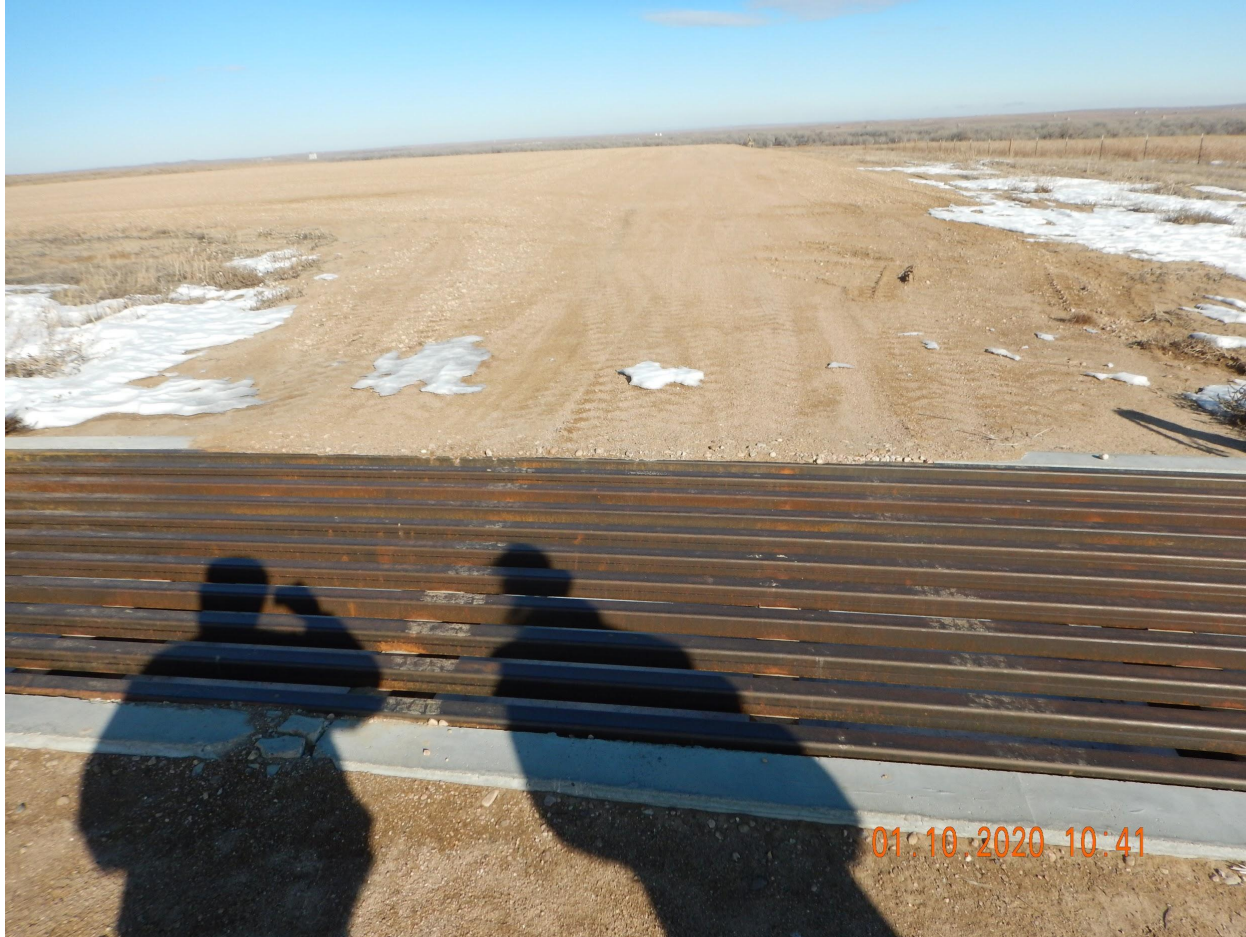
Photo 2. Photo taken from the entrance of the location, facing North. Photo illustrates another vehicle tracking device BMP.

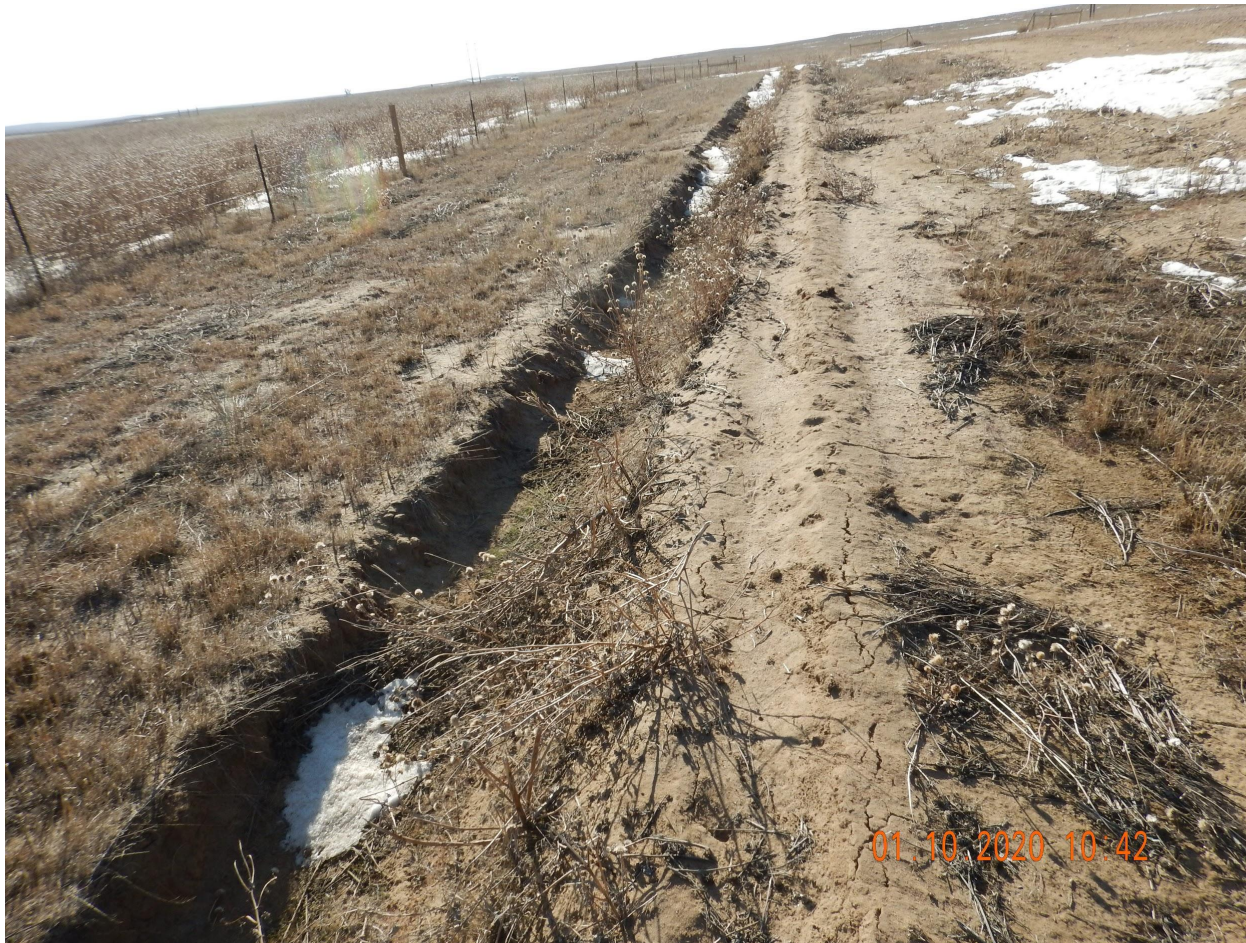
Photo 3. Photo taken from the eastern perimeter of the location, facing South. Photo illustrates a ditch BMP. Although there was no observed discharge from location, the ditch BMP has not been constructed in accordance with good engineering practices (i.e., proper depth and 2:1 side slopes).

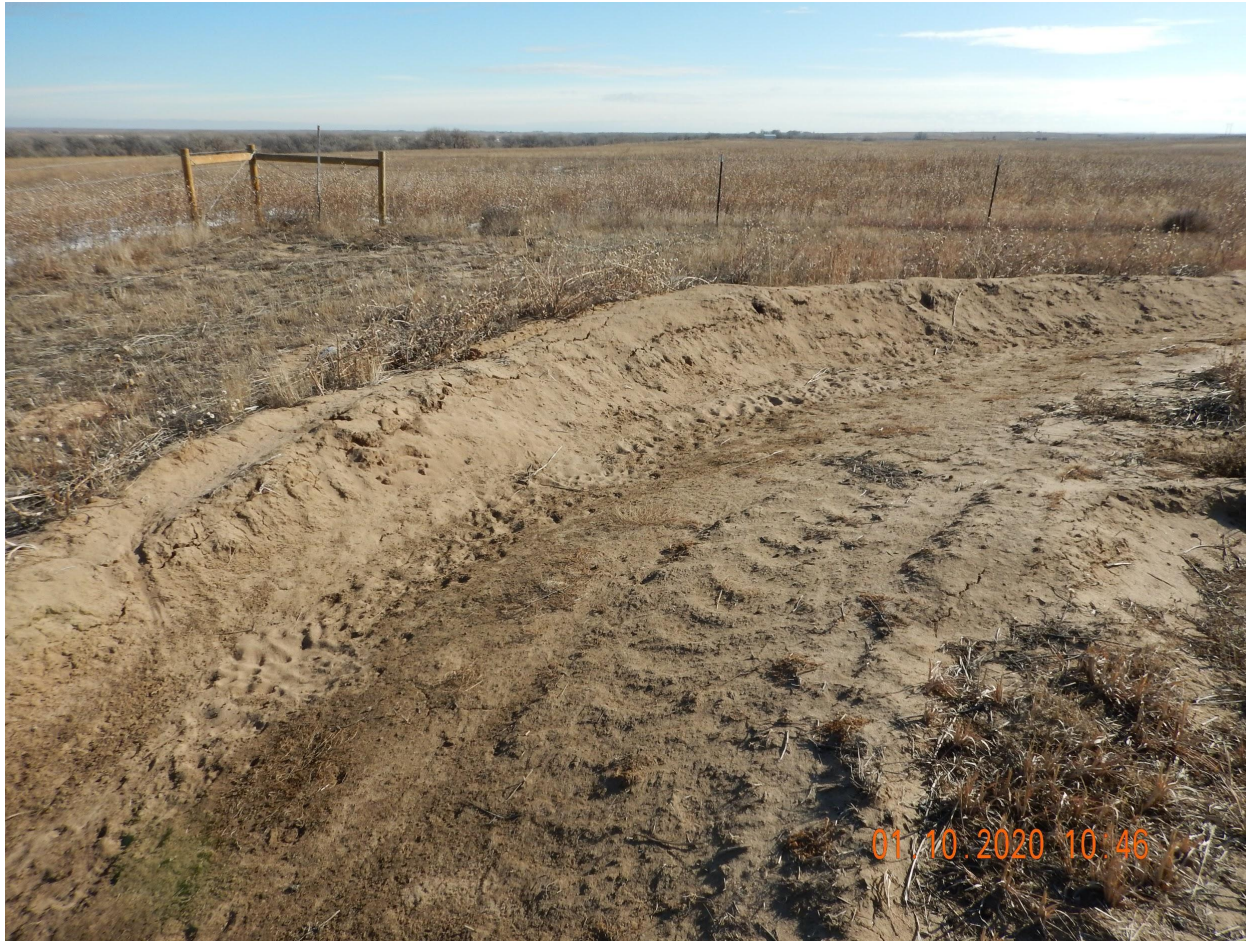
Photo 4. Photo taken from the northeastern perimeter of location, facing East. Photo illustrates there is no stabilized outlet, only a ditch BMP. Although there was no observed discharge from location, a ditch by itself is not sufficient.

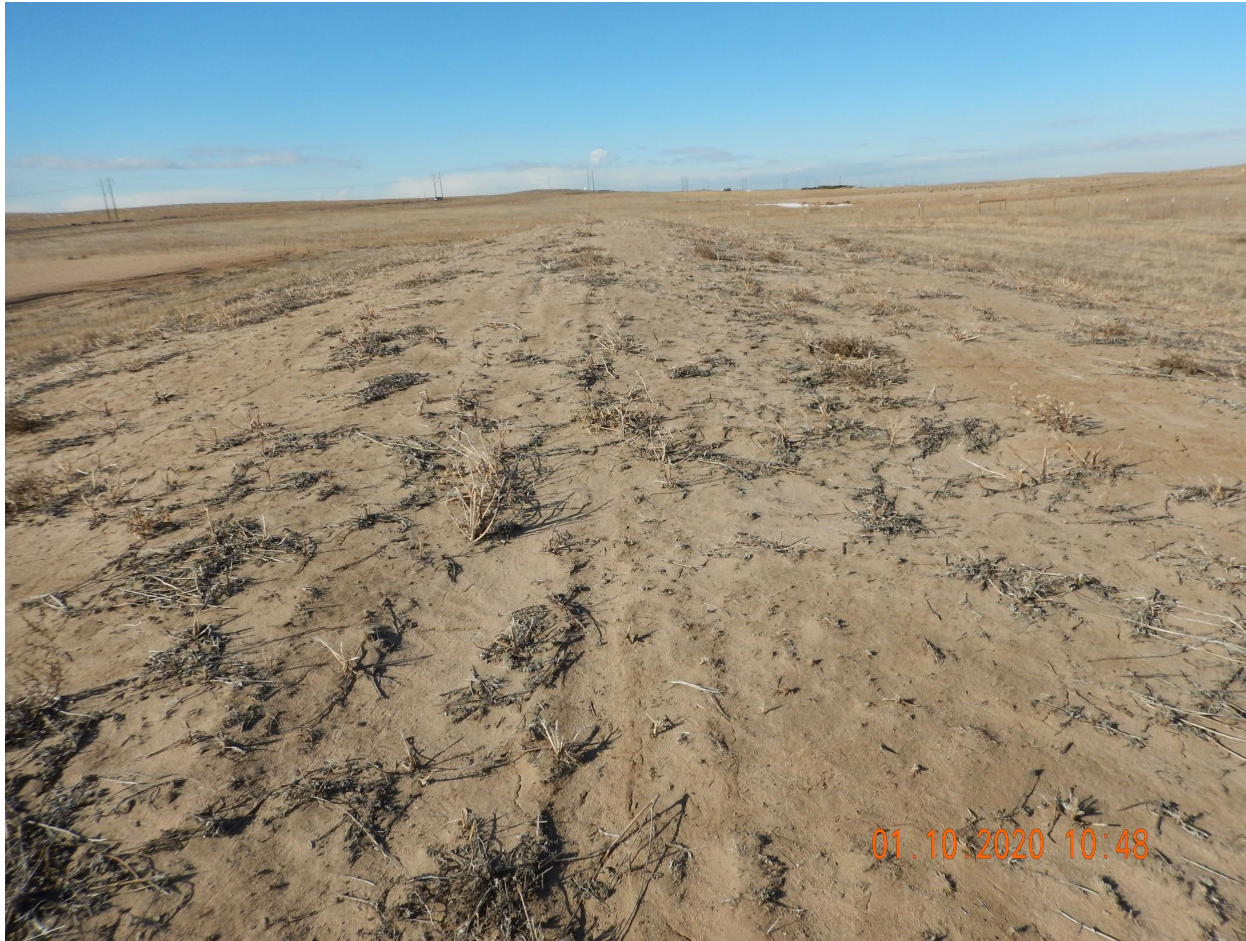
Photo 5. Photo taken from the topsoil stockpile, facing West. Photo illustrates the topsoil stockpile has not been properly stabilized and weed establishment was evident.

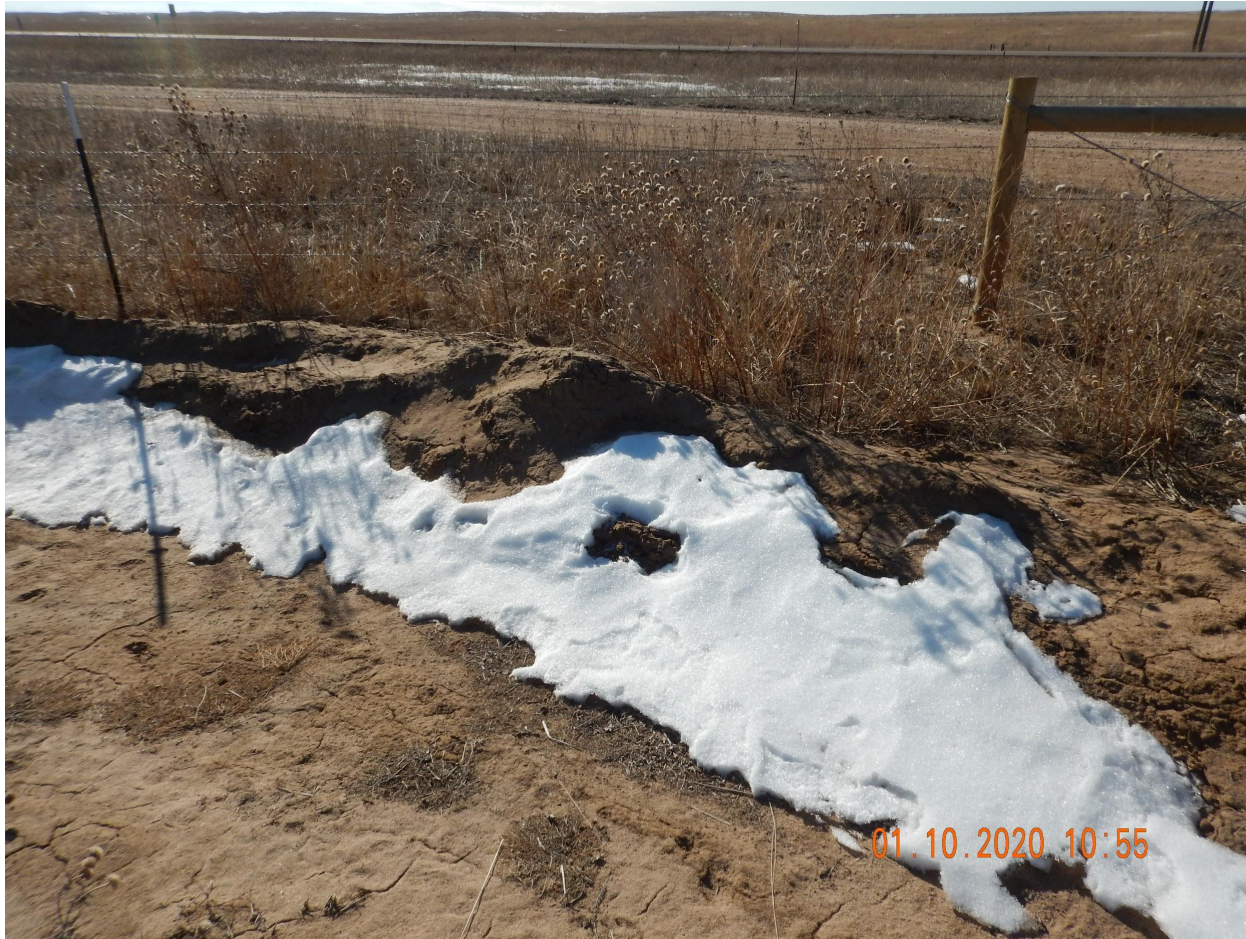
Photo 6. Photo taken from the southwestern perimeter of the location, facing South. Photo illustrates an insufficient ditch BMP installed.
