Construction and Stormwater Inspection

January 10, 2020

Operator: BONANZA CREEK ENERGY OPERATING COMPANY LLC - #8960

Inspection Photos
Location Name: State Antelope /34-24 Pad
Location ID: 434712

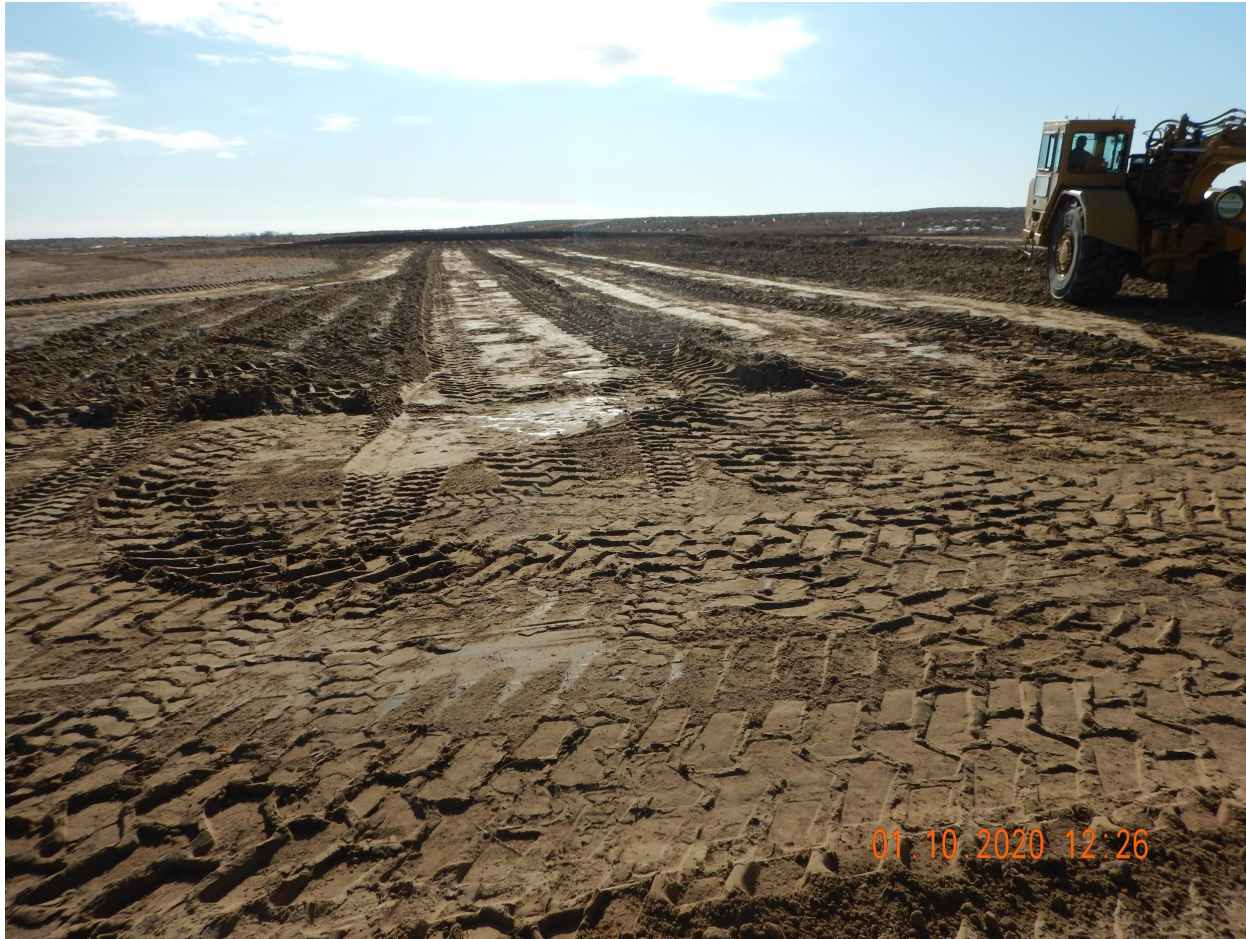
Photo 1. Photo taken from the northern location, facing South. Photo illustrates Operator was in-process of salvaging topsoil. Note: Operator was performing topsoil salvage operations without BMPs along portions of the location.

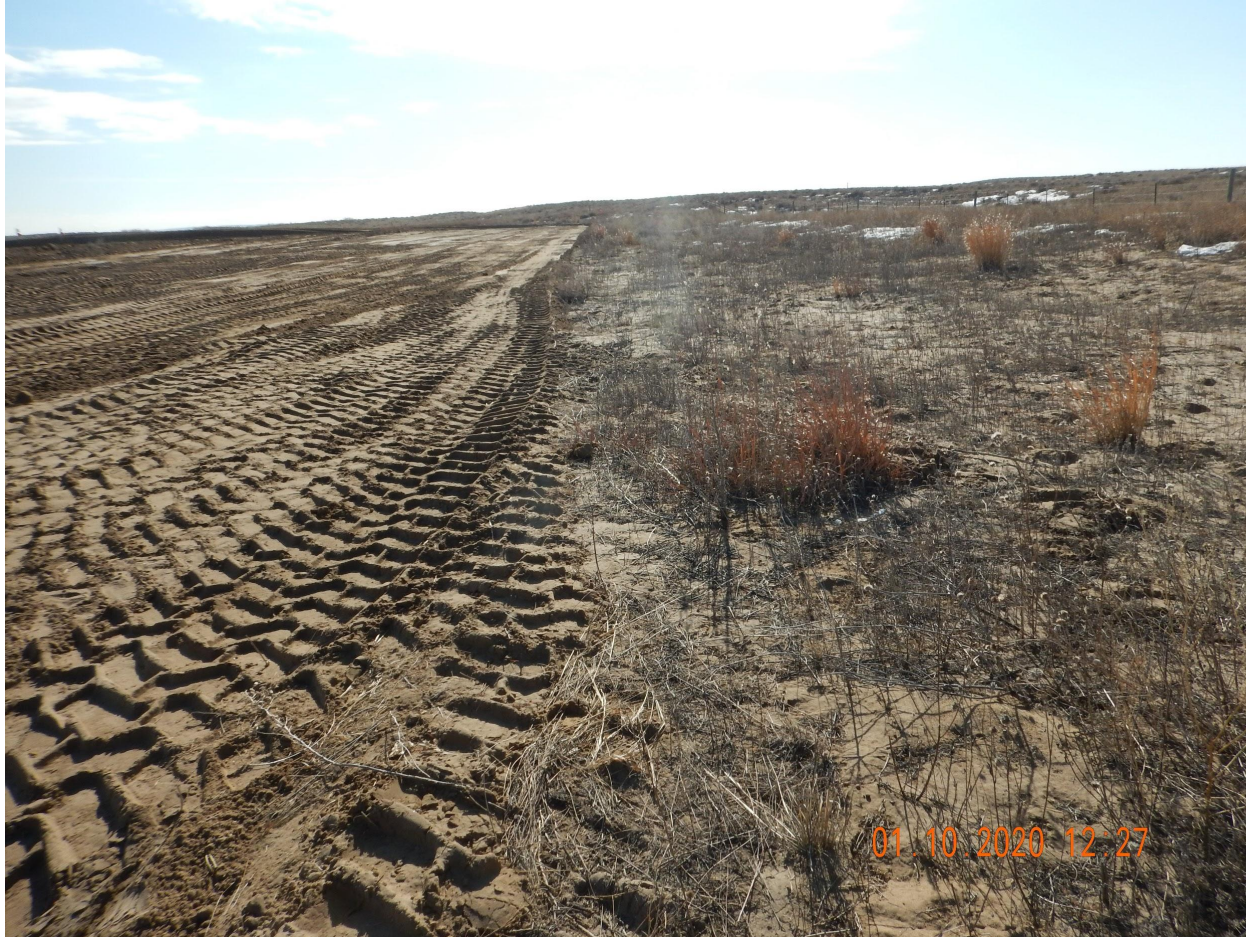
Photo 2. Photo taken from the northwestern location, facing South. Photo illustrates no BMP has been installed during topsoil salvage operations.

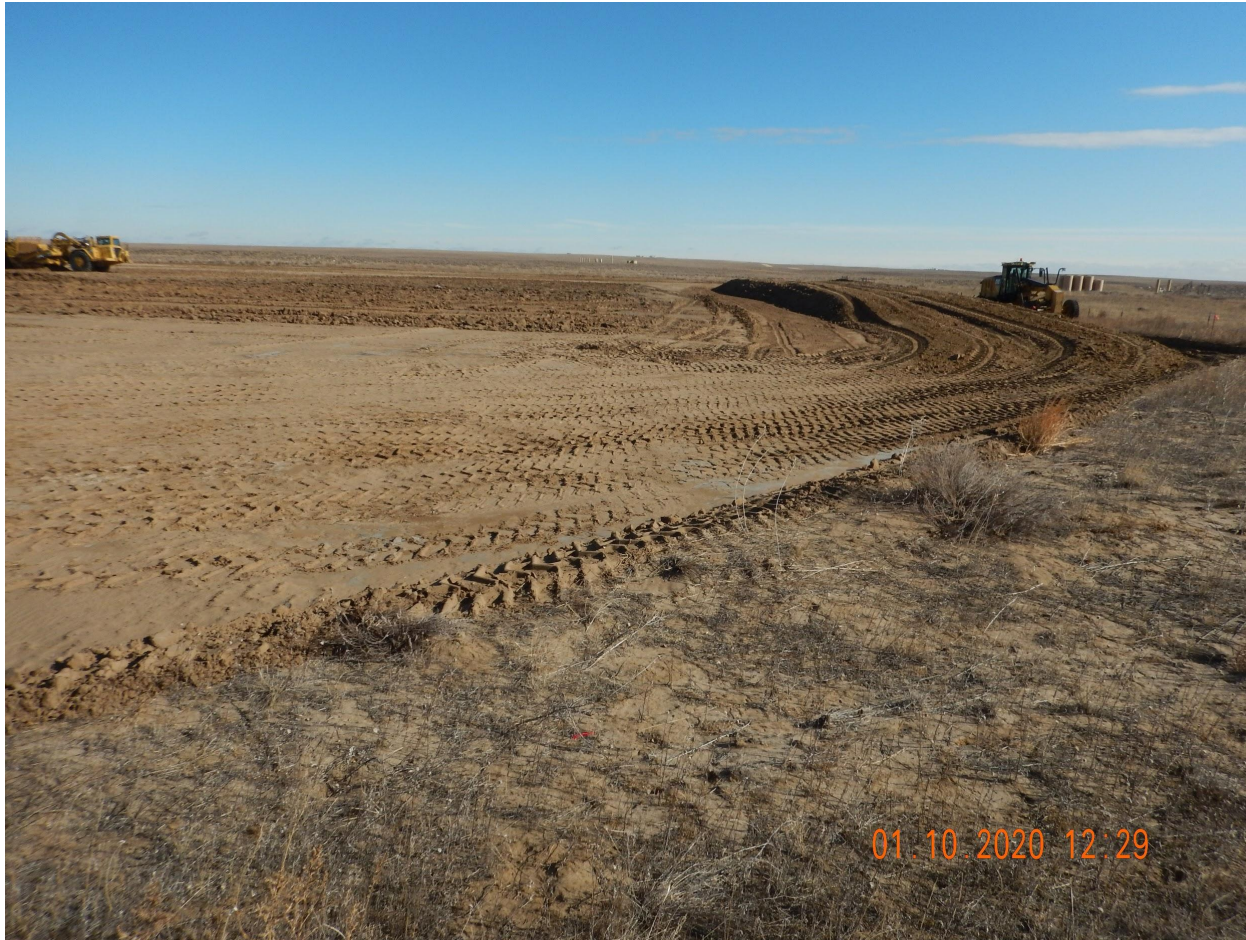
Photo 3. Photo taken from the western perimeter of location, facing East. Photo illustrates the topsoil stockpile area along the southern location. Photo also illustrates the Operator installing a ditch BMP after COGCC staff informed the contractor of the requirement for BMPs during topsoil salvage operations.

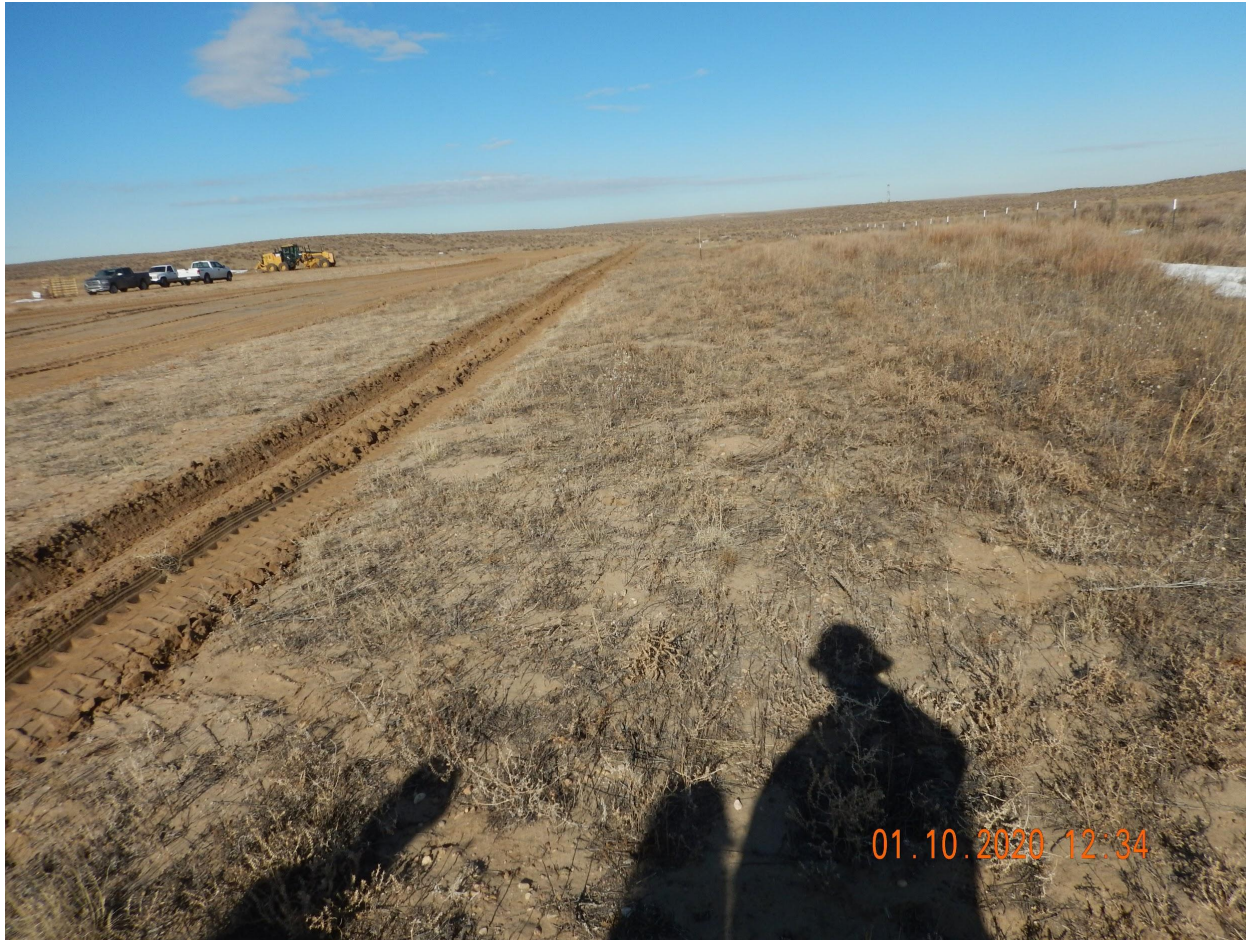
Photo 4. Photo taken from the southeastern perimeter of location, facing North. Photo illustrates a ditch BMP which was installed after COGCC staff informed the contractor of the requirement for BMPs during topsoil salvage operations.
