Inspection Photos
Operator: BP America
Location/API #: 067-07003
Date: 1-15-2020

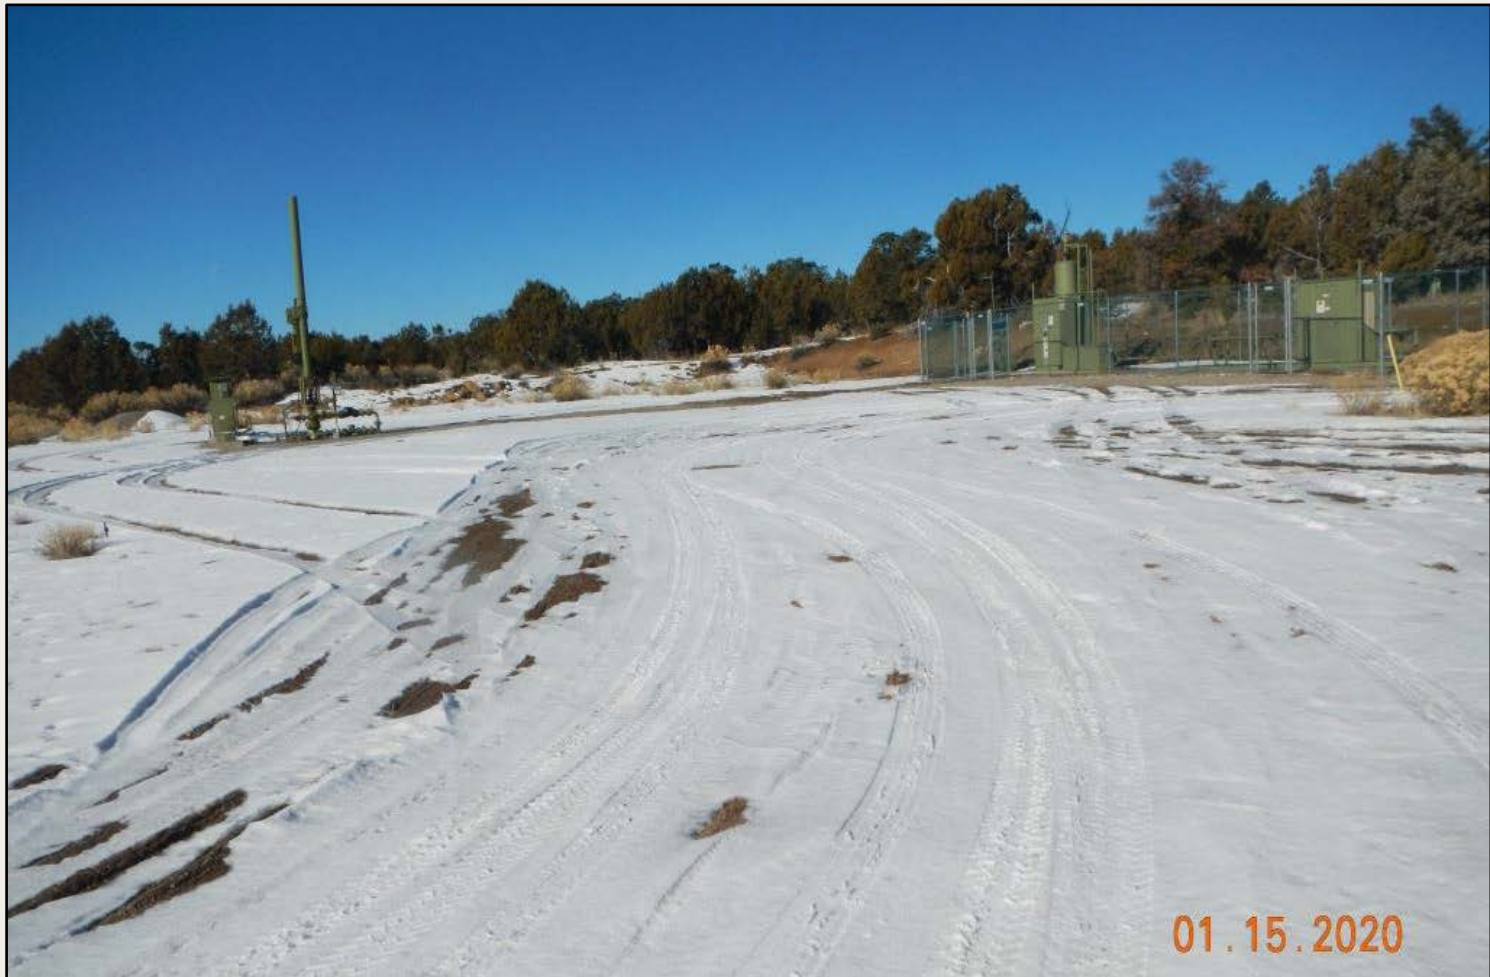
Photo 1. View of the project area from the well pad entrance facing center.

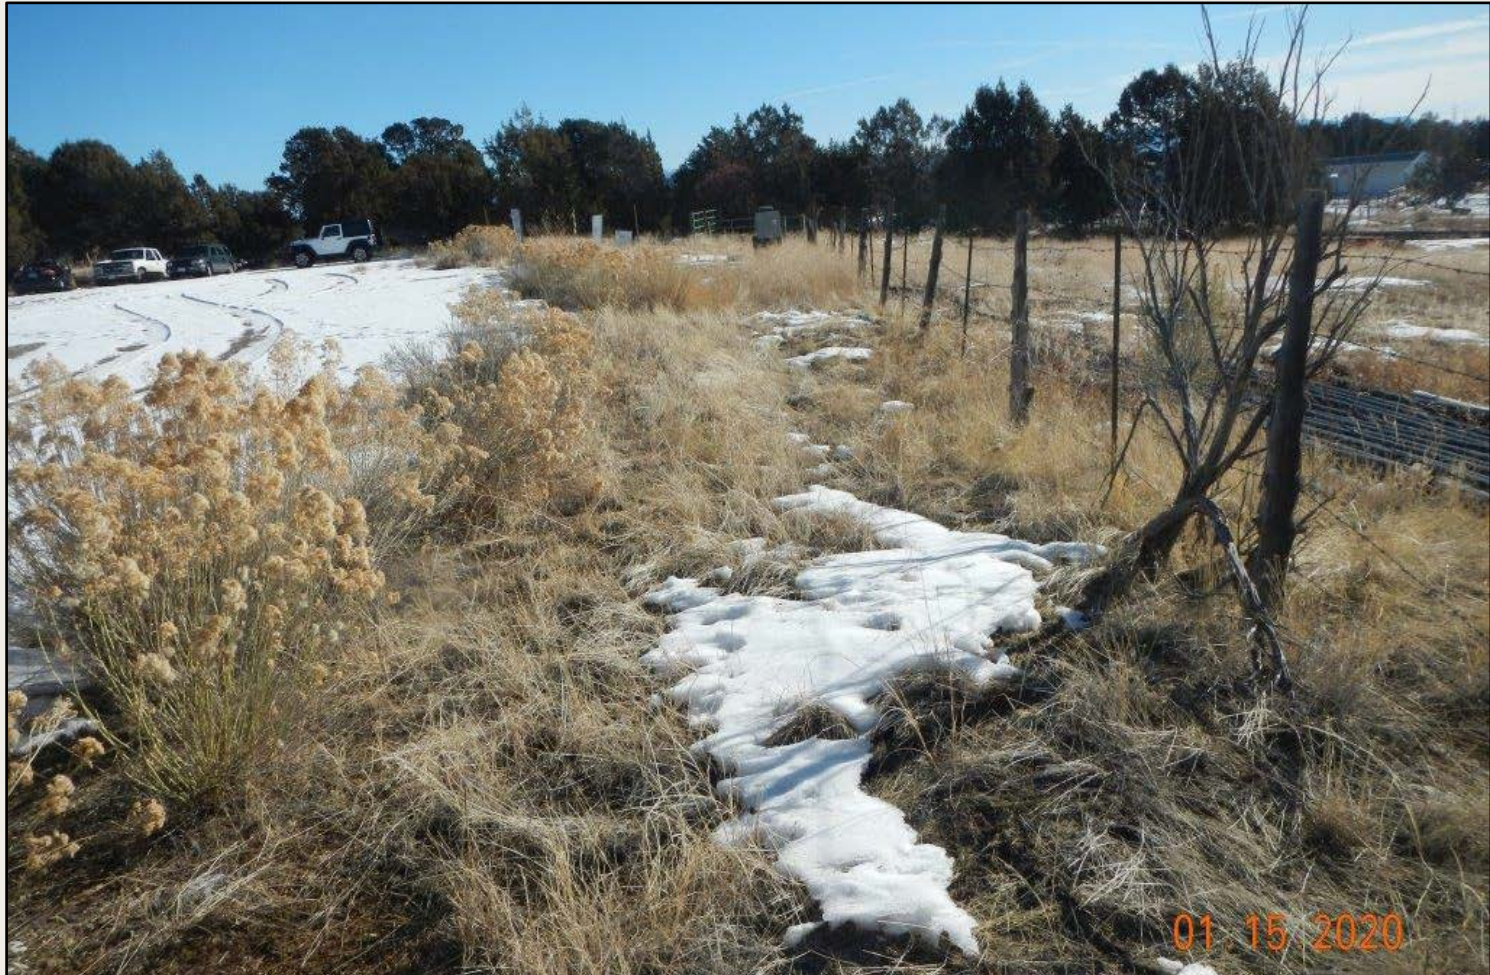
Photo 2. View of the southern fill slope from the southwestern corner facing eastward. Revegetation is progressing with grasses such as sand drop seed and western wheatgrass. Jointed goatgrass, an annual grass species identified in 2018 inspection needs treatment in spring (before flowering) if present.

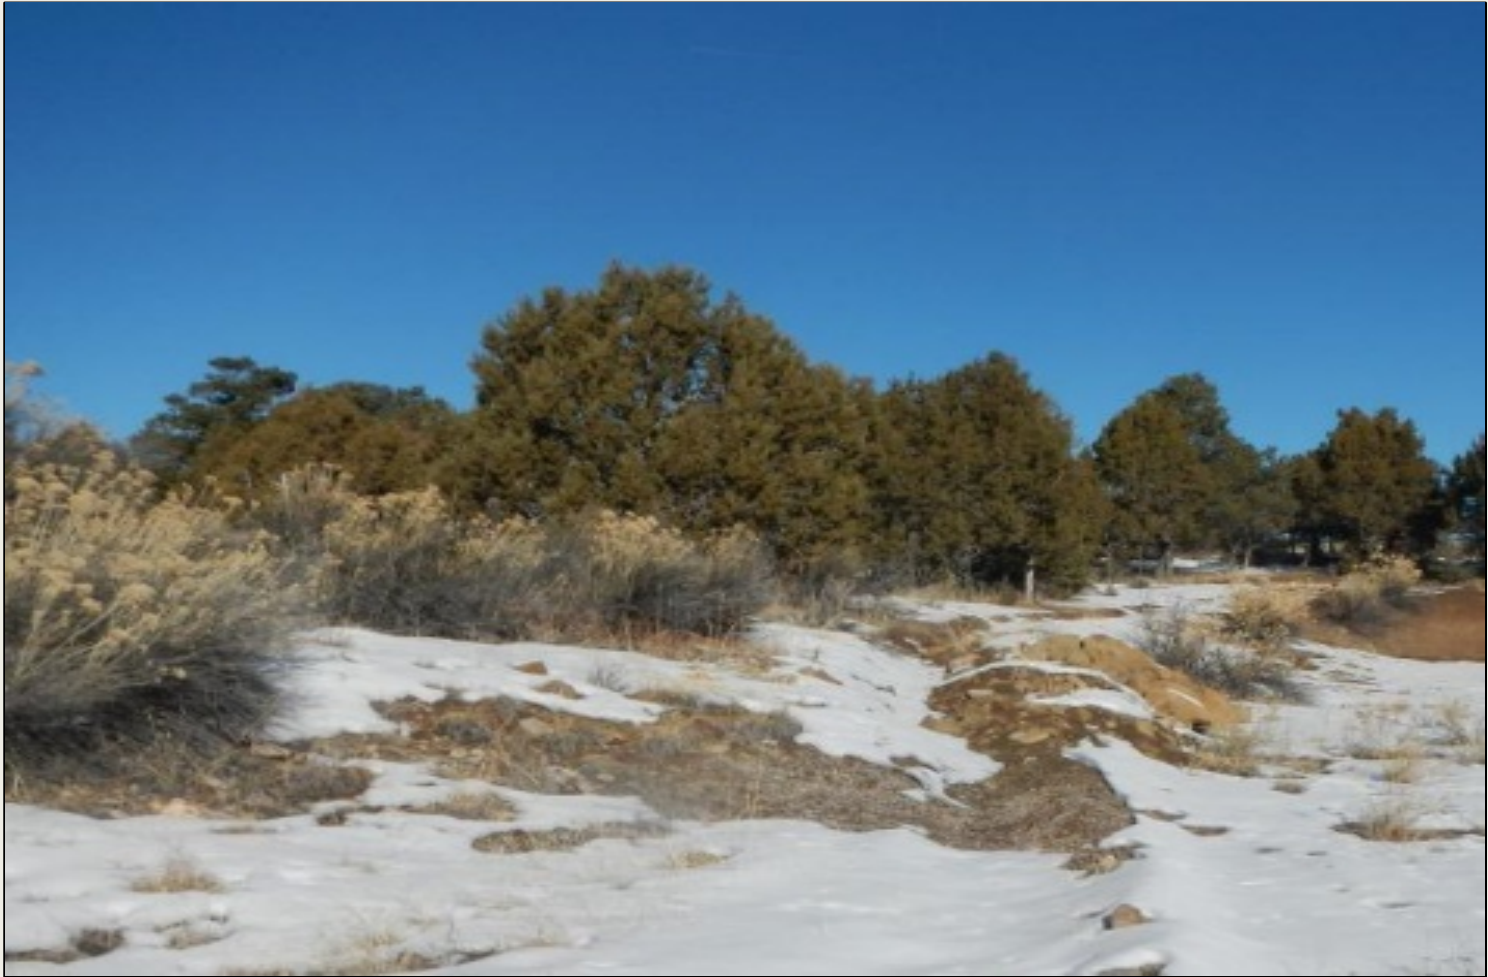
Photo 3. View of the western project area from the southwestern corner facing northward. A diversion is installed since the 2018 reclamation inspection. Stormwater erosion needs to be assessed after snow melt/soil thaw.

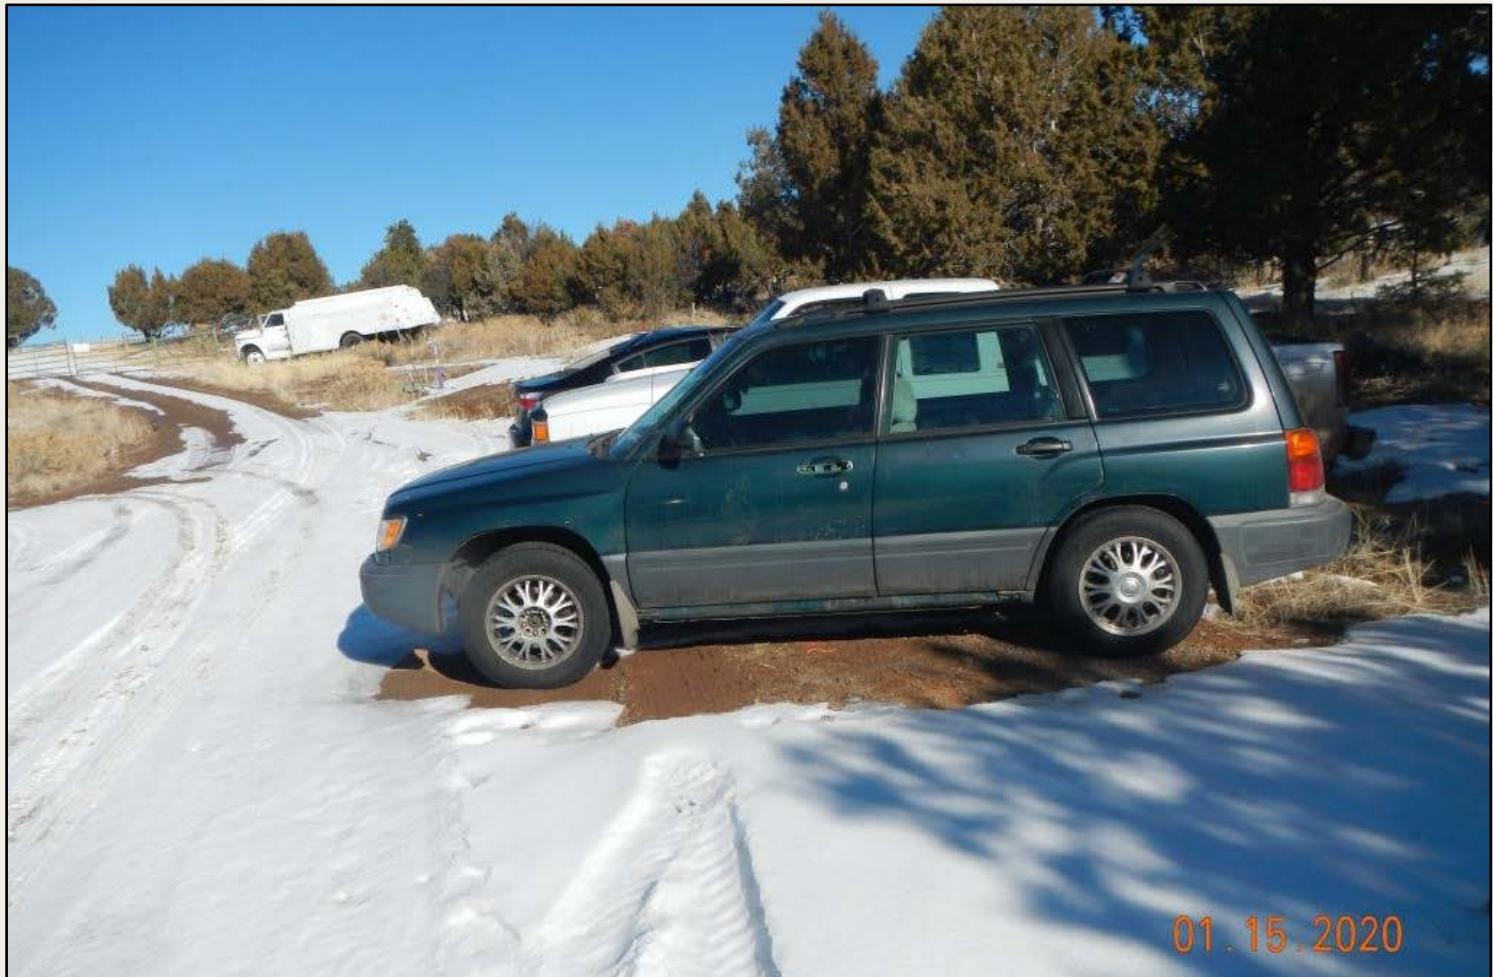
Photo 4. View of vehicles stored within the eastern project area.
