**Inspection Photos**  
**Operator: BP America**  
**Location/API #: 067-09536**  
**Date: 1-15-2020**

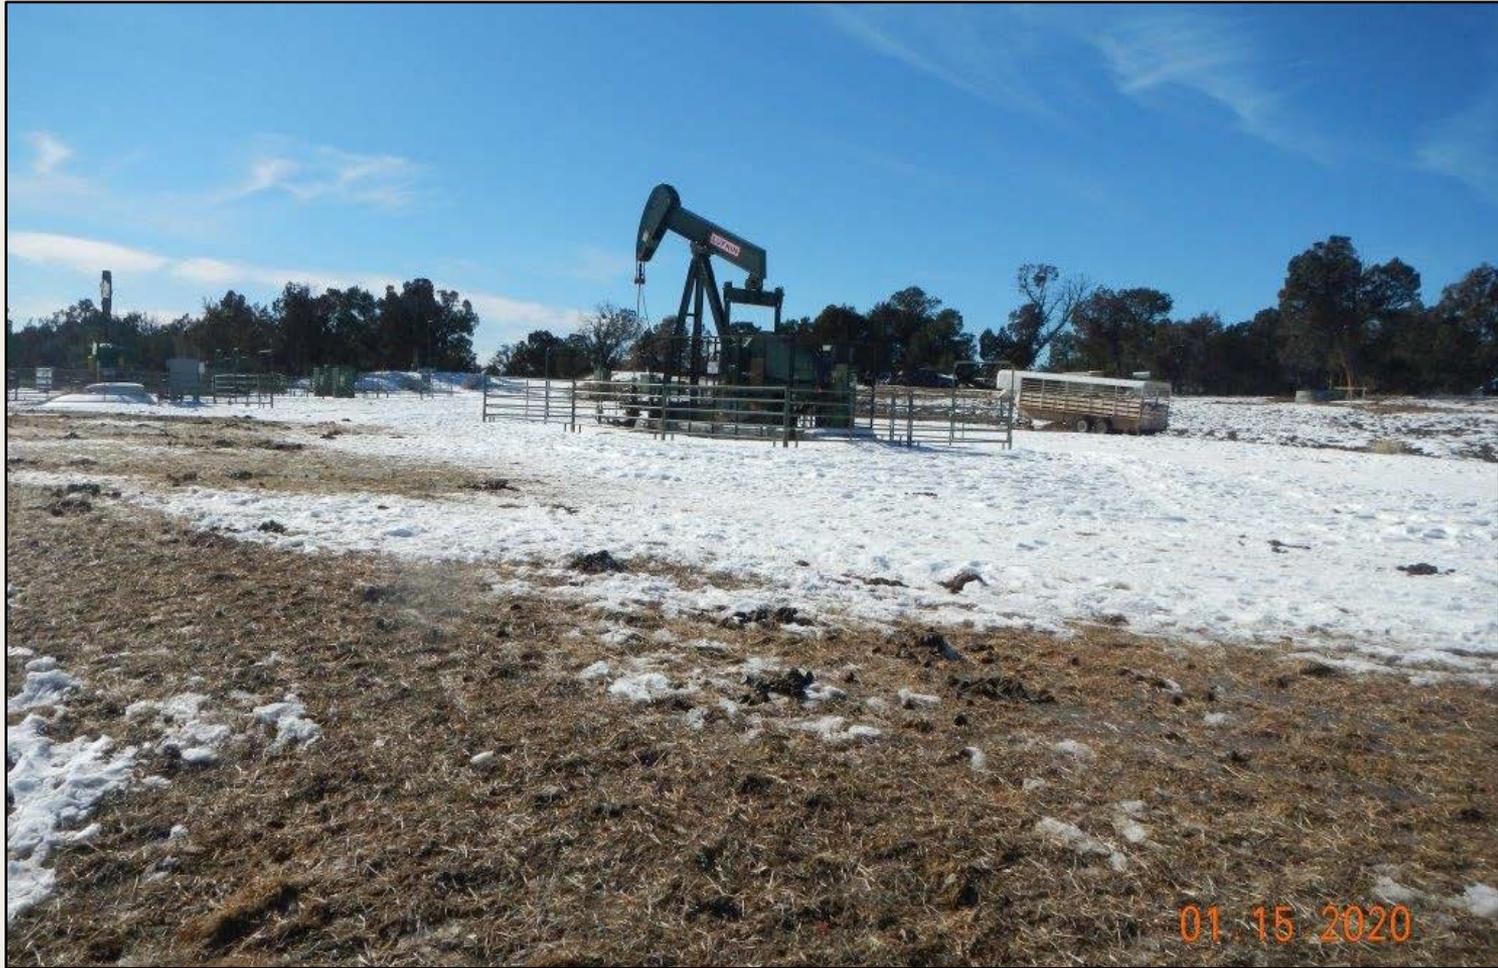
Photo 1. View of the project area from the northeastern corner facing center.

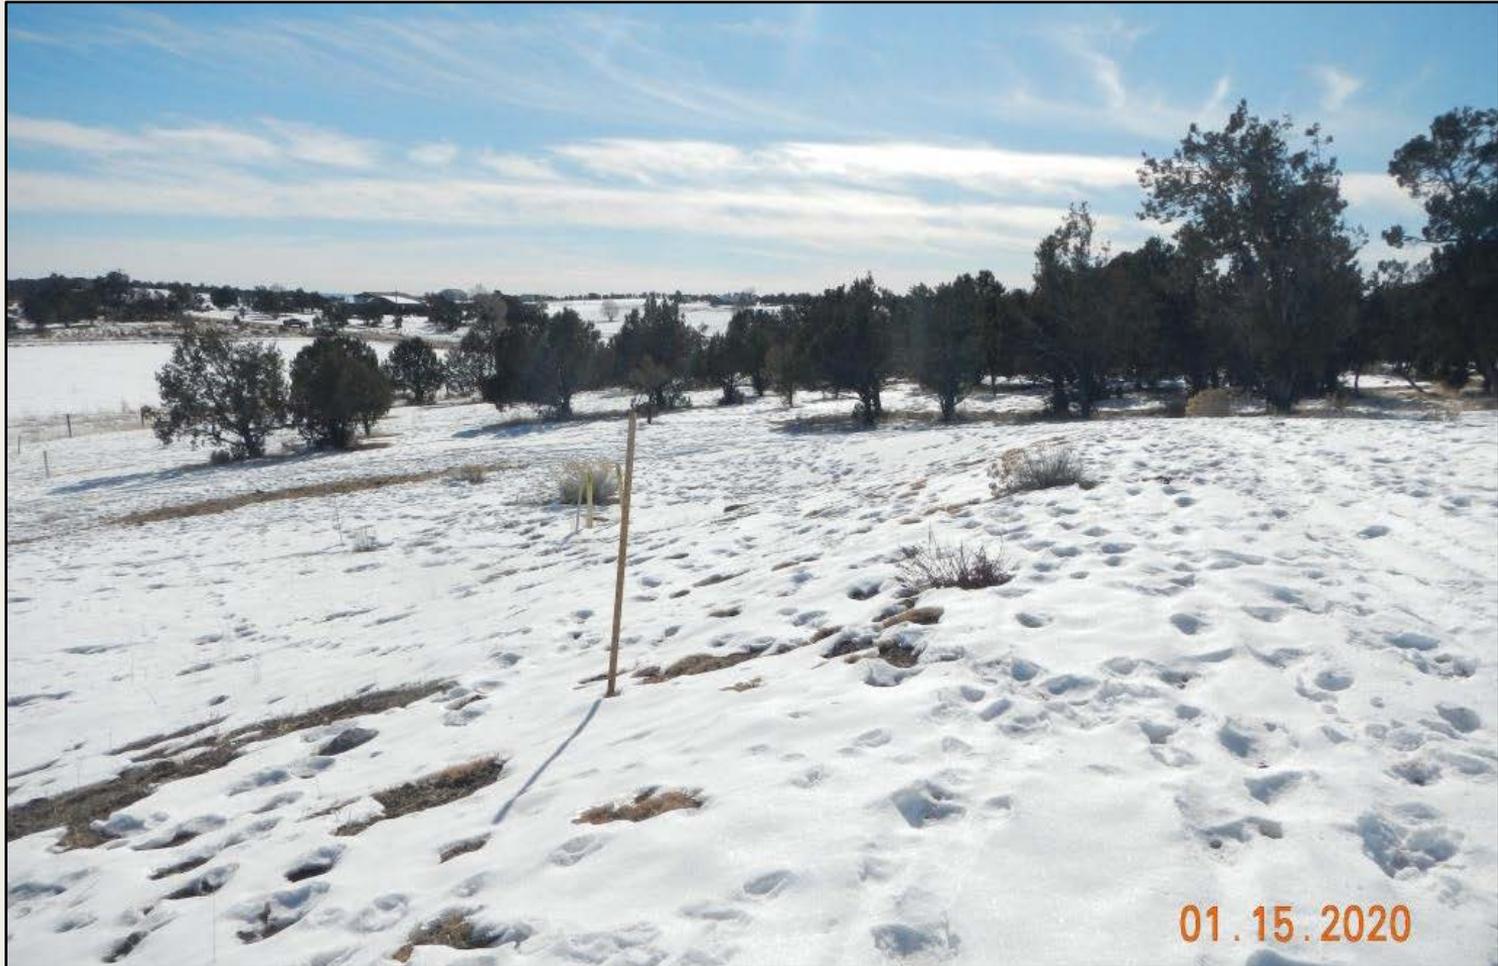
Photo 2. View of the eastern project area from the northeastern corner facing southward.

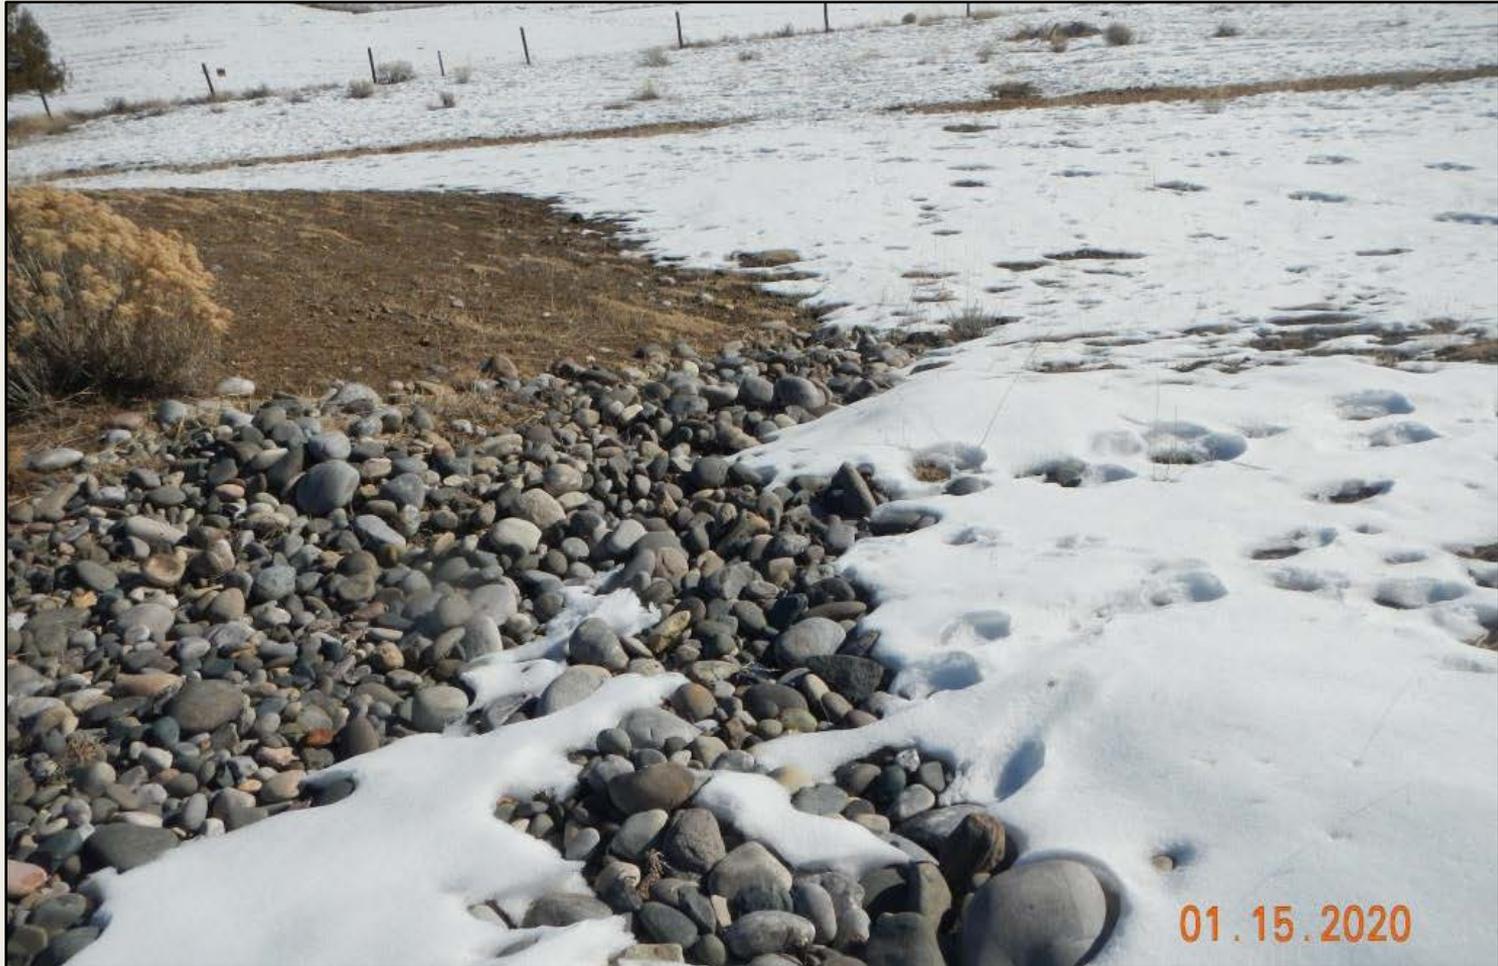
Photo 3. View of cobble within the southeastern project area, although functionality is not assessed due to snow cover. Operator should note that cobble rock is not considered a BMP, as it does not effectively reduce energy of stormwater flows. Course rock is needed where rock is used as a stormwater BMP. Operator needs to continue to monitor stormwater erosion and apply BMPs according to good engineering practices when/where stabilization is needed.

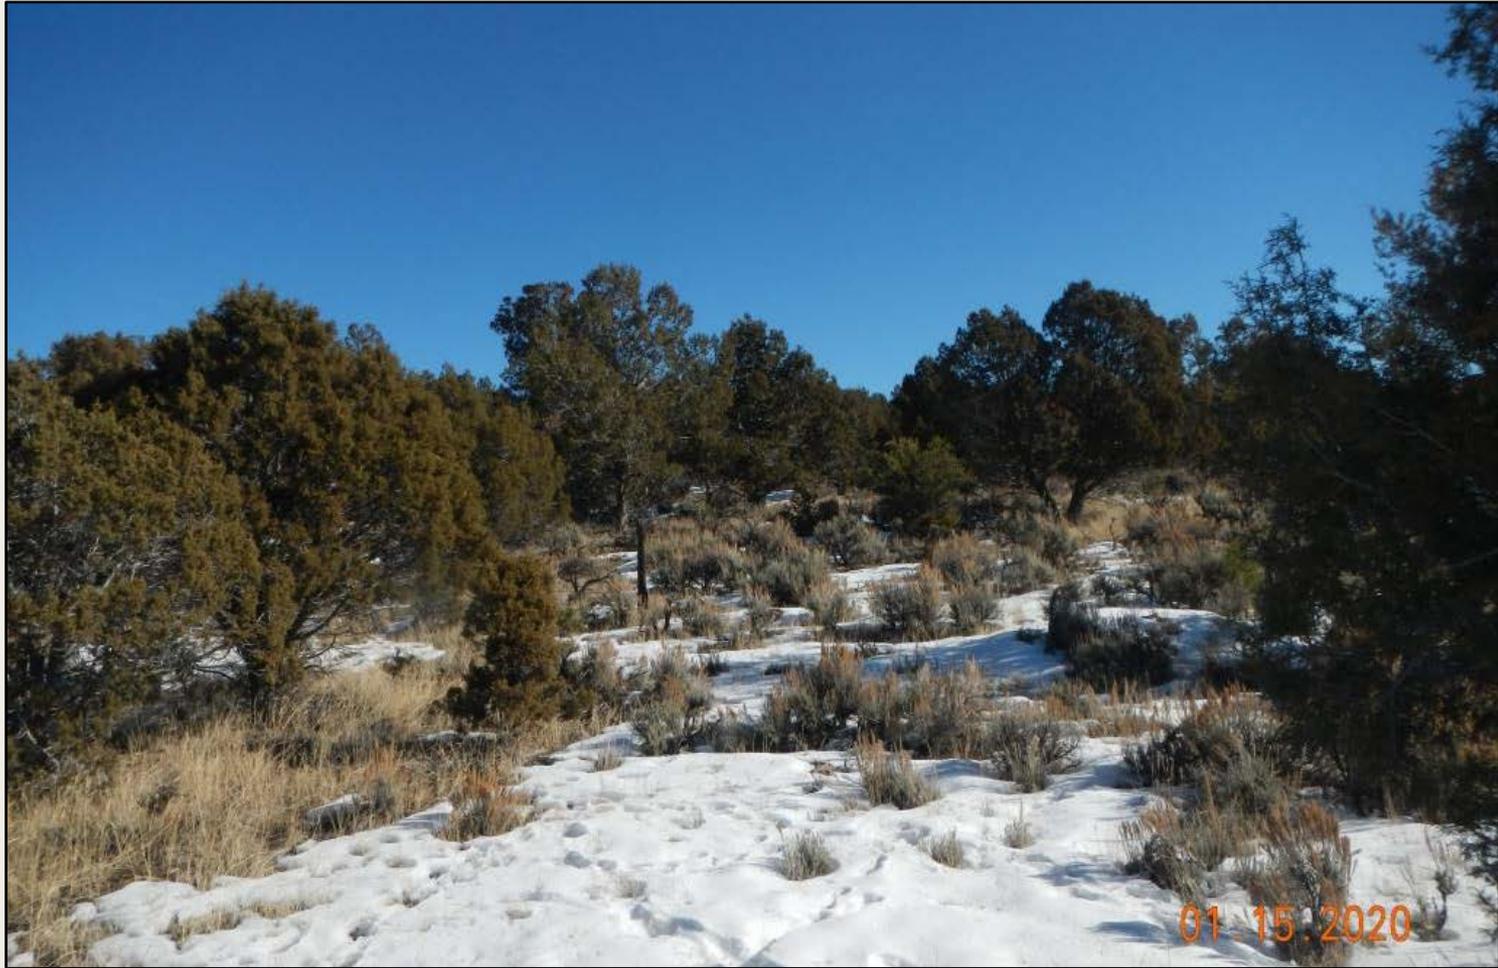
Photo 4. View of reference area, comprised of open pinyon and juniper woodland with sagebrush dominated understory.
