Inspection Photos

API: 05-017-07700

Operator: VECTA OIL & GAS

Inspection Date: 1/14/2020

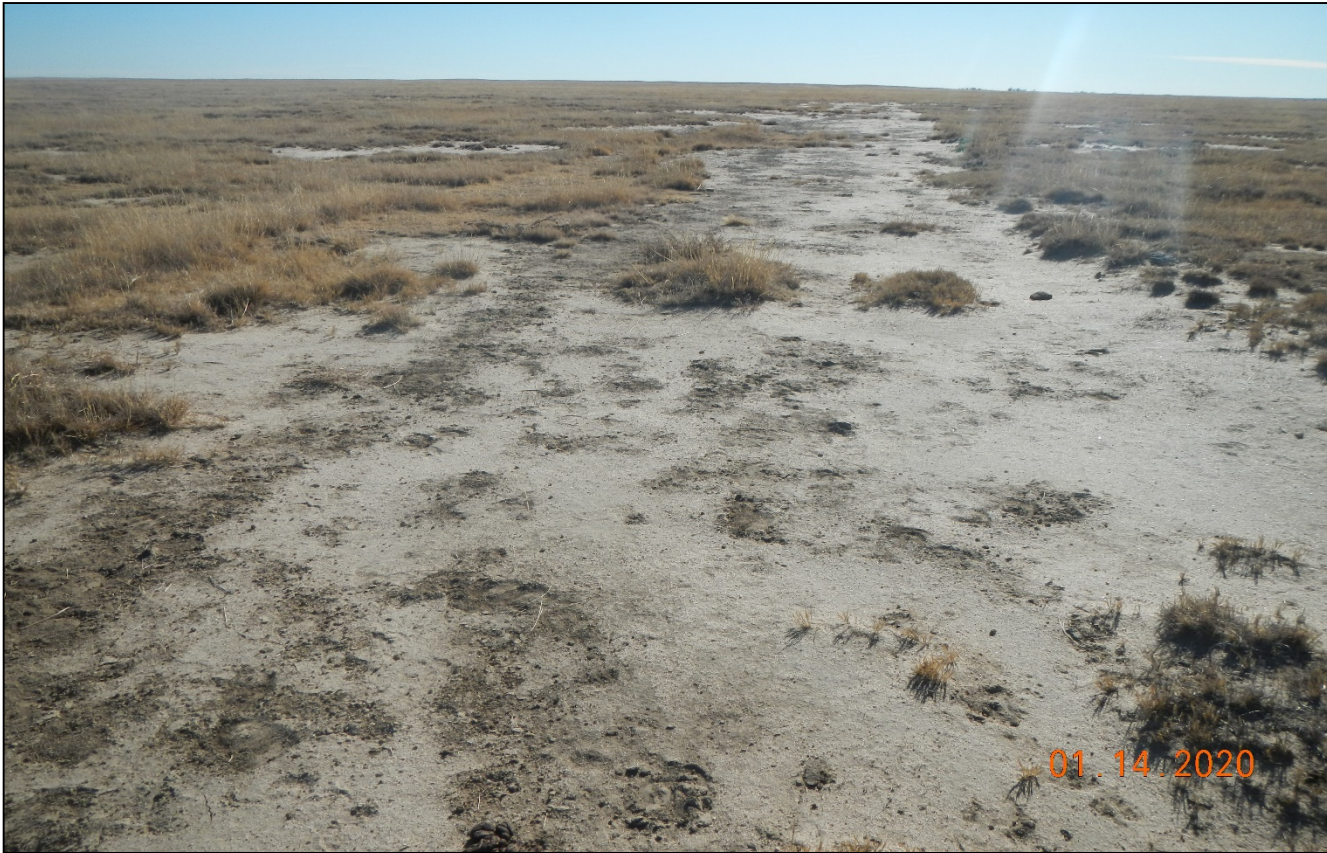
Photo 1. Facing south along the former access road. This area is bare of vegetation. Soils did not seem to be compacted but should be evaluated.

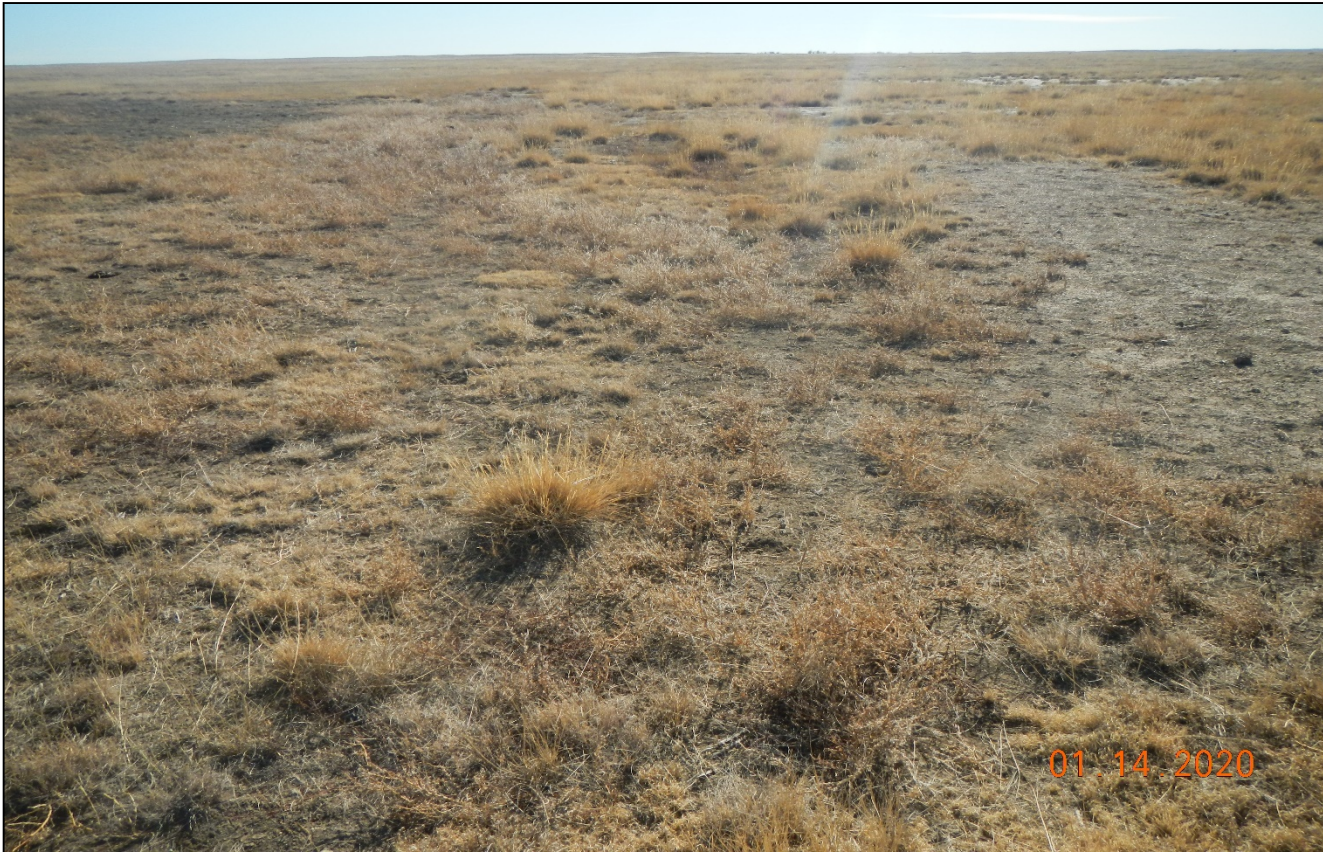
Photo 2. Center of the location facing south.

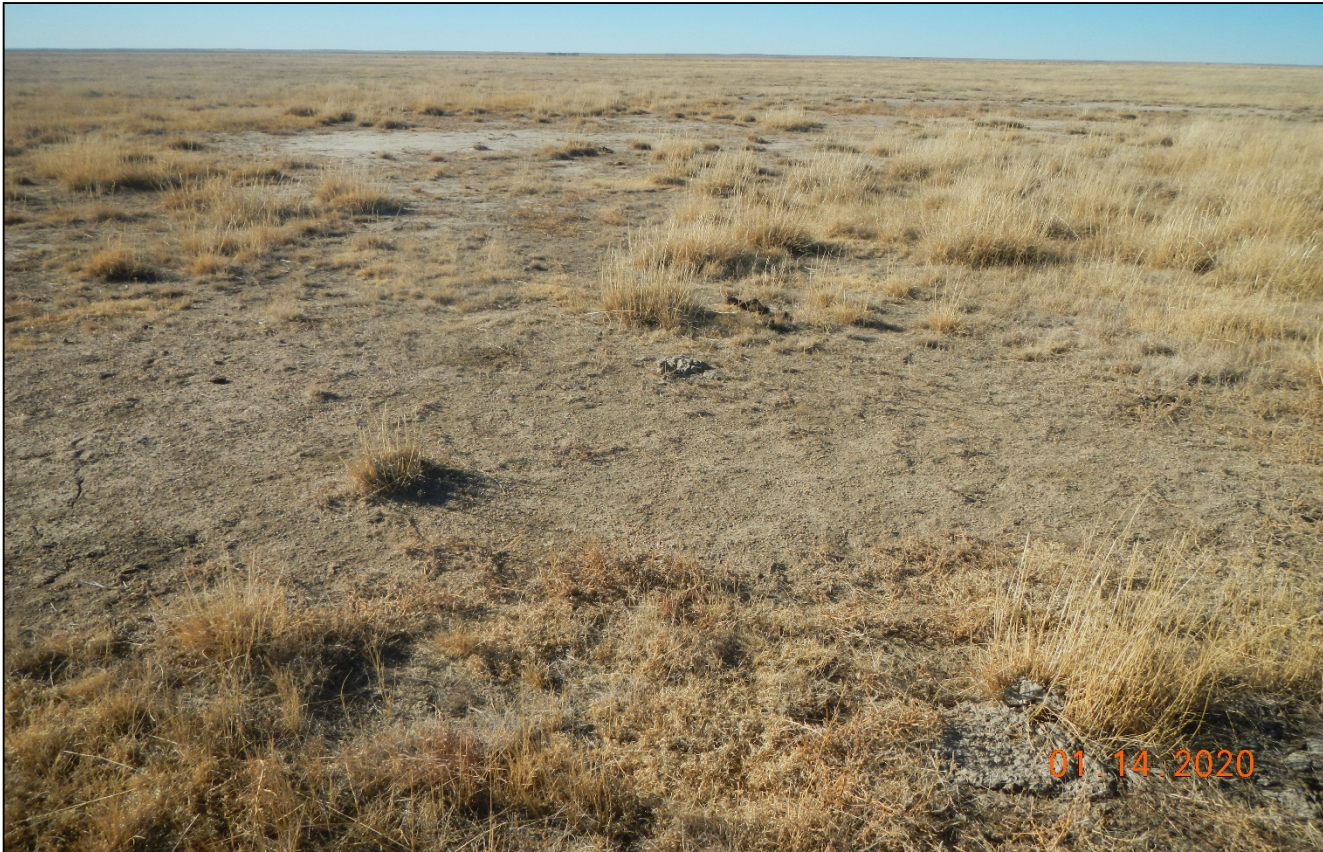
Photo 3. Center of the location facing west.

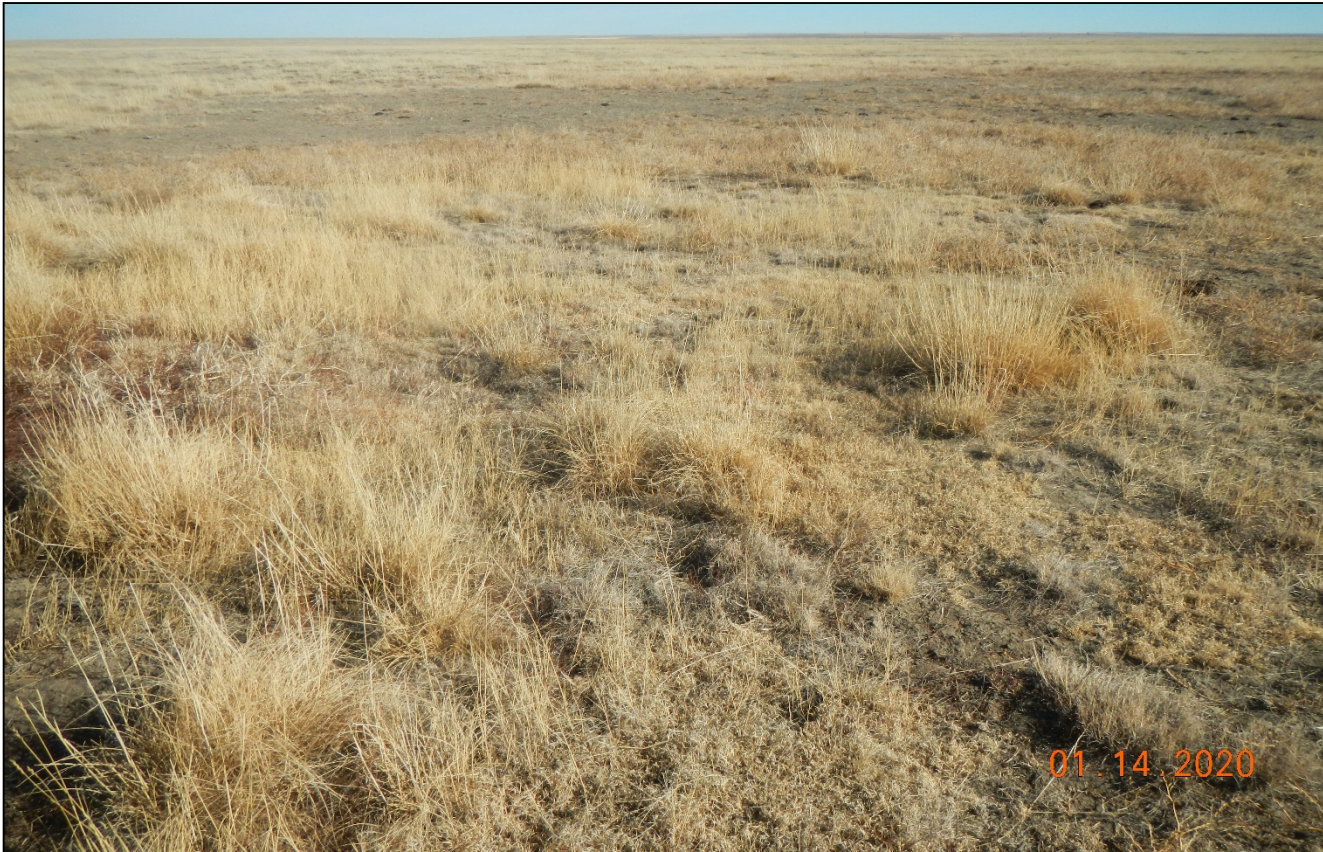
Photo 4. Center of the location facing east.

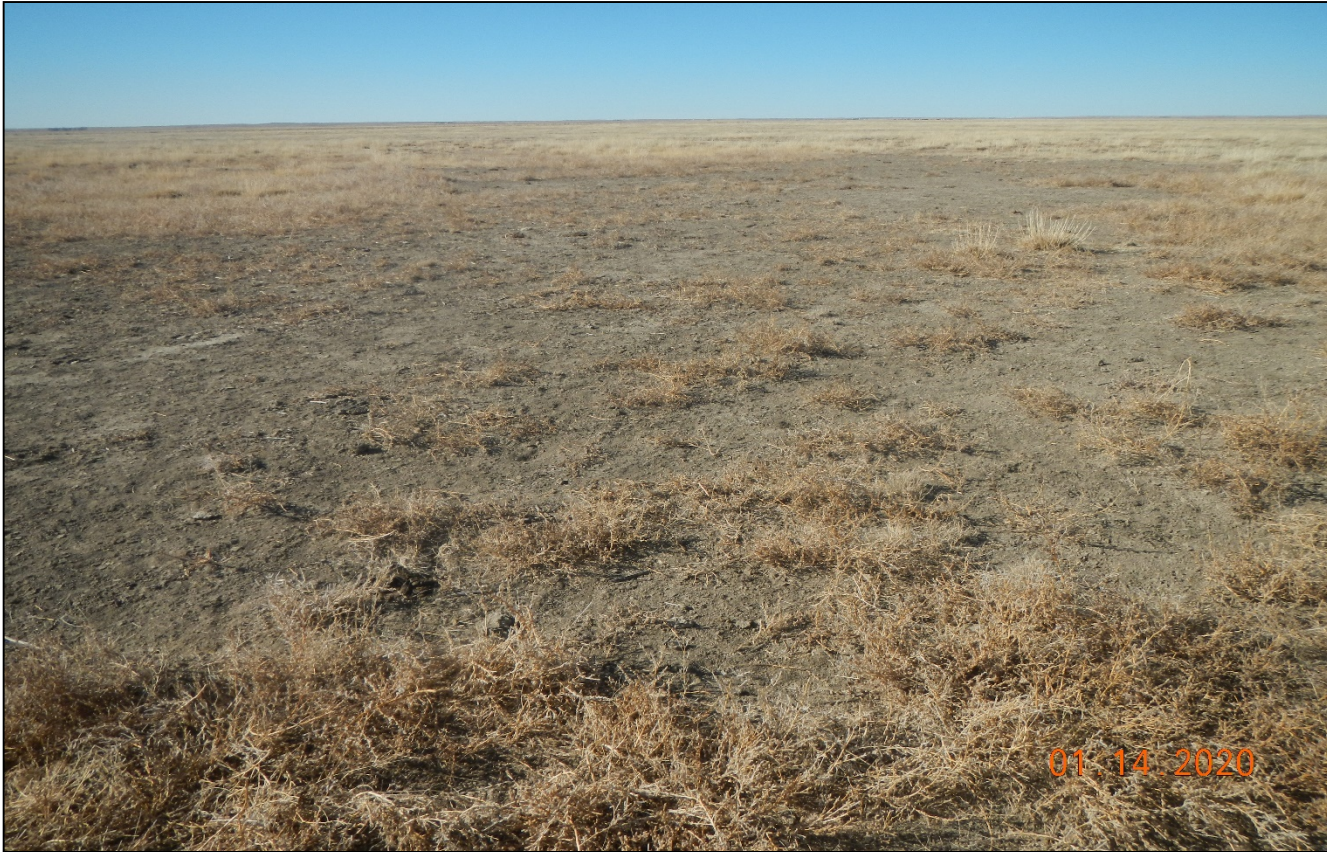
Photo 5. Facing north toward the eastern side of the location. This area is bare of vegetation. Approximately 200 ft. x 75 ft. area.

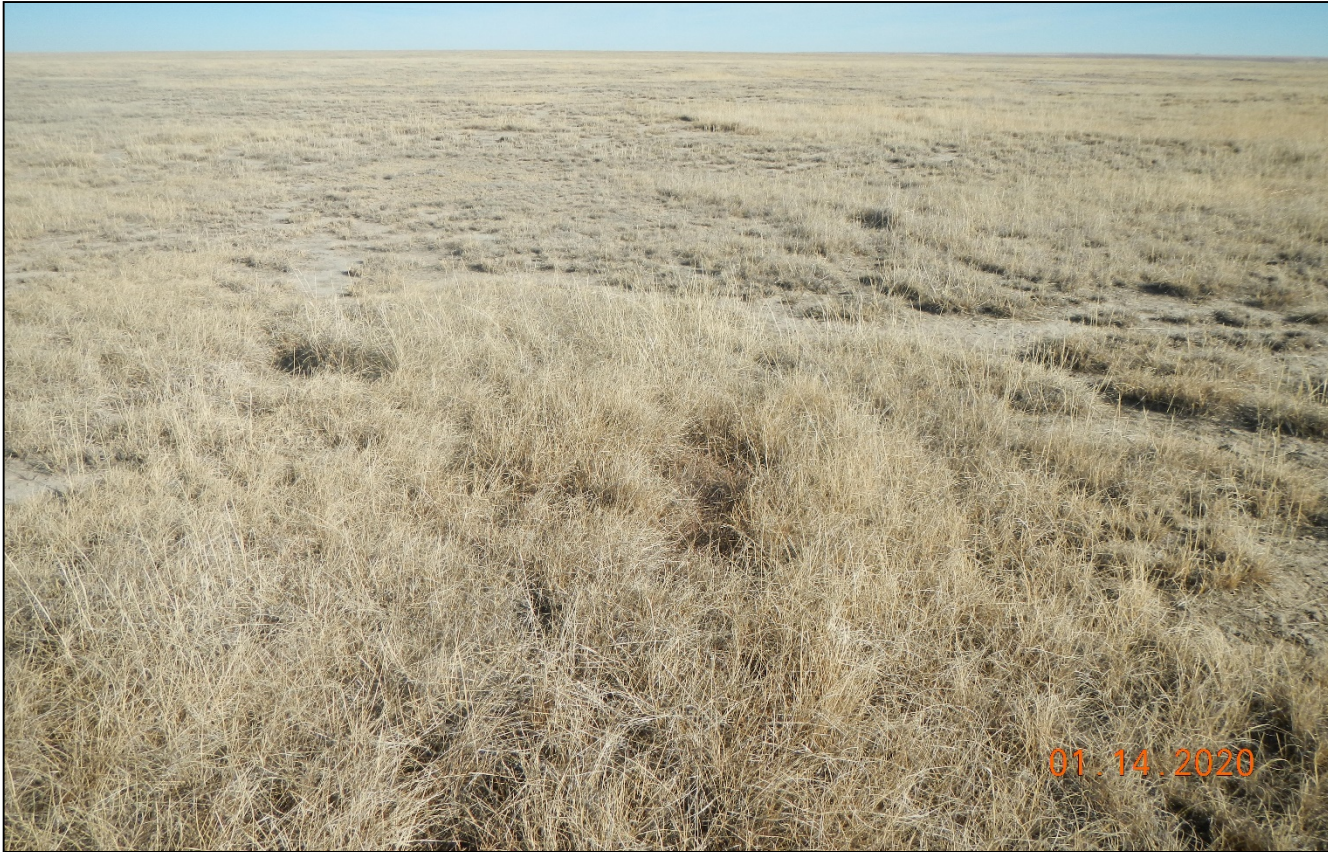
Photo 6. Facing east toward the undisturbed pasture.
